SILVERTOWN TUNNEL

**Preliminary Environmental Information
Report: Appendix 16.D**

**River Wall
Structural
Condition Survey**

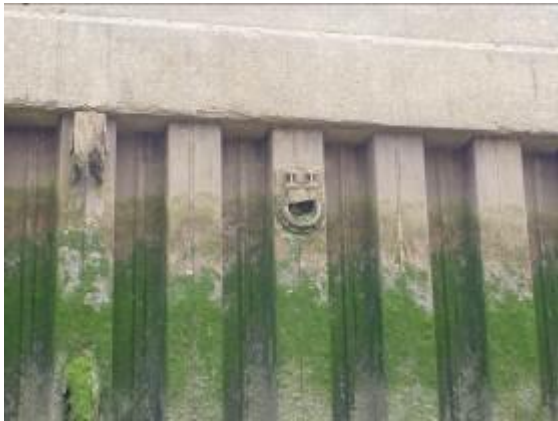
Figure 4 - Broken flap valve on sheet pile wall

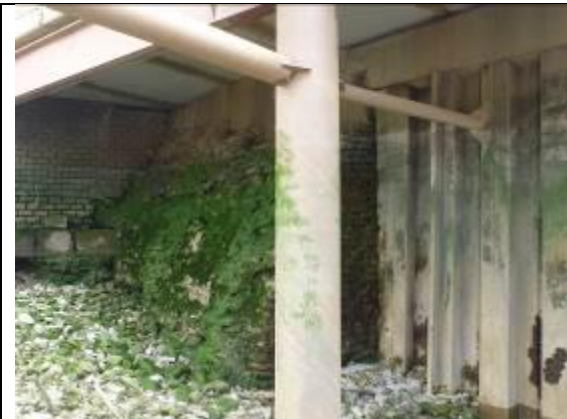
<p>Structural Condition</p>	<p>Concrete bag work appears to be in good condition with no signs of missing or damaged bags. However, a close inspection was not possible [Figure 5].</p> <p>Sheet pile cut off has been installed at approximately 10m chainage for approx 10m; it has likely been installed to either retain the toe of the rock armour revetment and concrete bag work section or to protect the structures from impact damage. Alternate piles are “left high”[Figure 7]. The cut-off is in good condition with only minor superficial corrosion and no sign of vessel impact.</p> <p>The blockwork wall is generally in good condition and appears stable along the majority of the frontage. Some erosion and scour of the toe is evident at the eastern extent where it meets the bag work [Figure 6].</p> <p>The alignment of the steel sheet piling appeared to be good with no indication of leaning. The piles themselves appeared to be in good condition with limited levels of corrosion. There are no visible waling bolts or anchor bolts in the steel sheet pile section.</p> <p>There are 2 flap valves which are missing from the sheet pile section. One has a large void behind which might indicate loss of fill material [Figure 4].</p> <p>A topside survey could not be carried out on the upstream extent of the steel sheet piling and concrete bagwork sections due to the presence of a temporary structure covering the ground over this asset [Figure 8 and Figure 9].</p> <p>No settlement behind the wall was observed along the sections which could be accessed.</p>

Figure 5 - Concrete bagwork section with steel frame for spoil transfer hopper in foreground

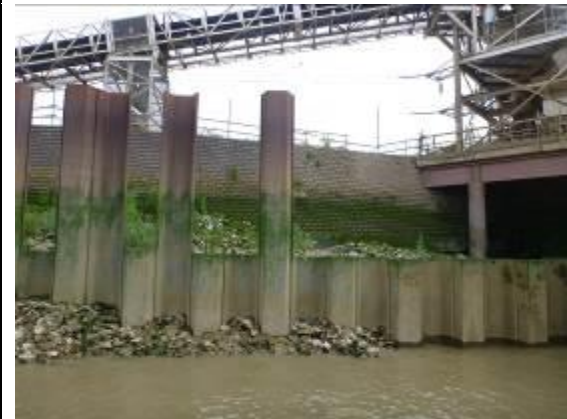
Figure 7 - Steel sheet pile toe protection to block wall

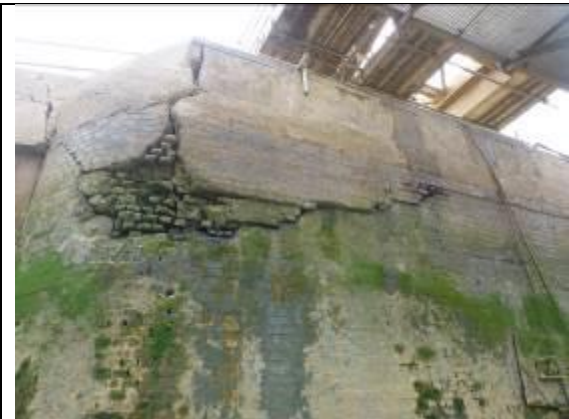
Figure 10 - Section of heavily cracked and unstable masonry at upstream end

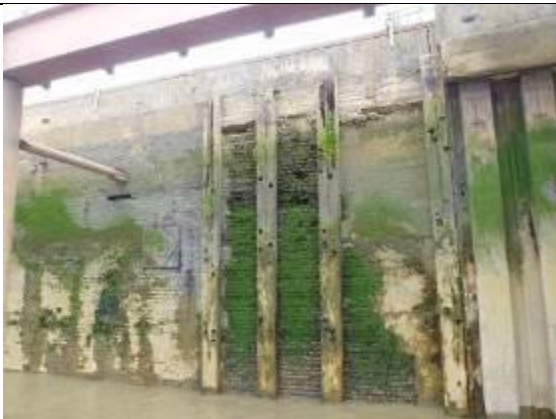
Wall Construction	<p>Masonry mass gravity wall with raised concrete parapet, three no. ground anchors at approximately 5m centres. The wall line is advanced, compared to the adjacent asset 06304TH000303L03. A steel frame supporting rails for a spoil transfer hopper has been constructed in front of the flood wall. The frame is protected by large diameter steel tubular piles with rubber fenders. Horizontal bracing members have been installed between the spoil support frame and the masonry wall, presumably to provide lateral support to the frame.</p>
Structural Condition	<p>The wall is in poor condition.</p> <p>There is a section of older masonry at the downstream extent of the frontage with loss of pointing; timber fenders have been attached to the wall at this section, possibly to protect the unstable section of wall from further impact damage [Figure 11].</p> <p>There is a 5m (w) x 3m (h) section of heavily cracked masonry at the top of the wall adjacent to asset 06304TH000303L03 (upstream). This section appears unstable. The masonry units immediately below have suffered considerable erosion and loss of pointing [Figure 10].</p> <p>The frontage as a whole appears to be misaligned and there is evidence of bulging. There is a horizontal crack which runs along a mortar joint across the entire length of the frontage. The crack is approximately mid-height between bed level and the elevation of the restraint anchors [Figure 12 and Figure 13].</p> <p>There is some voiding behind the ground anchor plates.</p> <p>There are several missing bricks at high level below the line of the horizontal bracing for the spoil transfer hopper rails [Figure 11].</p> <p>There does not appear to be any settlement behind the frontage.</p>

Figure 11 - View of older masonry and timber fenders at downstream end

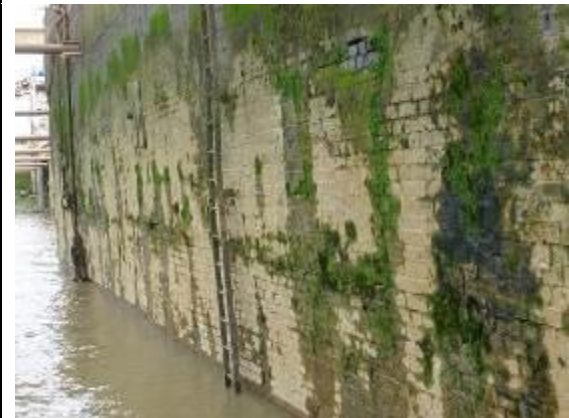
Figure 12 - View of misalignment and bulging in wall

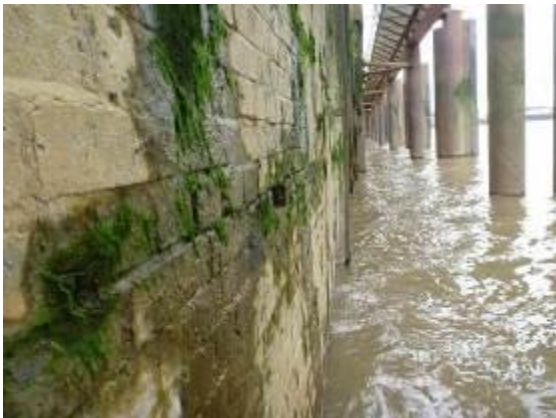
Figure 13 - View of horizontal crack in bed joints mid-height between bed level and anchor height

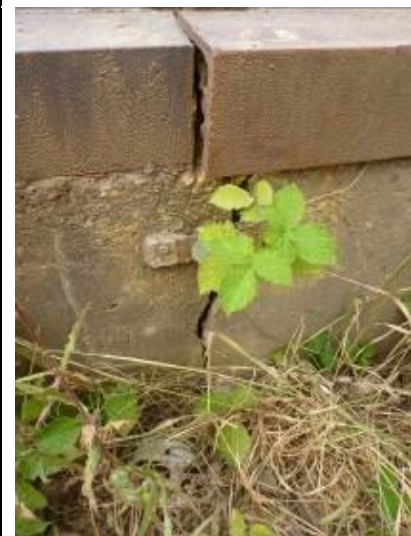
Figure 14 - Crack in concrete parapet with crack monitoring plates

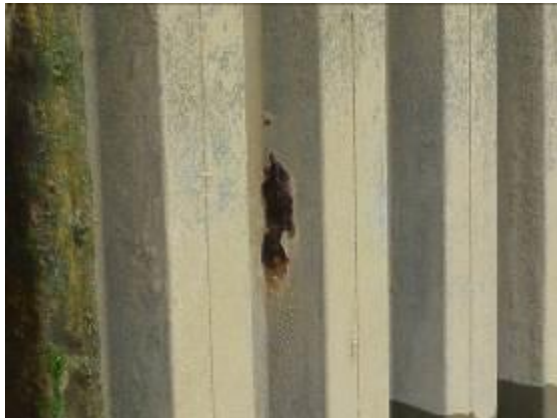
Figure 17 - Localised corrosion, possible Accelerated Low Water Corrosion

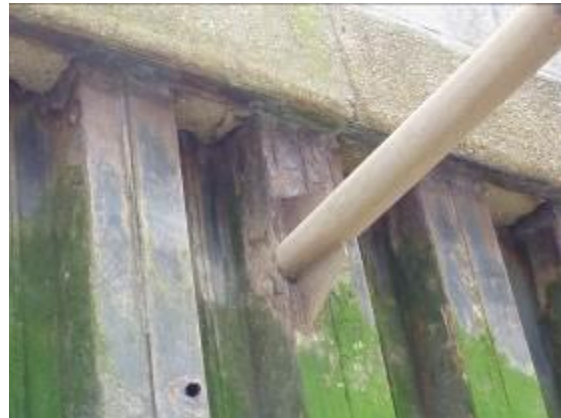
Figure 18 - Welded connection to brace hopper support frame. Elevated corrosion of piles around connection evident

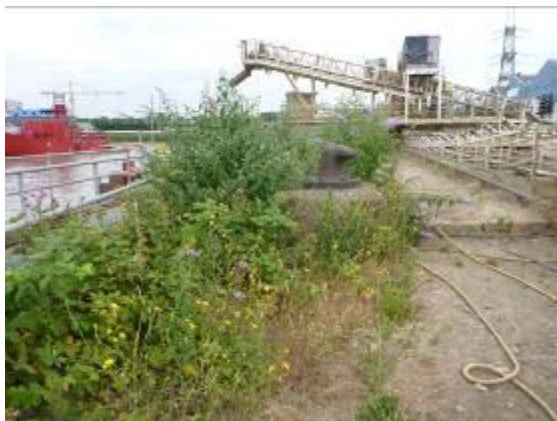
Figure 19 - Vegetation growth behind the raised flood wall

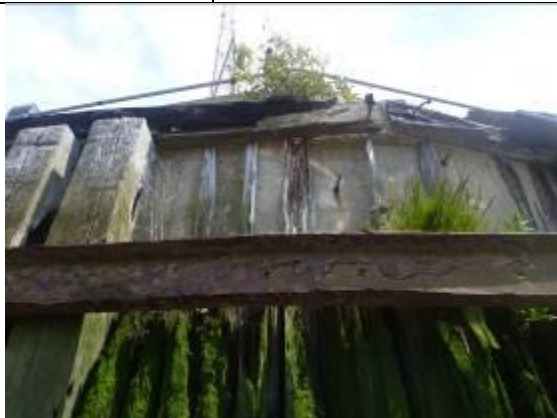
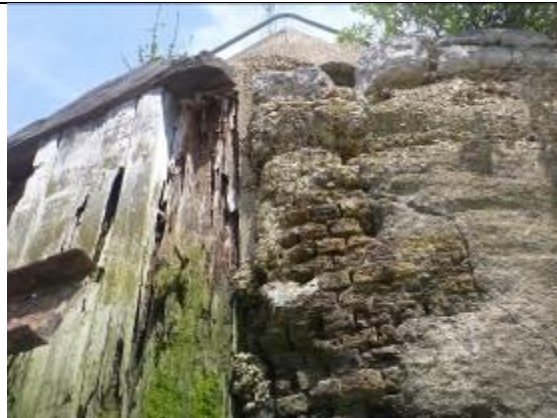
Wall Construction	Masonry mass gravity wall with timber cladding and sections of concrete repair.
Structural Condition	<p>This frontage is in poor condition.</p> <p>Where exposed, the masonry is badly eroded and there is a large vertical crack in the eastern curved section where the wall returns to meet the adjacent frontage [Figure 21 and Figure 22].</p> <p>Attempts have been made to patch either damaged or missing masonry with mass concrete or a repair grout. These repairs are up to 3m² in area. Some of these repaired sections appear unintegrated with some separation lines evident [Figure 22].</p> <p>There is no visible cracking on the parapet.</p> <p>The upstream section of the wall is clad in timber and thus it was not possible to view the structure behind. The timber cladding is severely rotted. There is a steel channel section approximately 1-2m below the top of the wall which is severely corroded and whose connections to the wall have become loose. It is not clear whether this channel is intended to provide restraint to the wall or only the cladding [Figure 20 and Figure 21].</p>

Figure 20 - Corroded steel restraint channel which is separating from the wall

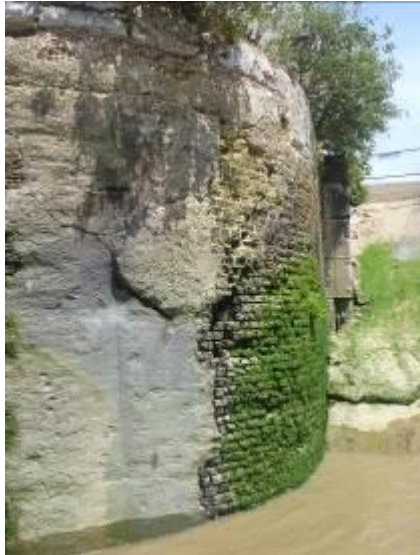
Figure 21 - Interface between exposed masonry sections and timber clad section. Masonry is badly eroded or missing. Large repairs using (sprayed) concrete

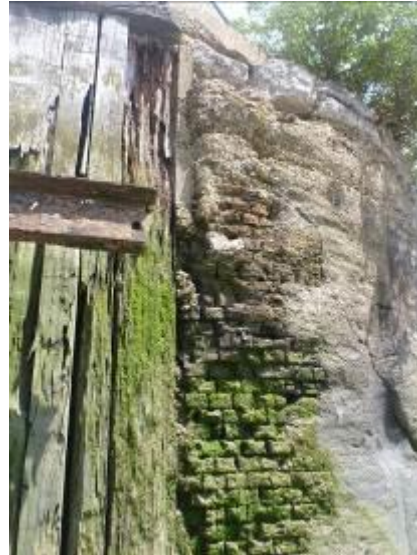
Figure 22 - Large vertical crack in masonry section

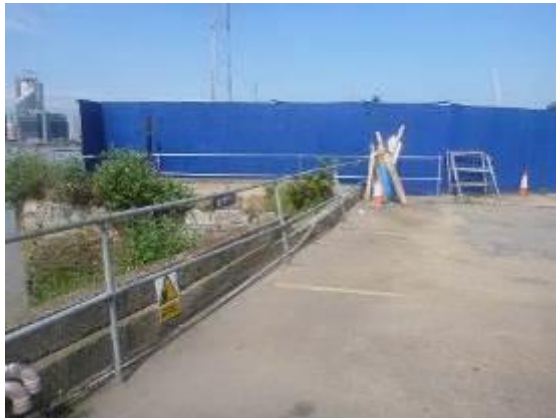
Figure 26 - Impact damage to concrete parapet and possible settlement behind the frontage

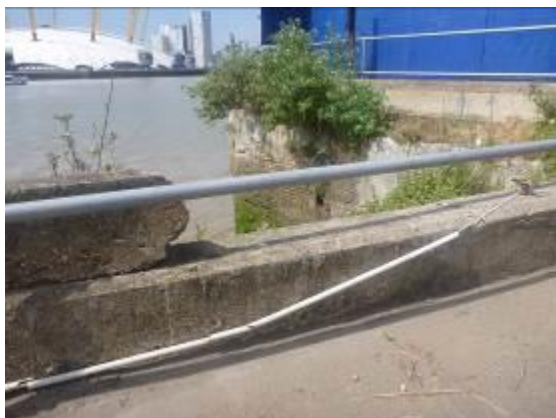
Figure 28 - Missing section of raised concrete parapet

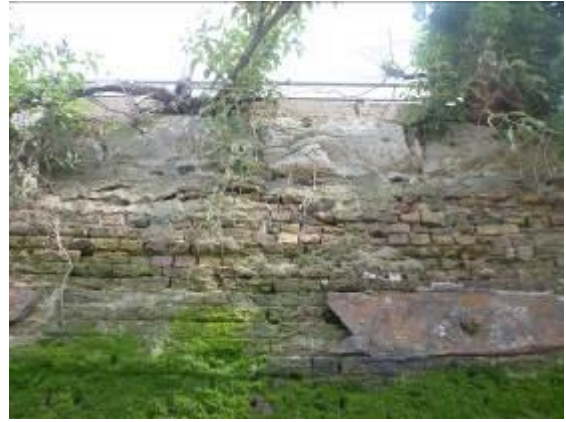
Wall Construction	Masonry mass gravity wall with remnants of timber fenders.
Structural Condition	<p>This frontage is in poor condition.</p> <p>There is heavy erosion to the masonry units with loss of pointing [Figure 30 and Figure 31].</p> <p>Large sections of missing masonry have been replaced with newer brickwork [Figure 29].</p> <p>There are remnants of an anchored horizontal steel waling beam approximately 1.5-2m below crest level. This steel section is now missing although the ties are still visible [Figure 30].</p> <p>Voiding of the masonry was observed behind the remnants of a timber fender at high level [Figure 31].</p> <p>Algal growth precluded a more thorough assessment of the condition of the masonry [Figure 32].</p> <p>There is no evidence of settlement behind the structure.</p>
Land Use	The land immediately behind the frontage is occupied by the site office for ASD Metalworks Ltd.

Figure 30 – View of eroded masonry wall with concrete parapet and remnants of steel waling beam.

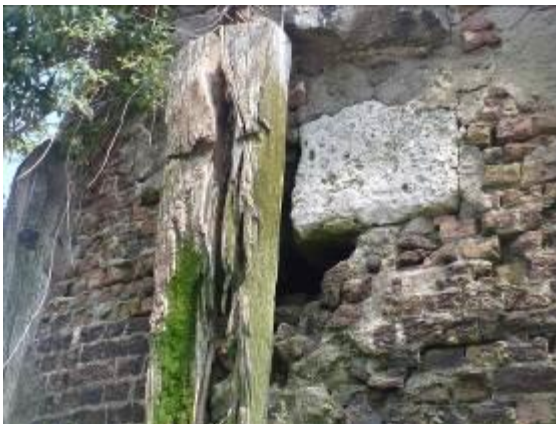
Figure 31 - Voided masonry behind remains of timber fender

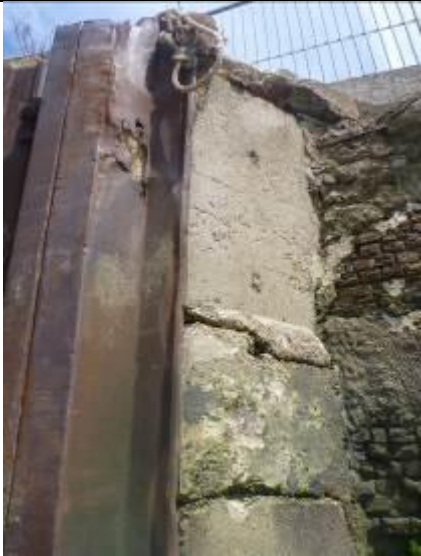
Figure 34 – Damage to concrete interface between sheet pile wall and downstream adjacent masonry wall

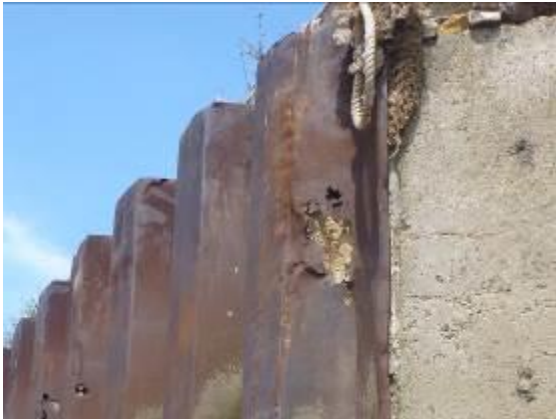
Figure 36 – Full-thickness corrosion at the downstream extent of the frontage

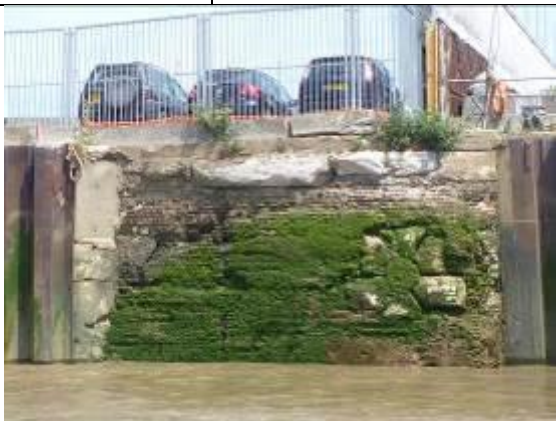
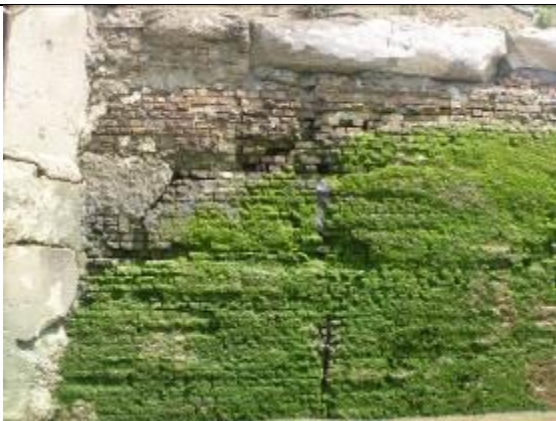
Wall Construction	Masonry mass gravity wall	
Structural Condition	<p>The wall is in poor condition.</p> <p>The masonry wall is badly eroded and cracked, with several surface voids [Figure 38 and Figure 39].</p> <p>There is a large crack and hole at the base of the wall at the eastern extent of the frontage.</p> <p>The alignment of the wall appeared to be fair with no sign of bulging.</p> <p>There is no sign of crest settlement behind the frontage.</p>	
Land Use	Car park for ASD Metalworks Ltd	
Condition Grade	4

<p>Figure 38 - Masonry wall with car park behind the frontage</p> <p>Figure 39 – Cracking in masonry wall</p>	
Flood defence levels	Level from 2013 topographic survey	5.1m AOD
	Evidence of crest settlement	No
	Raising required to meet current statutory flood defence level (+5.18m AOD)	0.08m
	Raising required to meet future flood defence level (+6.2m AOD)	1.1m

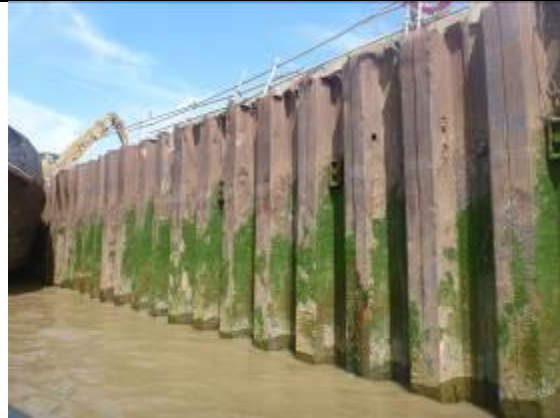
Figure 40 - Steel sheet pile wall with crumple damage to the top of the piles

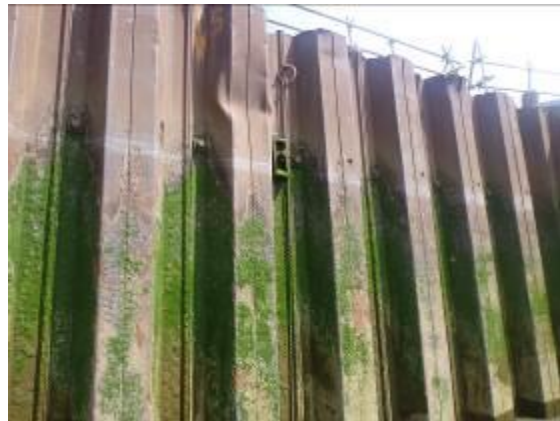
Figure 42 - Impact damage to steel sheet piles

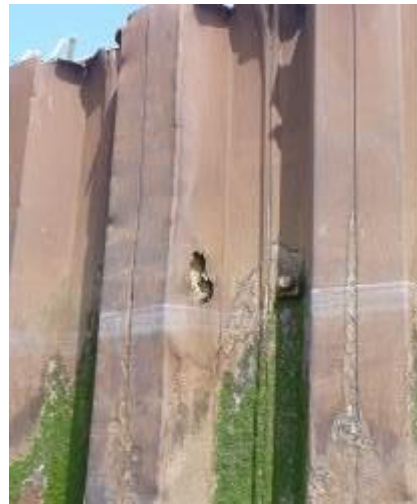
Figure 43 - Localised full-thickness corrosion to sheet piles

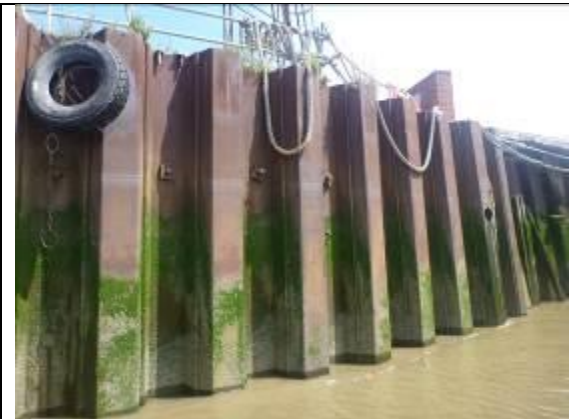
Land Use	The land behind the frontage is used for spoil transfer and disposal. There is regular HGV traffic and excavators traversing the area immediately behind the frontage.
Condition Grade	4 (pending further investigation of the cause for the piles’ non-verticality)

Figure 44 – Pile non-verticality

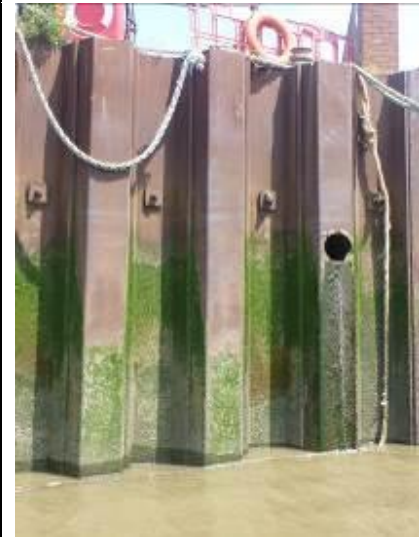
Figure 46 - Hole in sheet piling indicating missing flap valve

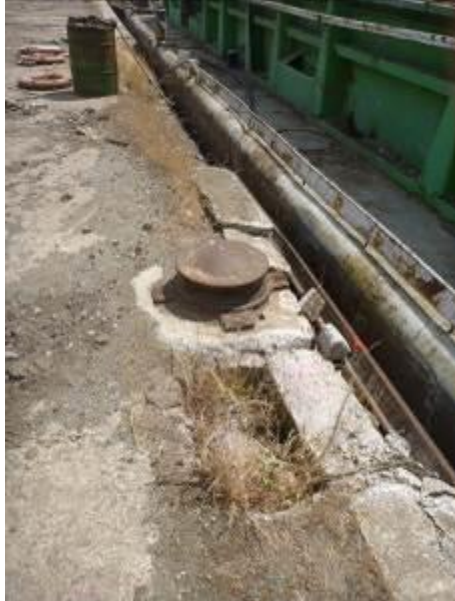
Figure 51 – Damage to coping adjacent to mooring bollard

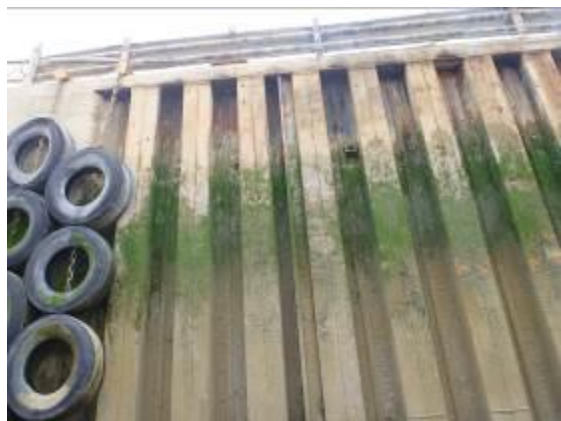
Figure 56 - Perished waling bolts

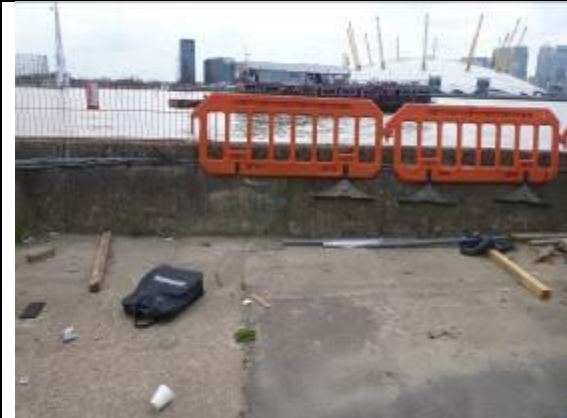
Figure 61 - Crack in river wall with resurfacing on the land directly behind the frontage

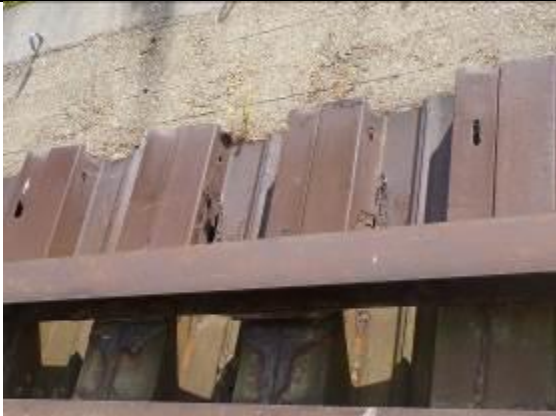
Figure 64 - Full depth corrosion of steel sheet piles with voids in the concrete back fill

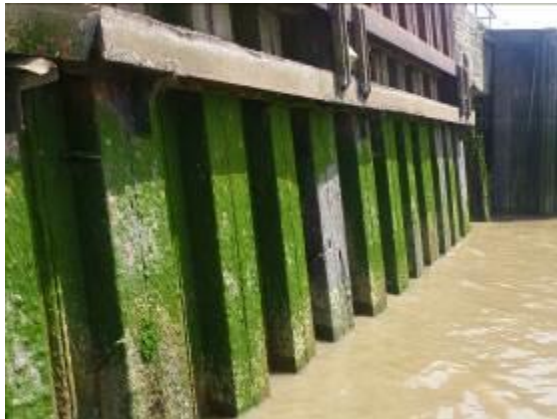
Figure 65 - Steel sheet pile wall with external waling beam. Piles leaning backwards

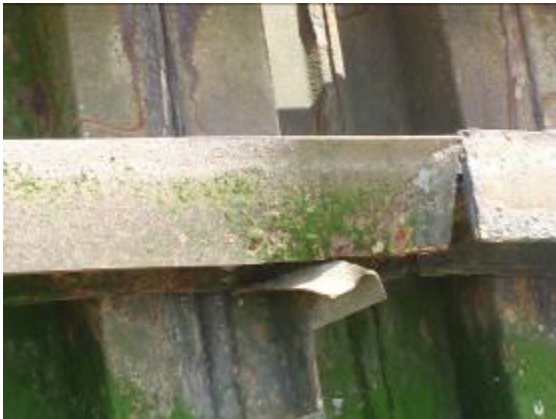
Figure 66 - Impact damage to waling beam

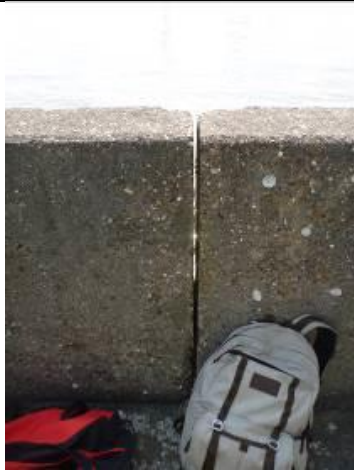
Figure 67 - Movement joint with no sealant present

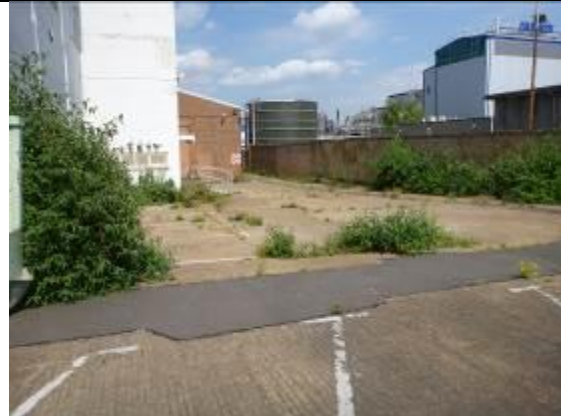
Figure 68 - Cracked and uneven surfacing behind the frontage

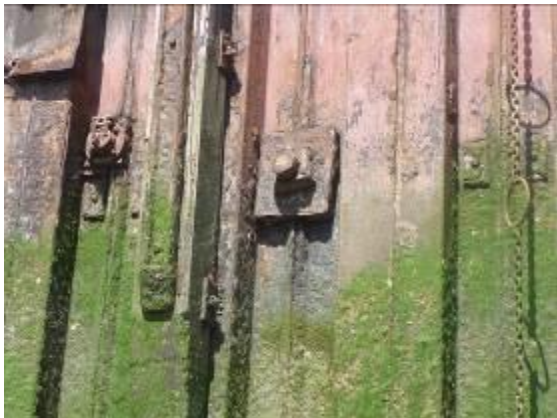
Figure 72 - Corroded waling and anchor bolts
