## **A10.2 – Building Damage Assessment Reports**

# Bank Station Capacity Upgrade Building Damage Assessment Report

This report summarises the results of a Stage 2 damage assessment for 27 Poultry/5 Princes Street (Building ref. A4).

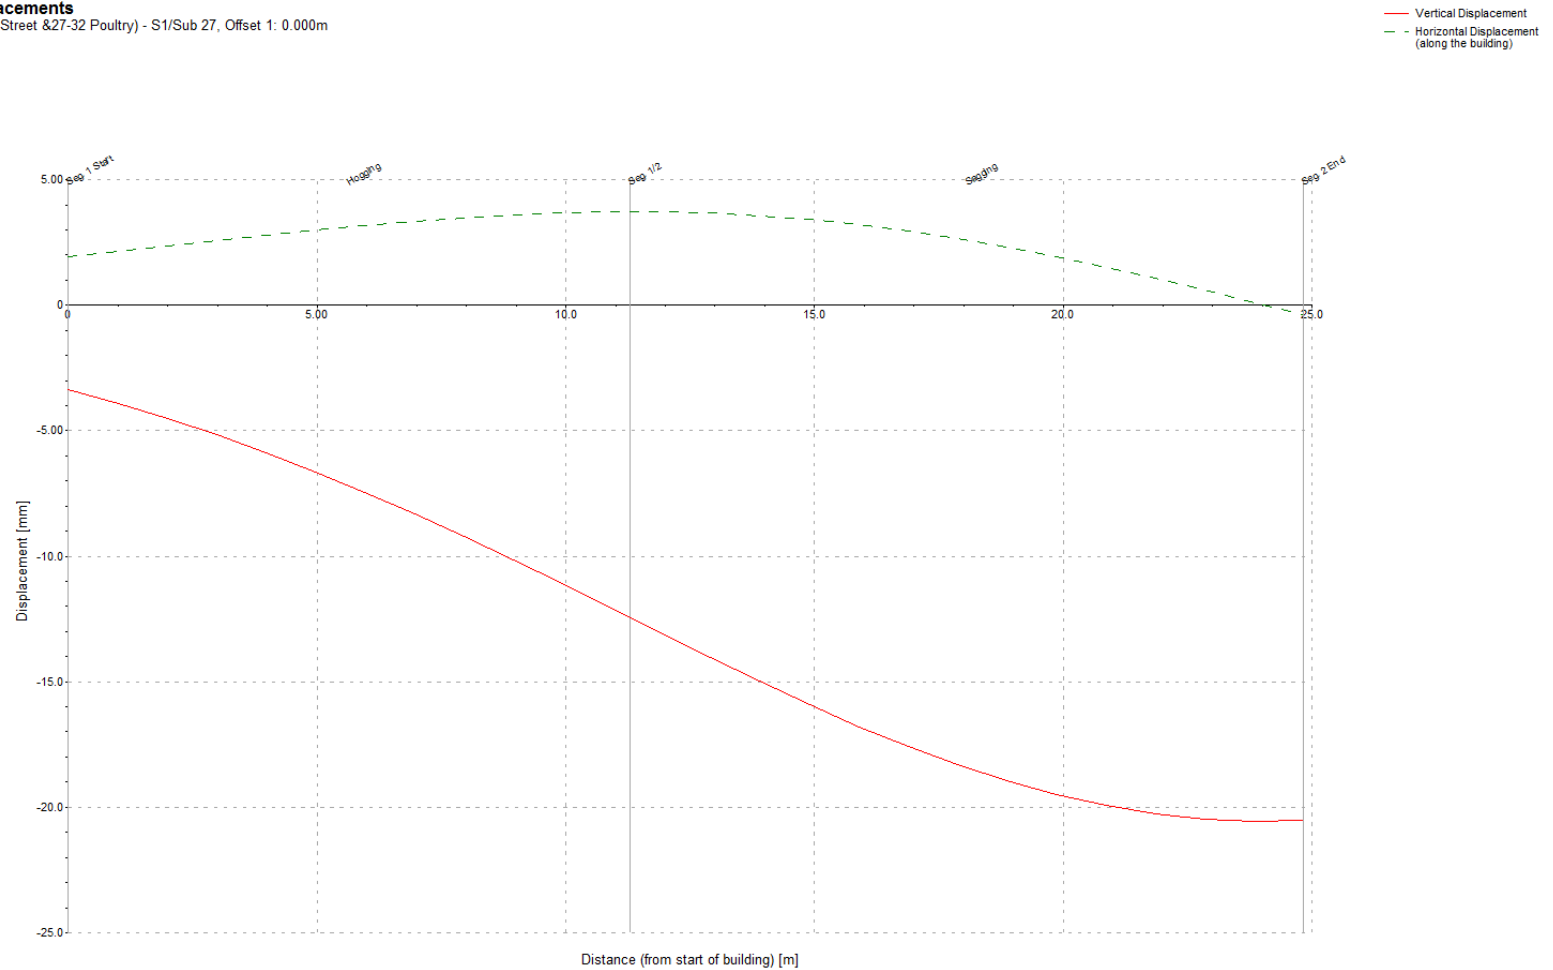
**Figure 5: Building displacement at founding level at stage 4 (line 4) of worst case for tensile strains**

Line No	Strains in section (Curvature)	Position from start (m)	Length (m)	Average* Horizontal Strain (%)	Maximum Tensile Strains (%)	Damage Category
4	Hogging	0	11.4	0.016	0.018	Negligible
4	Sagging	11.4	13.4	-0.030	0.011	Negligible

The Stage 2 engineering assessment has predicted that the maximum tensile strain falls within damage category 0. This corresponds to Negligible damage in accordance with Table 2.

The settlement of the building at foundation level at the end of Stage 2 is approximately 21mm, which does not increase in the subsequent stages.
