Board

Date: 30 January 2018

Item: Tram Overturning at Sandilands, Croydon on 9 November 2016 – RAIB and TfL Investigations and Non-Operational Incident Responses Update

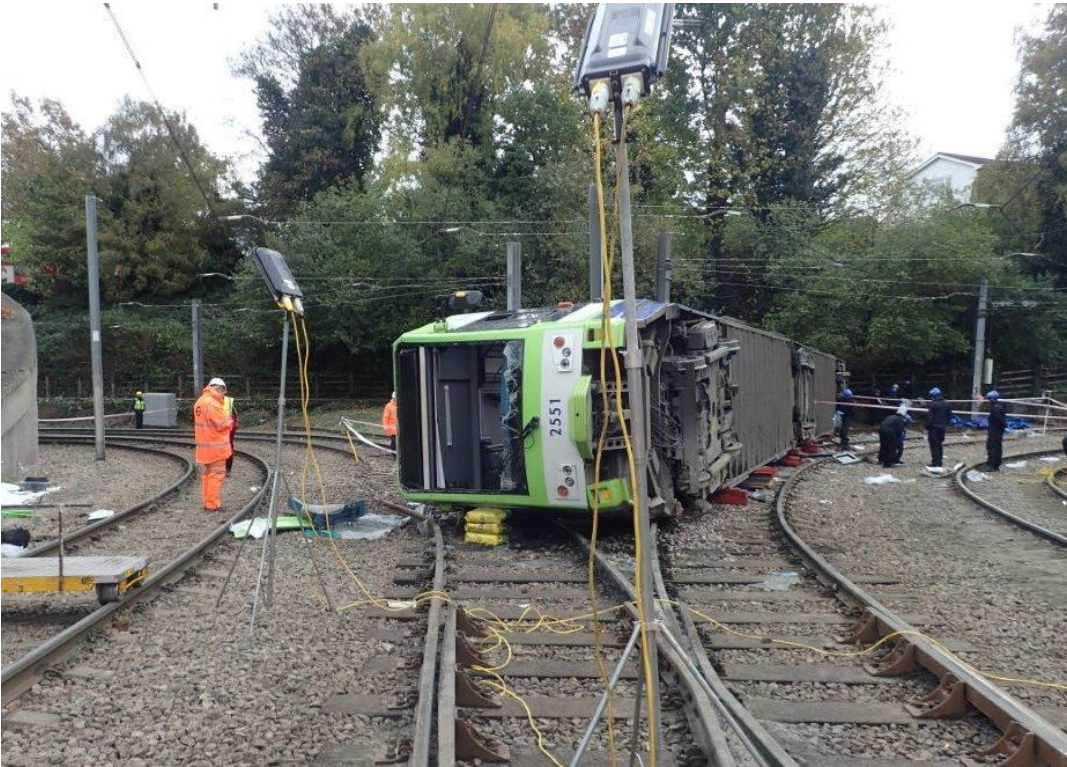
The overturned tram itself impacted an overhead electricity stanchion, lineside equipment cabinets as well as rails being stored nearby (see Figure 1 and Figure 2). Significant damage was sustained to both the tram and the adjacent infrastructure. Work is ongoing as a part of a separate workstream to investigate the performance of the tram structure during the overturn.

Figure 1 - Tram 2551 overview of resting position on adjacent tracks

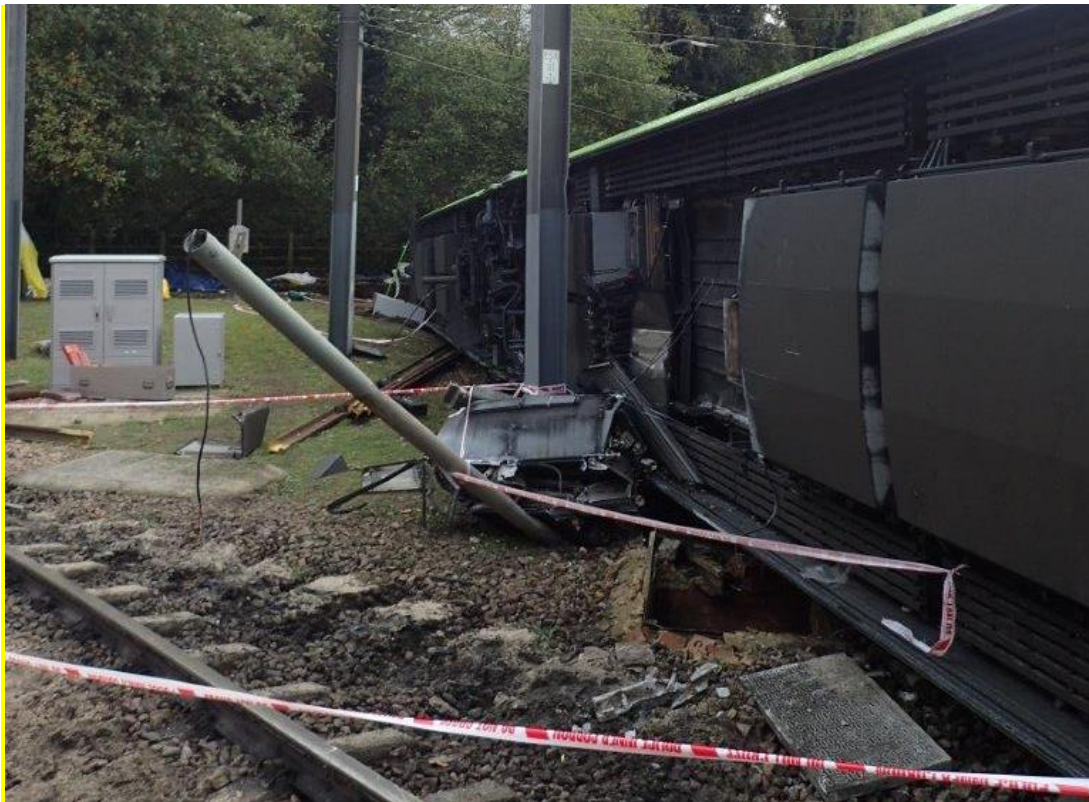
Figure 2 - Tram 2551 roof against infrastructure

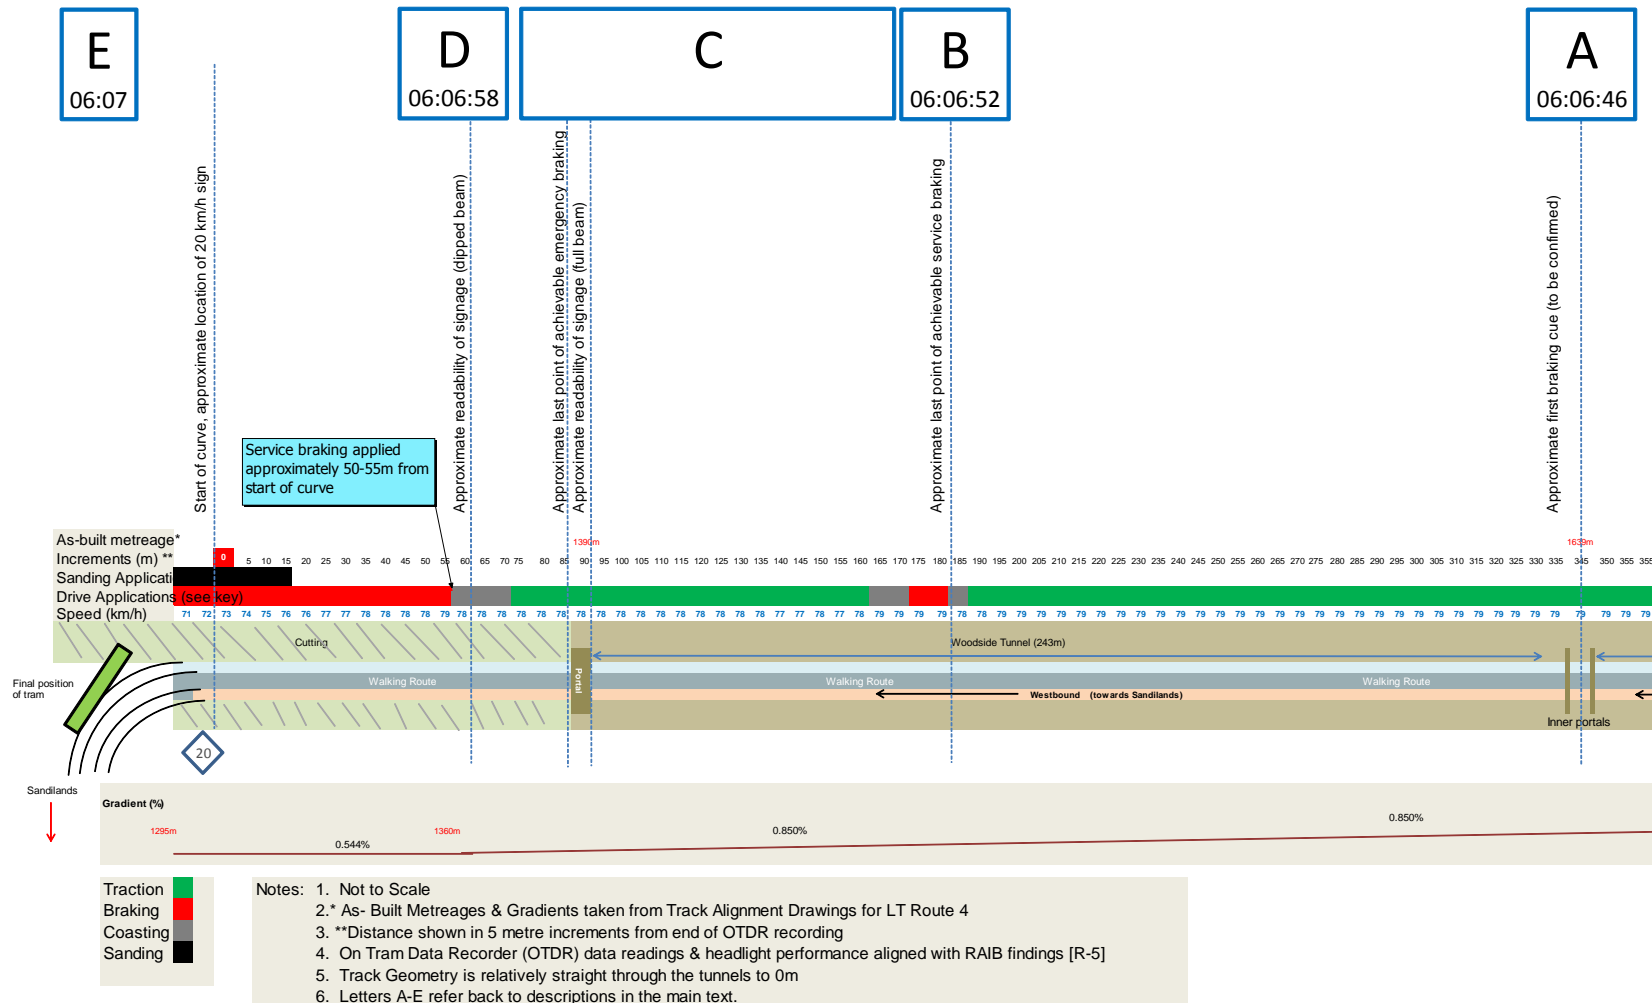
- 06:06:58 [denoted "D" on diagram] The tram braked, with a rate of retardation in line with that of a normal service braking applied by the driver (around 1.3 ms^{-2}), with the sanding system being initiated (either automatically by the wheel slip/slide protection system, or manually by the driver) at 06:06:59 until 06:07:01.

Figure 4 - Extract of Appendix A Sequence of events (schematic) over final 15s/330m (approximation) before curve.

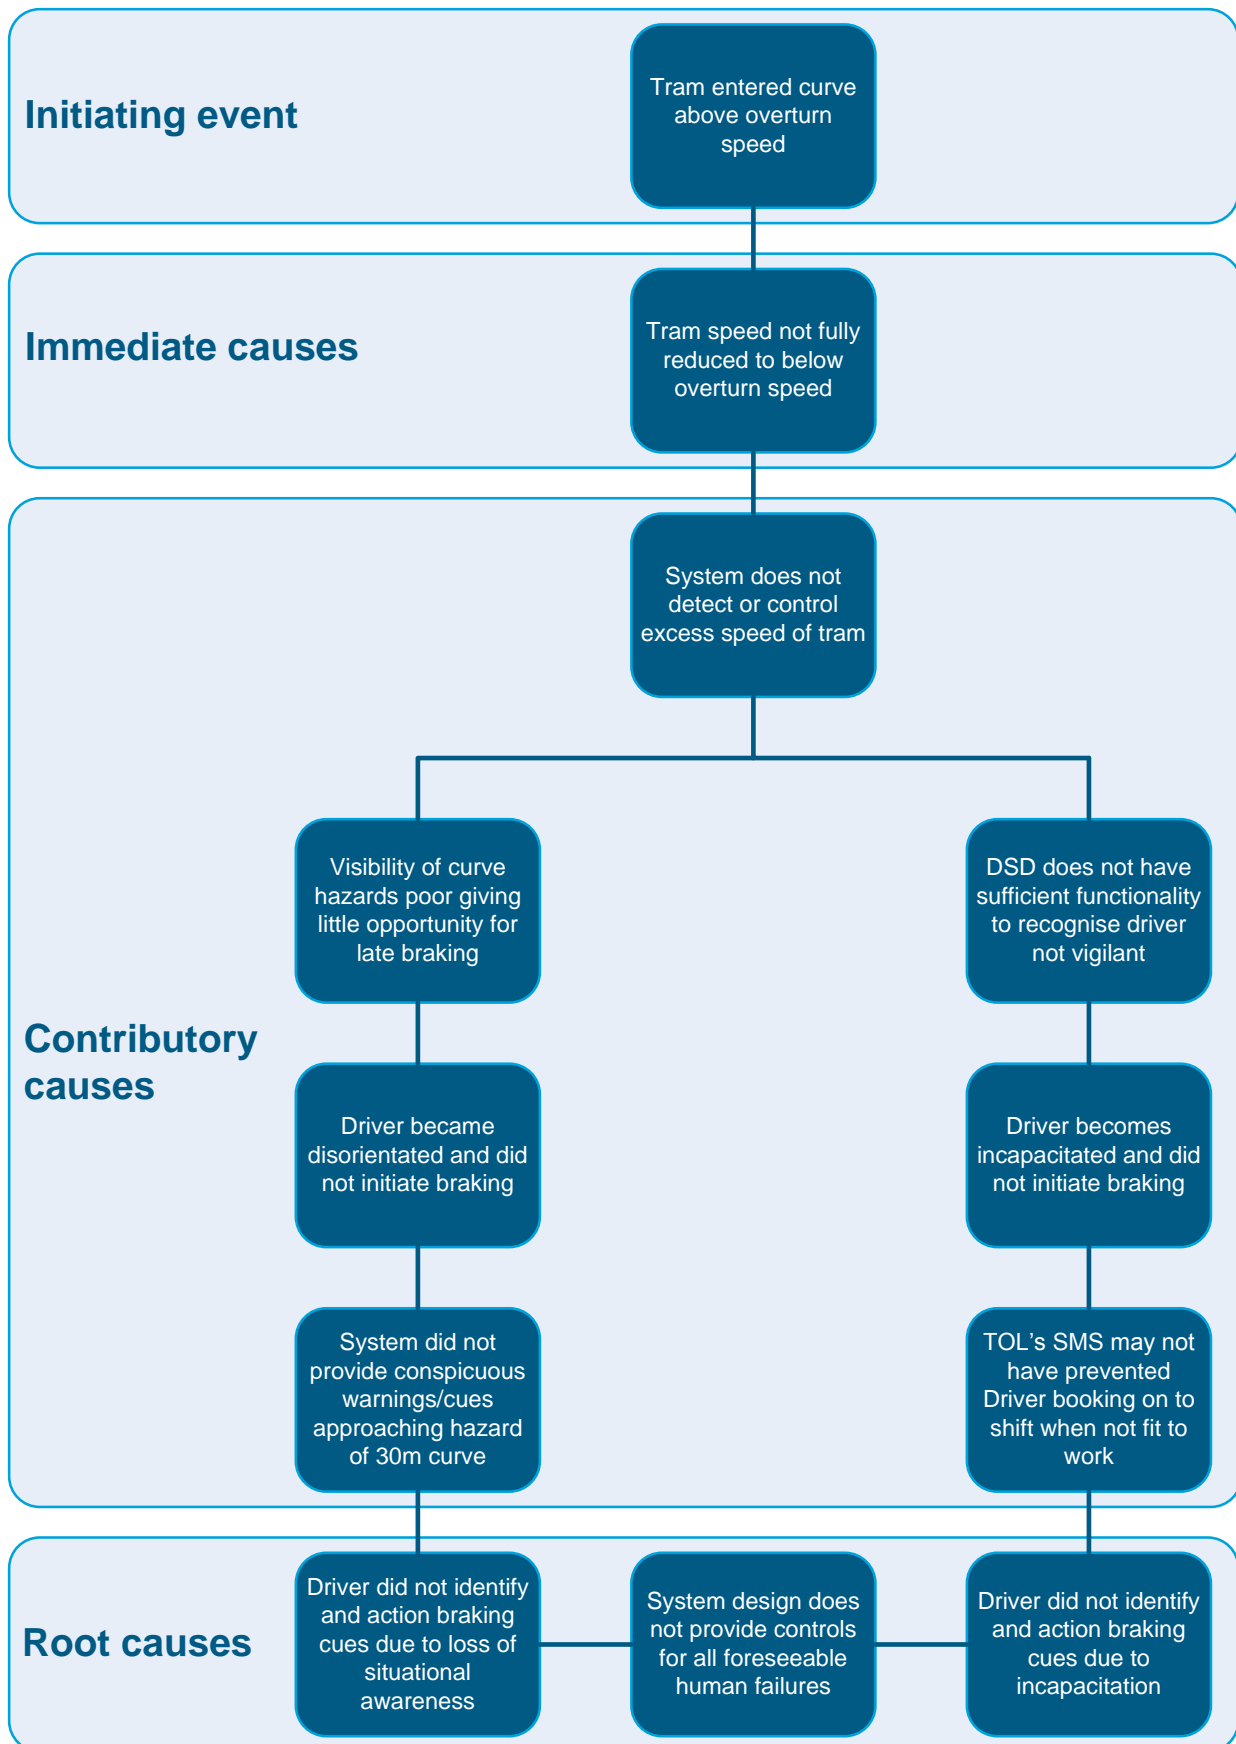
Figure 5 - Overview of Causal Chain

The causal chain (see Figure 5) described as two possible contributory chains. Completion of investigations may enable one to be eliminated or identified as more probable than the other, to confirm one as the most likely causal chain. This report describes the initiating event and immediate cause as shared conclusions, and then discusses both the probable contributory and associated root causes in turn.

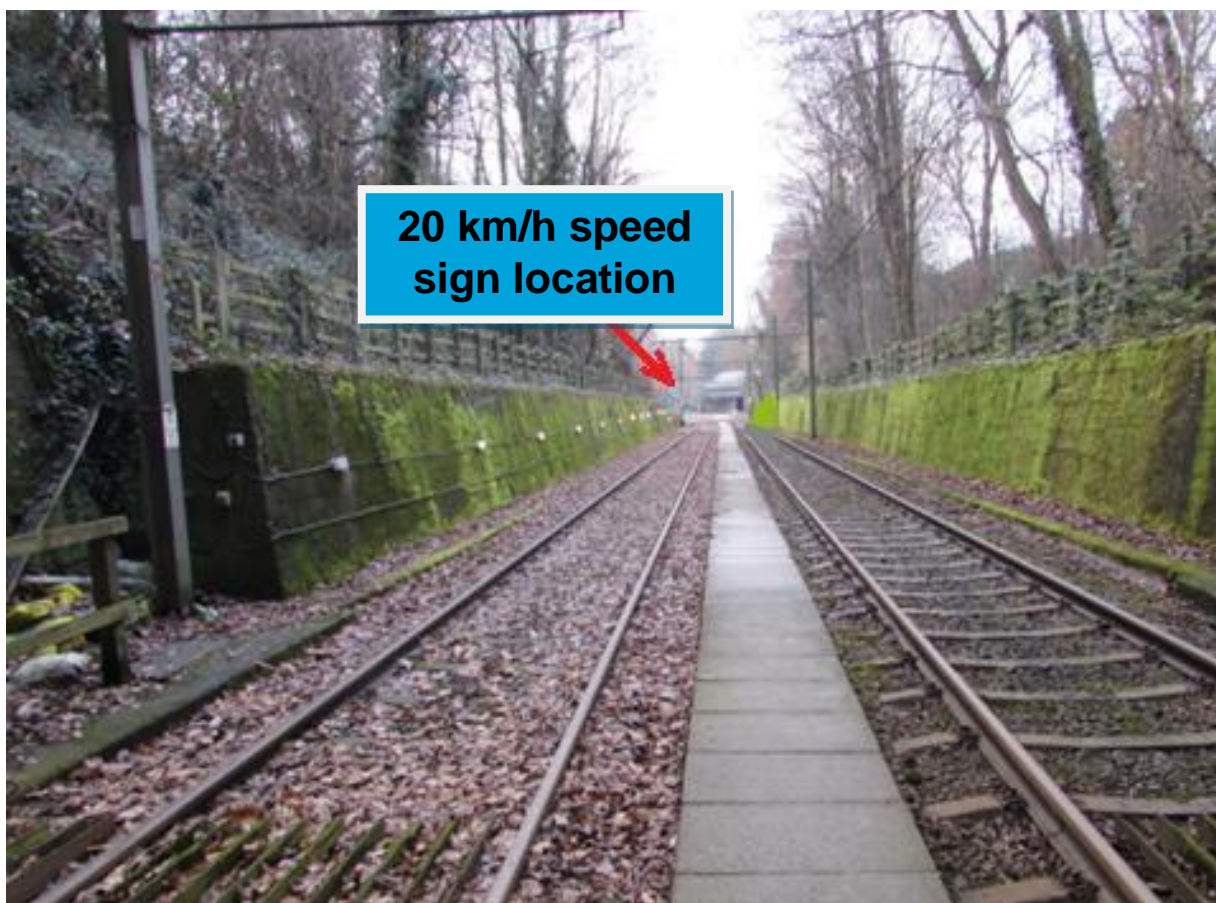
The reflective signage indicating the 20km/h PSR is readable (i.e. the numerals can be read) on a clear night, from the driving position of a tram driven at caution, from a distance of around 60m (dipped beam) and 90m (on full beam) [R-5]. This figure could be reduced by heavy rain, such as that experienced on the morning of the incident [R-5]. The ability of the driver to detect the signage will also be influenced by the tram speed, the driver's visual acuity, the local lighting as well as any other tasks that the driver was undertaking. See Figure 6 below.

Figure 6 - 20km/h board on exit from Woodside tunnel (photo taken around 85m from the start of the curve)

The incident has highlighted that there is no relevant signage that can be sighted from the required start of braking. Knowledge of the route and the next maximum permissible speed is therefore required and the ability to successfully complete this task is dependent on the driver correctly identifying the point for the start of braking.

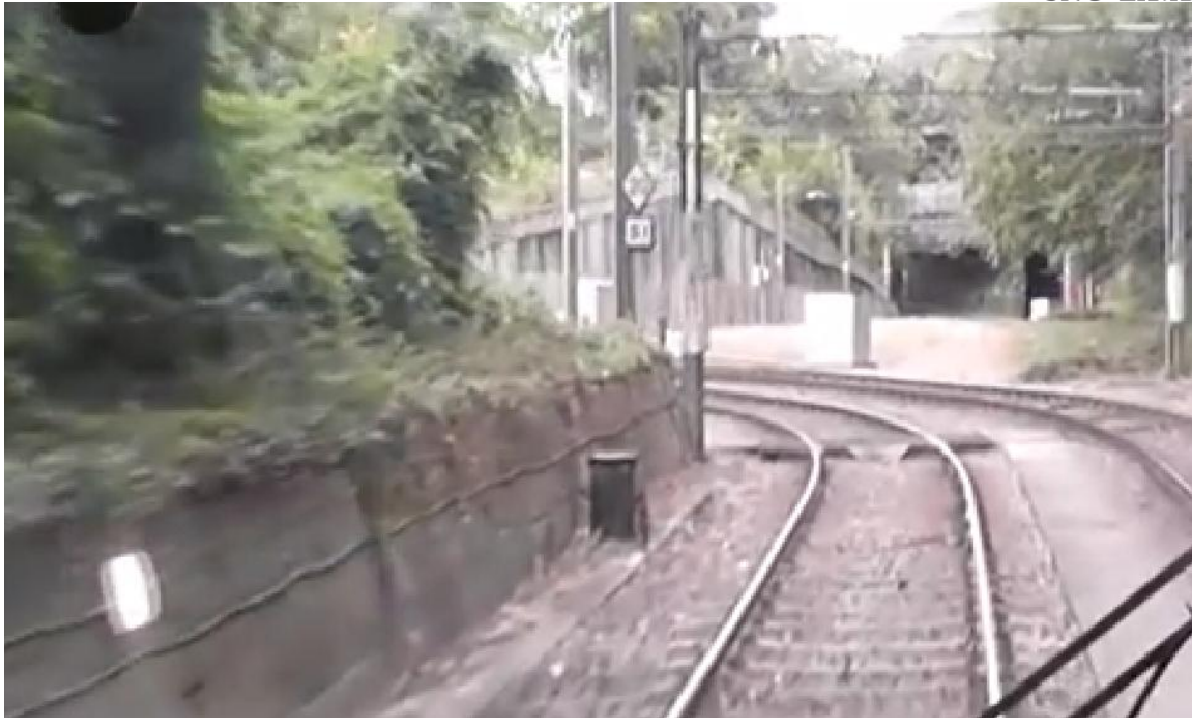
The signs are standard across the tramway, they comply with current guidance [R-9] and those at Sandilands Junction at the time of the incident were clean and in good condition.

Figure 7 - 20 km/h PSR board on 30m radius curve, with the entrance to the Elmers End/Beckenham Junction branch line showing opposite
