Transport for London

**Final Investigation Report into the incident at Bridge LTN/1-19 (generally known as GE19) that occurred on 28<sup>th</sup> May 2008.**

**Version 1.3**

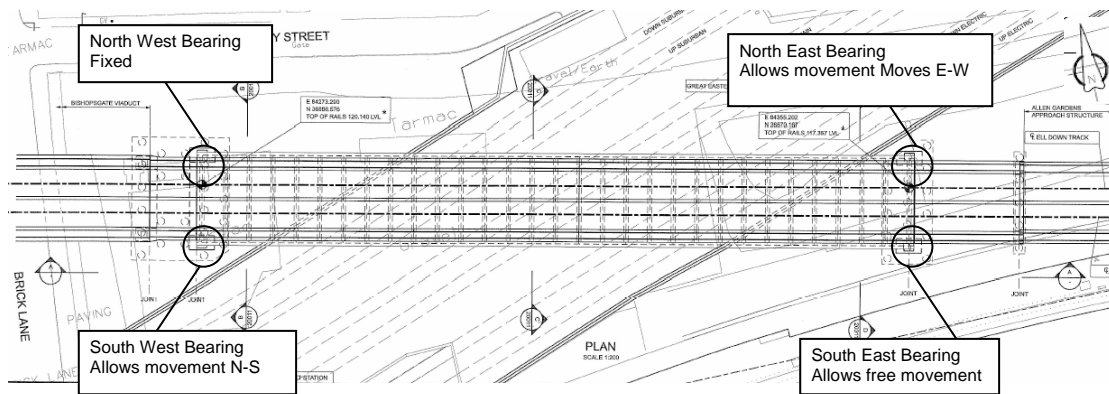
**Figure 2 GE19 Bearing Orientations**

4.2.9 Figure 2 below shows the bearing arrangements on the bridge, and the movement that the bearings allow.

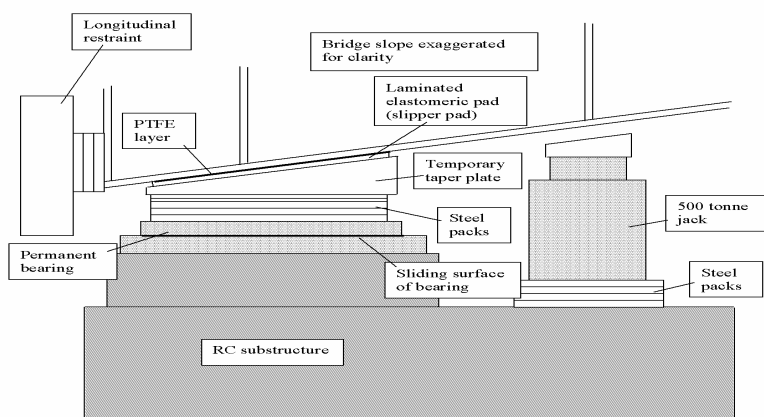
**Figure 3 : Bearing arrangements at east abutment on the night of the incident**

Figure 3 below shows the packing arrangement at both the north and south bearings on the east abutment, on the evening of the incident. PTFE slipper pads are in place (see appendix A). It should be noted that the diagram is exaggerated: on site the slope of the tapered plate is barely noticeable.

7.1 The Inquiry Panel are satisfied that the immediate cause of this incident related to the incorrect positioning of PTFE on the sloping surface of the taper plate. Due to the fact that PTFE was placed on a slope, the vertical load of the bridge generated a horizontal force. The presence of a second slip plane within the permanent bearing plates, allowed the taper plate and the support packing materials between the PTFE surface and the fixed bearing surface to be ejected. It is believed that a small movement in the structure, perhaps 2-3mm, as the result of temperature change during the evening of 28<sup>th</sup> May, resulted in the initiating movement of the bridge, such that the coefficient of friction between the PTFE and the packing plates changed from static to dynamic. The dynamic coefficient of friction of PTFE is significantly less than that in its static state.
