APPENDIX G – PERS ASSESSMENT

- G.1.1 This Pedestrian Environment Review System (PERS) audit has been submitted to support the Silvertown Tunnel Transport Assessment. It has been undertaken in order to establish the quality of the existing pedestrian environment within the vicinity of the proposed tunnel portals in the North Greenwich and Silvertown areas.

Silvertown Tunnel
Preliminary Transport Assessment

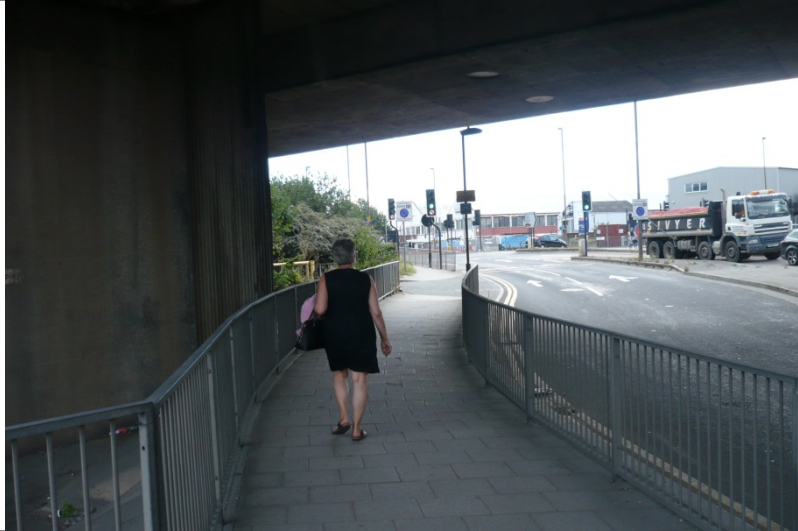
<p>Link 20 (A1020 Lower Lea Crossing): narrow link and because of the overgrown vegetation, the effective width is unacceptable. The vegetation also offers many places of concealment, therefore decreasing the perception of personal safety.</p>
	<p>Link 28 (A1011 Silvertown Way slip road): insufficient lighting, noise, debris</p>
	<p>Link 31 (Seagull Lane): overhead traffic sign is vertically positioned less than 2m tall; narrow footway.</p>

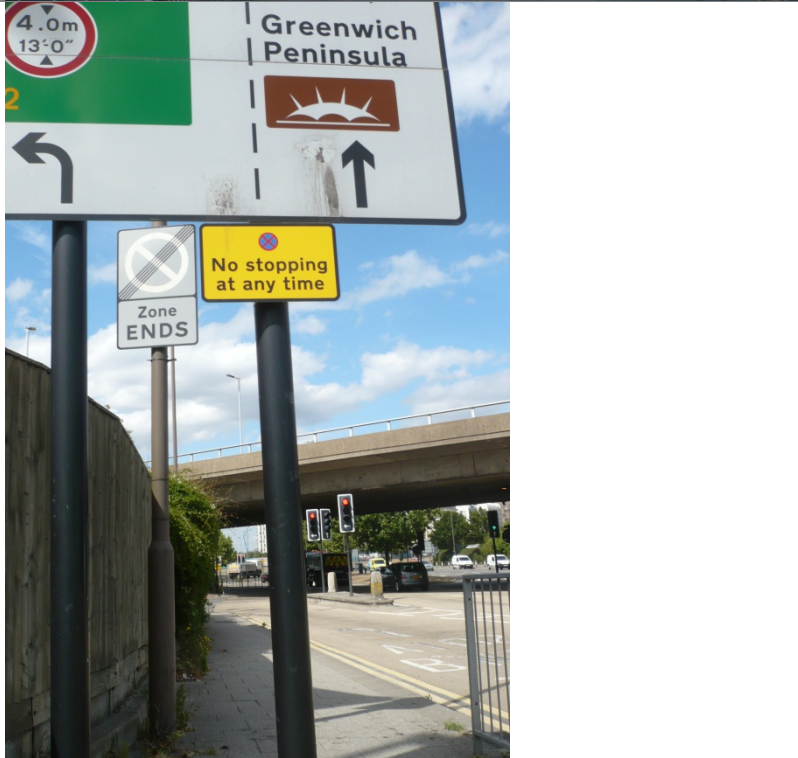
<p>Link 12 (A2203 Blackwall Lane): insufficient lighting, noise, debris, narrow footpath</p>

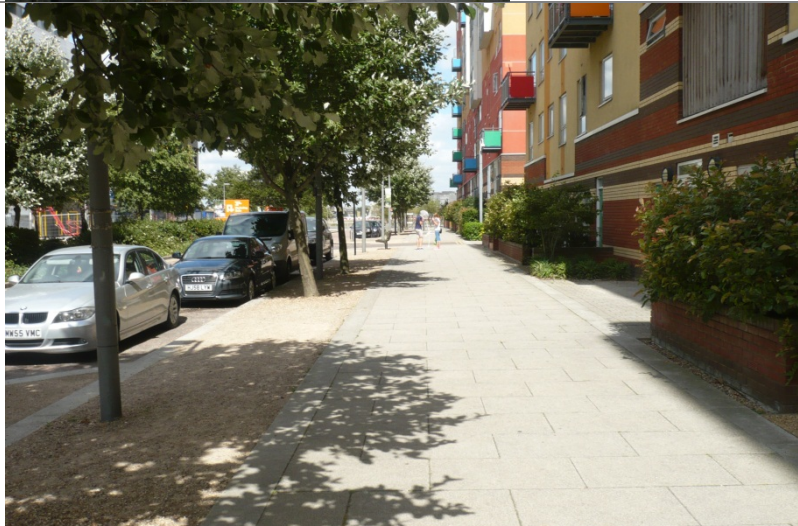
<p>Link 13 (A2203 Blackwall Lane): Awkward positioning of traffic & parking signs; some signs are obscured. These signs clutter the footway; a wheelchair user might have difficulty traversing this link.</p>

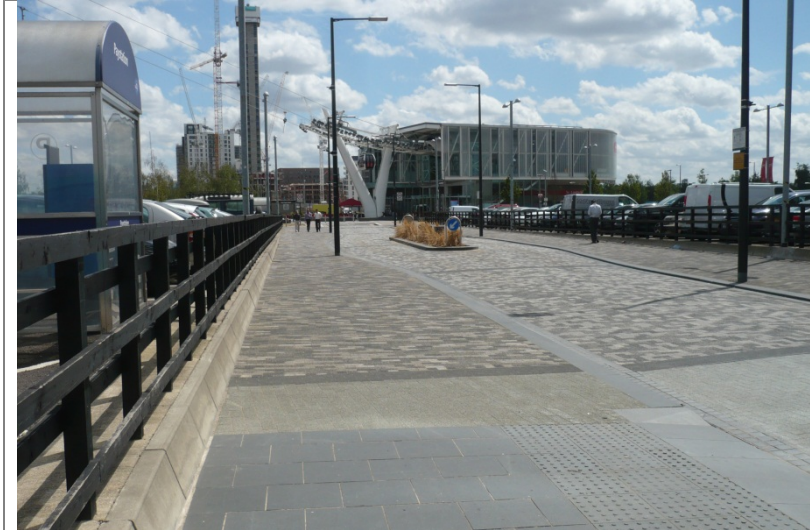
<p>Link 15 (John Harrison Way): wide link, pleasant & high quality pedestrian environment.</p>

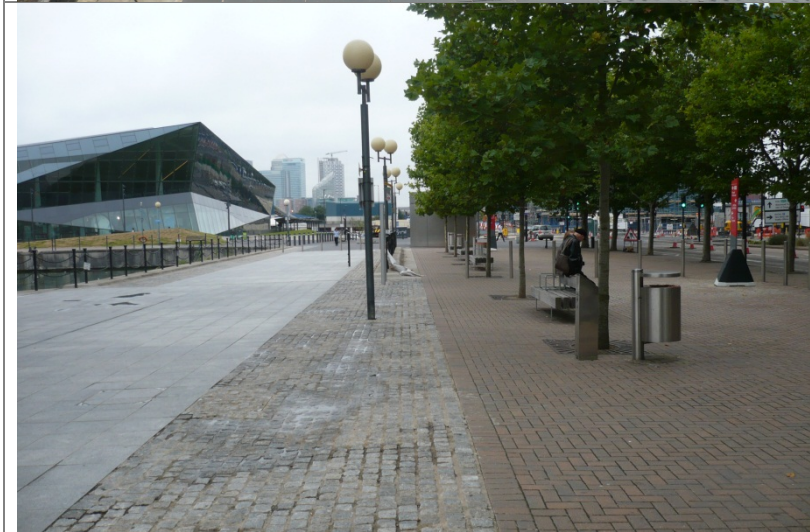
<p>Link 4 (Cutter Lane): High quality materials and design which enhances permeability. Wide footpath, good provision of tactile information and dropped kerbs.</p>

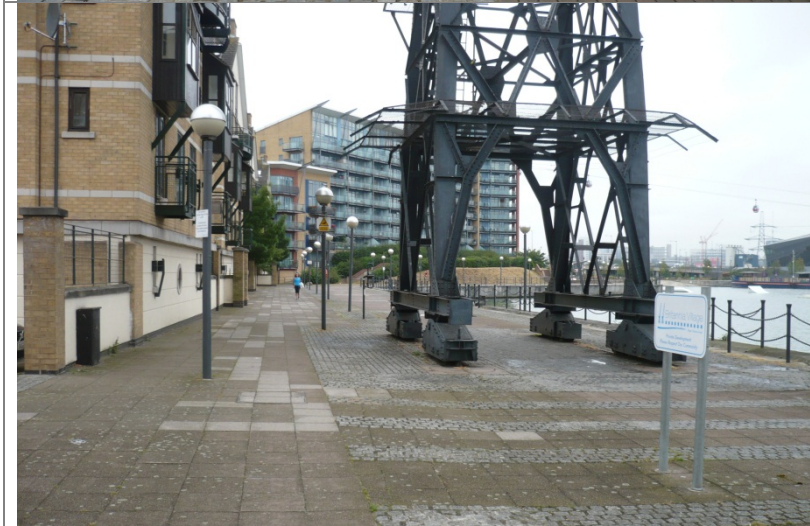
<p>Link 32 (Western Gateway): Place making through urban design, high quality materials and furniture.</p>

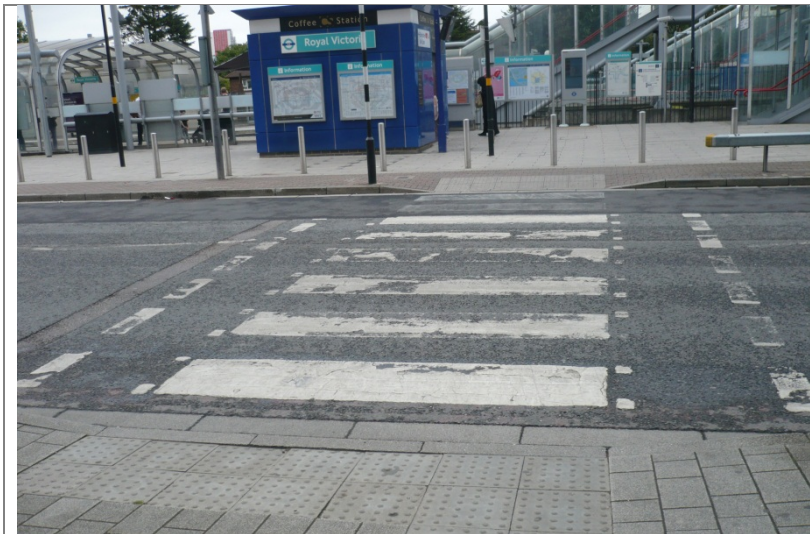
<p>Crossing 8 (Blackwall Lane slip road): faded markings, fast flowing traffic, debris, faded tactiles, pedestrian pinchpoints to the approach, insufficient lighting.</p>
 	<p>Crossing 4 (Western Gateway): reduced legibility (amber light is obscured by trees/sign), markings need repainting, no tactile, obstructions.</p>

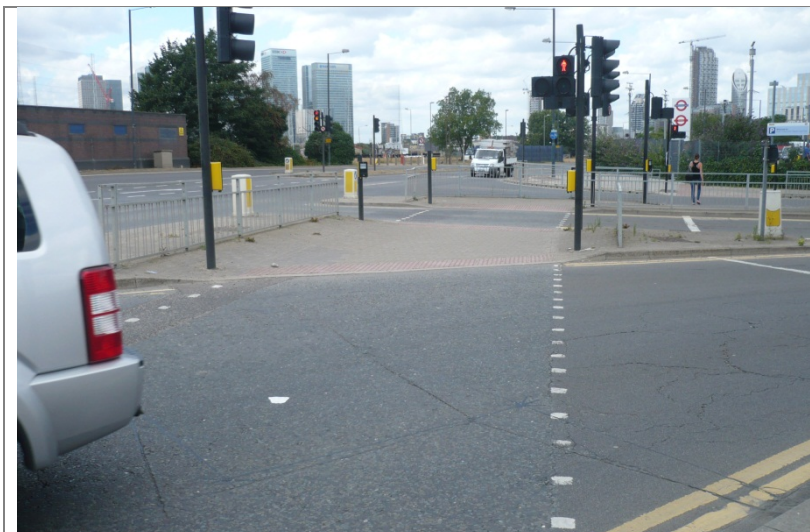
Crossing 9
(Blackwall Lane
slip road): very
narrow approach
to the crossing,
overgrown
vegetation, fast
moving traffic,
limited waiting
areas, rutted
tarmac (tripping
hazard)

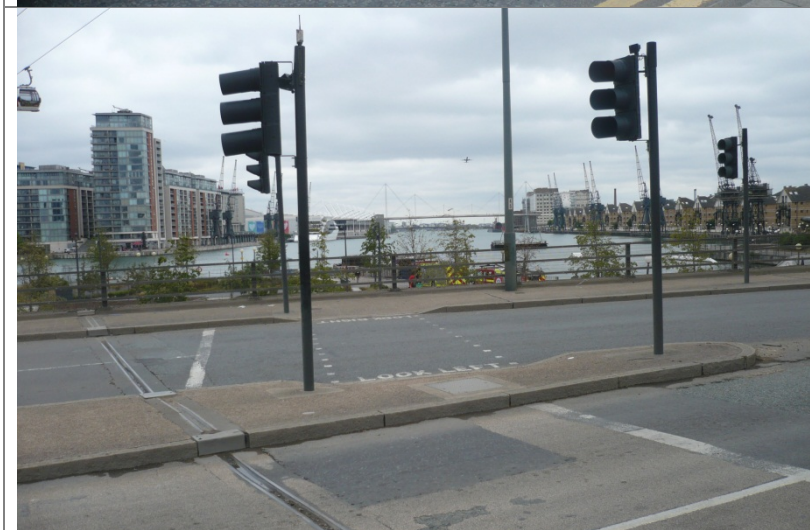
<p>Crossing 2 (Edmund Halley Way): Large refuge, crossing capacity & performance, new drainage system</p>

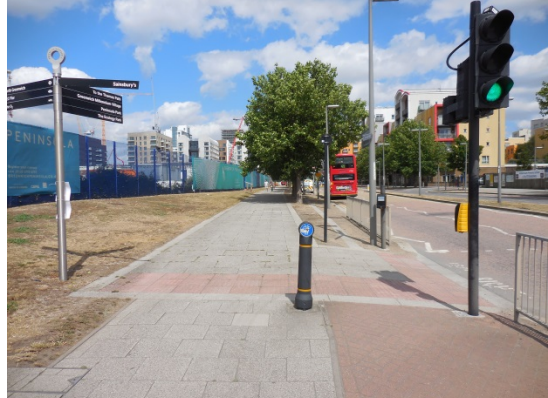
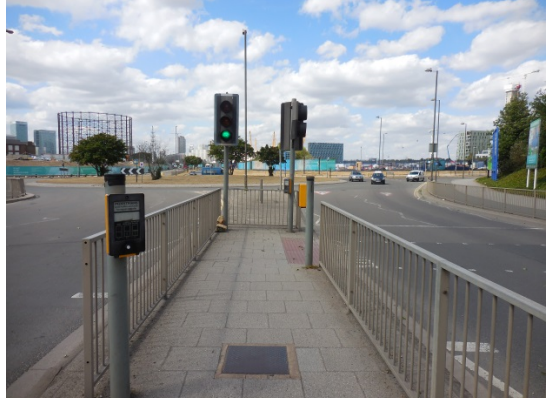
Shared footway cycle track near Millennium Way roundabout	Non-Toucan crossing, Bugsby's Way (which cyclists are directed down)

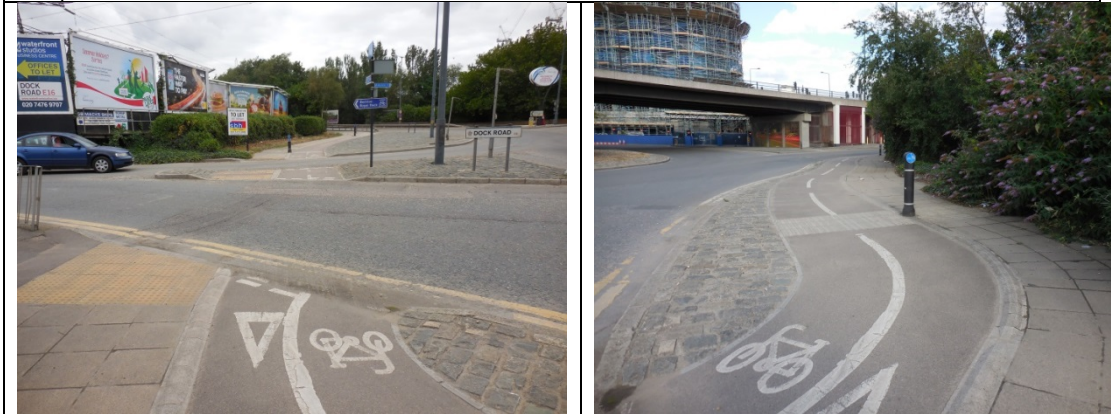
Two way cycle track orbiting the junction (uncontrolled crossing of Dock Road, left)

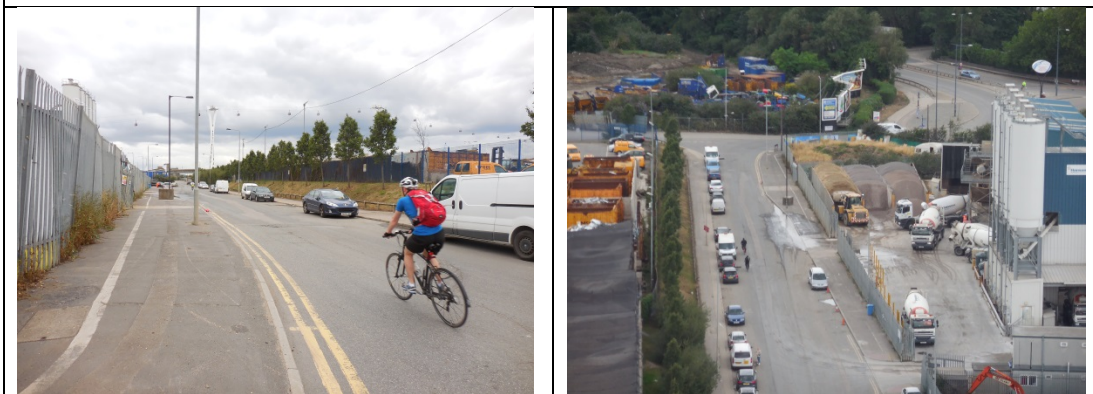
Dock Road – flat, direct and lightly trafficked making it a relatively popular cycle route
