Bank Station Capacity Upgrade

1 King William Street Heritage Statement

September 2014

LUL Document Reference
LUL-8798-STT-G-002115

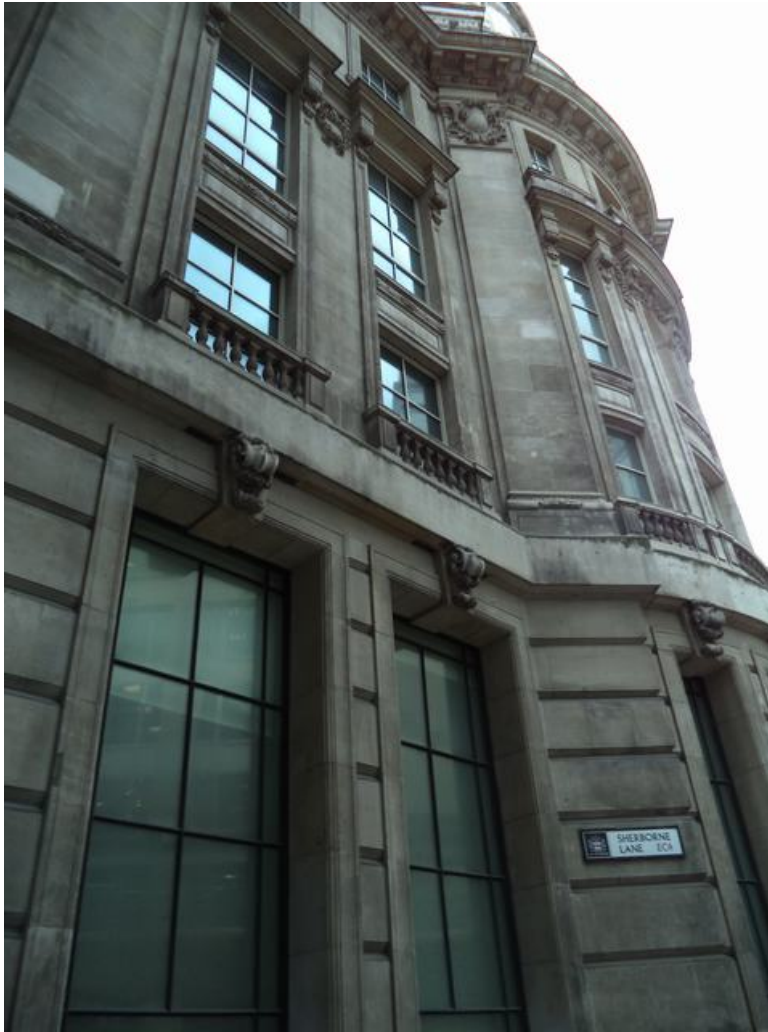
- 5.1.2 At the current concept design stage, a conservative, reasonable worst case geotechnical assessment ('Stage 2' Building Damage Assessment included at Appendix 5) has been undertaken, indicating that there may be a maximum settlement of 79mm to the building, with the greatest displacement occurring towards the south-east at the Sherborne Lane elevation shown in photo 2.

5.1.6 The Stage 2 Building Damage Assessment report concluded that predicted settlement is high along the Sherborne Lane elevation, with differential movements. It is likely that cracks will be concentrated at joints, junctions and openings, and the cracking may cause a permanent impact to the historic fabric. This may damage the material and aesthetic significance of the building.

Photo 2: Section of Sherborne Lane elevation in the location of the largest predicted settlement

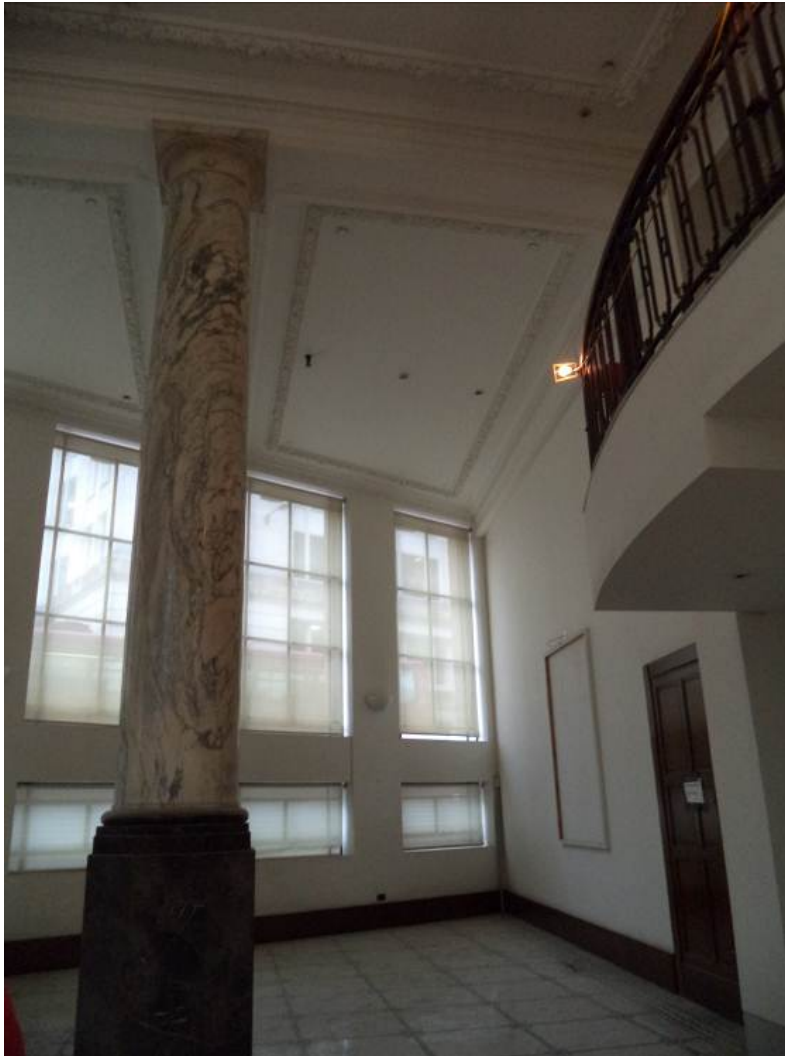
Photo 3: Remaining historic interior - decorative plaster to the ceiling in the foyer

- 5.1.7 The decorative plasterwork to the ceiling in the foyer (shown in photo 3) is also sensitive to small movements, however this is in good condition and fine cracking would be easily repairable.
- 5.1.8 It is considered that the impacts of the predicted settlements are such that they could be detrimental to the heritage significance of 1 King William Street. Therefore, proposals for protective works are outlined within the following section and the impacts of these protective measures are discussed. Further investigations of sensitive elements, including survey and examination of survey plans, will continue to be undertaken during detailed design of the BSCU project.

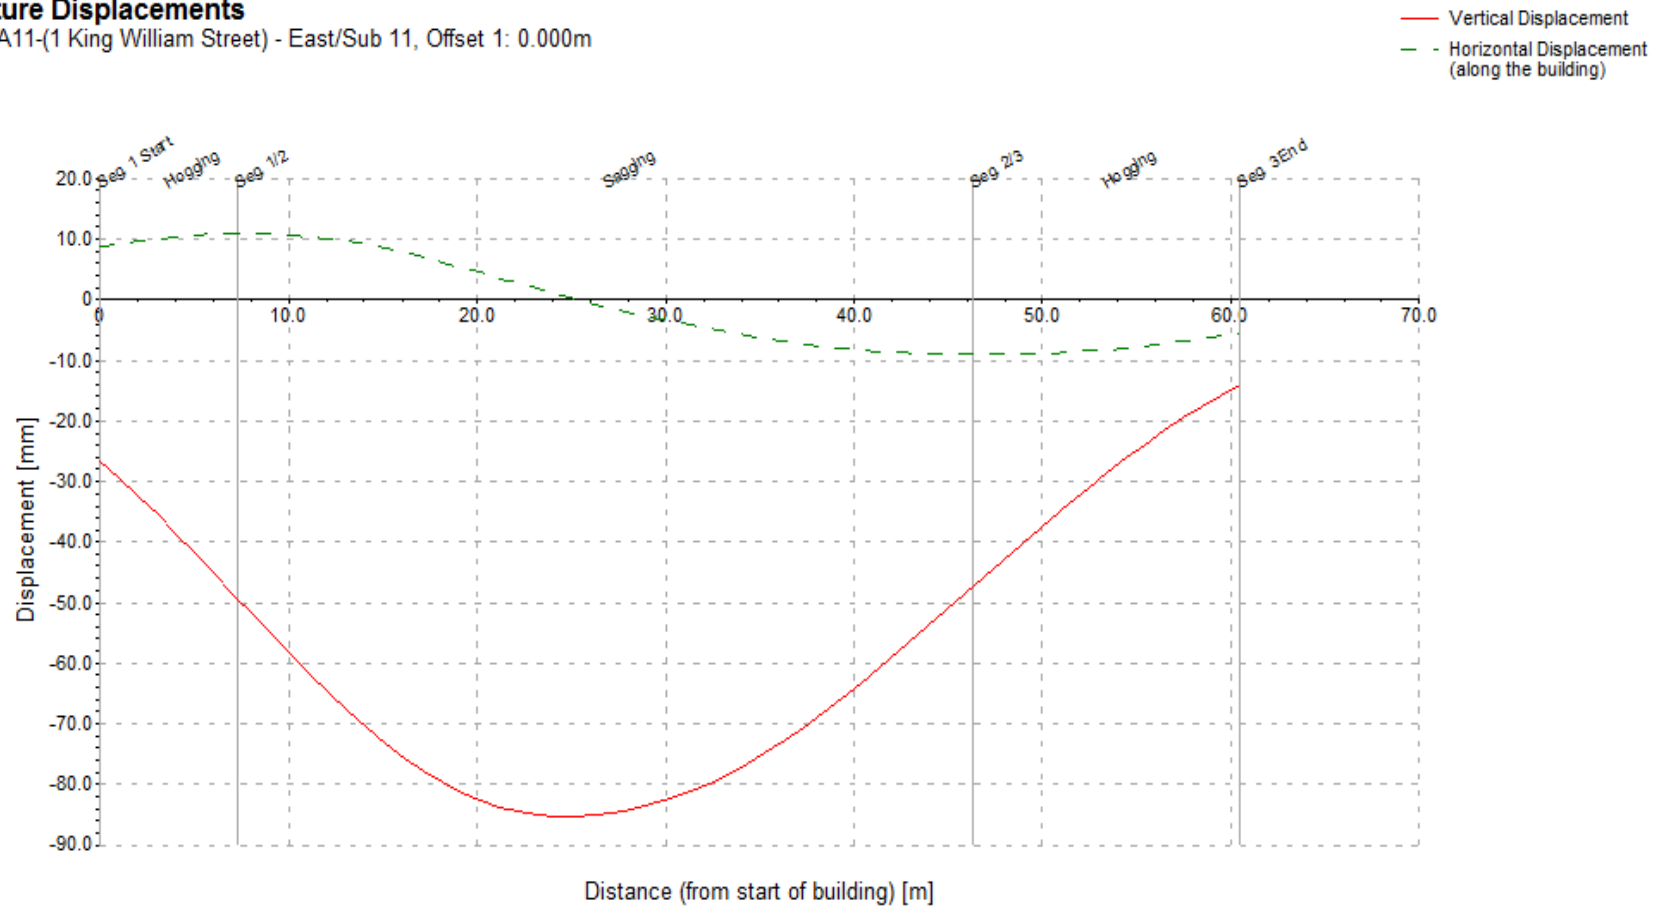
The maximum settlement of the building at foundation level (line 1) occurs at the end of construction and is 79mm.

Figure 4: Building displacement at founding level of (line 1) at stage 4 of worst case for tensile strains

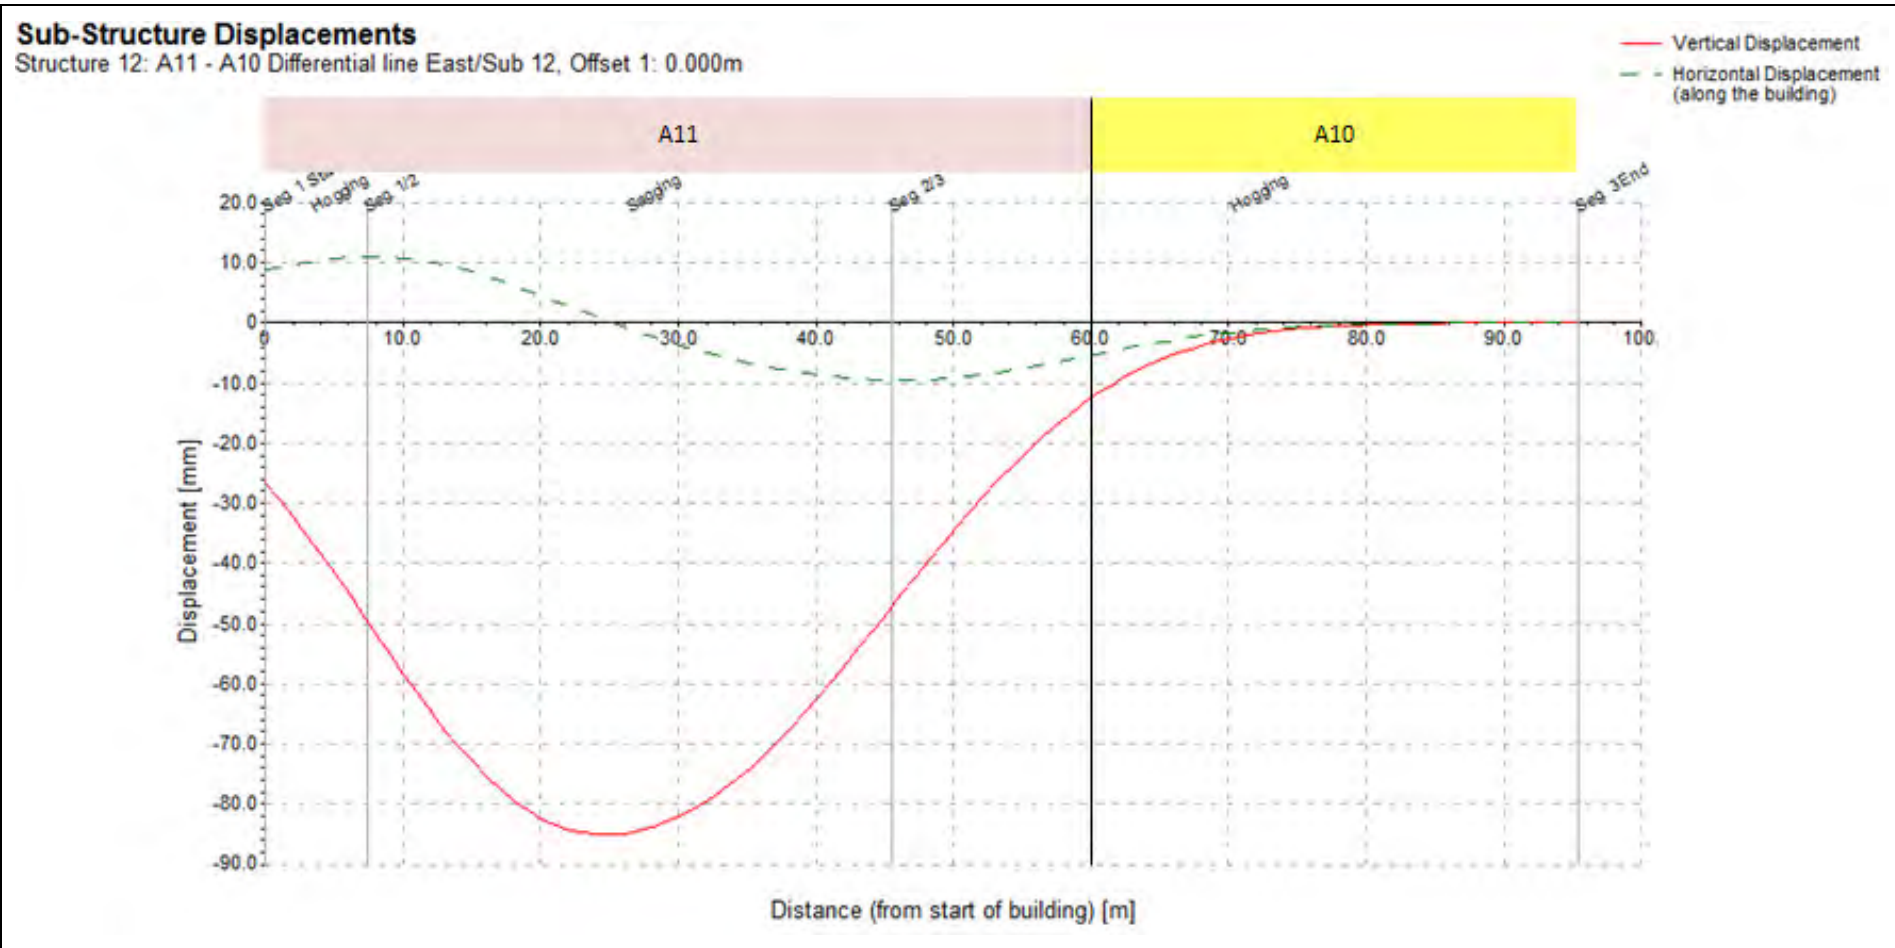
Figure 5 and Table 8 show the strains between the two adjacent buildings are in hogging mode. This could induce cracking at the junction between the two buildings. The maximum tensile strains in this area (line 3) (0.070%) result in a very slight damage category.

Figure 5: Building displacement at founding level of (line 3) at stage 4 of worst case for tensile strains

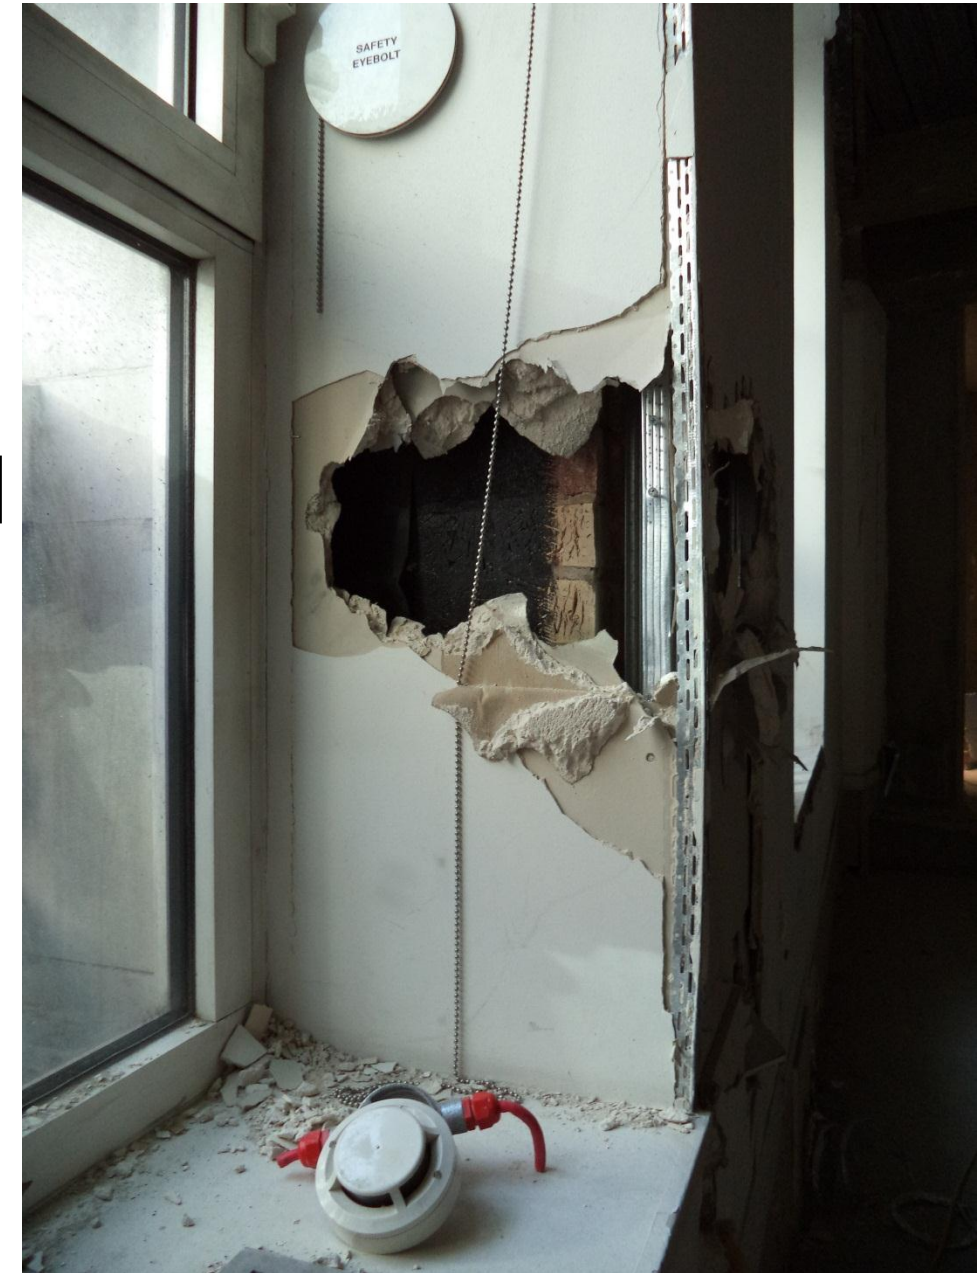
Current typical interior finish in area of proposed strengthening works, showing masonry external wall behind opened-up plaster during works undertaken by others
