Bank Station Capacity Upgrade

29 Martin Lane Heritage Statement

September 2014

LUL Document Reference:
LUL-8798-STT-G-002117

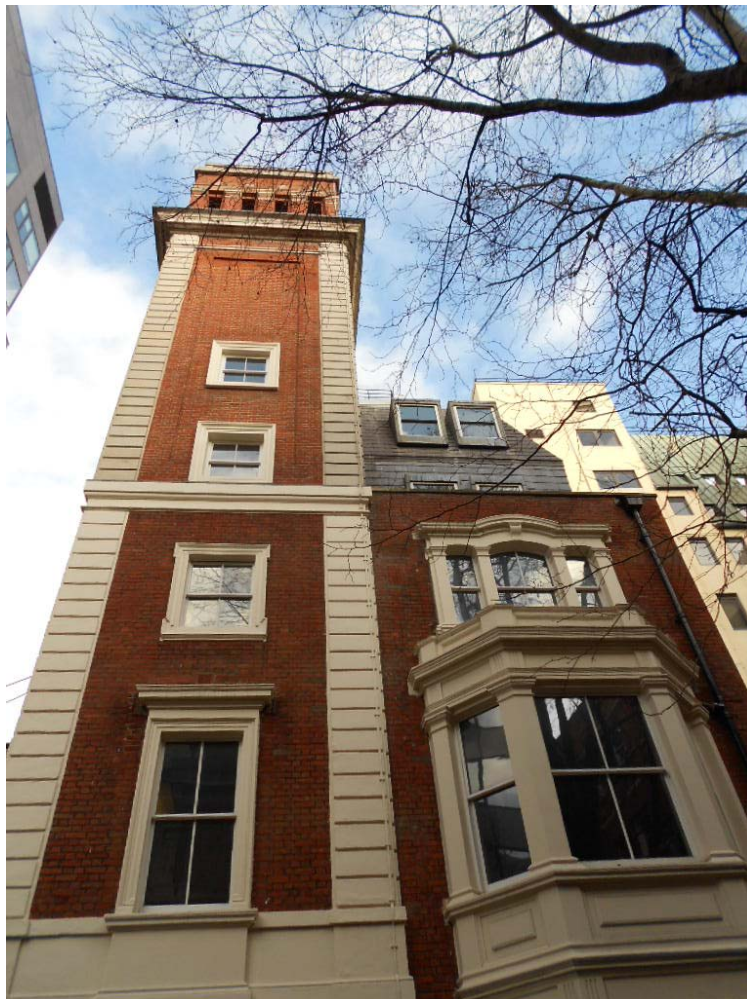
- 4.1.4 The southern elevation, including the bell tower which is to the west on the Martin Lane frontage, has a canted bay window from basement through to first floor and two attic storeys within a slated mansard roof rising behind a plain parapet. Windows to the main elevation and to the southern elevation have stucco surrounds and moulded architraves. This elevation is shown in photo 2.

Photo 2: Southern elevation of 29 Martin Lane, tower to left and top of bay window to right

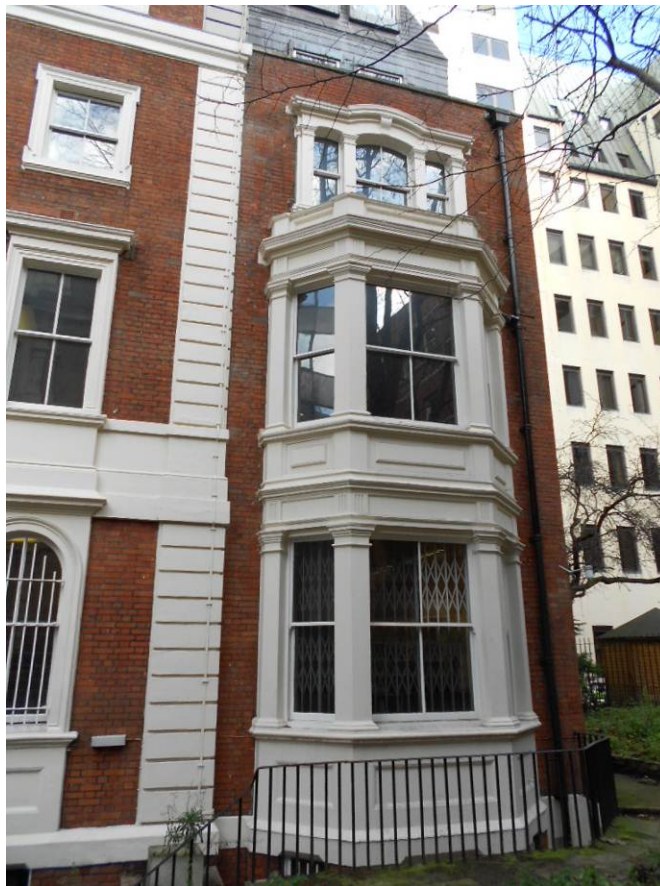
- 5.1.6 Whilst the strains and settlement to 29 Martin Lane are predicted to be small, the bay window to the southern elevation may be sensitive to small movements, depending on its internal construction and bonding. Areas of interest and areas to be affected are shown in Appendices 6 and 7.

- 5.1.7 A worst case assumption is that the bay's structure of mullions and lintels may be poorly bonded to the main external wall. As such, there is a possibility that settlement may cause the structure to crack at its joints and pull away from the main external wall. Further investigation of the feature will continue to be undertaken during the detailed design of the BSCU project.

Photo 3: Detail of the bay window and its stucco dressings

- 6.1.4 In the unlikely event of differential movement with the potential to have an adverse impact on the bay, temporary protective works in the form of propping is proposed. This will comprise the construction of a temporary external bracing tower, which may be fixed to the main elevation. The scaffold structure will support the bay from basement to first floor level and will be designed to have a minimal impact on the building. The structure will be fixed, where practicable, to the mortar joints of the brickwork with ties at either side of the bay. Intrusion into the stucco finishes of the bay window surrounds will be avoided where possible. There will be struts at each level which will support the structure of the bay and minimise movement away from the main wall.

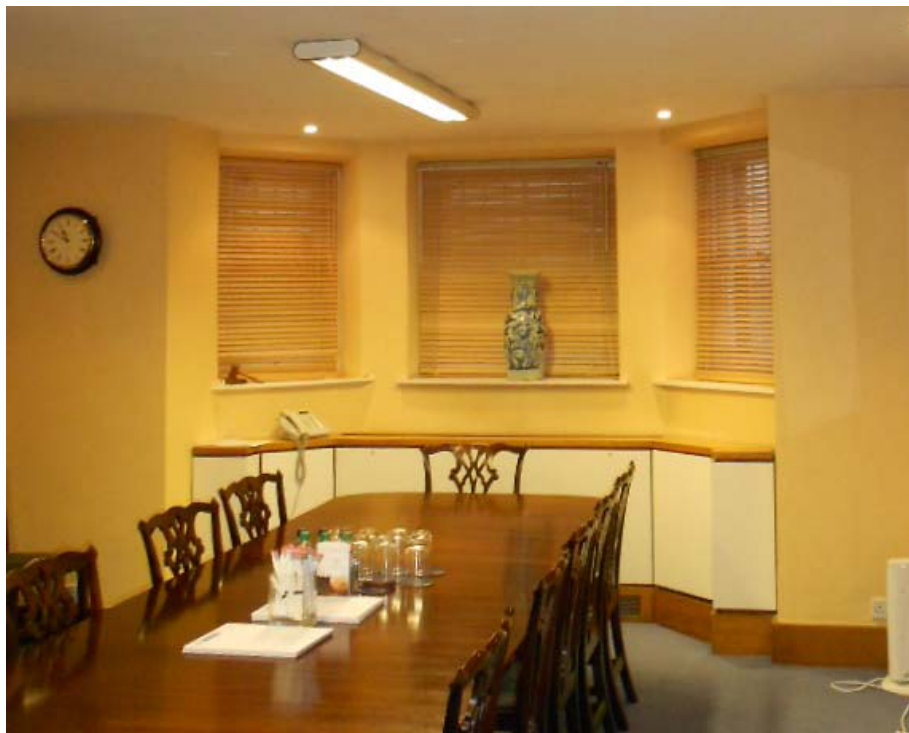
- 6.1.5 The structure will remain in place until settlement relating to the tunnelling has reached an acceptable level (based on monitoring of ongoing settlements throughout and after the works), at which time internal ties and brackets will be inserted as required to tie the bay back to the main building, and repairs will be undertaken to cracked areas and areas of fixing, on a like for like basis. These works will only affect areas of modern finishes on all floors, the example shown in photo 4 being typical throughout the building.

Photo 4: Internal area to the ground floor, around the bay window, showing modern finishes.

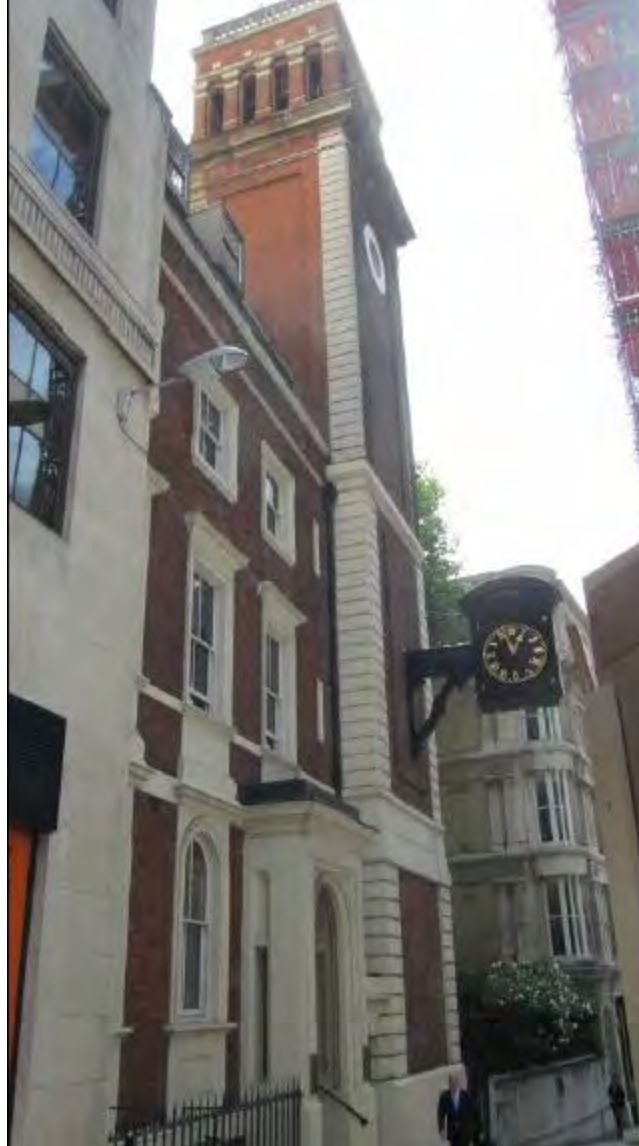
Plate 1: General view

The exterior is in good condition, with no visible defects apart from ponding water in side parapet gutter, and efflorescence under grand cornice on tower. Interior condition is average, with bouncy timber floors, falling damp to ground and first floor side bay window, water damaged roof over spiral stairs, and water damaged ceiling over clock-room in tower. The external walls appear plumb and true, without cracks, or distortion of door and window openings. This indicates that the building is solidly founded and not suffering from differential settlement.

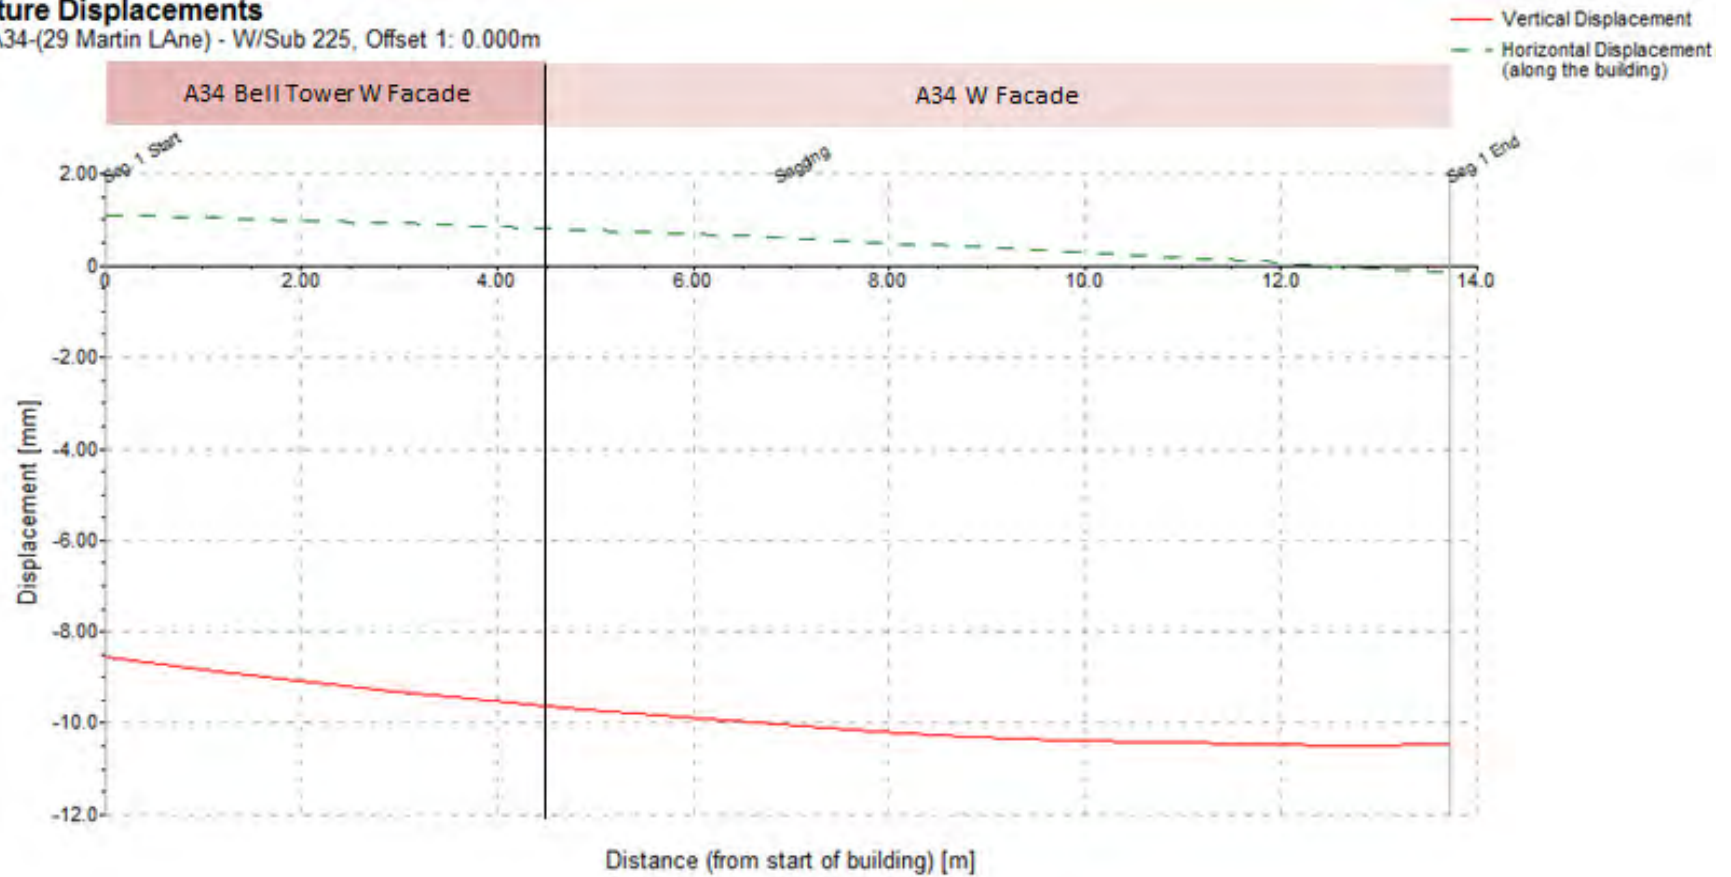
The maximum settlement of the building at foundation level is 10mm which occurs at the construction stage 1, is fairly uniform across the site.

Figure 6: Building displacement at founding level at stage 1 (line 3) of worst case for tensile strains

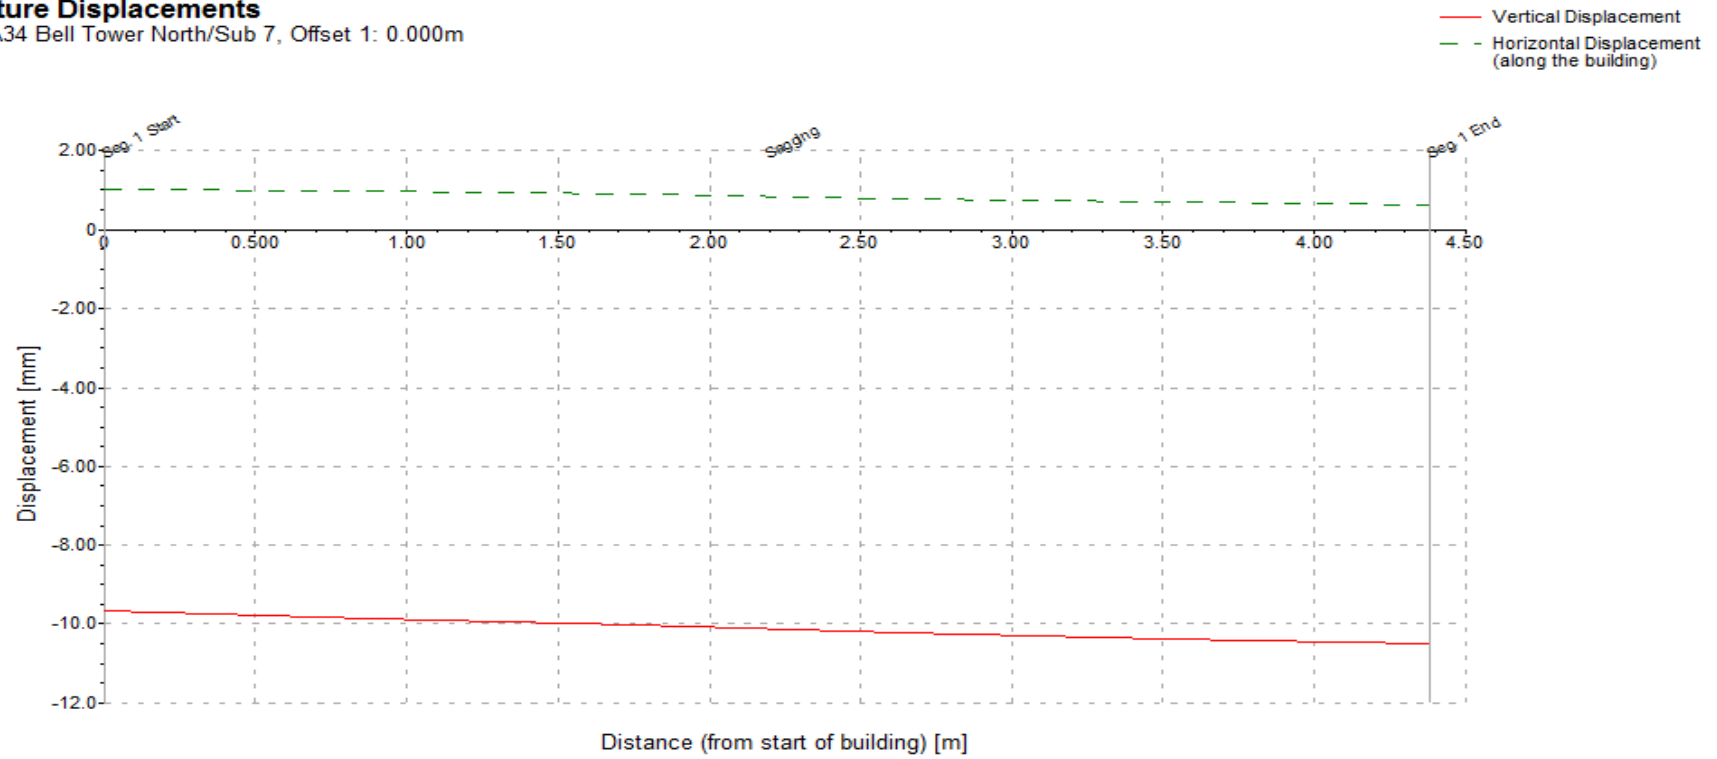
The brick bell tower is taller and heavier than the rest of the building. If the ground is disturbed by tunnelling there is a risk that the tower will settle more than the rest of the building, crack the adjoining walls, and possibly tilt out of vertical. British Geographical Society sheet 256 indicates the outcropping stratum to be Alluvium overlying London Clay to considerable depth. For a solid foundation London Clay would be capable of carrying the building on shallow spread footings immediately below the basement. The bell tower would need a raft. Piles would not have been necessary but their use cannot be ruled out. Given the age of the tower, if piles were used they would have been timber but as such their depth would have been limited.

There is a risk that the tower will tilt slightly, generally cracking the junctions between the tower and the adjoining walls, with racking of the bay-window elevation. Consideration should be given to the design of contingency measures such as temporary bracing of the bay window elevation during tunnelling. A methodology to ensure the building is in equilibrium before removing the bracing should be included. The bay window may crack at its joints, and pull away from the main external wall, requiring remedial strapping restraint.

Figure 7: Building displacement at founding level (Bell Tower) at stage 1 (line 4) of worst case for tensile strains

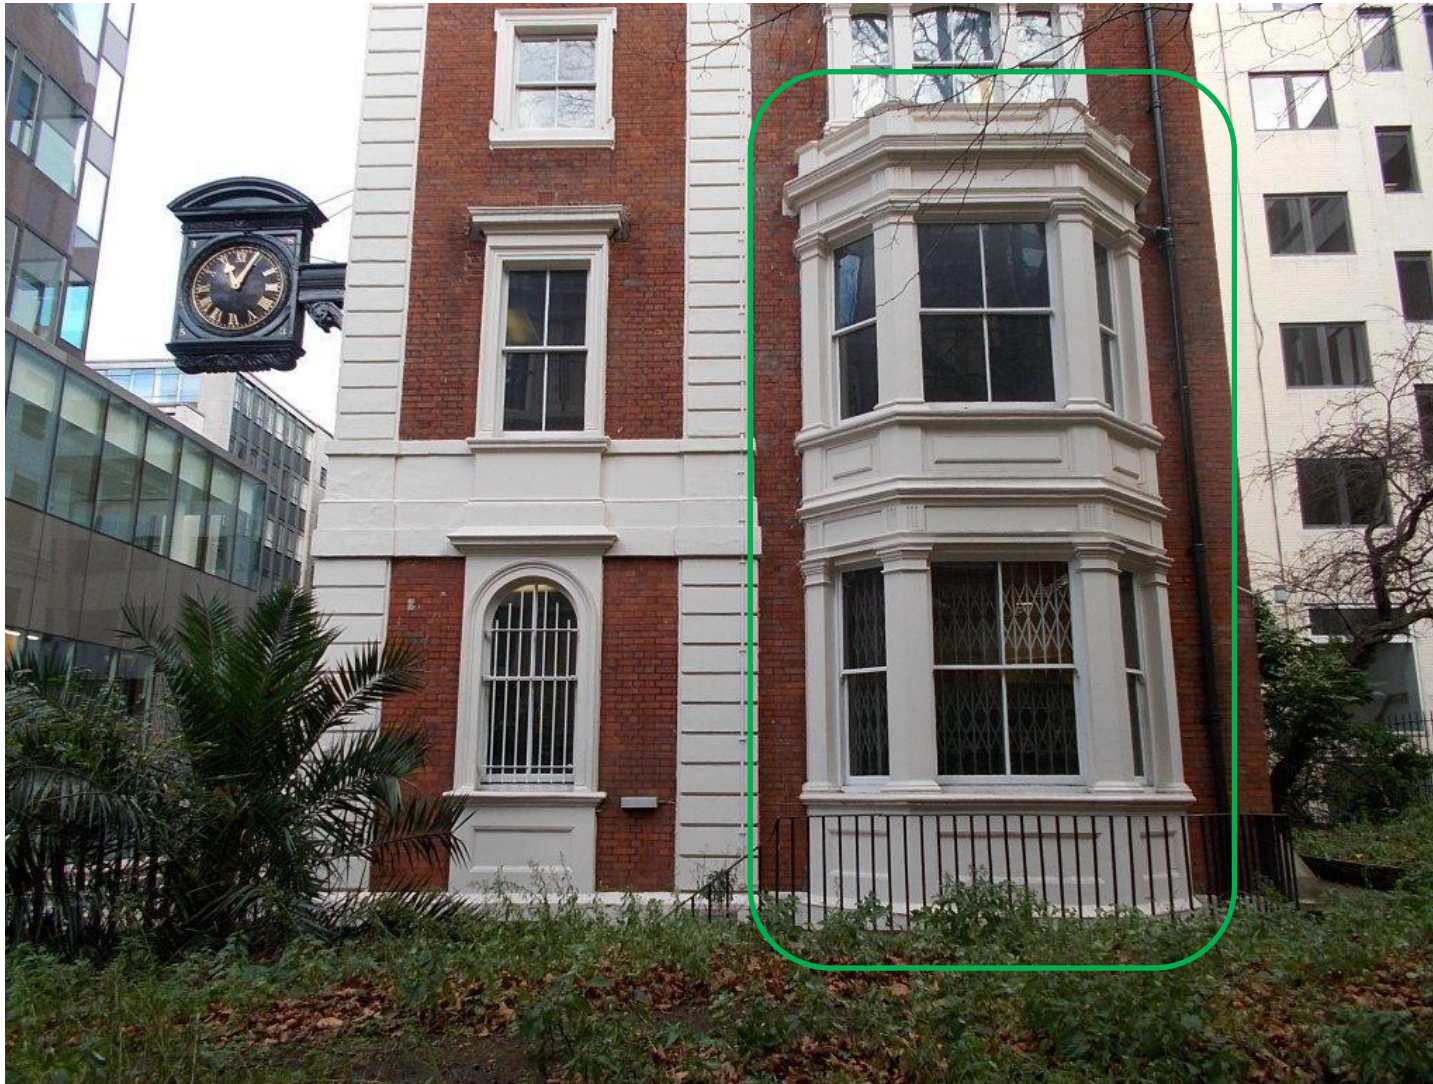
Areas to ground and first floor on south elevation to be impacted by temporary support, with fixings to brickwork

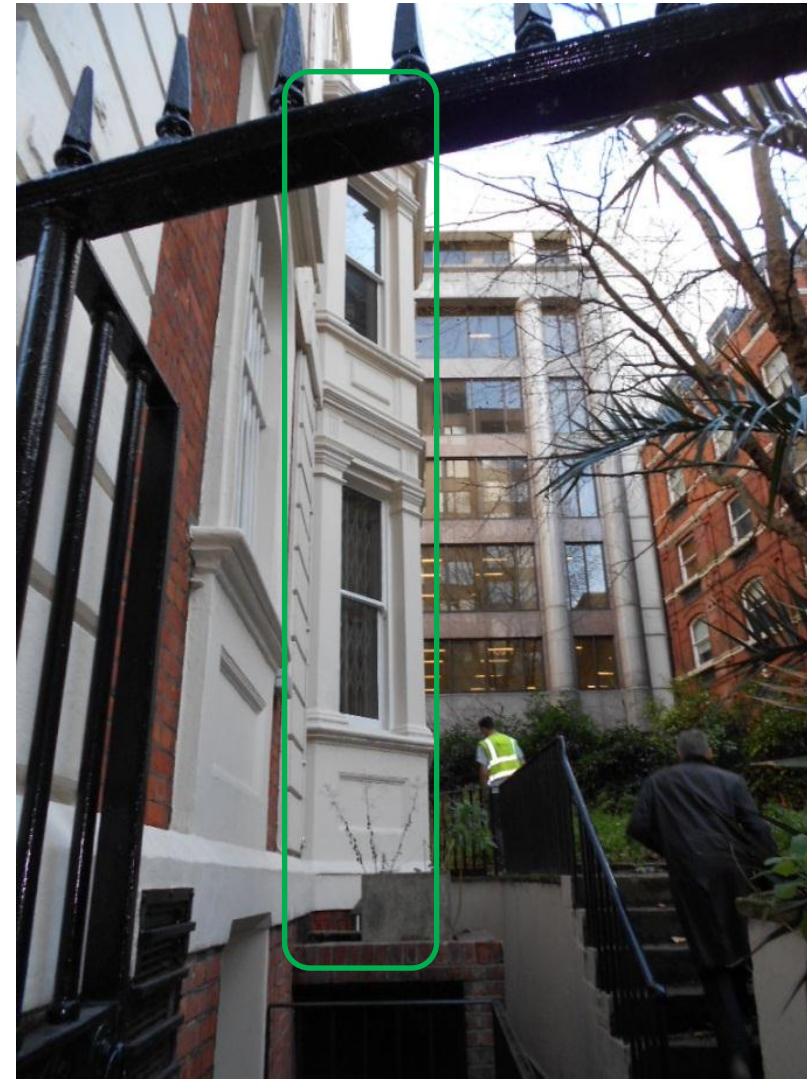
Basement external area on south elevation (viewed from west) below bow, where temporary support will be placed

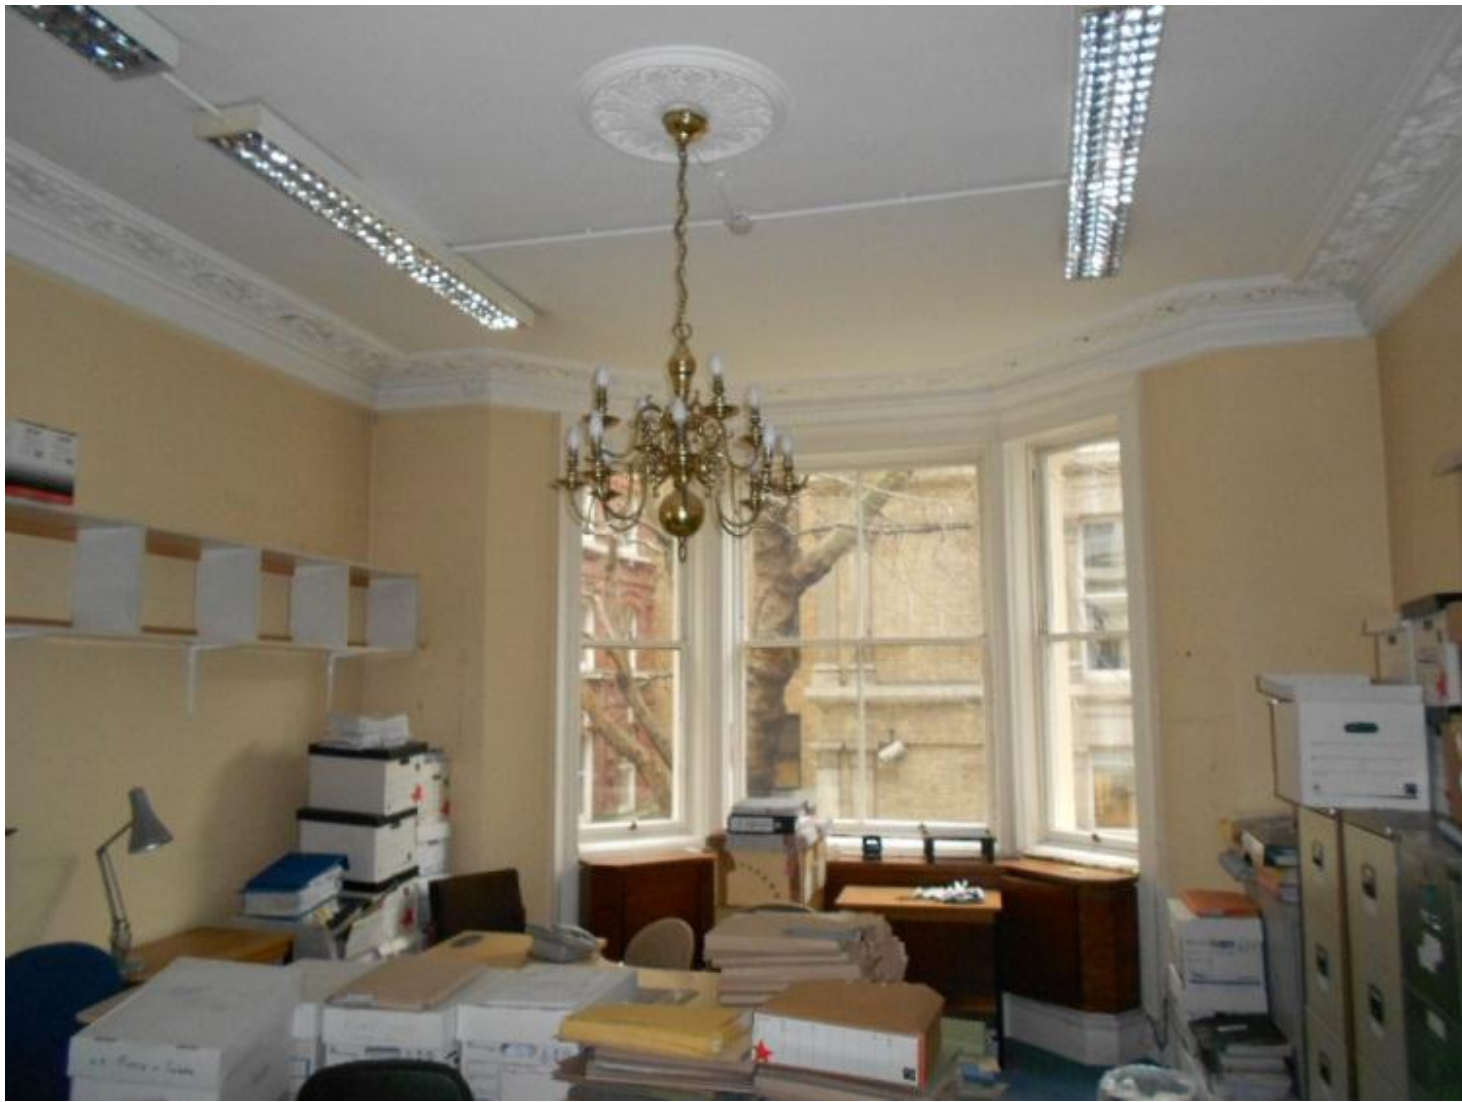
Internal view of first floor bay window

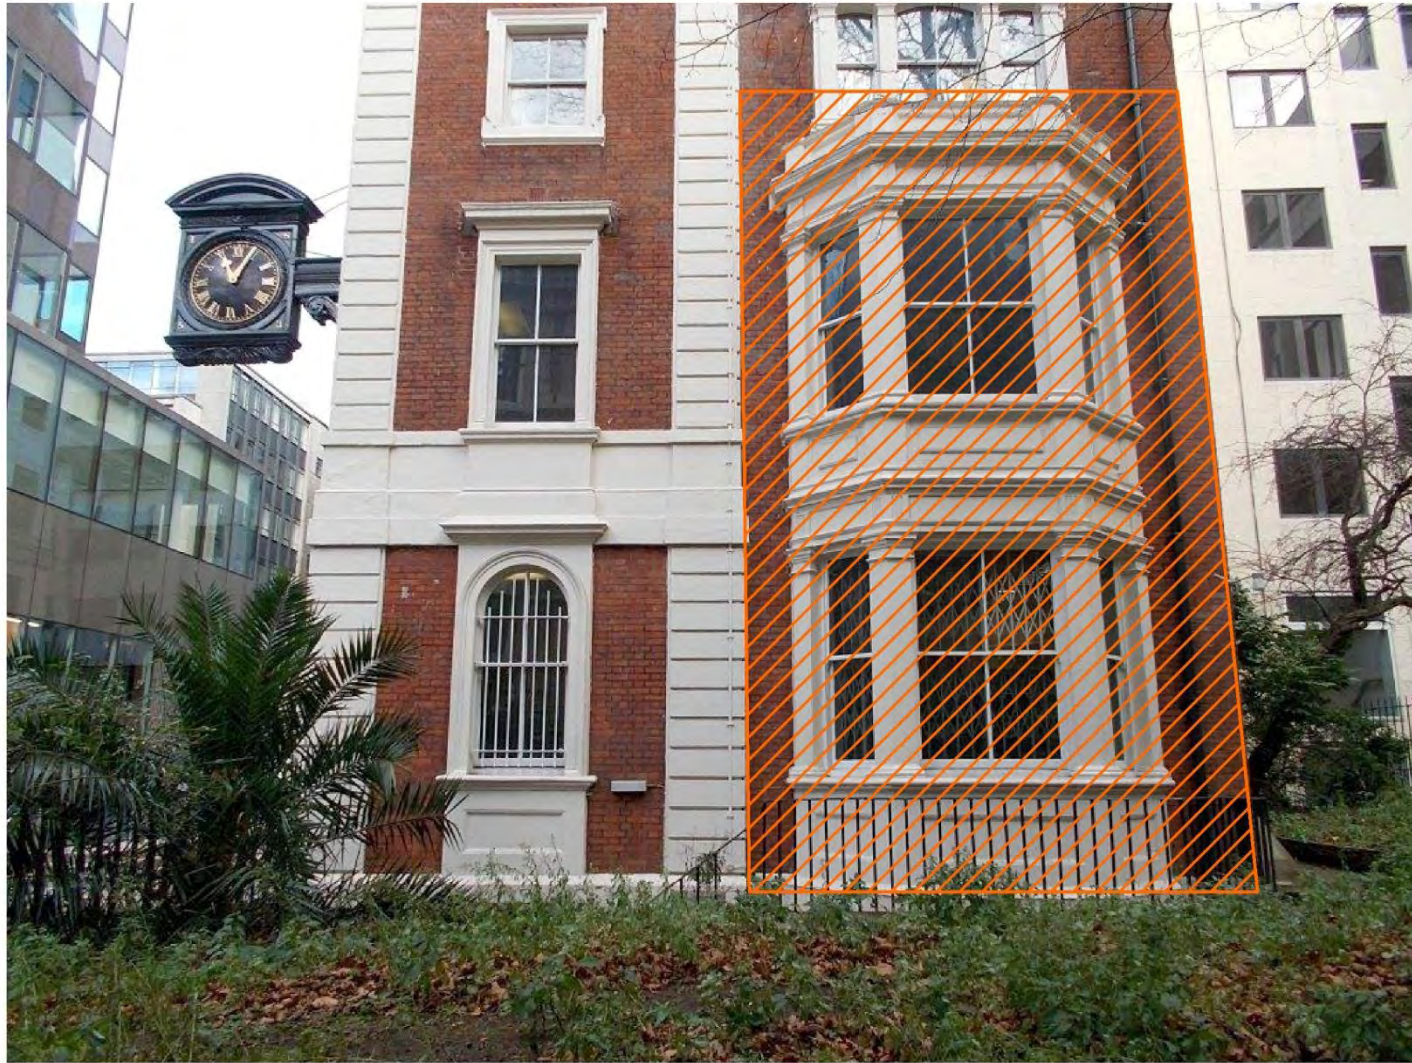
Southern elevation

External areas potentially affected by protective works

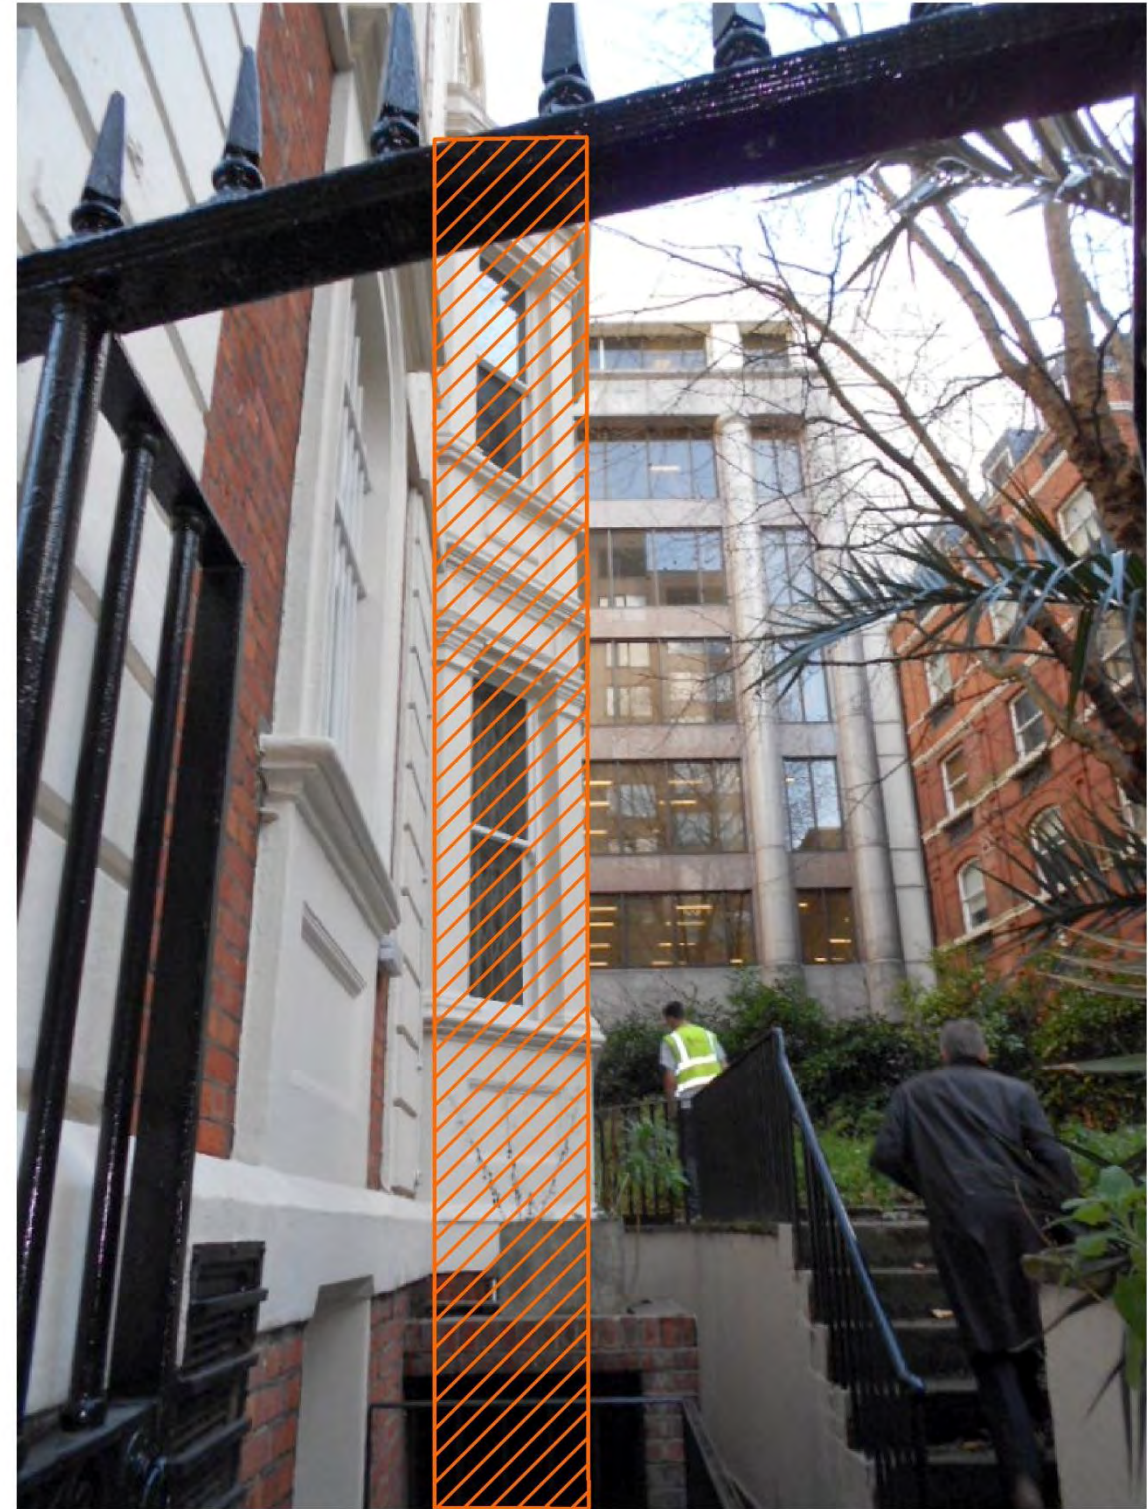
Southern elevation,
photo taken from
west

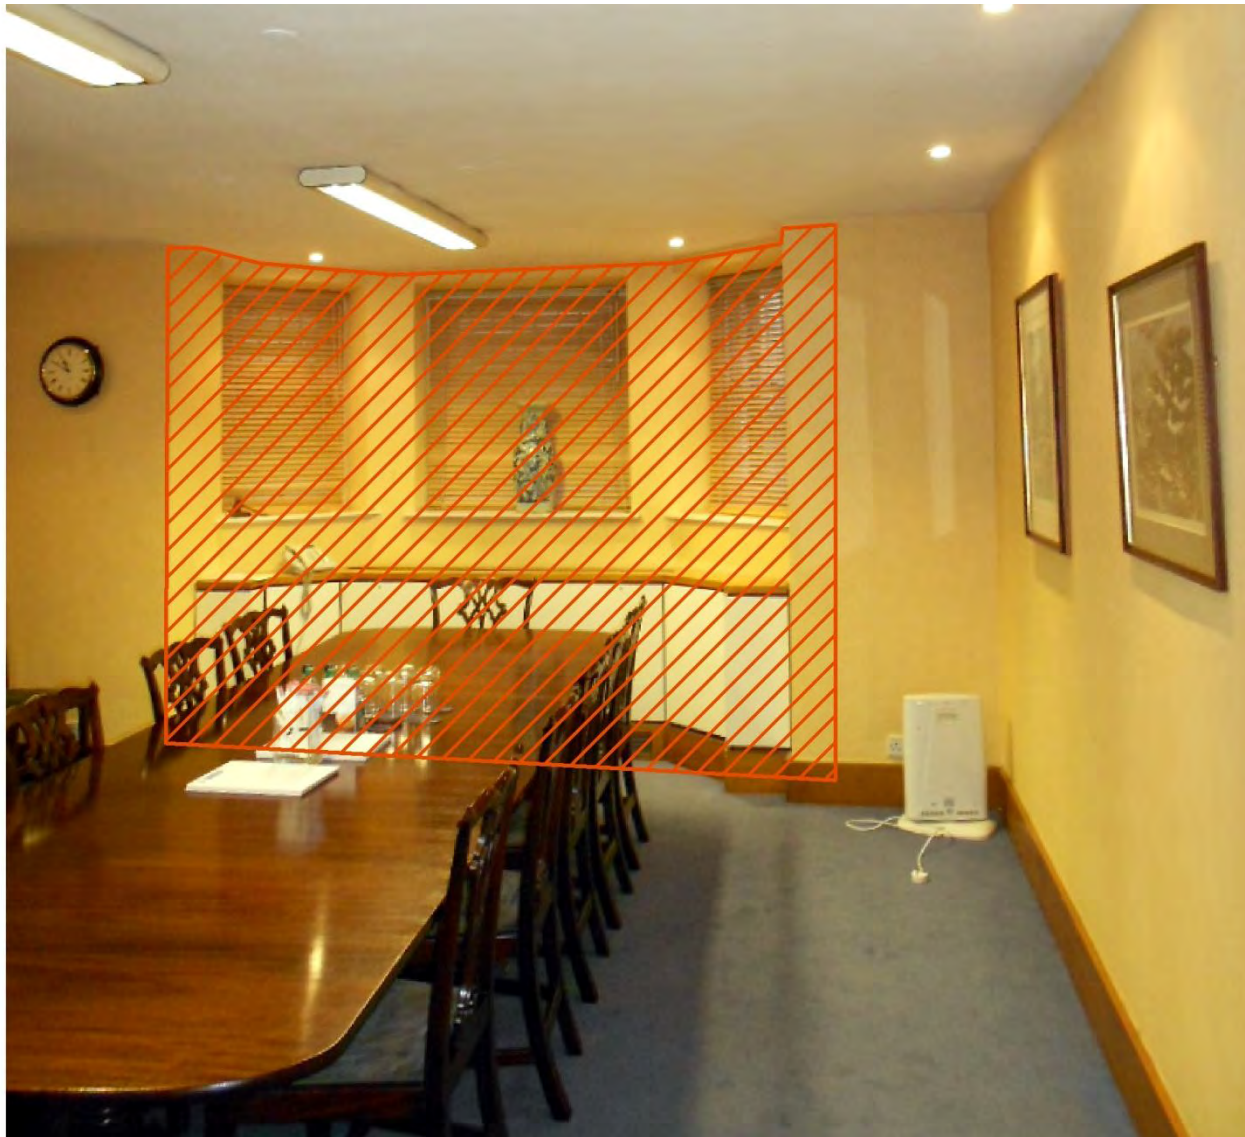
Bay window internal view to the ground floor

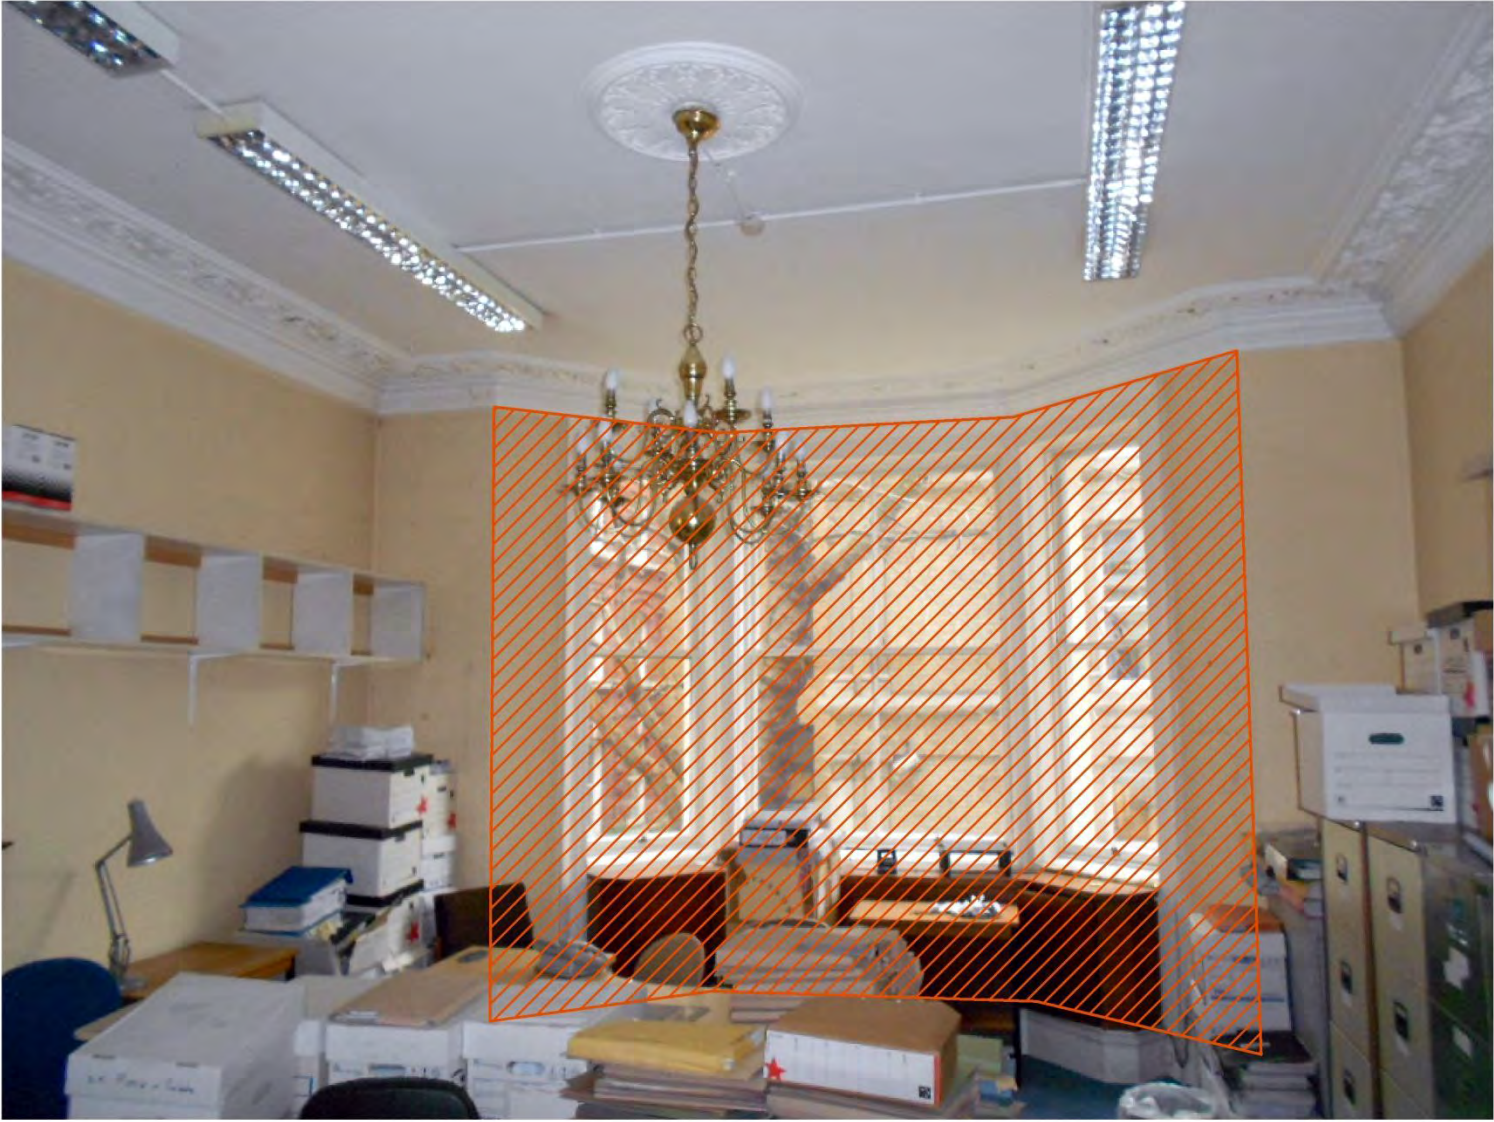
Bay window internal view to the first floor. Note, decorative plasterwork will not be impacted by protective works
