Bank Station Capacity Upgrade

5 King William Street Heritage Statement

September 2014

LUL Document Reference:
LUL-8798-STT-G-002116

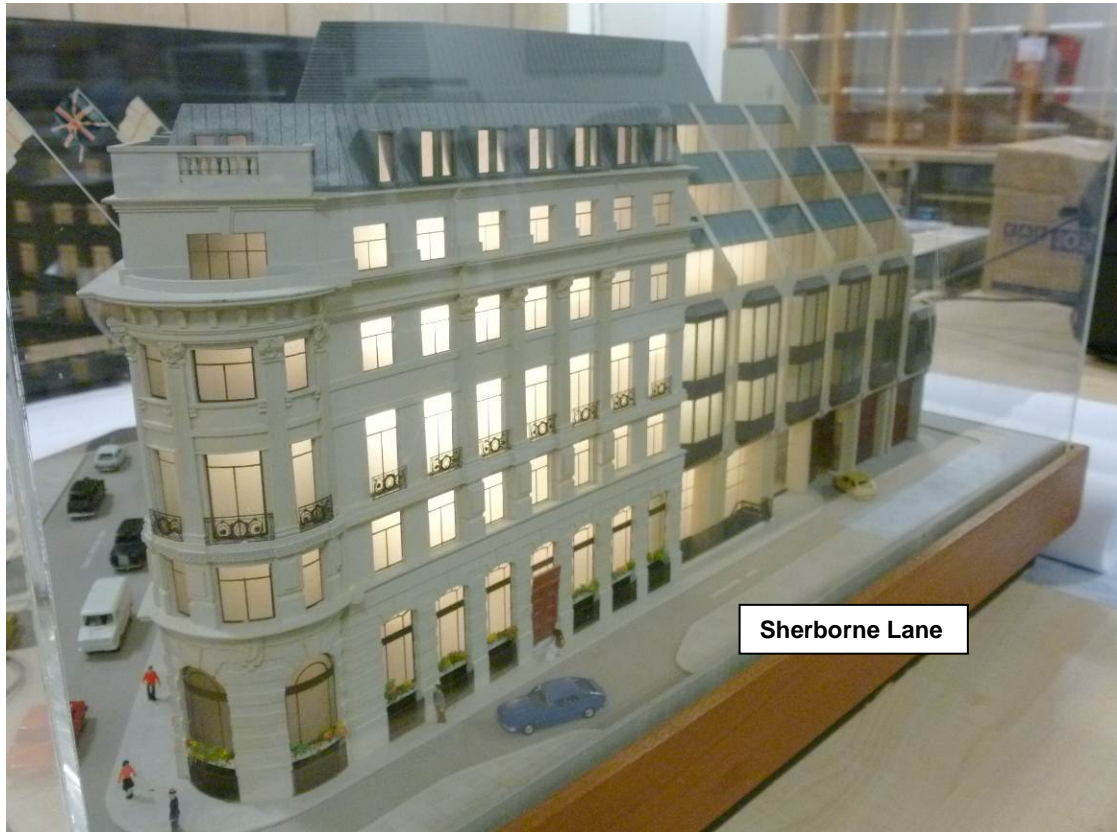
Photo 1: Building model showing Sherborne Lane elevation (retained façade and modern addition), predicted to be subject to the greatest ground movement

- 5.1.6 To the façades, which are currently in good condition, there is the possibility of cracking or loss of historic material in the event of settlement. This may damage the material and aesthetic significance of the building. Damage is most likely to occur to historic elements of the elevation to Sherborne Lane, shown in photo 1 (alongside a modern addition), with cracking concentrated at joints and openings with the potential to damage decorative voussoirs and cornices. This is because the greatest settlements and steepest settlement slopes are predicted to occur at this elevation, giving rise to increased strains.

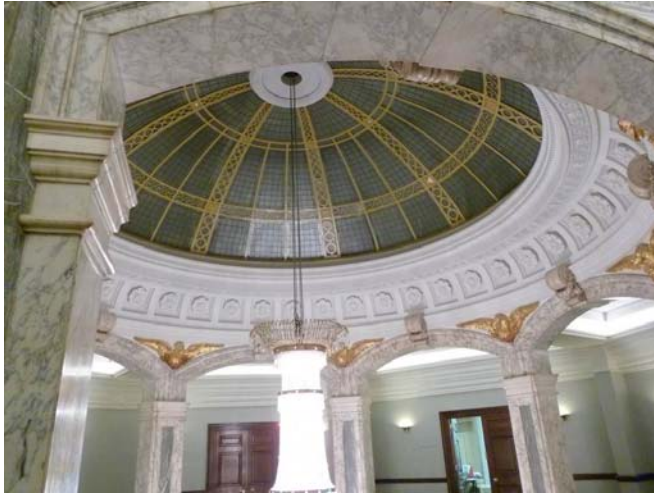
- 5.1.7 Within the foyer, the effect of settlement may in the worst case undermine the stability of the columned balcony, and subsequently damage fragile heritage finishes such as marble and surrounding plaster detailing. Historic elements within the foyer, which are in good condition, are shown in photos 2 and 3.

Photo 2: Detail of the upper balcony level and glass dome

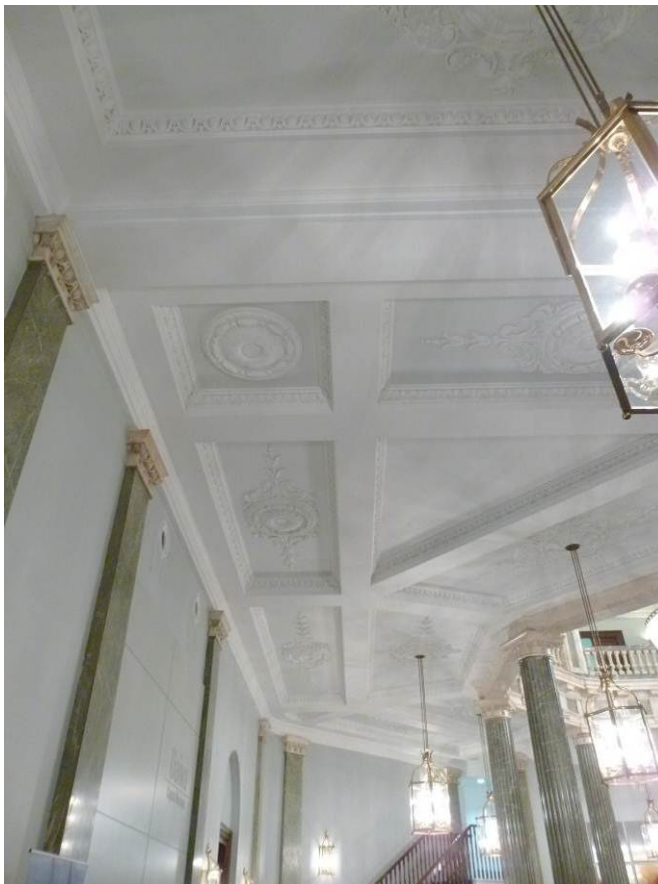
Photo 3: Beneath balcony, fine plaster and marble columns

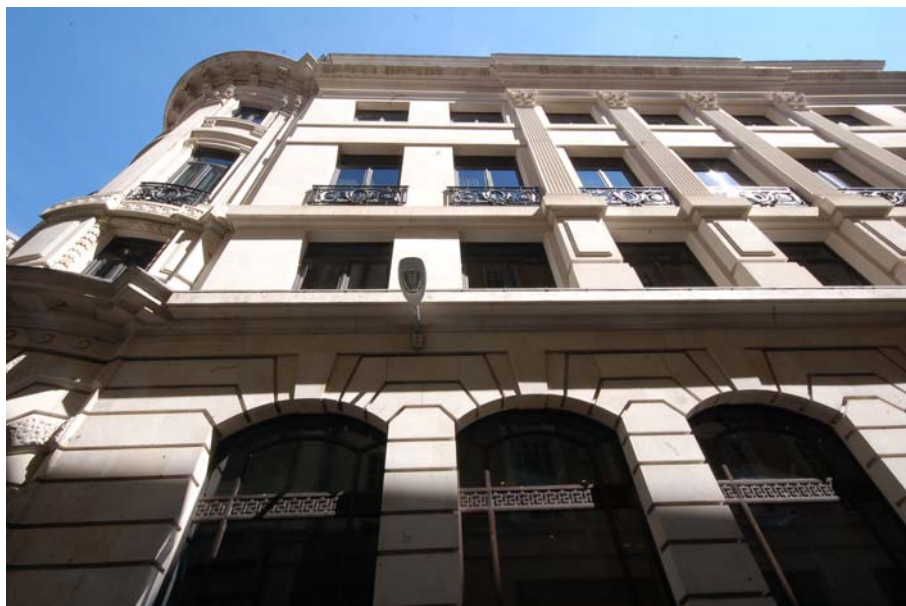
Photo 4: Detail of Sherborne Lane elevation, historic façade with close jointed stone and fine architectural detailing

- 6.1.5 Subject to investigation by intrusive survey, the Sherborne Lane façade may require the adjustment or enhancement of existing fixings in areas where the largest movements are predicted to occur. This would be achieved by opening up of internal finishes at the locations of fixings behind the façade, and adjustment of existing ties or insertion of enhanced ties to the façade and building structure. The external façade to Sherborne Lane, where the greatest settlement is predicted to occur, is shown in photo 4 and illustrated in Appendix 8. Internal areas within this elevation have predominantly modern finishes.

- 6.1.6 These protective measures will be a permanent work to the building, to be installed prior to the commencement of the BSCU tunnelling works.

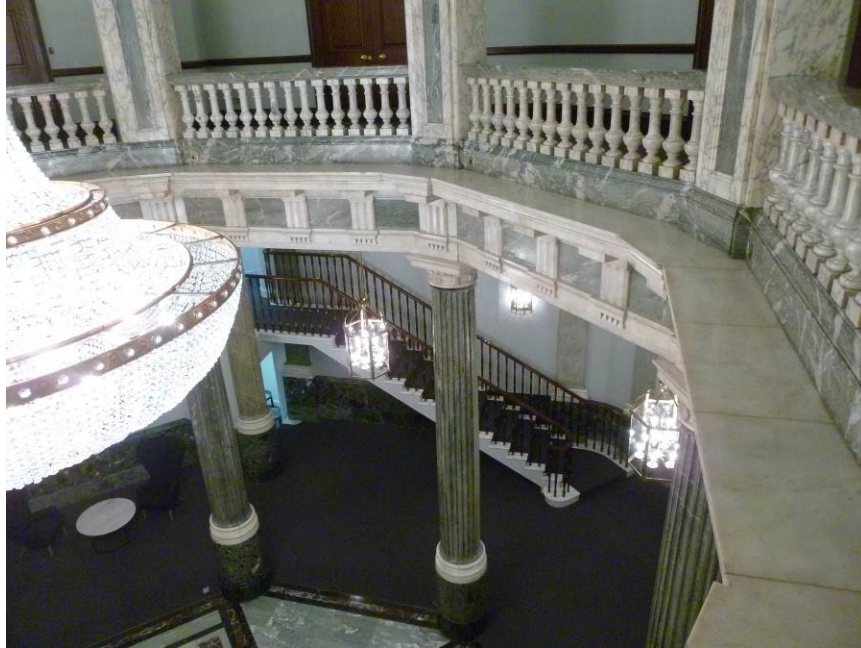
Photo 5: Showing columns and balcony of foyer

- 6.1.17 In the event of movements to the balcony structure of the foyer, it is proposed that a contingency support solution is provided (guided by a programme of monitoring). The design of this measure is to be confirmed, but will take the form of temporary non-invasive props placed where appropriate and padded to avoid damage to finishes. The props will be placed in ground floor or basement areas on a short term basis. These will provide additional support to the existing structure in the event of structural movement. The foyer area is illustrated in photos 5 and 6, and a section showing the indicative area which may require support is included at figure 1.

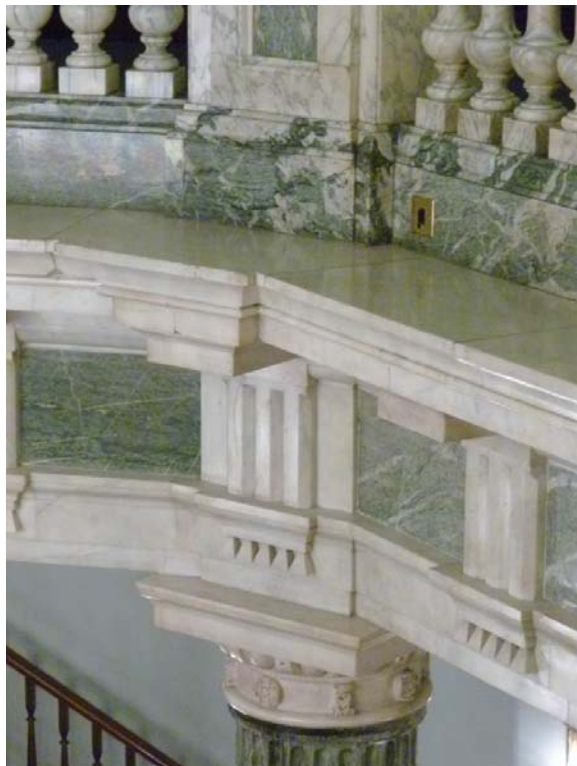
Photo 6: Detail, top of ground floor column to base of first floor column, foyer balcony

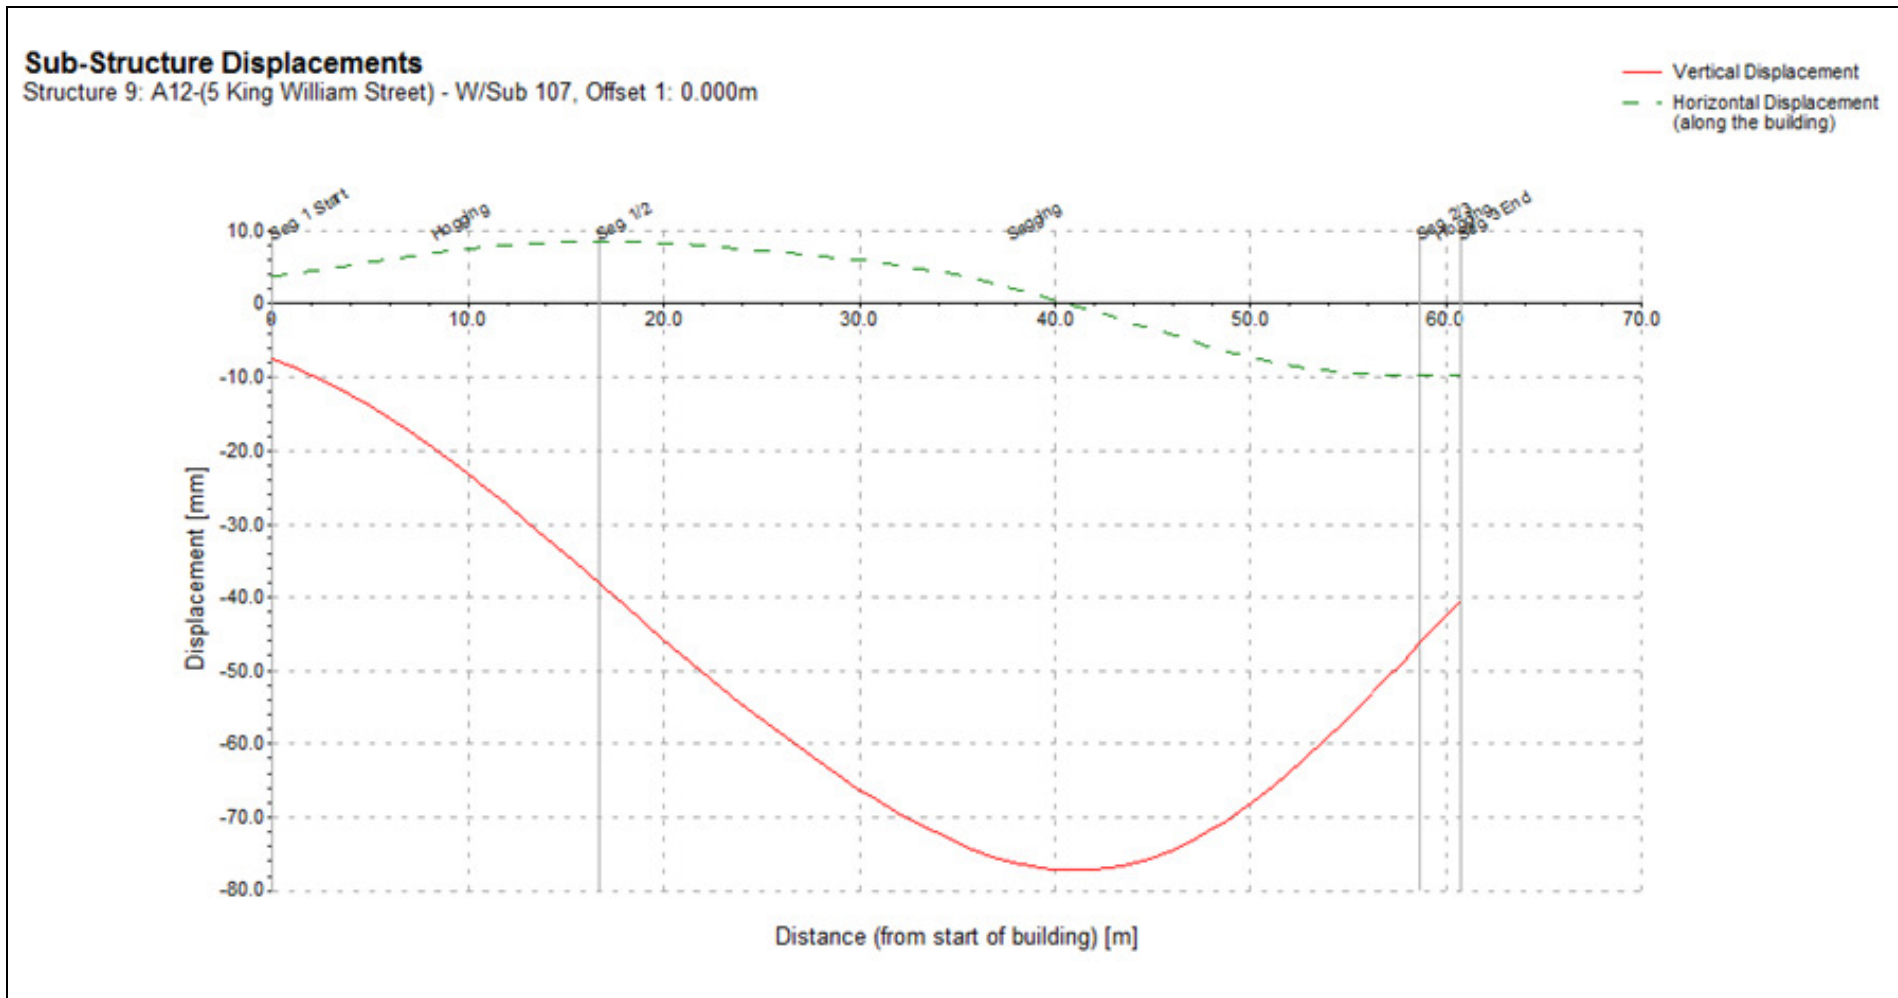
Figure 4: Building displacement at founding level of (line 1) at stage 4 of worst case for tensile strain

Line No (stage)	Strains in section (Curvature)	Position from start (m)	Length (m)	Average* Horizontal Strain (%)	Maximum Tensile Strains (%)	Damage Category
(Line 1) (Stage 4)	Hogging	0.0	16.7	0.028	0.036	Negligible
	Sagging	16.7	42	-0.044	0.063	Very Slight
	Hogging	58.6	2.1	0.008	0.008	Negligible
(Line 2) (Stage 2)	Sagging	0.0	7.6	-0.013	0.004	Negligible
	Hogging	7.6	19.9	0.029	0.043**	Negligible
	Sagging	27.5	11.8	-0.053	0.018	Negligible

The Stage 2 engineering assessment has predicted that the maximum tensile strain falls within damage category 1. This corresponds to Very Slight damage in accordance with Table 2.

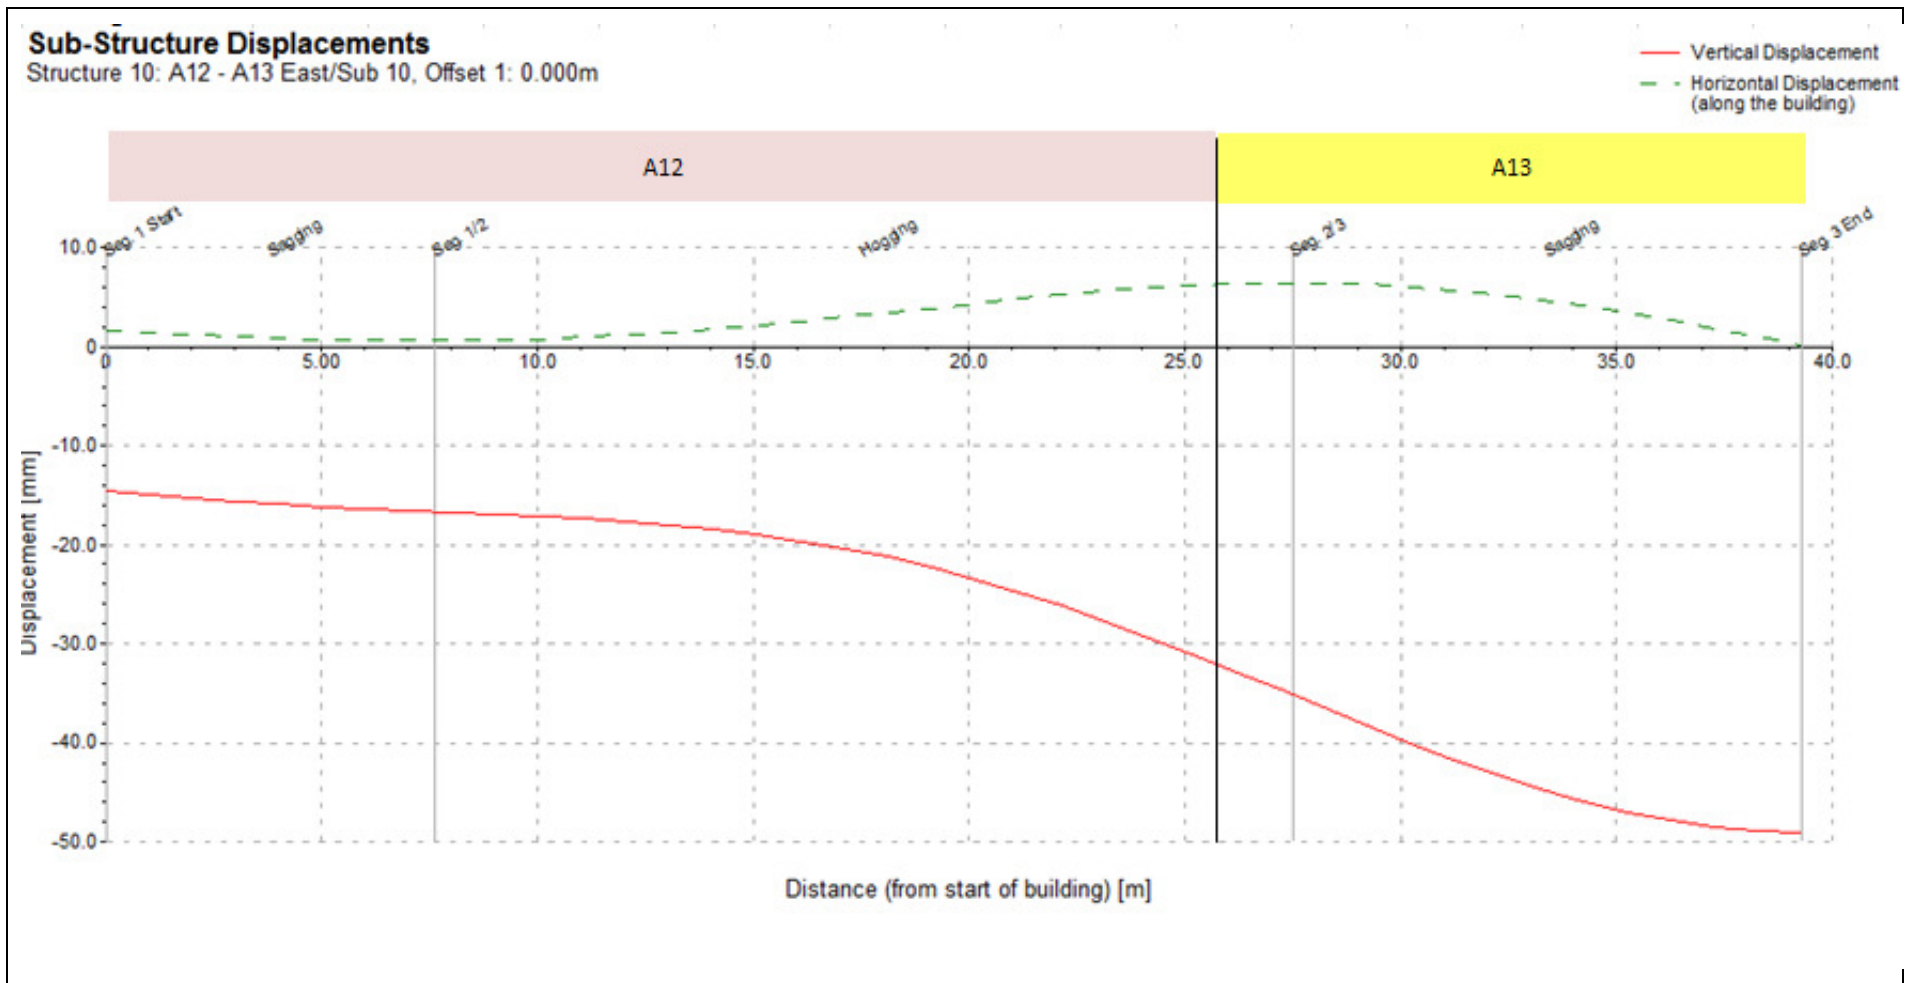
Figure 5: Building displacement at founding level of (line 2) at stage 2 of worst case for tensile strain

The displacement line 2 also shows the relative movements with the adjacent building A13 along Abchurch Lane. Unlike displacement line 1, the displacement line 2 undergoes its most onerous tensile strain (0.043% in hogging) at Stage 2. Figure 5 and Table 8 show that the strain between the two adjacent buildings is in hogging mode. These movements would tend to open a crack between the two buildings at high level. The maximum tensile strains in this area result in a very slight damage category.

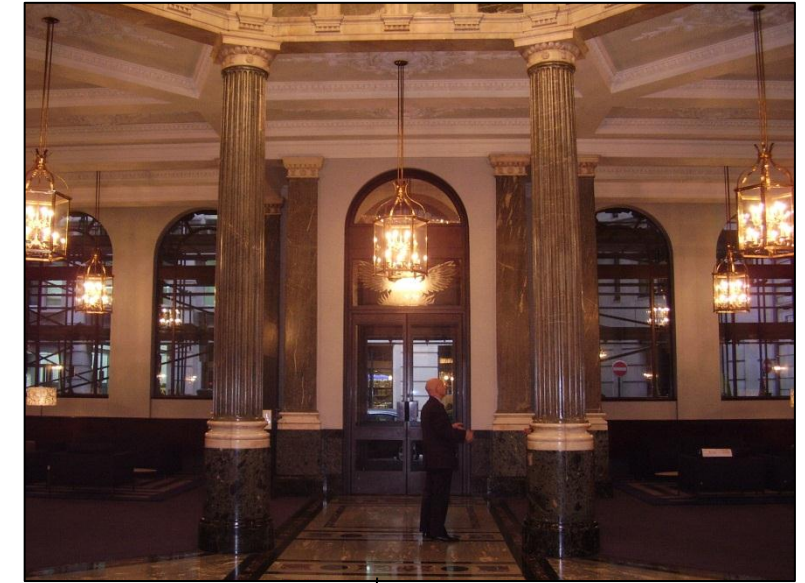
Interior at ground floor, foyer area, where it is proposed to locate contingency propping if required
