Bank Station Capacity Upgrade

The Mansion House Heritage Statement

September 2014

LUL Document Reference:
LUL-8798-STT-G-002111

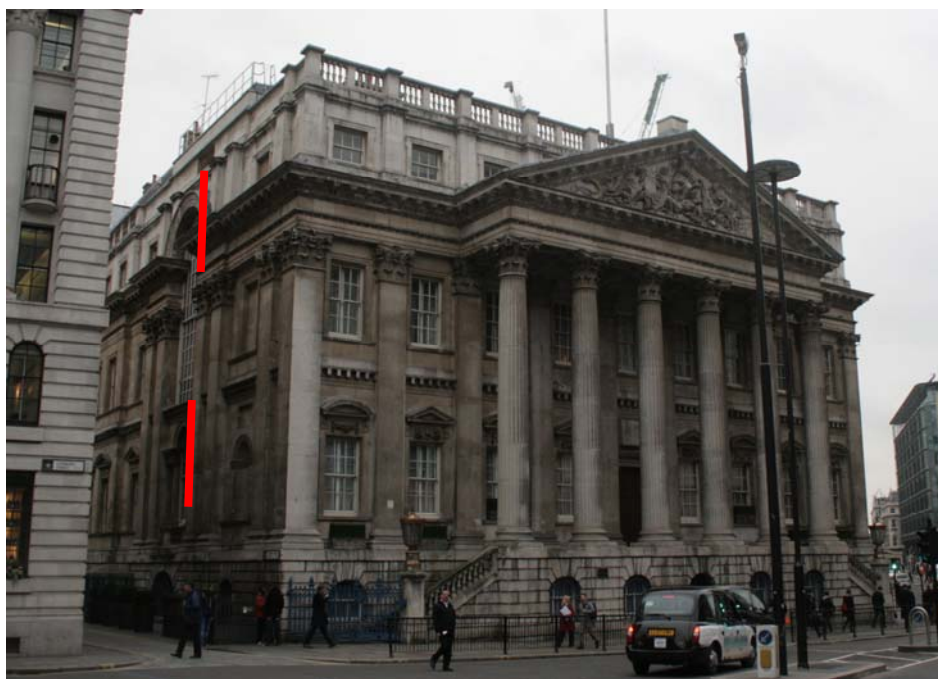
- 5.1.6 The north façade of the Mansion House is punctuated by regular window openings at the first, second and third floor level. At the north end of the east elevation is a large full height window that represents a line of potential structural weakness which may be sensitive to predicted movement (refer to photo 2, location identified on the photograph location sheet at Appendix 8).

Photo 2: North-east corner of the Mansion House with red lines indicating potential structural weakness

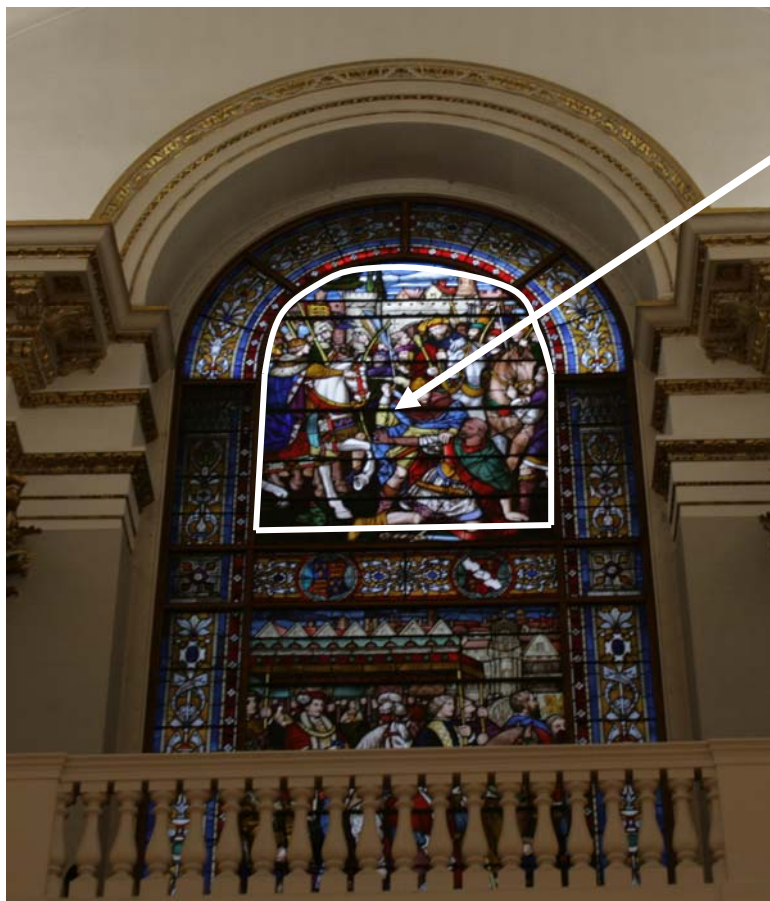
Photo 3: Stained glass window at the eastern end of the Egyptian Hall

- 5.1.8 At the southern end of the building on the east and west elevations, are full height windows to the Egyptian Hall. These windows contain fine stained glass. Some panels in the stained glass windows were damaged by a bomb blast in 1993. The window is currently in need of repair, and without protective works, there could be some damage. In the worst case this damage could include cracking to the stained glass to the eastern window and to the stonework at the top of the window arch.
- 5.1.9 A survey of the Egyptian Hall stained glass windows was undertaken by a specialist conservator in July 2014. This found that:

“the bowing to this [east] window is bordering on severe in places. The copper ties are stretched to their limit and any further movement mainly to the central section depicting the death of Wat Tyler at Smithfield would snap the ties completely and the bowing would progress rapidly causing cracking to the glass and damage to the solder joints. If the predicted movement to this window is of 1 - 2mm, mitigation works are recommended”.

The semi-circular headed panel to be temporarily removed for repair and conservation, and replaced prior to tunnelling works.

- 6.1.5 Following a survey undertaken in July 2014 to assess its condition and resilience to predicted movement, the topmost section of the large stained glass window at the eastern end of the Egyptian Hall (refer to photo 3) will be temporarily removed for specialist repair and conservation. During the period of its removal a temporary replica panel will be inserted in its place. These works to remove and replace the panel will be programmed in detailed consultation with the Mansion House team so that they have minimal impact on the operation of the Mansion House, particularly its ceremonial functions. It is estimated that removal of the window will take approximately one week, and the conservation and return of the stained glass panel will take approximately three months, occurring before tunnelling works which could impact the building commence.

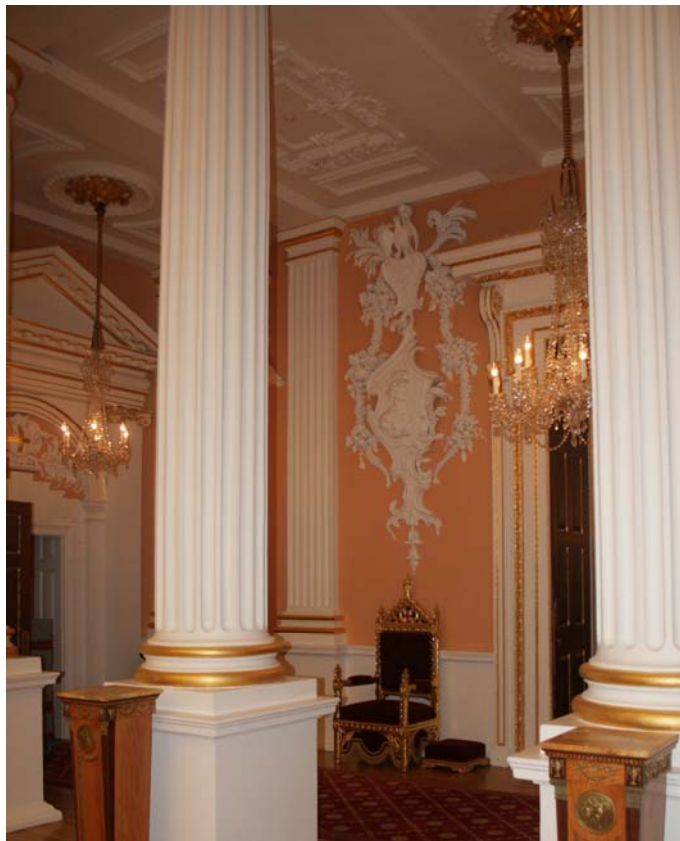
- 5.1.10 The full survey report is appended in Appendix 7.
- 5.1.11 Heavy plasterwork to ceilings within the ground and first floor principal reception rooms, in the north and central areas of the building, may have a limited tolerance to further settlement. The effects of settlement in the worst case may result in some cracking of historic plaster.

Photo 4: Example of heavy plaster enrichments to walls and ceilings that are at risk of damage due to predicted movement

- 6.1.6 Following non-invasive survey, any loose decorative plaster enrichments that are at risk of damage due to predicted movement will be consolidated by utilising a variety of methods ranging from crack filling, localised grouting of voids to insertion of stainless steel fixings anchored to timber substrates (refer to photo 4).

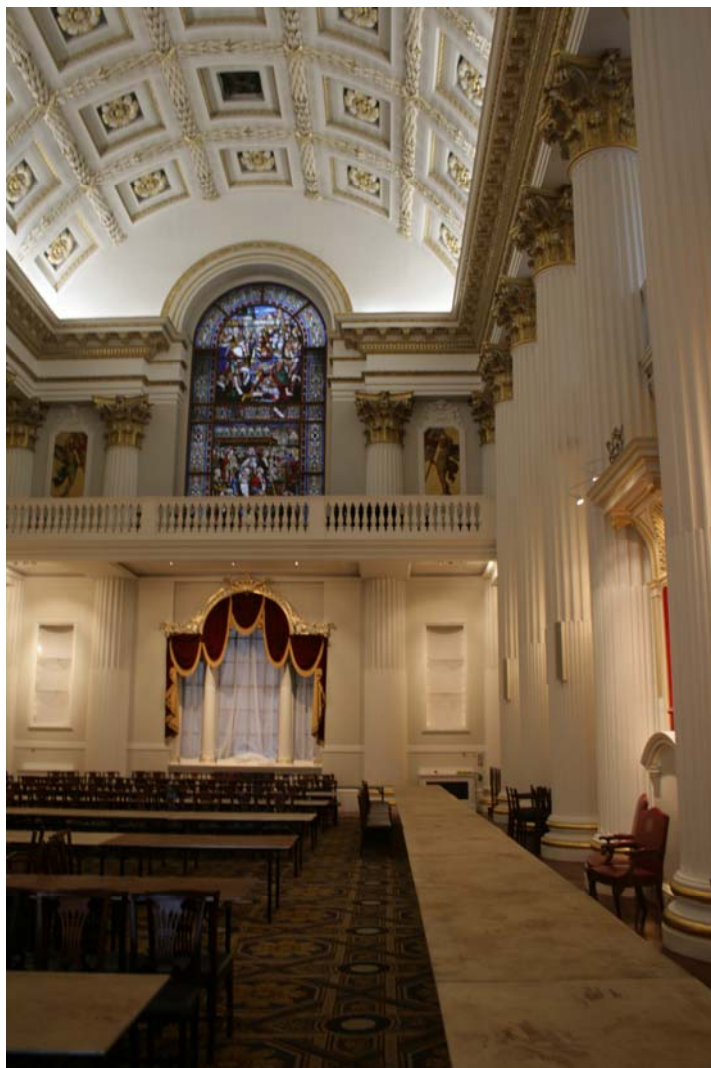
Photo 5: View of eastern Egyptian Hall window from ground (principal) floor level

- 6.1.9 The temporary removal of an upper portion of the Egyptian Hall stained glass window will have a temporary adverse impact on the significance of the building. However, the panel is at a height where the detail of the stained glass is not easily seen from ground level (as shown in photo 5). Therefore, the visual impact on the significance of the building will be mitigated by the temporary installation of a replica panel. The conservation of the stained glass panel will also have a beneficial impact on the aesthetic significance of the building as the condition of the window will be improved, reducing the risk of failure or damage for many years to come.

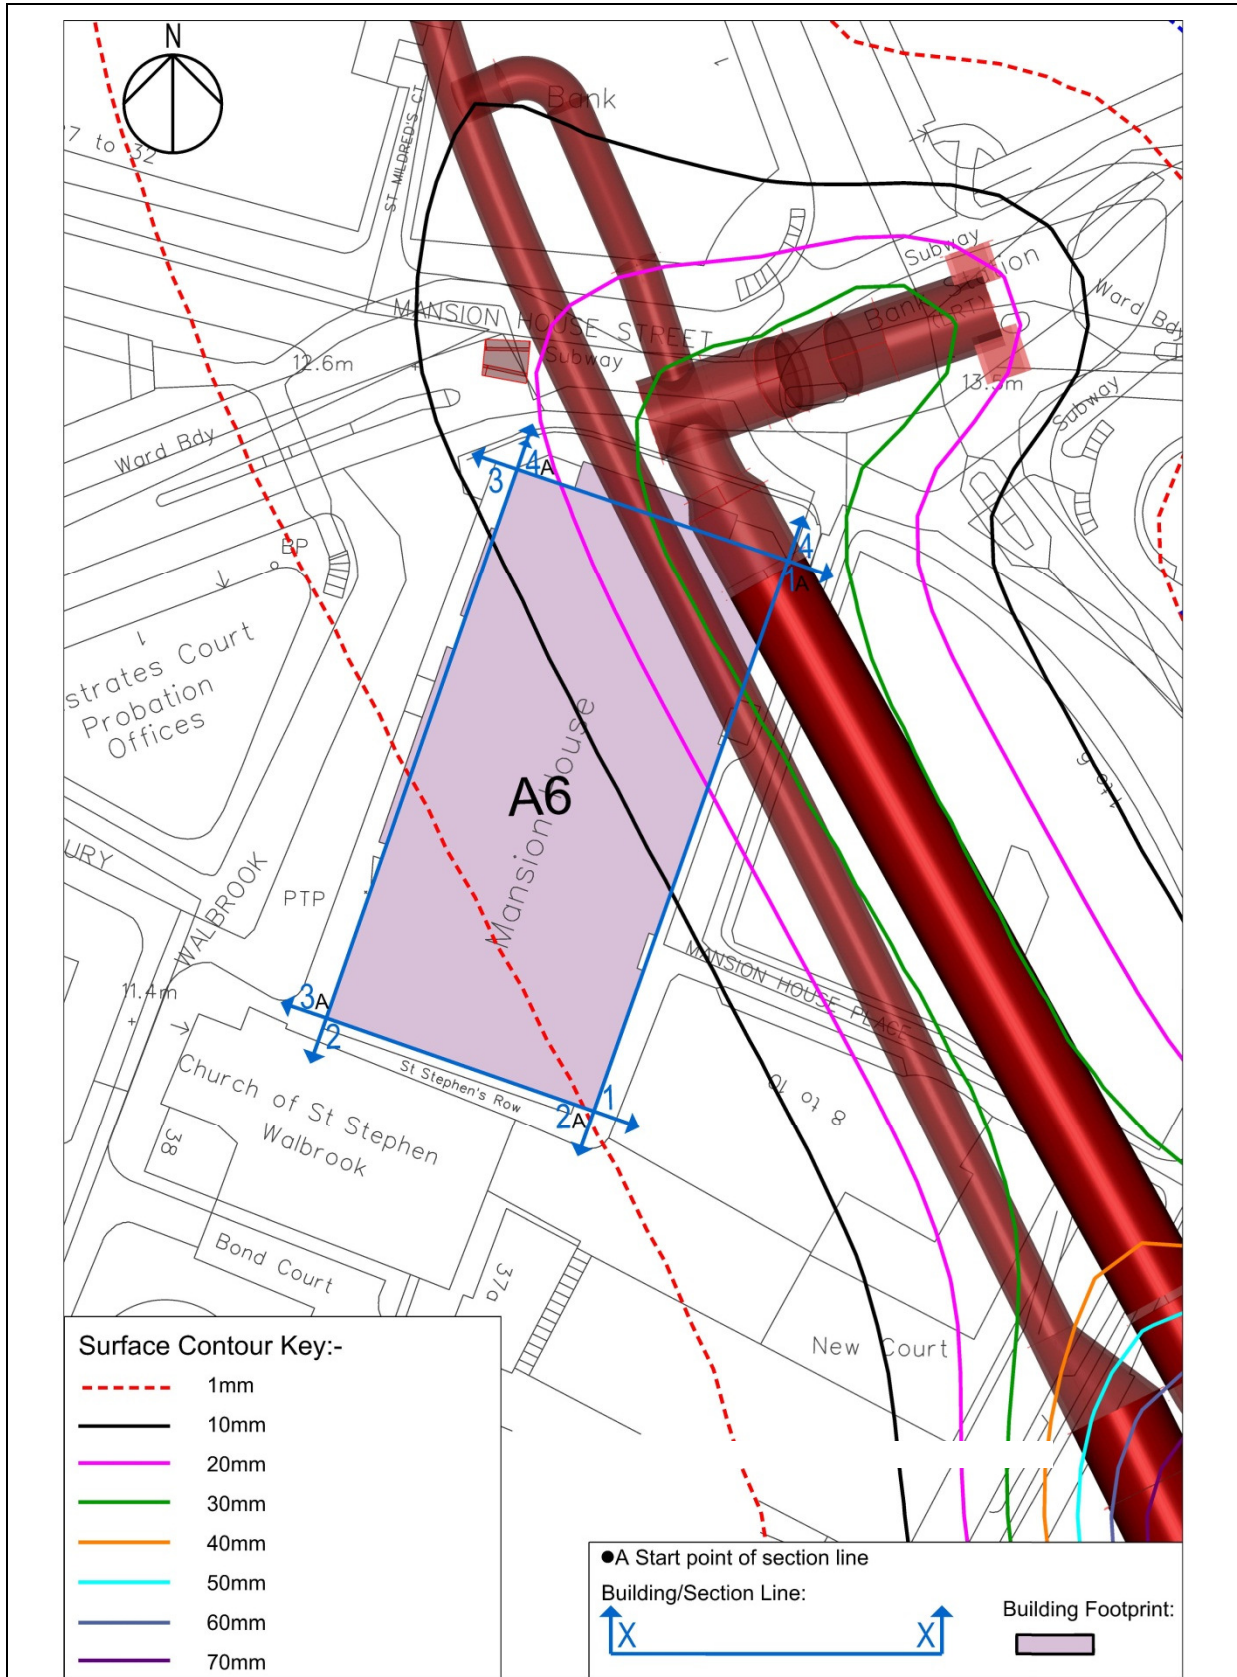
Figure 3: Building location, sections analysed and Settlement Contours at stage of worst case for tensile strains

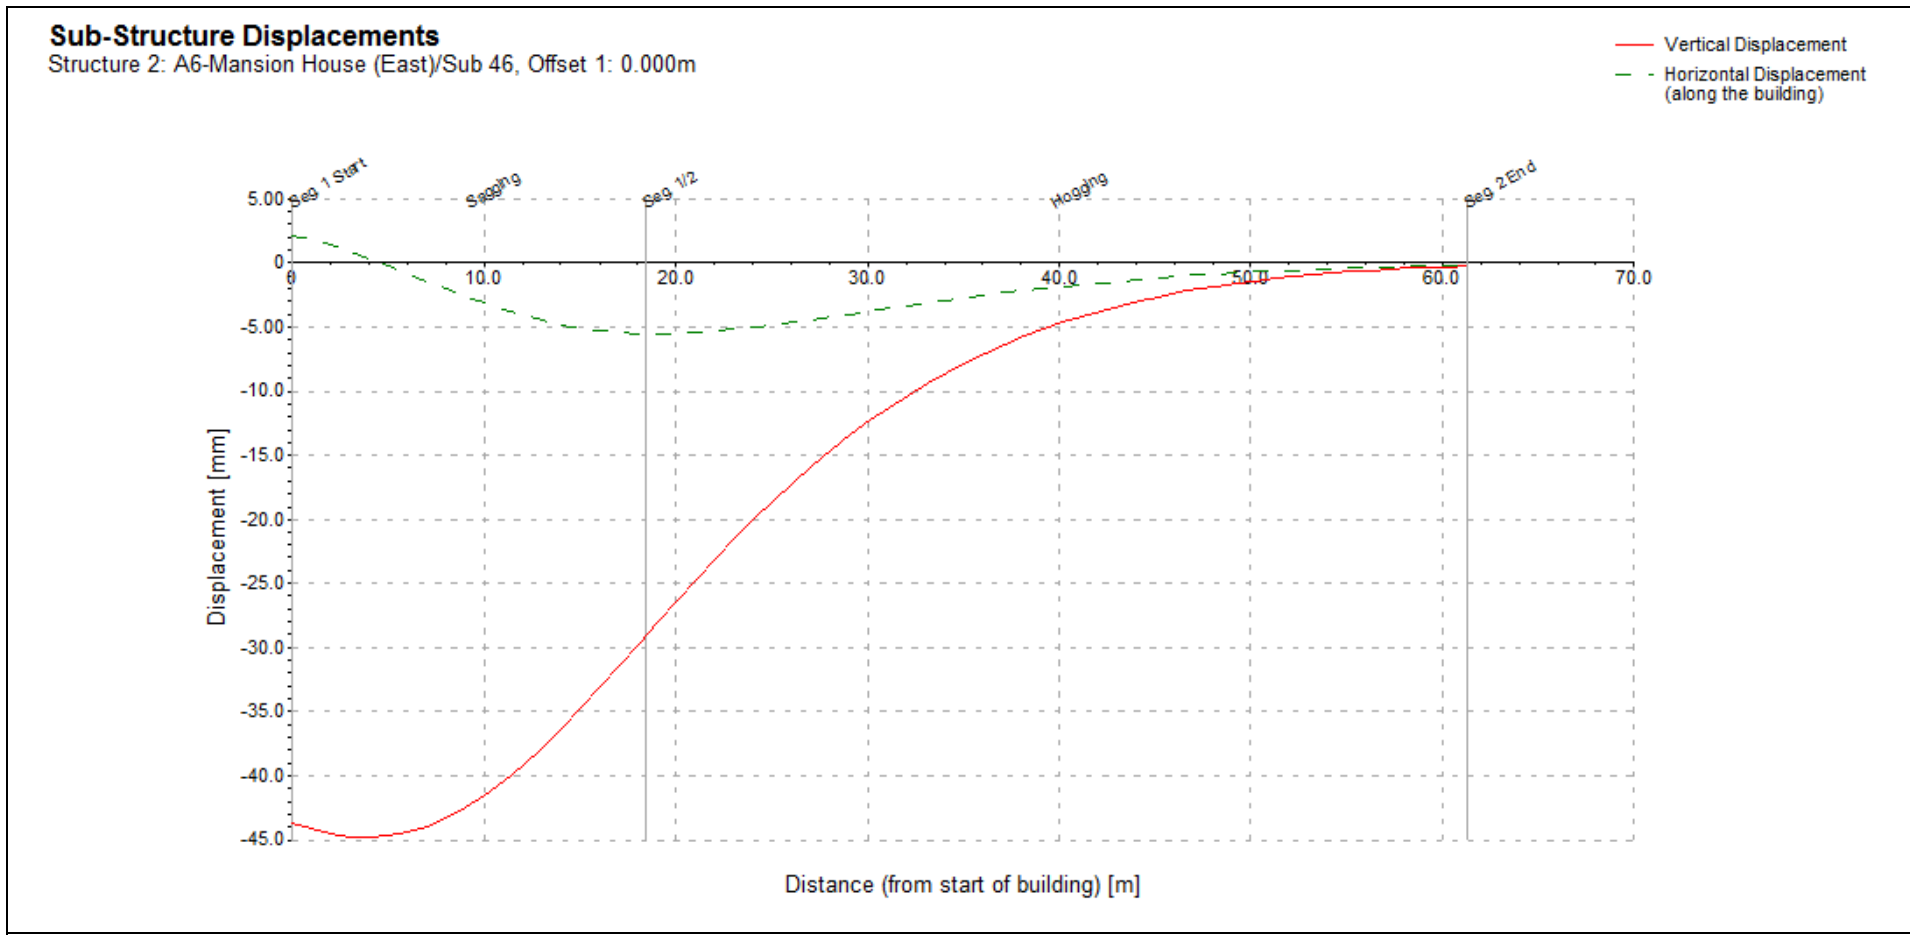
Figure 4: Building displacement at founding level at stage 4 (line 1) of worst case for tensile strains

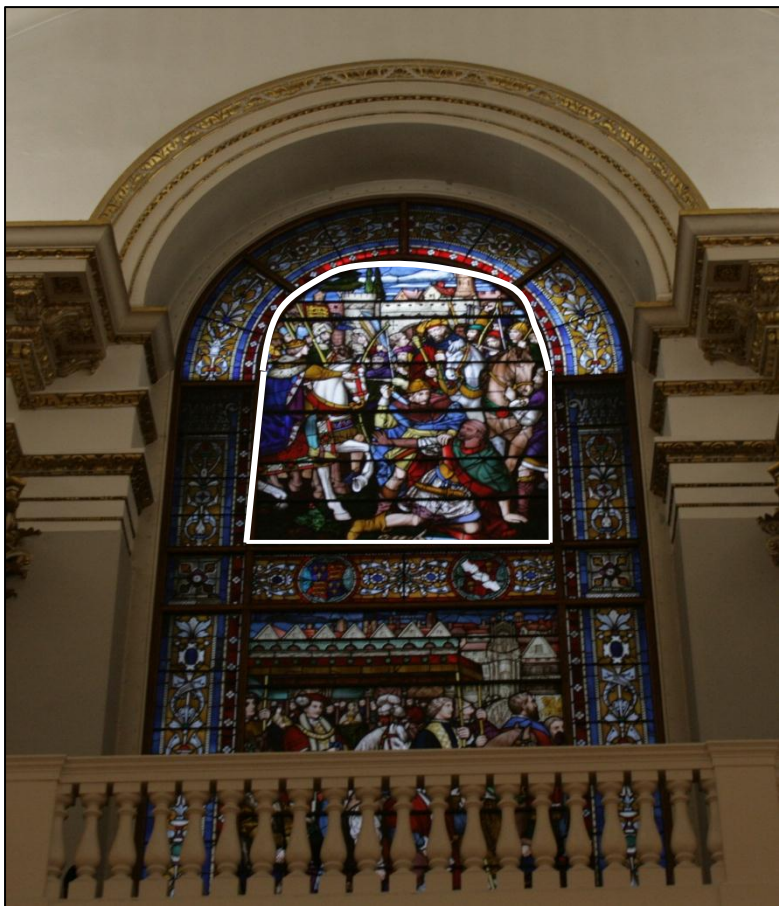
Stained glass window with panel to be removed shown in white outline

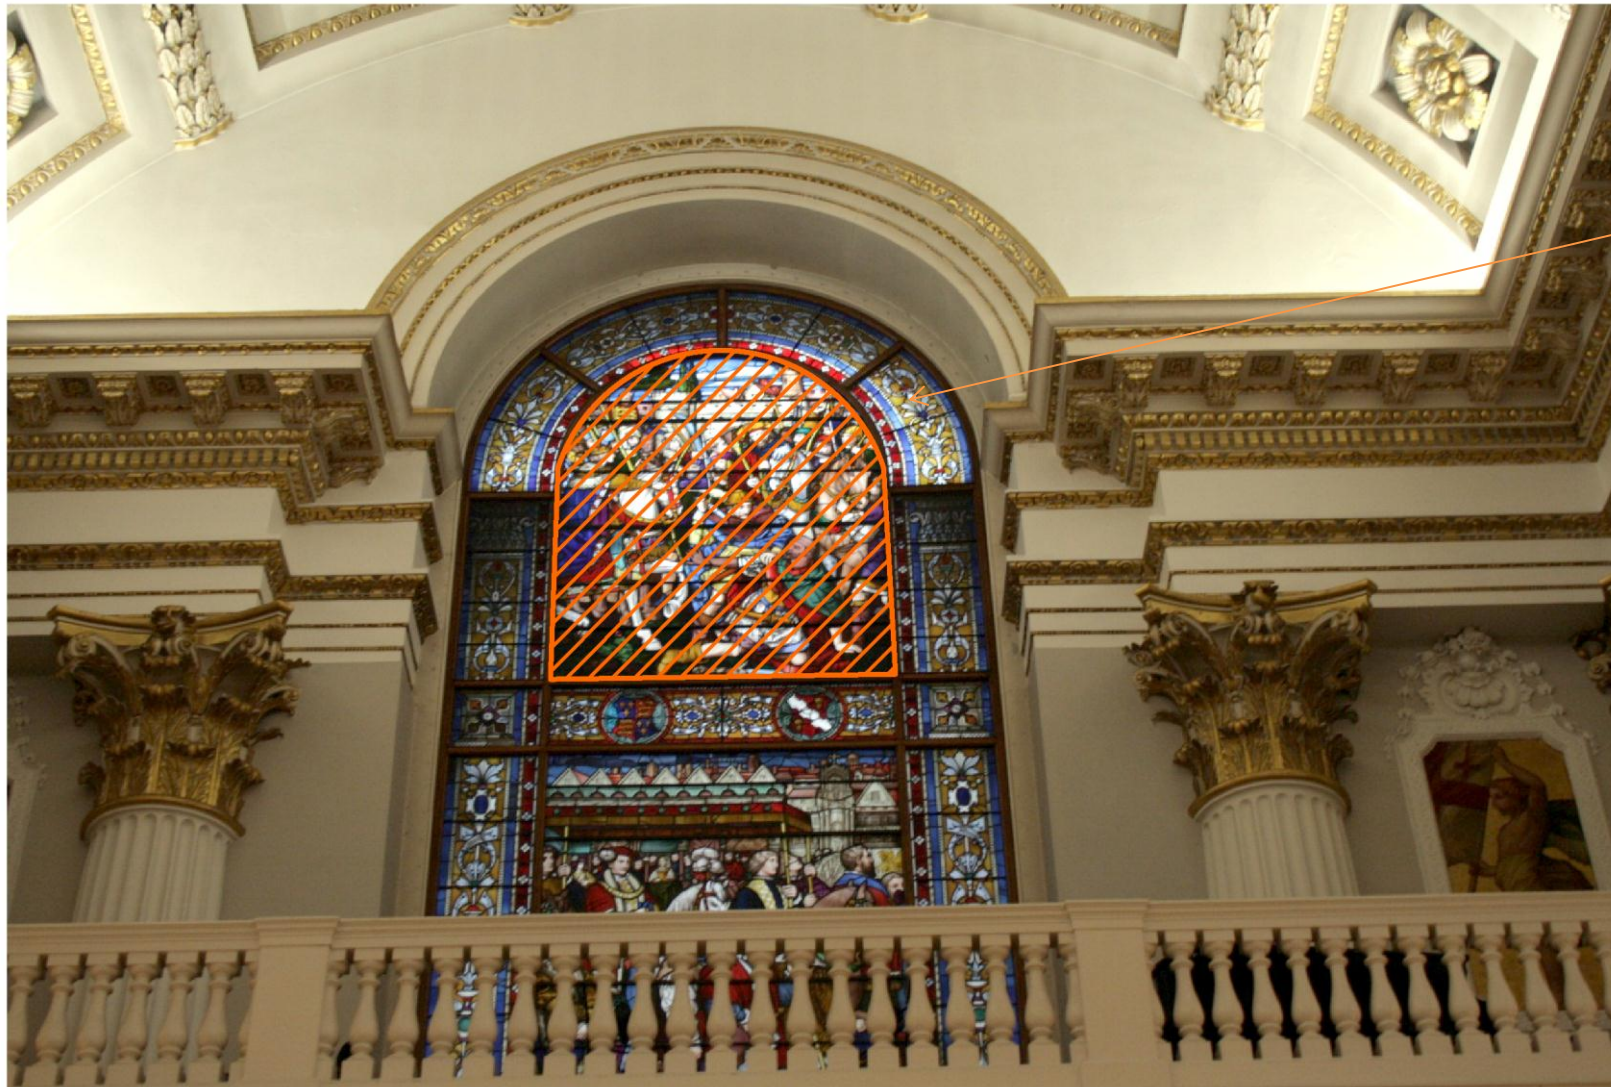
Egyptian Hall eastern window, panel to be temporarily removed
