Bank Station Capacity Upgrade

1 Princes Street Heritage Statement

In support of London Underground's
Listed Building Consent Application
for protective works

LUL Document Reference:
LUL-8798-STT-G-002112

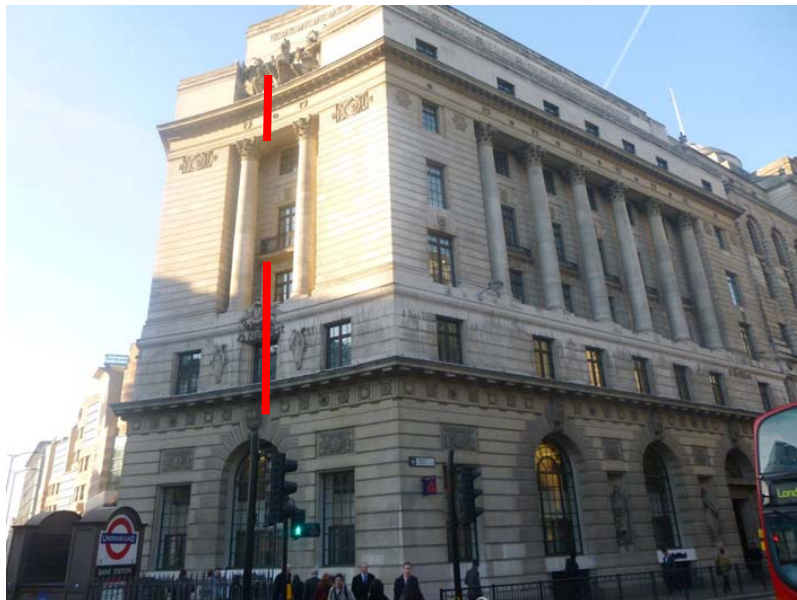
Photo 2: Predicted concentration of strains to 1 Princes Street elevation

5.1.6 The elevations of 1 Princes Street have large discontinuities, for example large openings under heavy cornices. The south-eastern (corner) elevation is especially sensitive due to the group of statues at attic level above a large opening. Should strain concentrate at this area, there is a small possibility that cracking to the cornice beneath the statues may result in movement of the statues, loss of fixing stability, and damage to carved detail. This is indicated in photo 2 (a plan showing locations of photographs can be found at Appendix 6).

5.1.7 It is considered that the impacts of the predicted settlements are such that they could be detrimental to the heritage significance of 1 Princes Street. Therefore, proposals for protective works are outlined within the following section and the impacts of these protective measures are discussed. Further investigations of

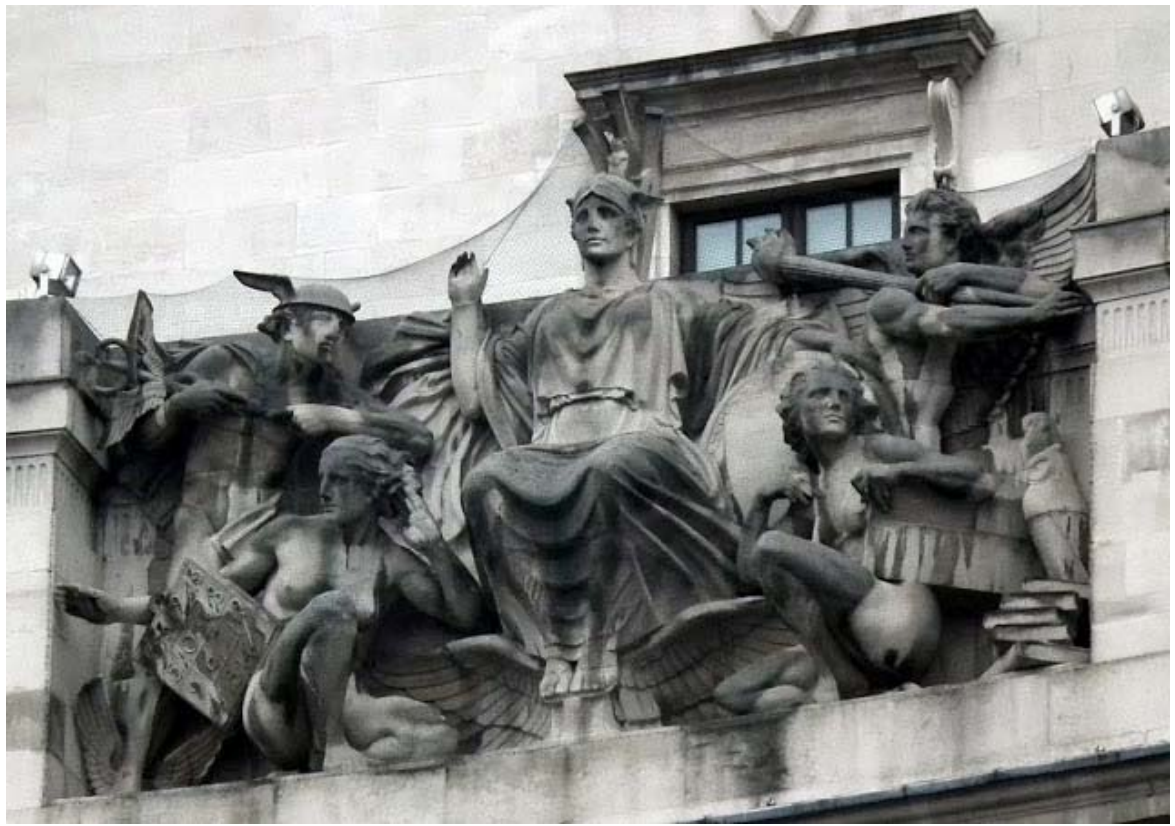
Photo 3: Group of statues proposed for examination and temporary removal
Impact of the works

- 6.1.4 Subject to investigation by close survey and the results of the Stage 3 Building Damage Assessment, the group of statues may require the provision of additional fixings by the insertion of steel brackets or ties. This may require temporary removal of the statues. The location of the statue group is shown in photograph 3. An annotated plan and photograph of the area where works will take place is included at Appendices 7 and 8.
- 6.1.5 These additional fixing brackets or ties would be permanent works; the removal of statues would be temporary and short term for the duration of the works.

- 6.1.6 The proposed protective works involving the temporary removal of the statues will have a short term impact on the significance of the listed building as well as a temporary impact on the setting of adjacent buildings to which it is a contributor. There will be a short term impact on the Bank Conservation Area resulting from the protective works.

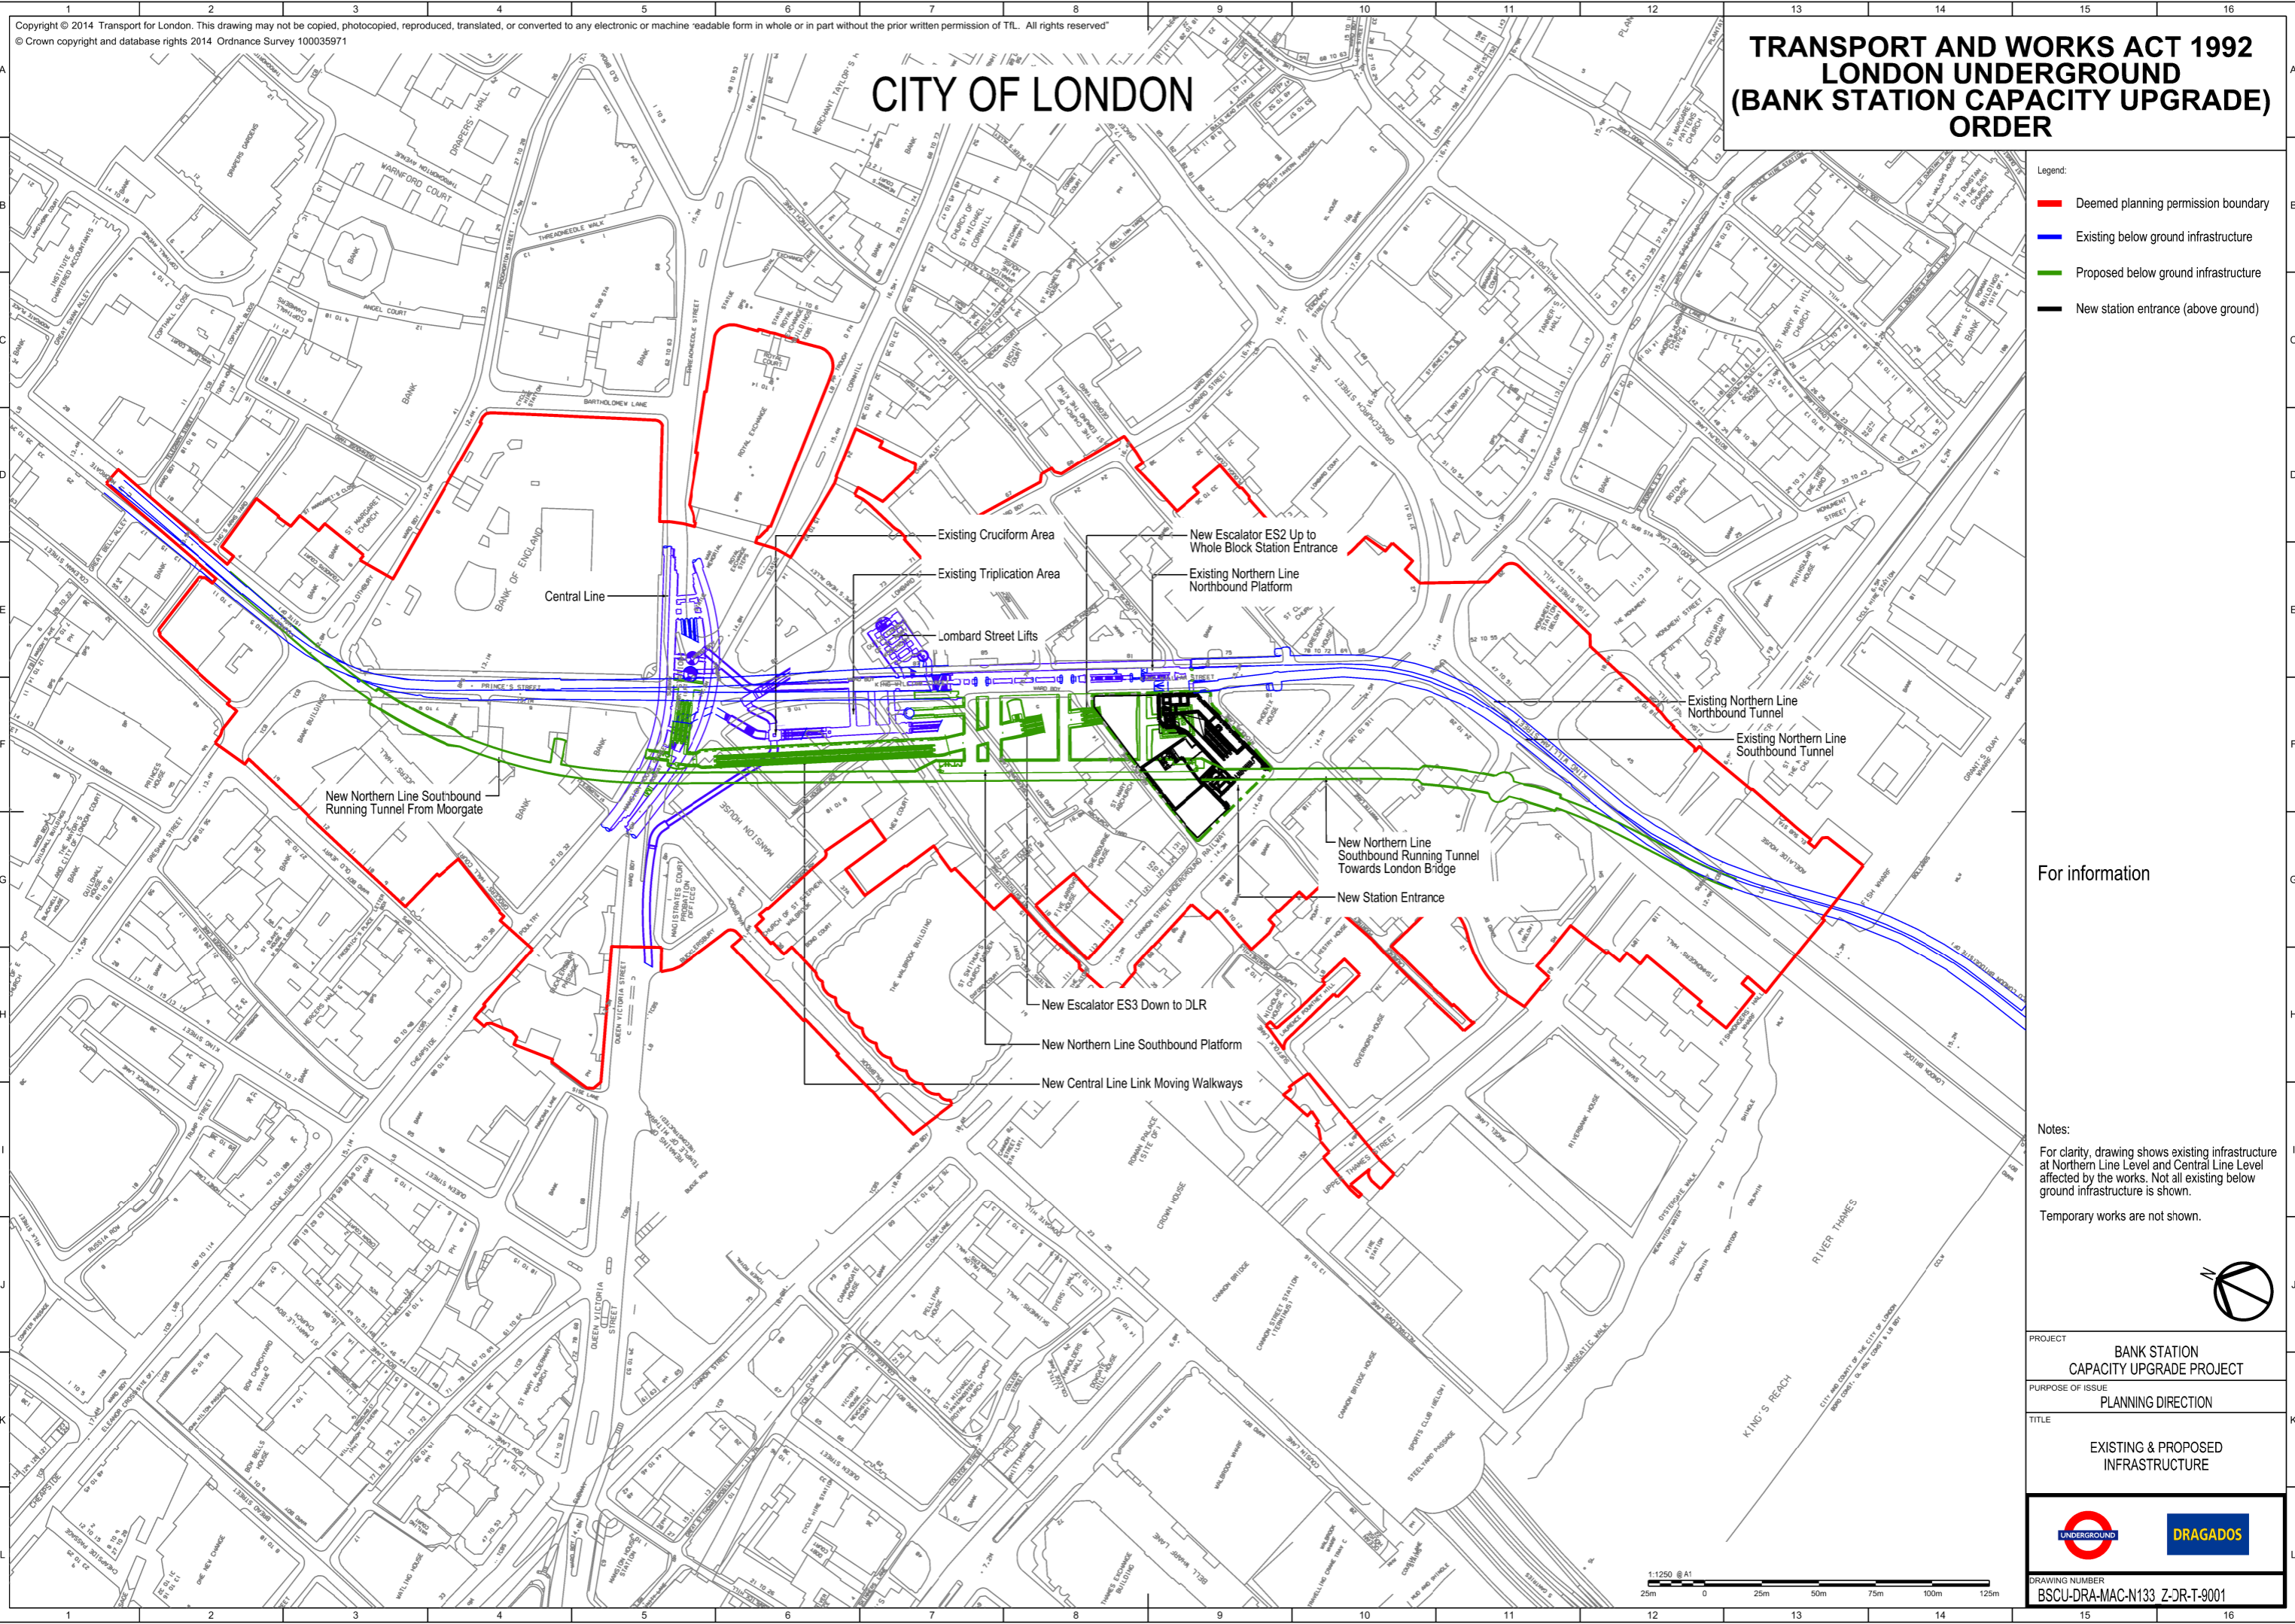
DRAWING NUMBER
BSCU-DRA-MAC-N133_Z-DR-T-0310

PROJECT	BANK STATION CAPACITY UPGRADE PROJECT
PURPOSE OF ISSUE	FOR INFORMATION
TITLE	1 PRINCE'S STREET EXISTING AND PROPOSED INFRASTRUCTURE

Notes:
 For clarity, drawing shows existing infrastructure at Northern Line Level and Central Line Level affected by the works. Not all existing below ground infrastructure is shown.
 Temporary works are not shown.

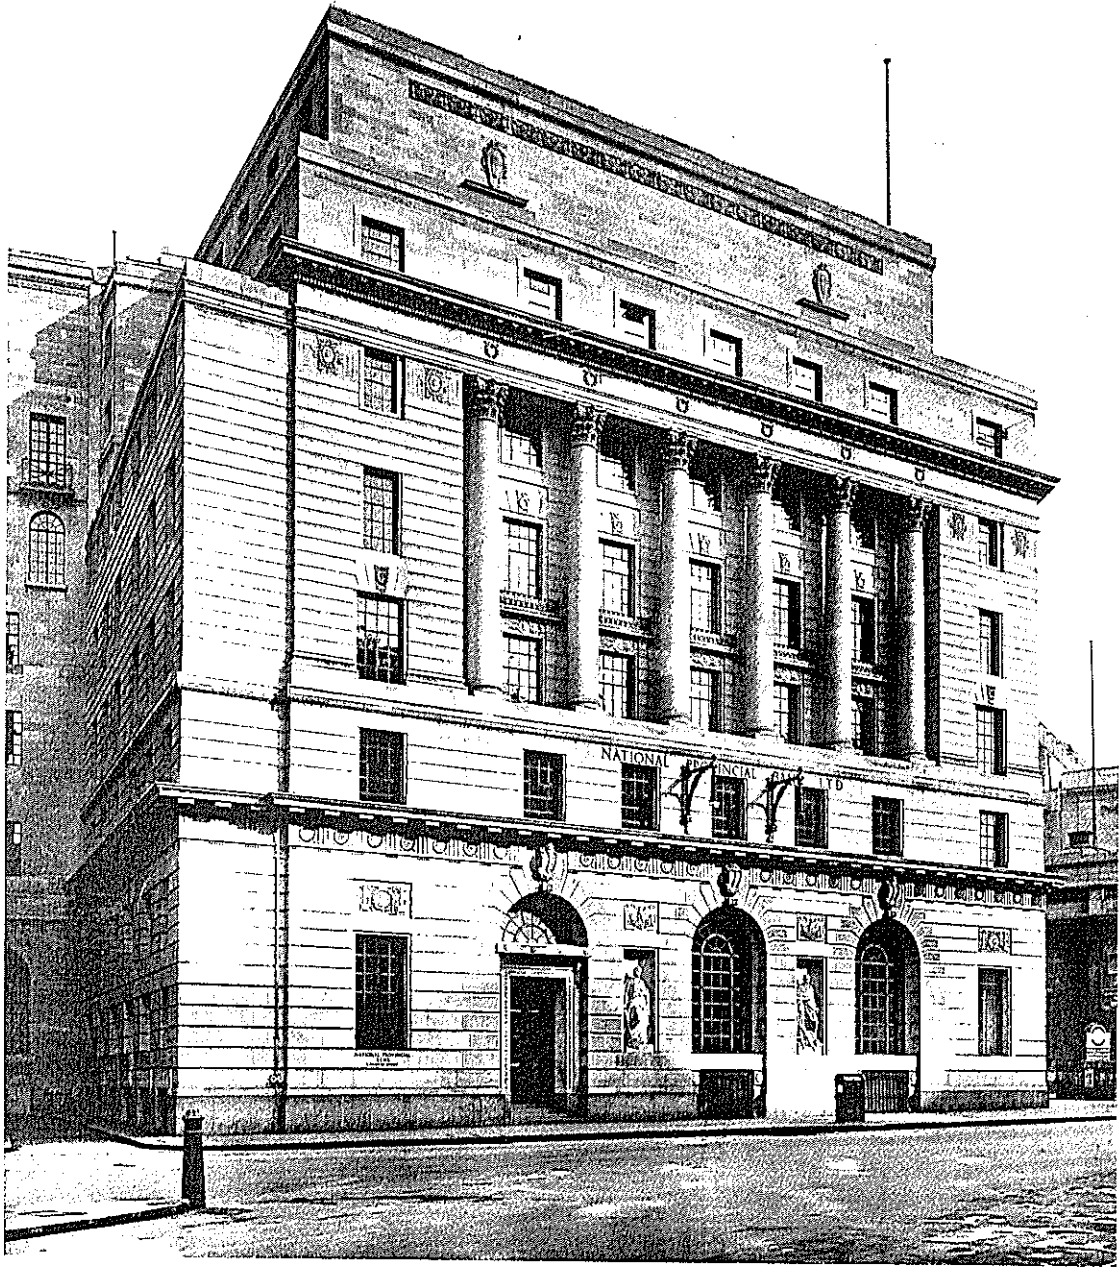
THE MANSION HOUSE STREET FRONT. The building is in Portland stone. The figures in the niches on the ground floor represent *Security* and *Integrity*, and are carved in Portland stone. Enlarged reproductions of the figures are given on page 145.

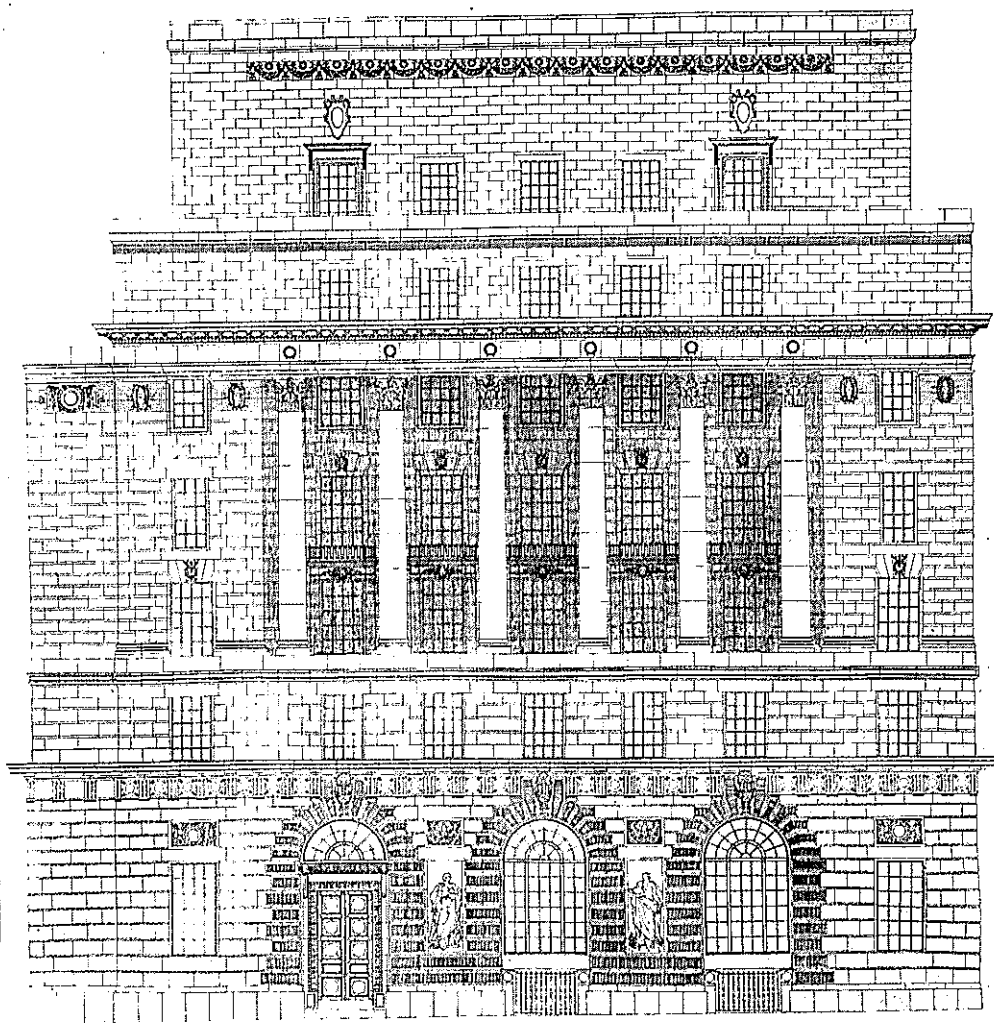
The elevation to MANSON HOUSE STREET.

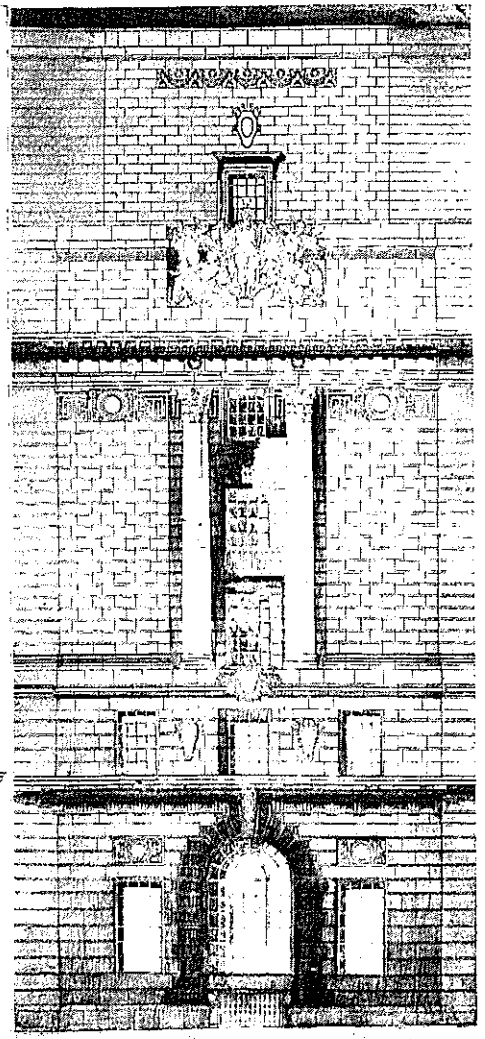
The elevation of the ANGLE TO MANSON HOUSE STREET AND PRINCES STREET.

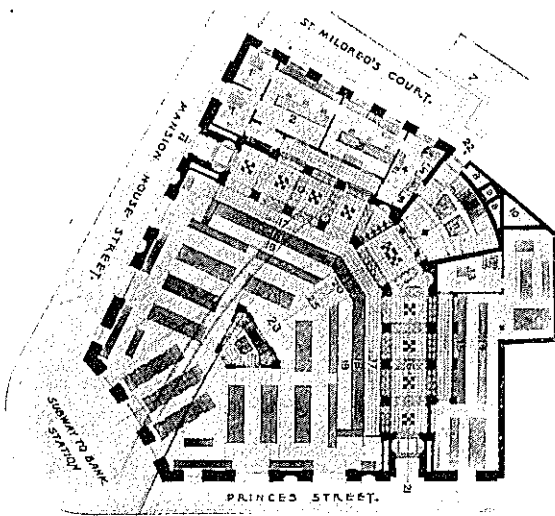
The GROUND-FLOOR PLAN.

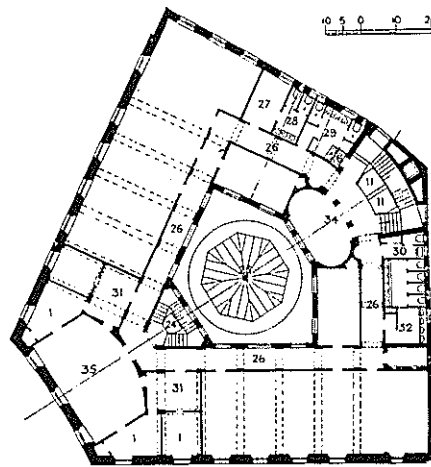
The FIRST-FLOOR PLAN.

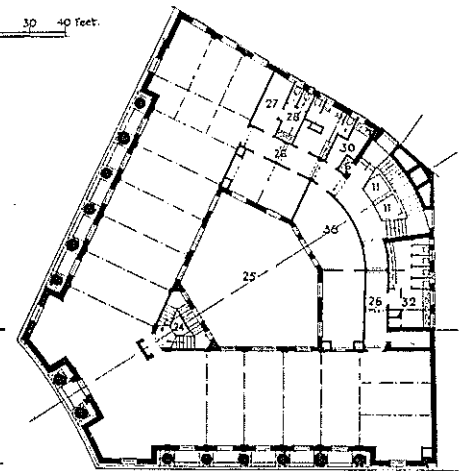
The SECOND-FLOOR PLAN.

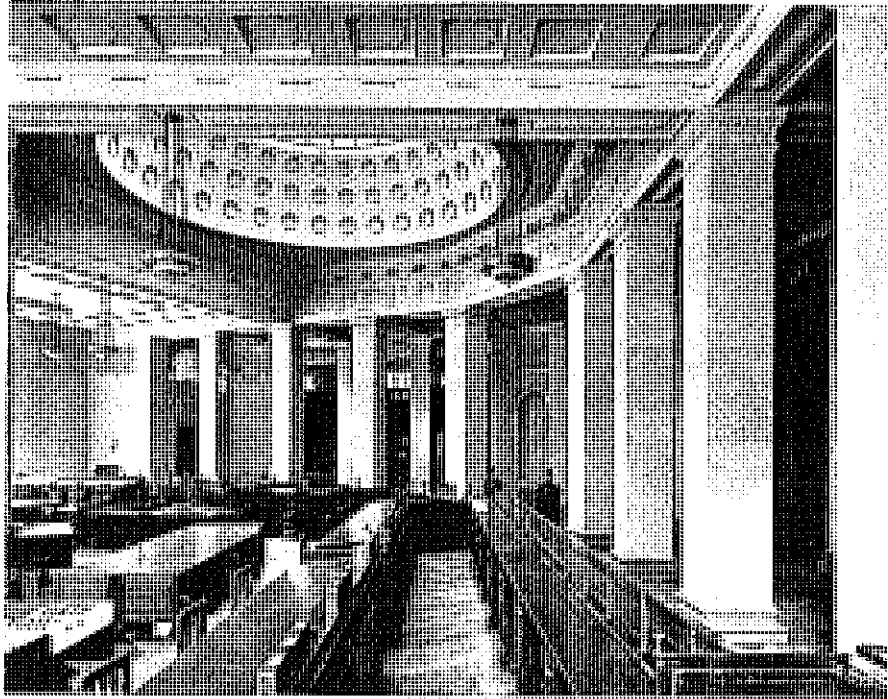
THE BANKING HALL.—The walls and columns are built of Subiaco marble. The floor is in Roman stone and the ceiling in fibrous plaster. The counter is made of teak with a Sienna marble and bronze front. The desks are in teak.

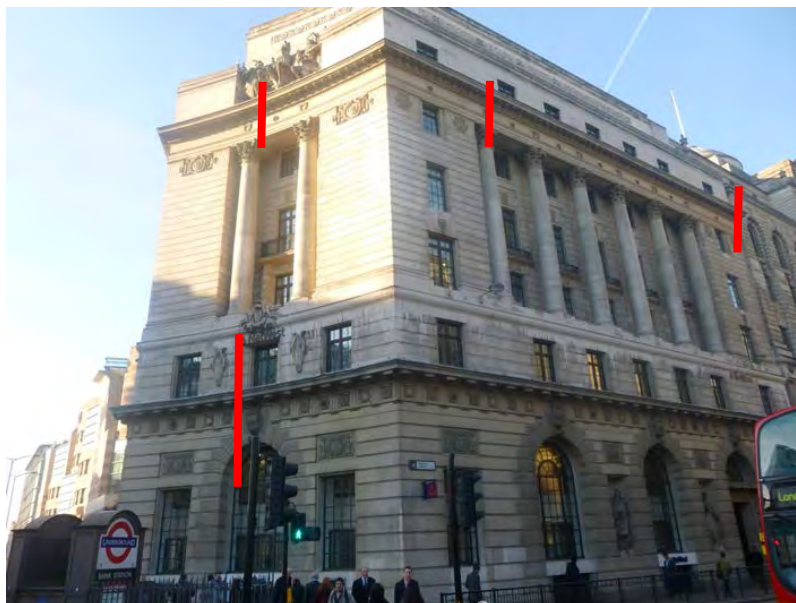
Plate 2: Stress Concentration in Elevations

The elevations to Princes Street and Mansion House Street include a large set back above second floor level extending to the underside of the cornice at sixth floor level. This set back will have the effect of concentrating all movement on these elevations to either end of the cornice, as indicated in the image below, where red lines indicate areas of stress concentration.

Score: 2 - The inset elements of the façade will effectively act as large openings, leaving the narrow cornice to prop the two ends of the opening. This will lead to a stress concentration at each end of the setback, focusing all movement in these locations.

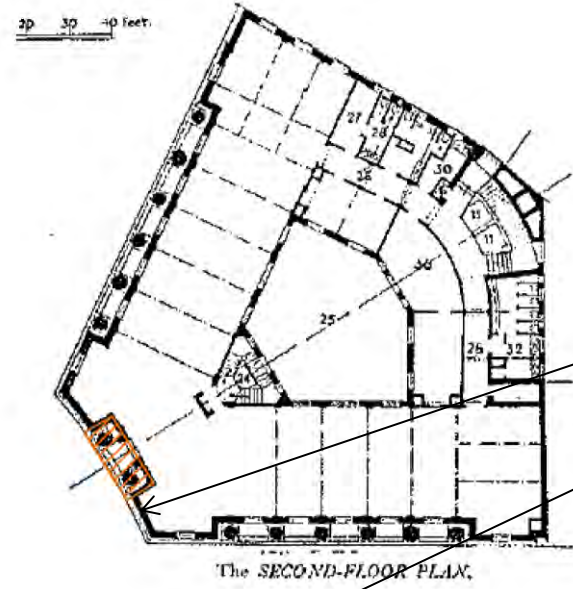
Location of corner elevation; statues at attic (sixth) floor

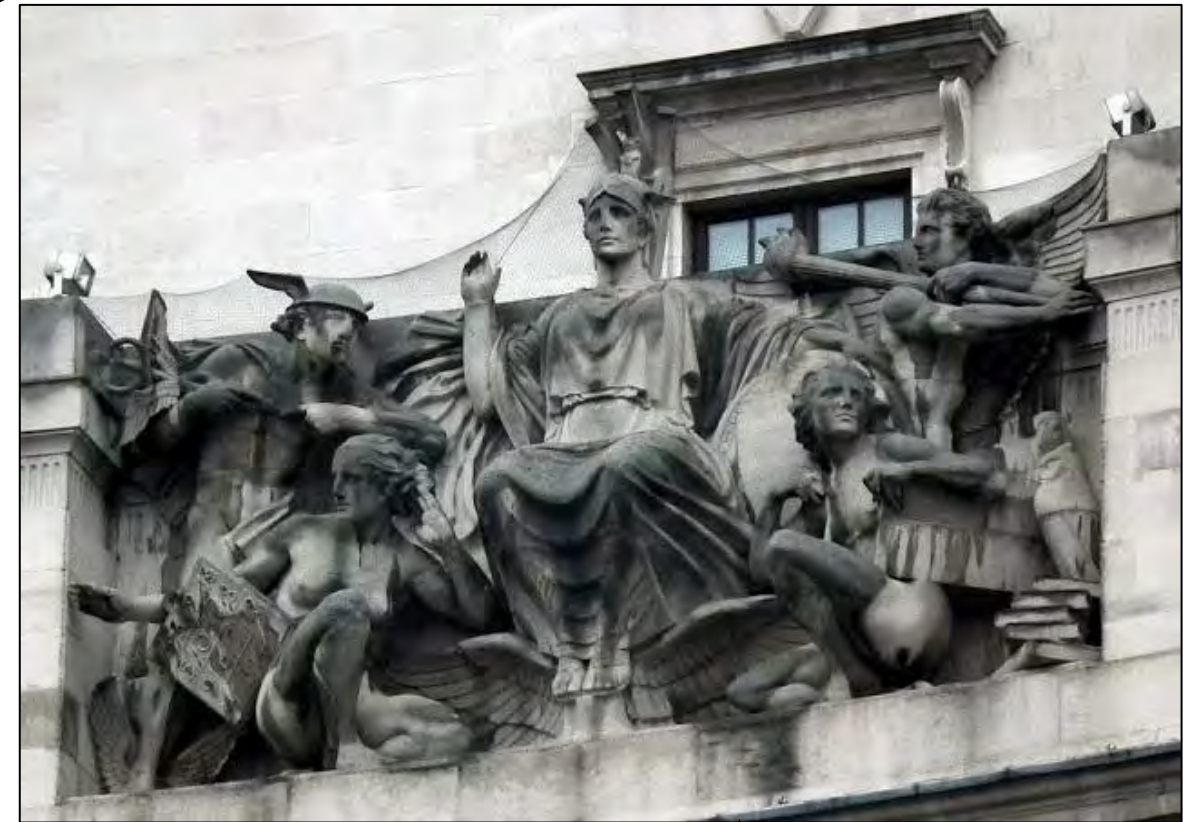
Group of statues to the corner elevation of 1 Princes Street

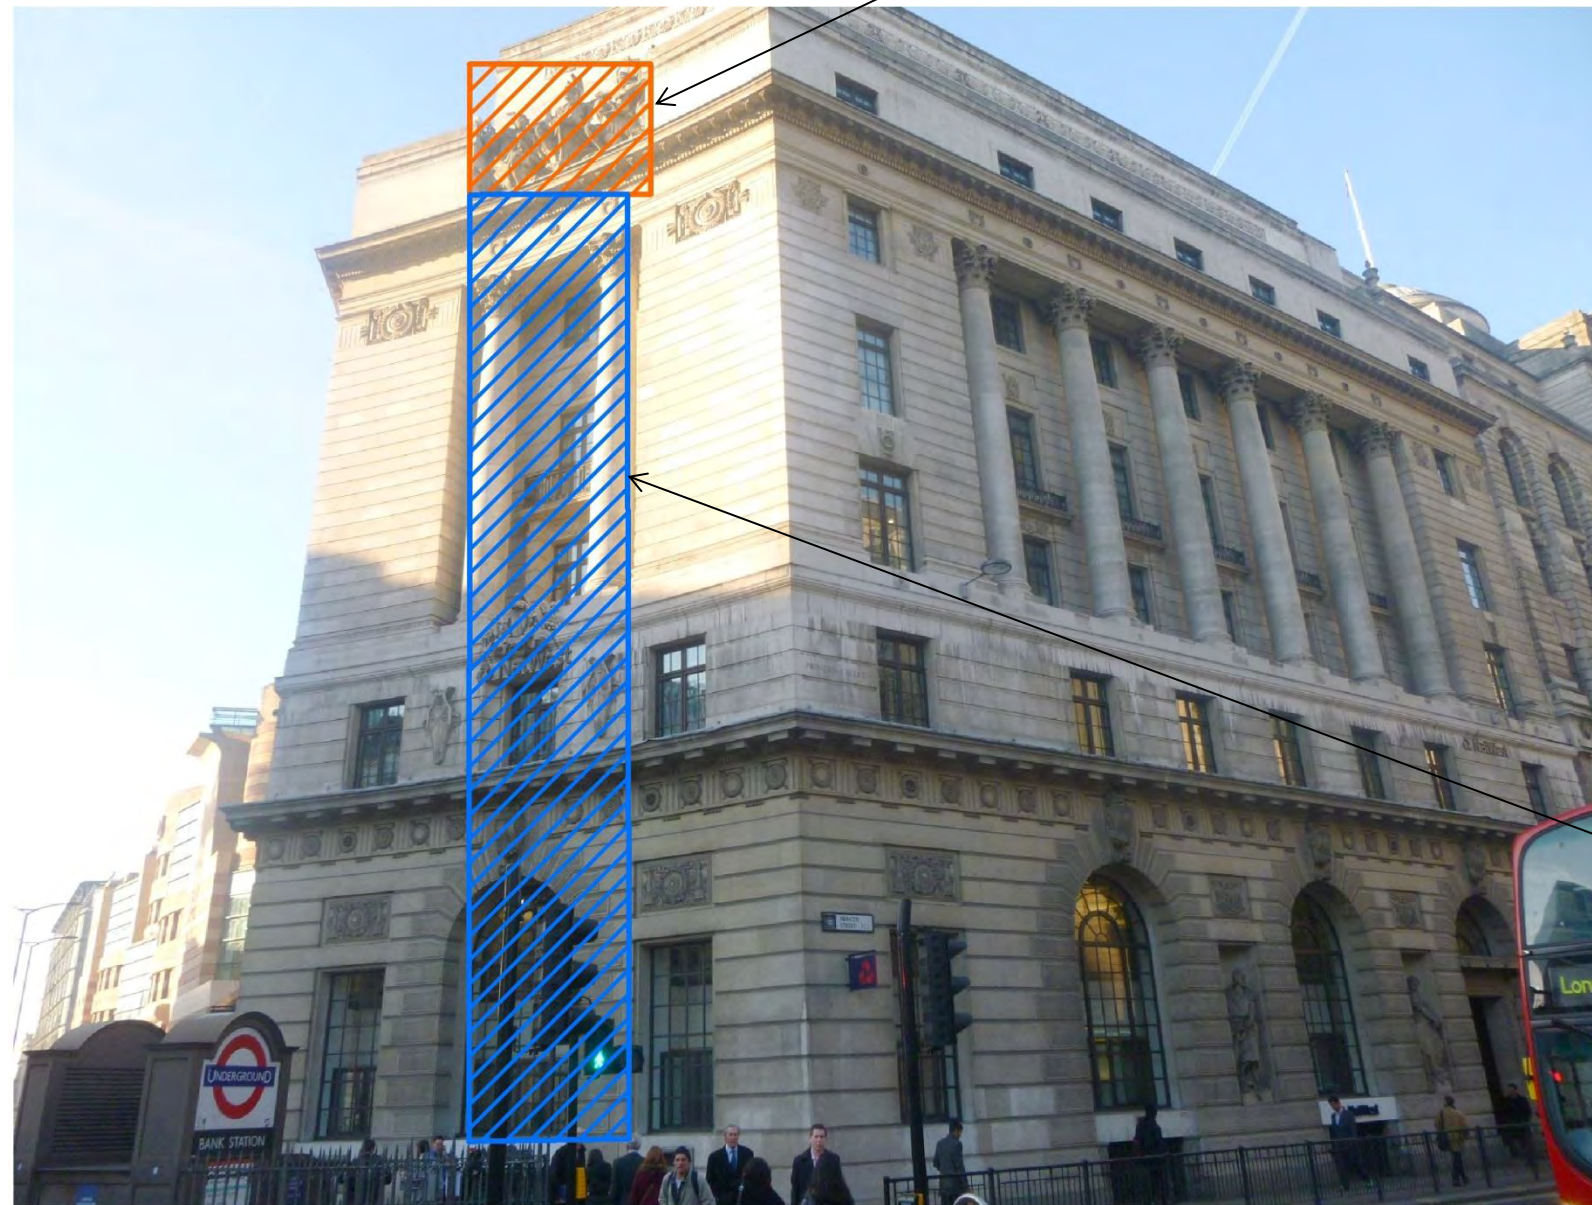
Area where strain is predicted to be concentrated in the event of ground movement to 1 Princes Street
