CLIENT: LONDON UNDERGROUND LIMITED

CONTRACT REF: TLL 7917

NORTHERN LINE EXTENSION

Kennington Green Passive Air Quality Monitoring – Six week report

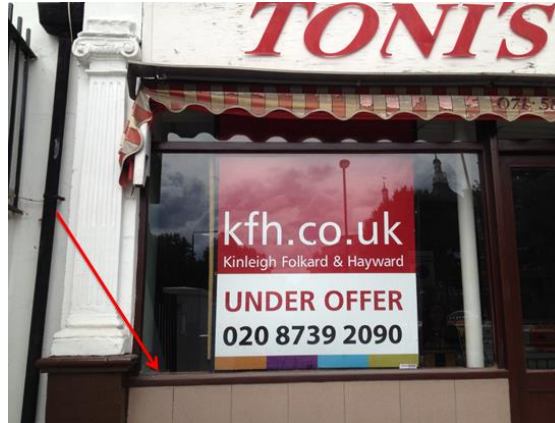
Figure 7 – Glass Slide 3

Glass Slide 3 – GS3

Location: front window of Toni's Café (344 Kennington Road)

Receptor: residents of Kennington Road (North-East NLE worksite)
