# Advanced Stop Line Variations Research Study

## Research Findings

JOB NUMBER: 503 1271			DOCUMENT REF: Findings Report May (2005)			
4	Final (V2)	NR	NG	NG		Oct 05
3	Final	NR	NG	NG		6 May 05
2	Final Draft	NR	NG	NG	IC	28 Apr 05
1	Uncontrolled draft	NG	TL			4 Mar 05
		Originated	Checked	Reviewed	Authorised	Date
Revision	Purpose Description	<b>ATKINS</b>

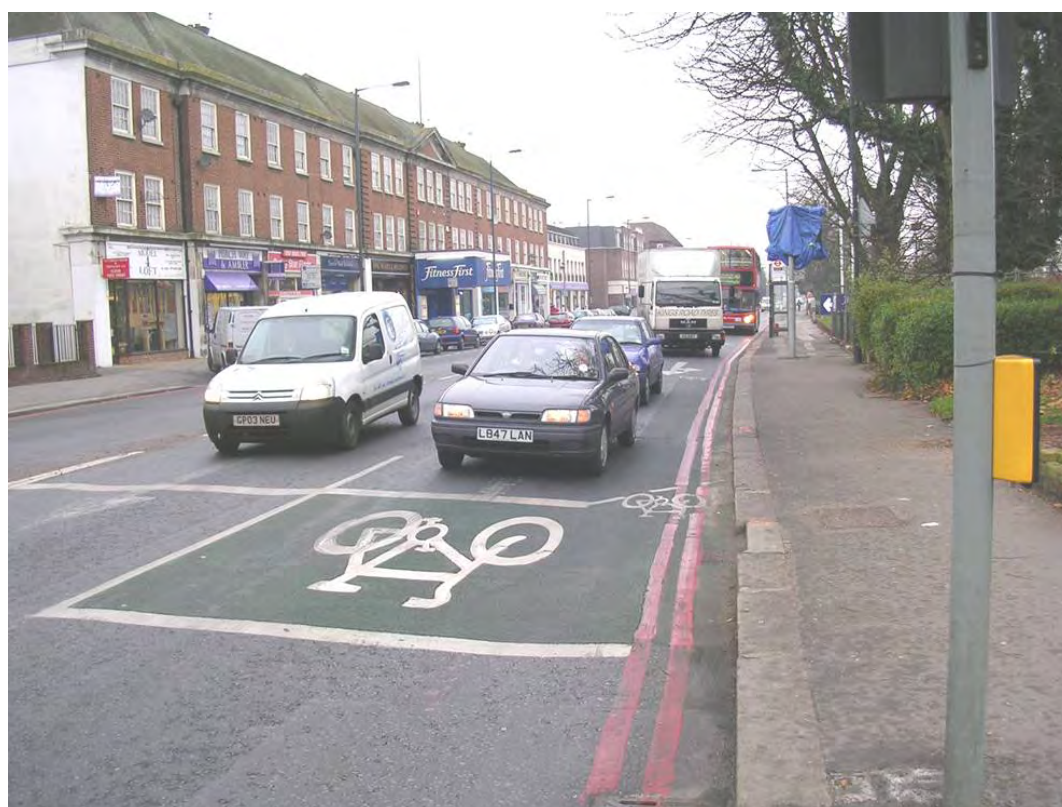
**Figure 5.1 – Photo of Site 1**

- 5.15 The site is the southeast bound approach of a T-junction (the top right bar of the T).
- 5.16 The site has a virtual cycle lane (VCL) and a part-width reservoir (PWR) on the nearside lane.

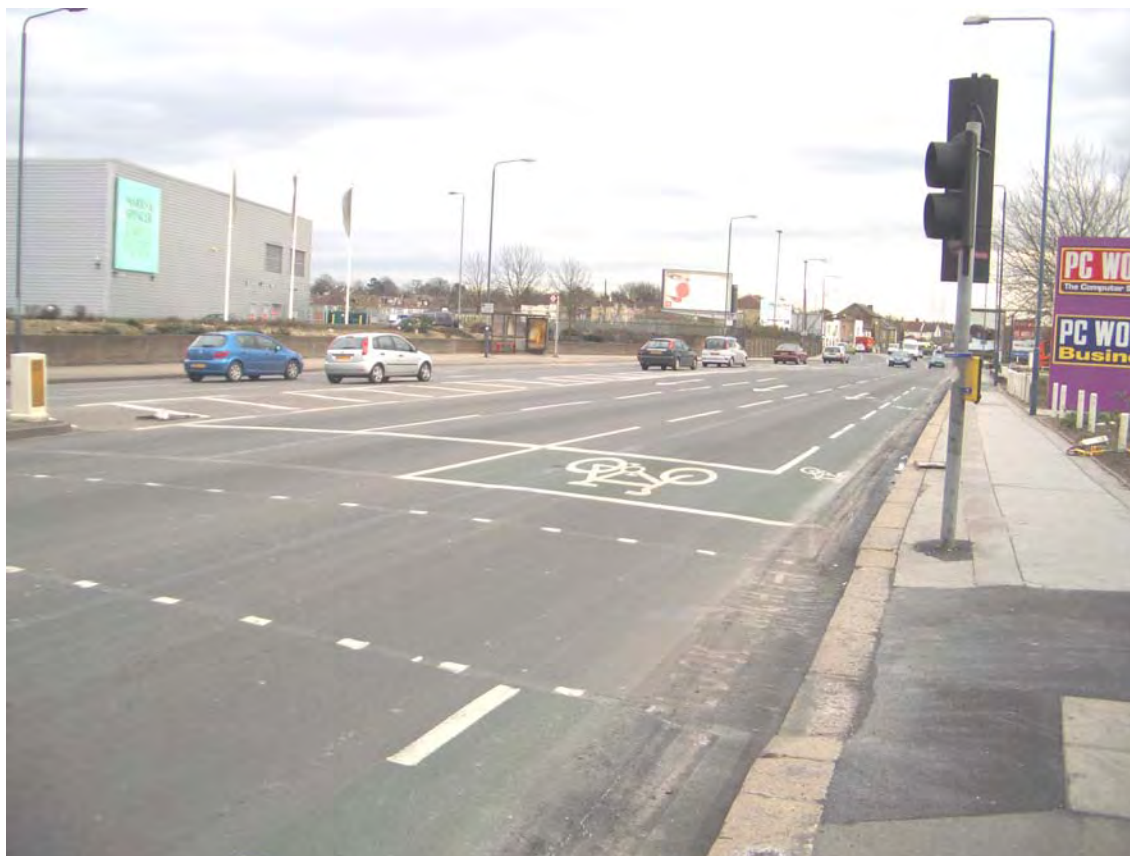
**Figure 5.2 – Photo of Site 2**

- 5.27 This site is the northern approach of a four arm junction. There is a LAJ and a conventional (advisory) feeder lane. Purley Way has three lanes; two are ahead only and one lane is a combined left turn and straight on. Purley Way is a main road.
- 5.28 There is a part-width reservoir (PWR) extending across the first of the three approach lanes.

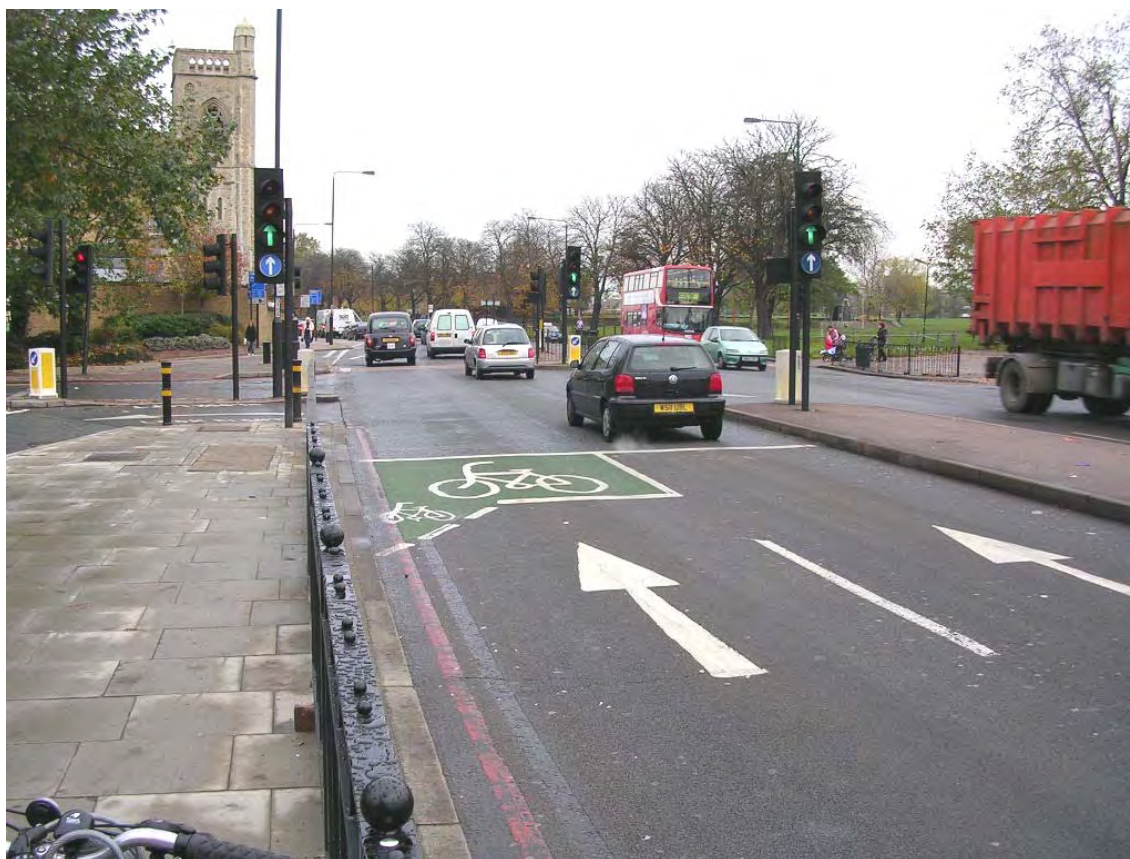
**Figure 5.3 – Photo of Site 3**

5.39 The selected arm was the northern approach (A23) at this four arm junction

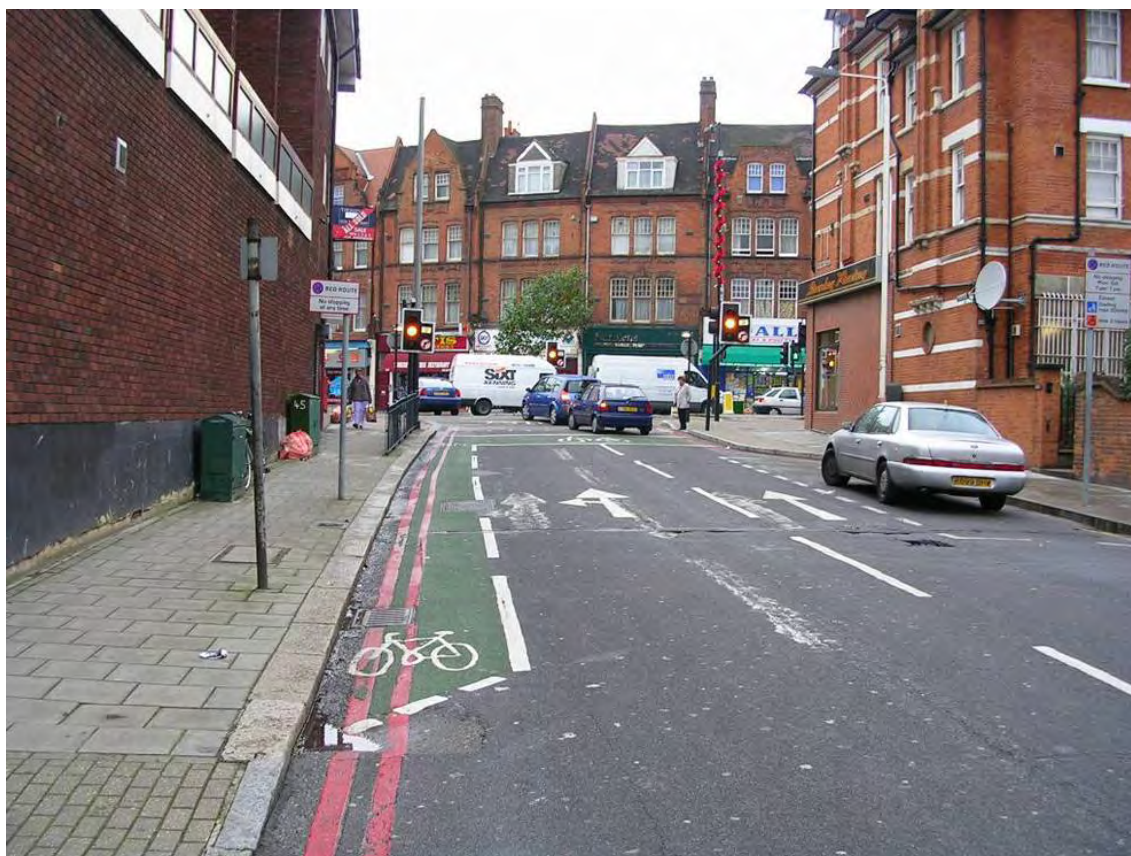
**Figure 5.4 – Photo of Site 4**

5.49 This site was the eastern approach (on a one-way street) of a four-arm junction. There was a standard layout ASL with a conventional (advisory) feeder lane. The junction has yellow box hatching. This approach was the minor road at the junction with the A23.

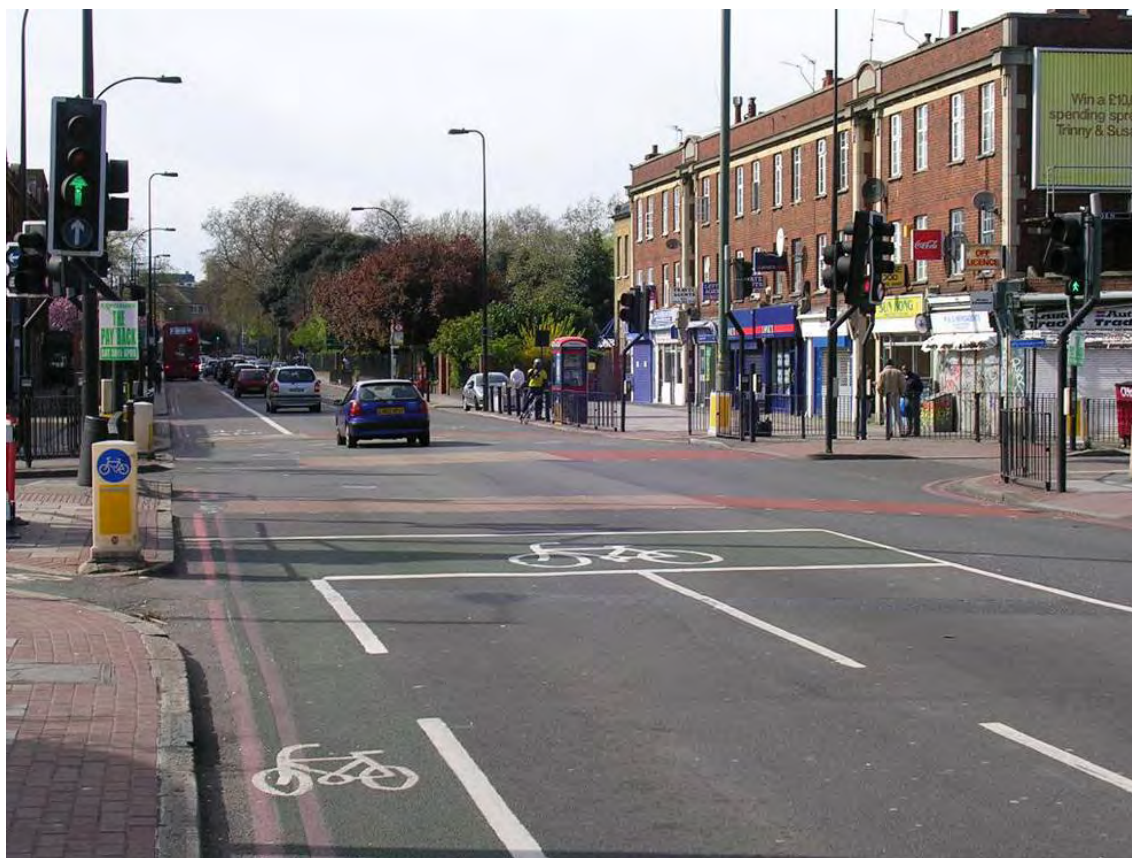
Figure 5.5 – Photo of Site 5

- 5.61 The part of this four-arm junction selected for the study was the south-eastern approach (Camberwell New Road).
- 5.62 The two lane approach had a standard ASL with an advisory feeder lane. The junction had yellow box hatching.
- 5.63 There was a 'no right turn' from the approach and the site was, therefore, intended to act as a control for a PWR.

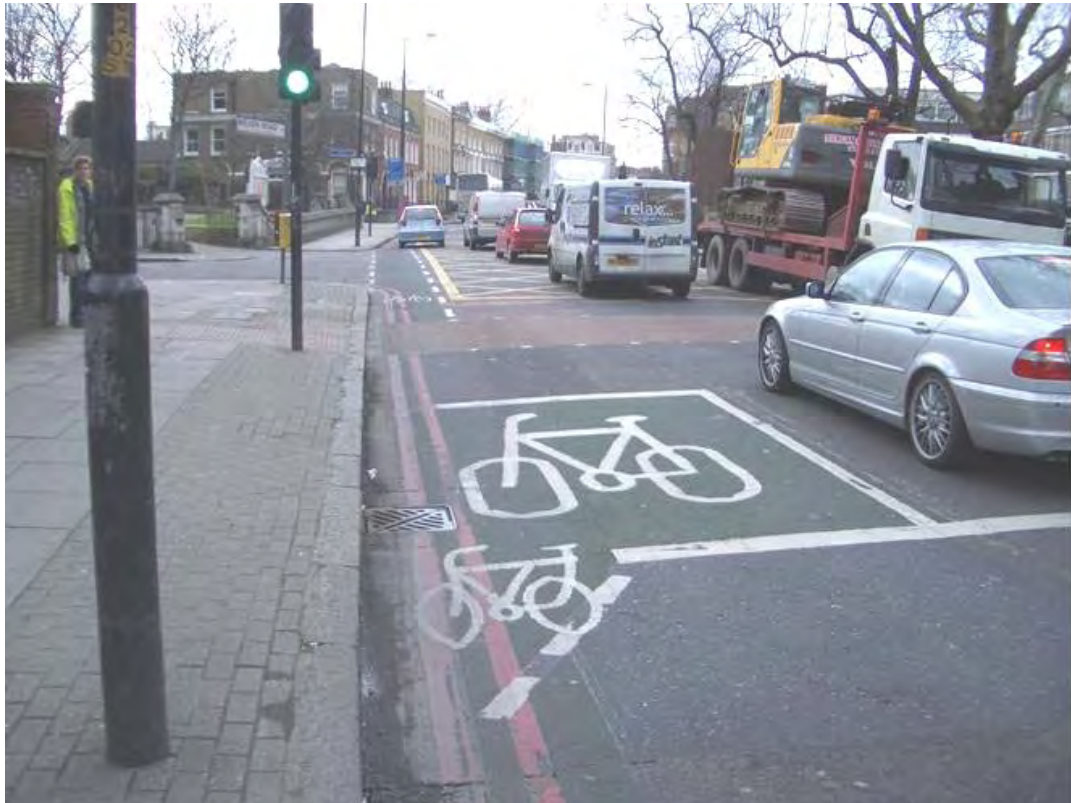
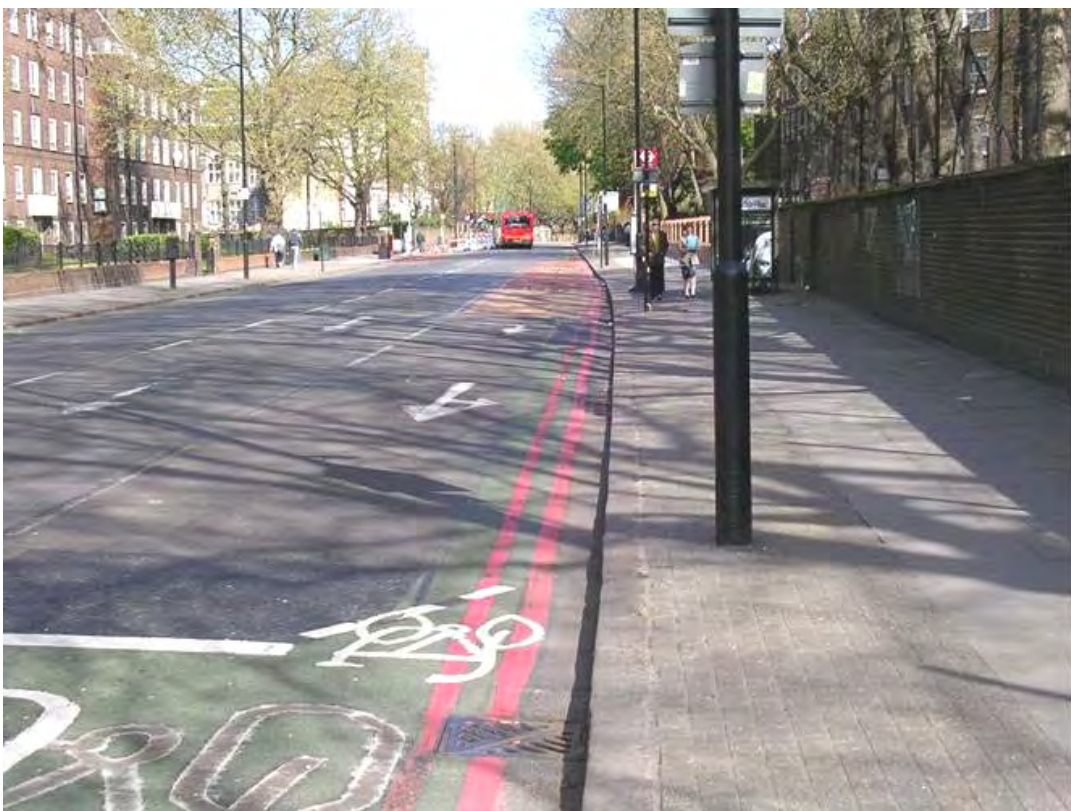
**Figure 5.6 – Photos of Site 6**

- 5.75 The part of this four arm junction selected for study was the two-lane, eastern approach on Peckham Road.
- 5.76 There was a part-width reservoir crossing the nearside lane and a virtual cycle feeder lane. The junction had yellow box hatching.

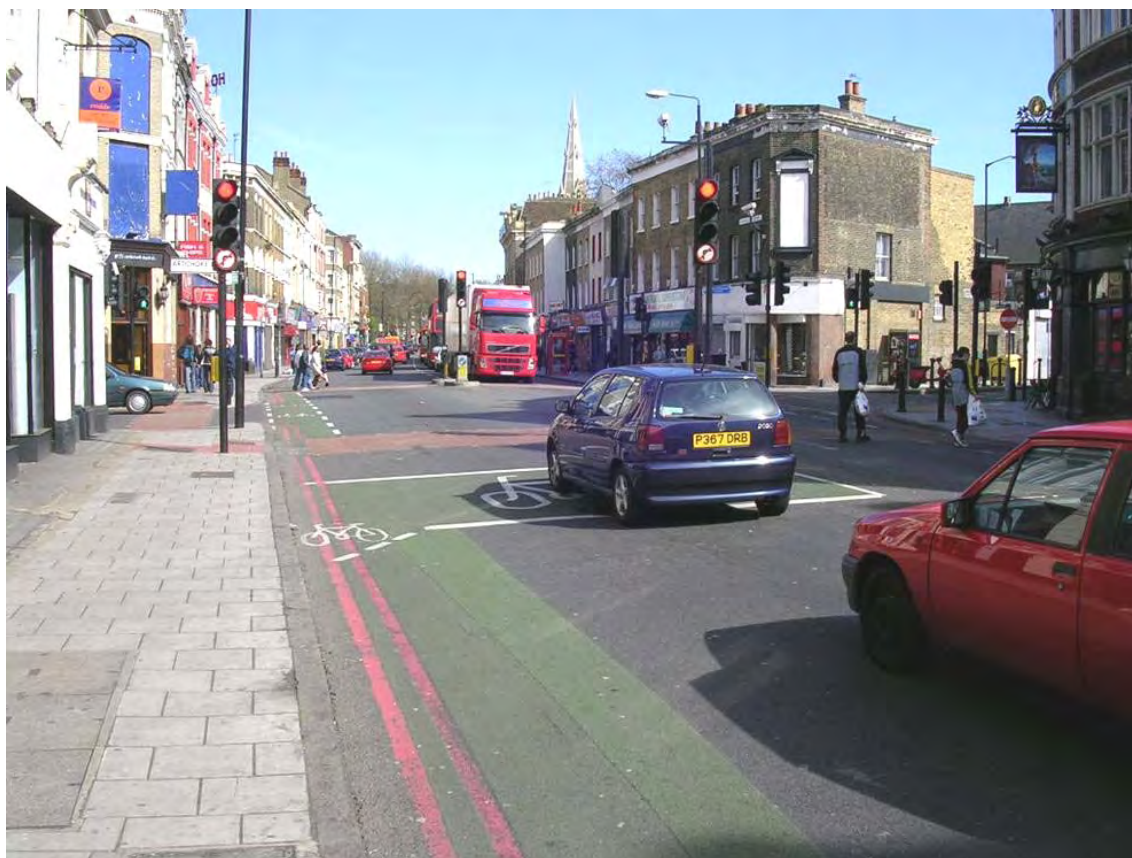
**Figure 5.7 – Photo of Site 7**

- 5.88 This junction had an eastbound single lane approach (which operated as two in busy periods) at a four arm junction. The site has a standard ASL reservoir with a VCL.

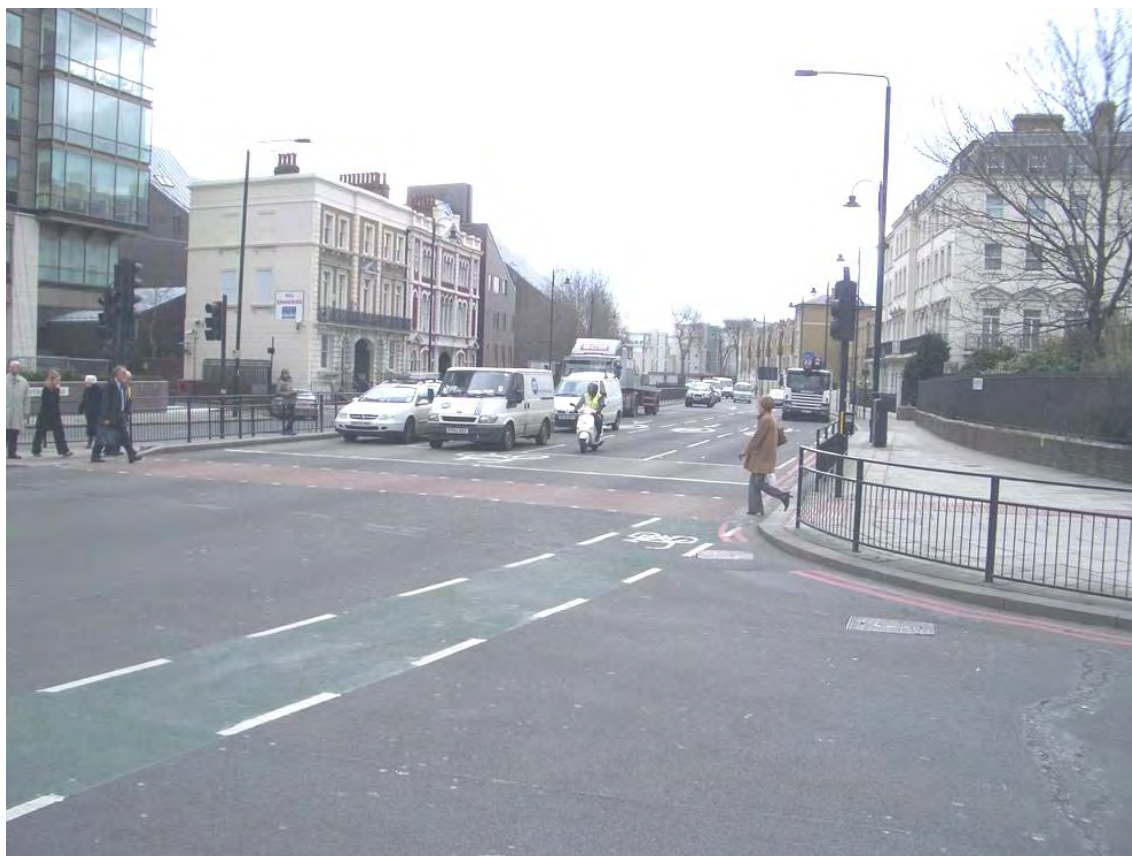
**Figure 5.8 – Photo of Site 8**

- 5.98 The approach selected at this four arm junction (of Vauxhall Bridge Road, Millbank, Bessborough Garden and Grosvenor Road) was the north-east bound approach.
- 5.99 The site has a standard layout ASL reservoir and feeder lane. Vauxhall Bridge Road has four lanes. Lane 1 permits left turn and straight through traffic, lane 2 permits straight ahead, lane 3 permits straight ahead and right turns, and lane 4 permits right turn only. The three through lanes merge into two lanes just after the junction but three rows of traffic sometimes pass through the exit arm pinch point.

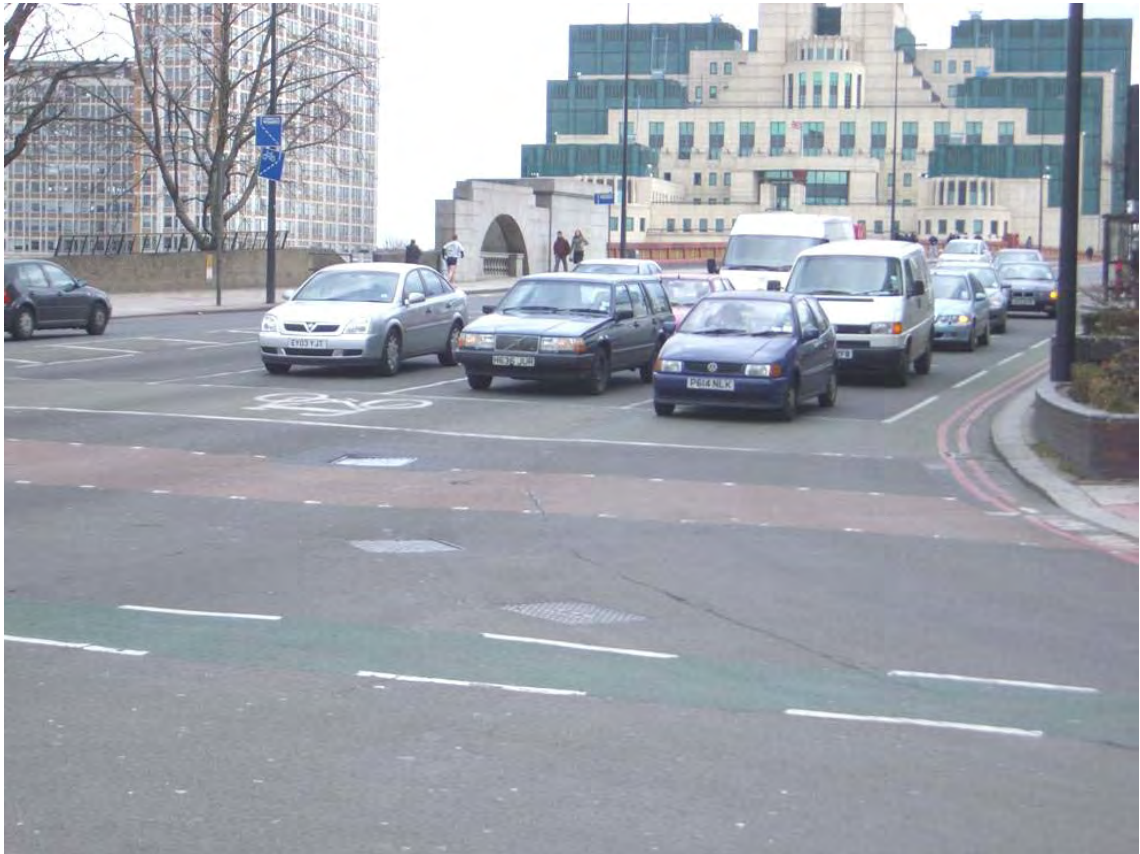
**Figure 5.9 – Photo of Site 9**

- 5.116 The approach selected at this four arm junction (of Vauxhall Bridge Road, Millbank, Bessborough Garden and Grosvenor Road) was the north-west bound approach.
- 5.117 The site has a standard layout ASL reservoir and feeder lane. Vauxhall Bridge Road has four lanes. Lane 1 permits left turn and straight through traffic, lane 2 permits straight ahead, lane 3 permits straight ahead, and lane 4 permits right turn only. There are usually two or three lanes of traffic at the exit arm pinch point.

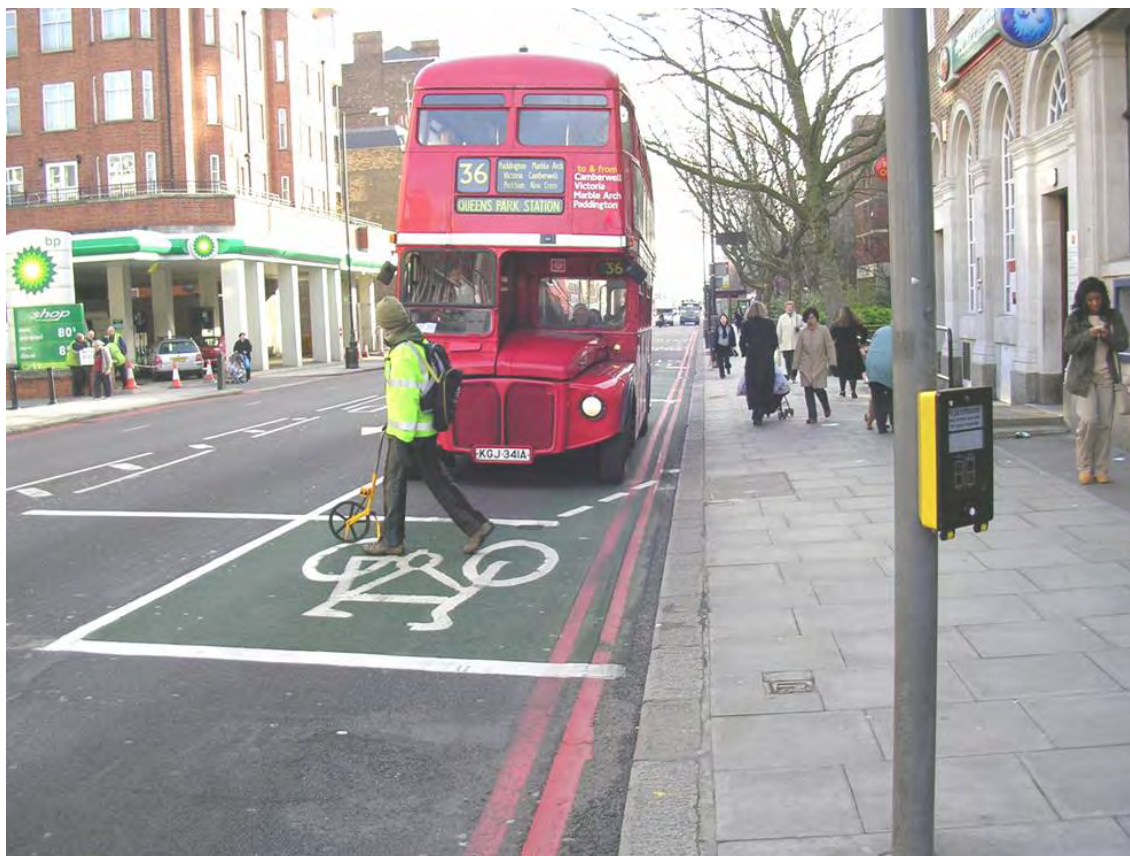
**Figure 5.10 – Photo of Site 10**

- 5.124 The northwest bound approach was selected at this four arm junction of Vauxhall Bridge Road, Rochester Way and Warwick Way.
- 5.125 This site had a part-width reservoir, a virtual cycle lane and a cycle lane across the junction.
- 5.126 The northwest approach, nearside lane, permits left turns and straight ahead movements whilst the offside lane permits straight ahead only. There is no right turn from either direction.
- 5.127 The virtual cycle lane extends back to the bus cage.

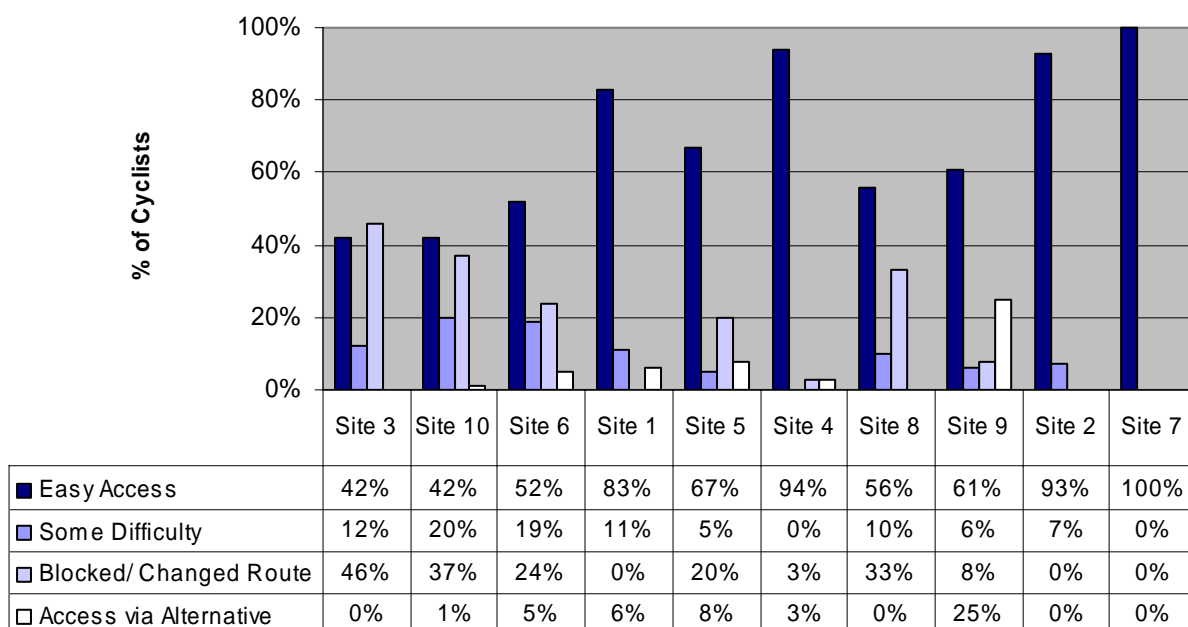
**Figure 7.4 – Reservoir Access**

7.36 Figure 7.4 indicates that ease of access increases with lane width. The standard feeder lane sites (2,4,5,8,9) all performed relatively well. The two virtual feeder lane sites which also provided high levels of easy access (1,7) both had relatively generous dimensions.

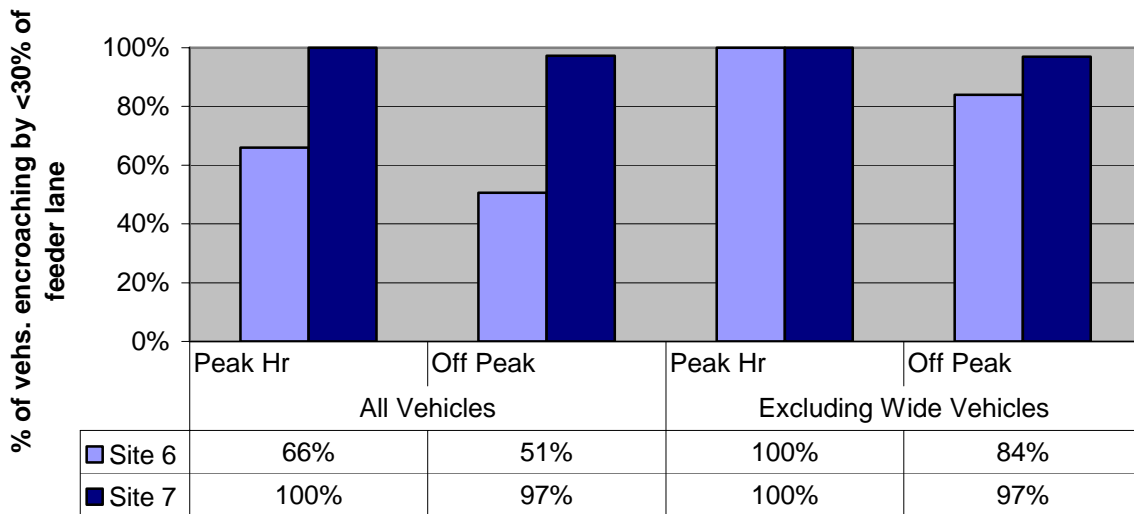
**Figure 7.5 – Vehicles Encroaching by ≤ 33% of the Feeder Lane Width at High Cycle Flow Sites**

7.37 Sites 7 and 6 were selected for testing this assumption. These sites were selected because they both have VCLs and high cycle flows during peak periods and are of similar width. A summary of the results can be seen in Figure 7.5.

7.38 Figure 7.5 shows that, for the sites involved, fewer vehicles encroached on the feeder lane during the off peak periods.

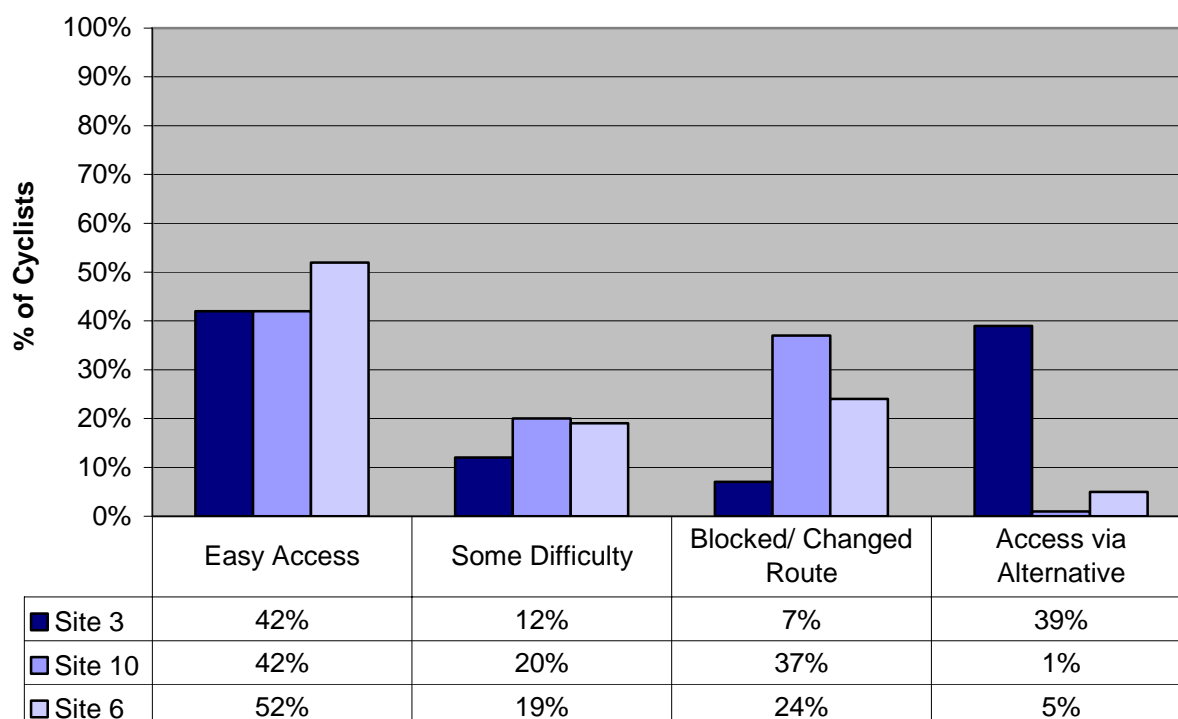
**Figure 7.7 – Comparing ‘Ease of Access’ Between Gated and VCL Sites**

7.55 This assumption can be tested using the 'ease of access' data for Site 3, which has a lane width of 3.0m, and comparing it with Sites 10 and 6, which have similar lane widths of 3.0m and 3.1m respectively. This is shown in Figure 7.7.

7.56 Figure 7.7 indicates that the access by gate was considered to be ‘easy’ at a similar frequency as the VCL sites. However, it can be seen that 39% of cyclists at the gate site (3) accessed the reservoir by an alternative route compared with up to 5% at the two VCL sites. With no formal feeder lane and restricted lane widths preventing access to the reservoir at Site 3, many cyclists left the carriageway and approached the junction on the footway.

7.57 Based upon the data comparing the gate site with two VCL sites of similar width, it appears that access by gate is not as easy as by VCL. In other words, the VCLs appear to provide a key advantage over the gate entries in enabling the cyclists to reach the front of the queue.
