**CLIENT: LONDON UNDERGROUND LIMITED**

**CONTRACT REF: TLL 7917**

**NORTHERN LINE EXTENSION**

## **Kennington Green Passive Air Quality Monitoring – Monthly report**

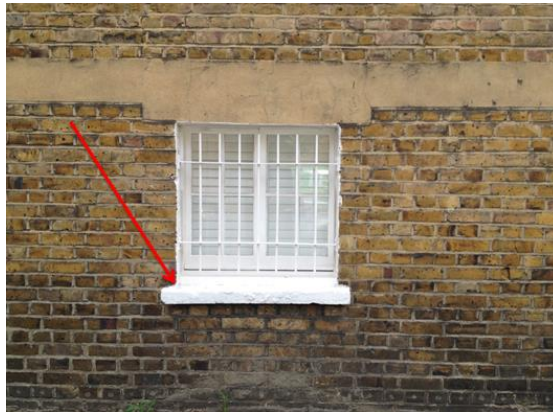
*Figure 4 – Glass Slide 1*

| GLASS SLIDE RESULTS | | | |
|---|---|---|---|
| GS1 | <50 | 32.9 | N |

| GLASS SLIDE RESULTS | | | |
|---|---|---|---|
| GS1 | <50 | 8.9 | N |

**Location:** front window of 3 Montford Place

**Receptor:** residents of Montford Place

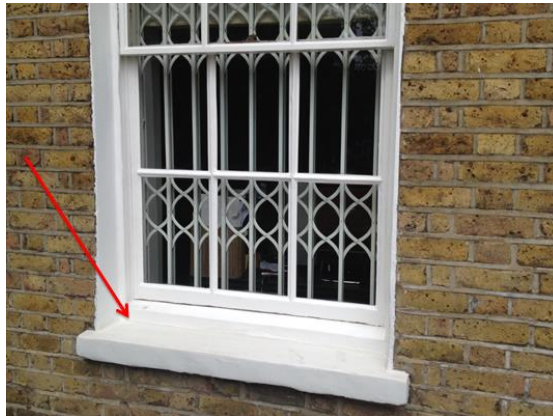
*Figure 5 – Glass Slide 2*

| GLASS SLIDE RESULTS | | | |
|---|---|---|---|
| GS2 | <50 | 10.4 | N |

| GLASS SLIDE RESULTS | | | |
|---|---|---|---|
| GS2 | <50 | 5.4 | N |

**Location:** front window of 350 Kennington Road

**Receptor:** residents of Kennington Road (North NLE worksite)

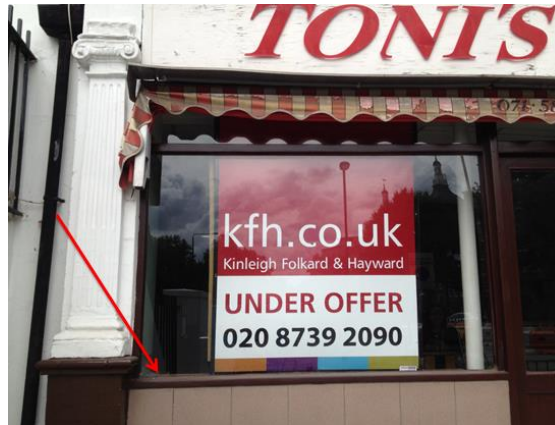
Figure 6 – Glass Slide 3

| GLASS SLIDE RESULTS | | | |
|---|---|---|---|
| GS3 | <50 | 11.0 | N |

| GLASS SLIDE RESULTS | | | |
|---|---|---|---|
| GS3 | <50 | 9.6 | N |

**Location:** front window of Toni's Café (344 Kennington Road)

**Receptor:** residents of Kennington Road (North-East NLE worksite)

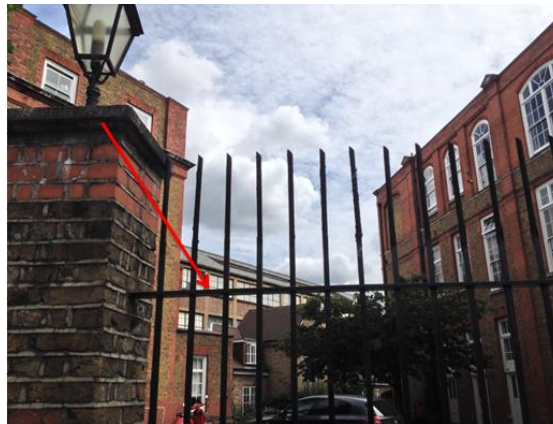
Figure 7 – Glass Slide 4

| GLASS SLIDE RESULTS | | | |
|---|---|---|---|
| GS4 | <50 | 34.2 | N |

| GLASS SLIDE RESULTS | | | |
|---|---|---|---|
| GS4 | <50 | 14.4 | N |

**Location:** car park fence of 1 Stannary St

**Receptor:** residents of Kennington Road (East NLE worksite)

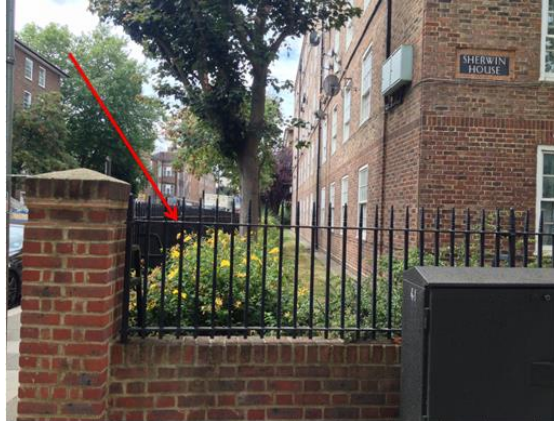
*Figure 8 – Glass Slide 5*

| GLASS SLIDE RESULTS | | | |
|---|---|---|---|
| GS5 | <50 | 41.9 | N |

| GLASS SLIDE RESULTS | | | |
|---|---|---|---|
| GS5 | <50 | 10.3 | N |

**Location:** street fence of Sherwin House

**Receptor:** residents of Sherwin House
