**PUBLISHED PROJECT REPORT
PPR984**

The Transport for London Bus Safety
Standard: Pedal Application Error
Prevention & Recovery

Evaluation of Safety Measure

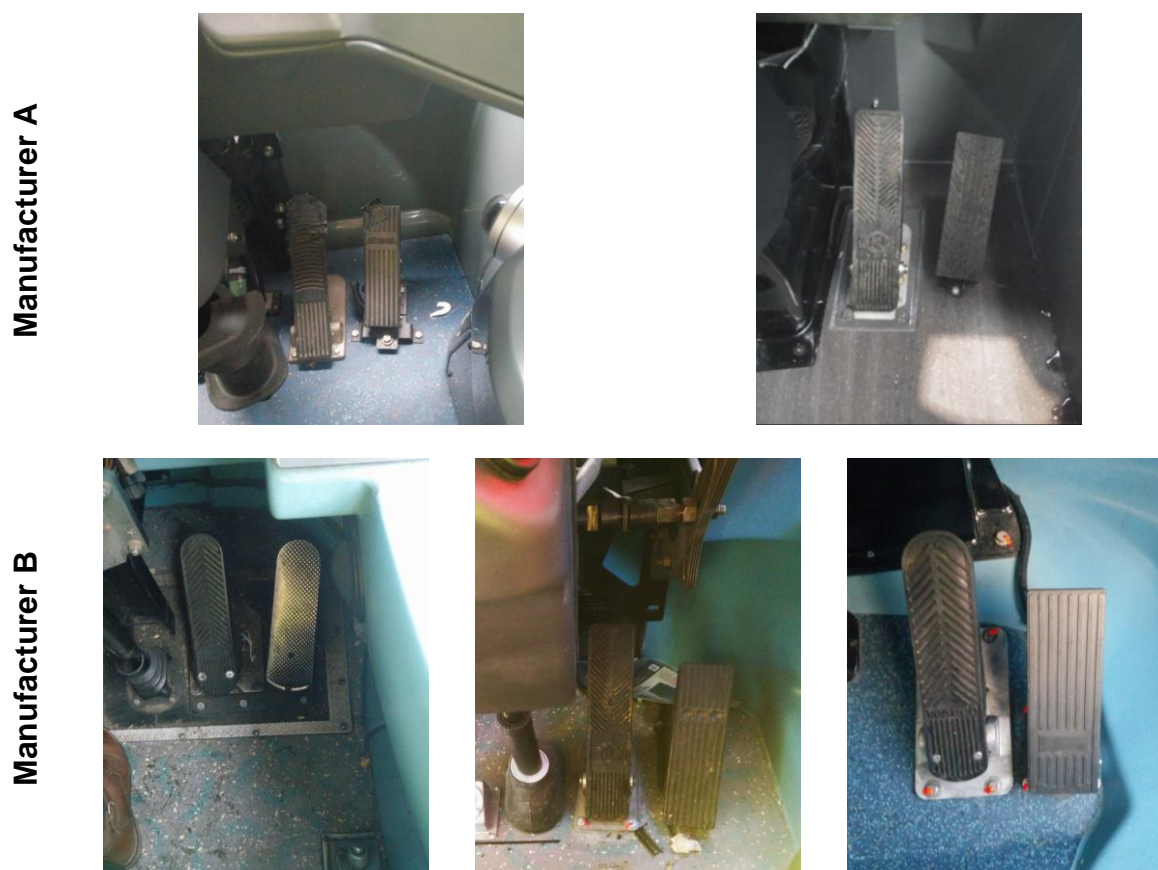
A visit at a Bus Operator's Depot enabled the review of existing pedal configurations of two buses from different manufacturers currently operating in London. This review showed that the braking and accelerator pedals were very similar in size, shape and location from one bus model to another (see Figure 3).

Figure 3: Two pedal configurations from Manufacturer A (top) – Three pedal configurations from Manufacturer B (bottom)

Most of the pedals are treadle type pedals (in difference with most automobile pedals which are pendulum types⁶). This level of similarity (pedal size and type) between brake and accelerator pedals may reduce drivers' ability to differentiate them using haptic feedback, although the most significant cues are the pedal feel (force) and position (direction and curvature of the movement to press on a pedal) according to Lococo et al. (2012). In terms of pedal positioning there was an example with the

Only one difference in pedal shape could be noted on one bus model (Manufacturer B), on which the accelerator pedal presents a heel stop (highlighted in red on Figure 2). This pedal type supposes that the driver presses the accelerator pedal with the heel positioned on the heel stop, in comparison with the treadle type on which the driver's heel is placed on the floor of the cab.

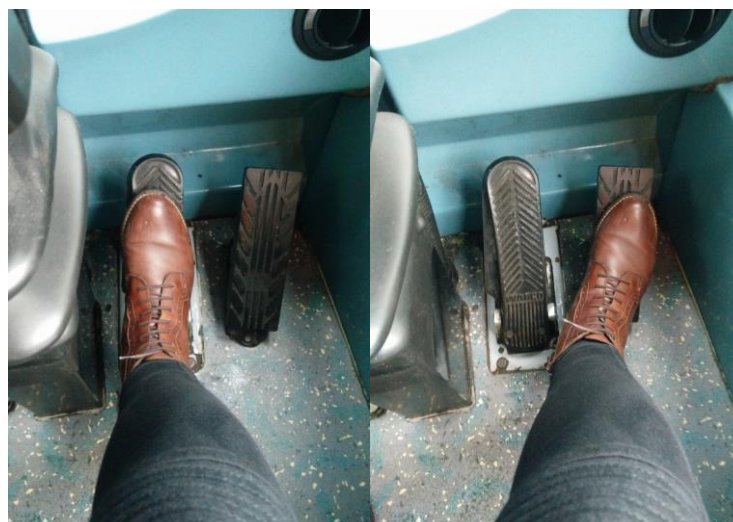
In regards of the lower-body movements, similar observations were gathered on both bus models. In order to operate the accelerator pedal while the right foot is being placed on the brake pedal, the driver has to move the entire leg with a rotation (a foot/ankle rotation is not sufficient to press the accelerator pedal when the foot is initially placed on the brake pedal). This means that if we consider a driver correctly seated (facing the road, seat correctly adjusted to the heel points) a large amplitude movement of the upper body will be required to move from one pedal to another (see Figure 5 and Figure 6), thus helping with the distinction of the two pedals (positioning cues introduced in section 4).

Figure 5: Bus from Manufacturer A – pedal configuration and leg movement

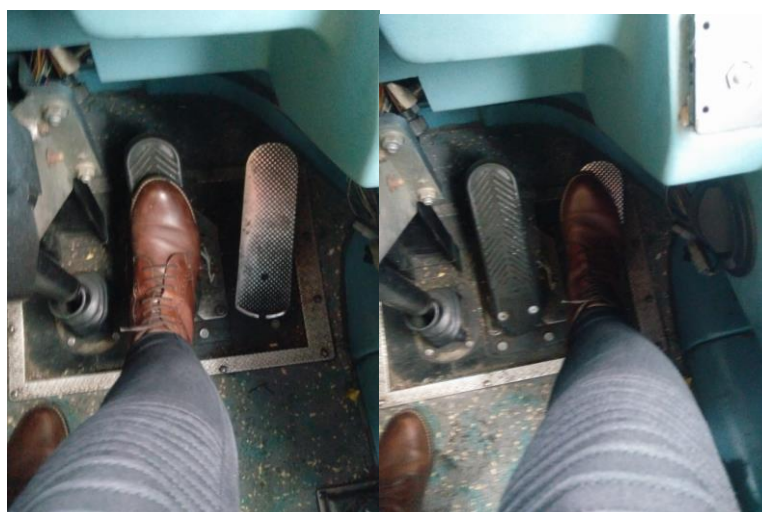
Figure 6: Bus from Manufacturer B – pedal configuration and leg movement

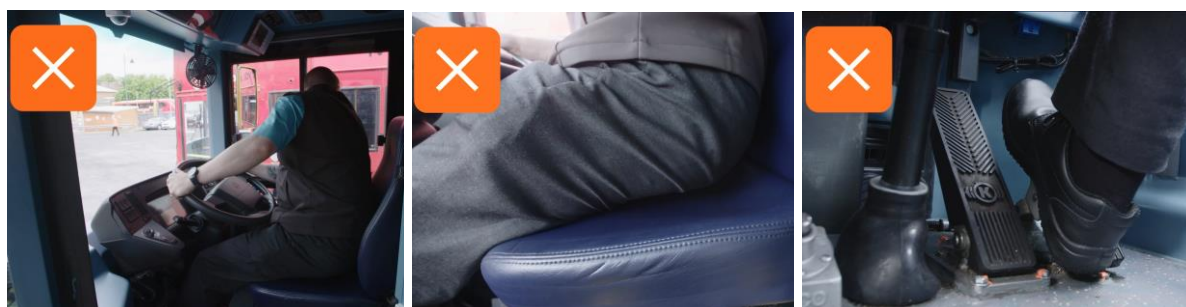
- The first time (see Figure 7), the driver is seen leaning and twisting the upper body part while lifting his left thigh to facilitate the blind spot check, leading to an entire rotation of the right leg on to the accelerator pedal (the misalignment of the body required for the blind spot check involves an unintended rotation of the left thigh which generates an "automatic" rotation of the right leg)

Figure 7: Arriva training video on pedal application error – impact of upper body movements on lower body parts when checking the blind spots

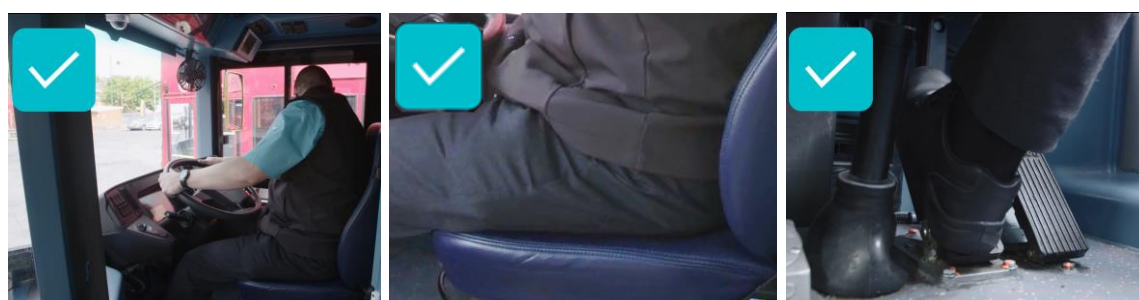
- The second time (see Figure 8), the driver is seen leaning and twisting the upper body part without lifting his left thigh, keeping his foot on the brake

Figure 8: Arriva training video on pedal application error – impact of upper body movements on lower body parts when checking the blind spots

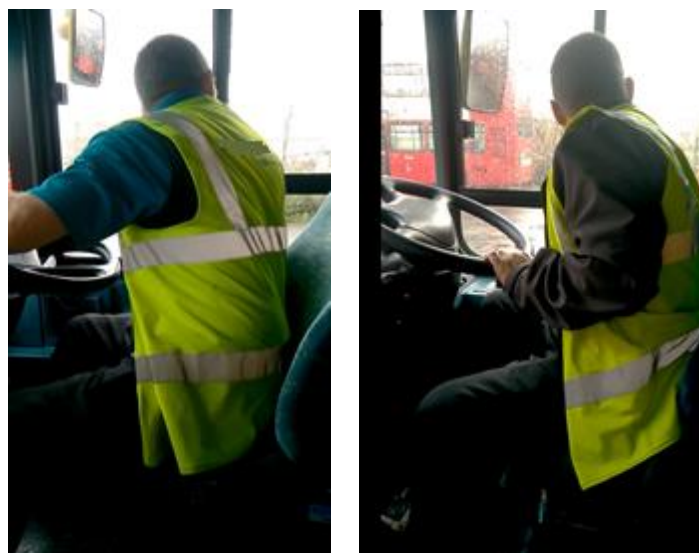
In order to check the frequency and level of body movements required for the blind spot checks, a site visit was conducted in a Bus Depot. Three bus models from three different manufacturers were reviewed with a driver, demonstrating the driving positions to check the right hand side blind spot (see Figure 9).

Figure 9: Review of upper/lower body movements while checking the right blind spot area - from left to right Manufacturer A, B (C not shown)

- The upper-body movements involve both leaning forward and twisting from the seat backrest on all bus models
- The angles observed between the seat backrest and the driver's back are quite significant, making it obvious that the driver cannot check blind spots without performing such movements of considerable amplitude (blind spot checks cannot be performed by rotating the head and shoulders only)
- These movements generate a lot of body displacements in the lower body parts, thus potentially causing body misalignment and pedal error

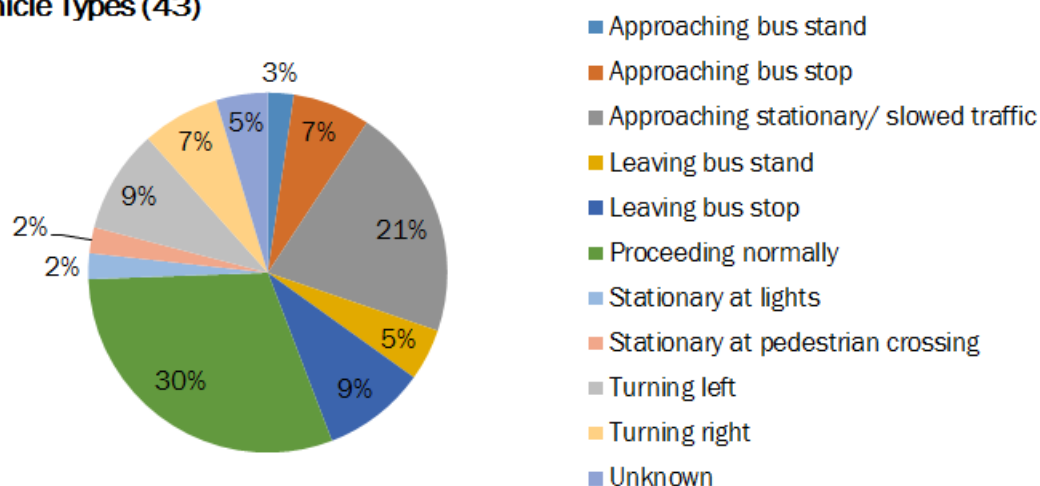
Figure 10: Bus driving manoeuvres performed in pedal application error incidents (Source: TfL)

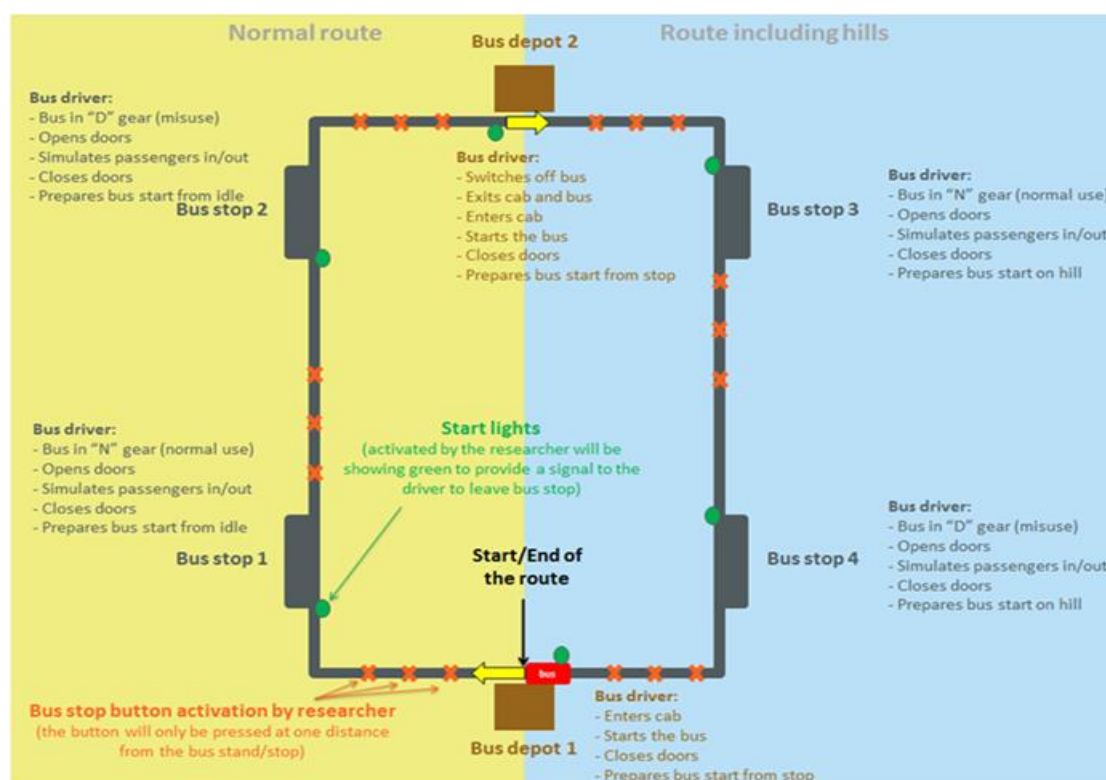
A section of the Alpine Route at the Millbrook test track was used for the trial, comprising a 'hilly' steep and a flat route section (see Figure 11). There were four simulated bus stops, two of which were on the steep route section and the other two were on the flat section of the route. A bus depot was simulated within the flat section of the route.

Figure 11: Driving route used during the user trial

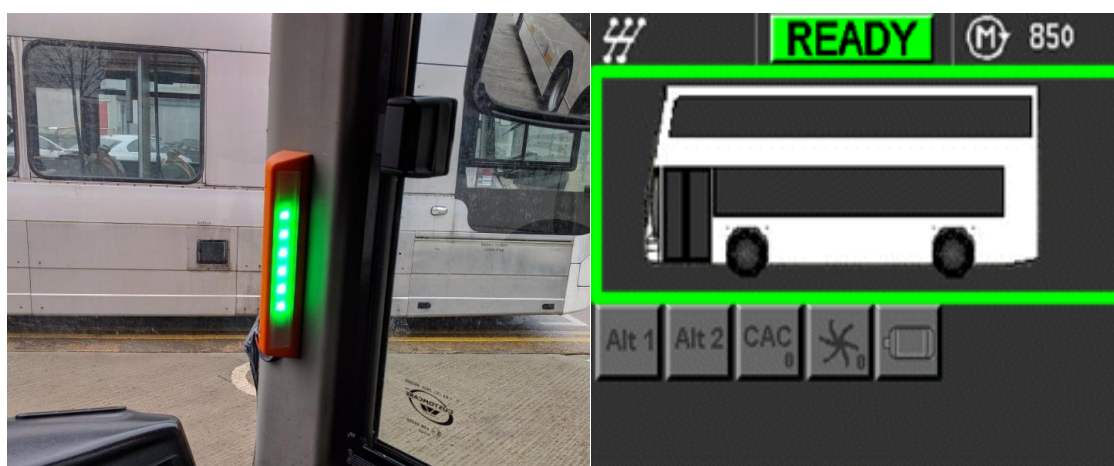
The test bus was equipped with the prototype system that consisted of a brake toggling solution and a brake/accelerator light indicator solution. The brake toggling solution consisted of a change to the interlock system that required the drivers to press the brake pedal before the accelerator pedal in order to deactivate the halt brake and move the bus from being stationary. The brake/accelerator light indicator solution (see Figure 12) consisted of adding an additional set of lights to the A pillar, as well as using a strip of pixels surrounding the bus icon on the LCD dashboard screen. When the brake pedal was pressed the lights turned red and when the accelerator pedal was pressed the lights turned green. When neither of the pedals was being pressed the lights did not activate.

Figure 12: Brake/Accelerator light indicator solution

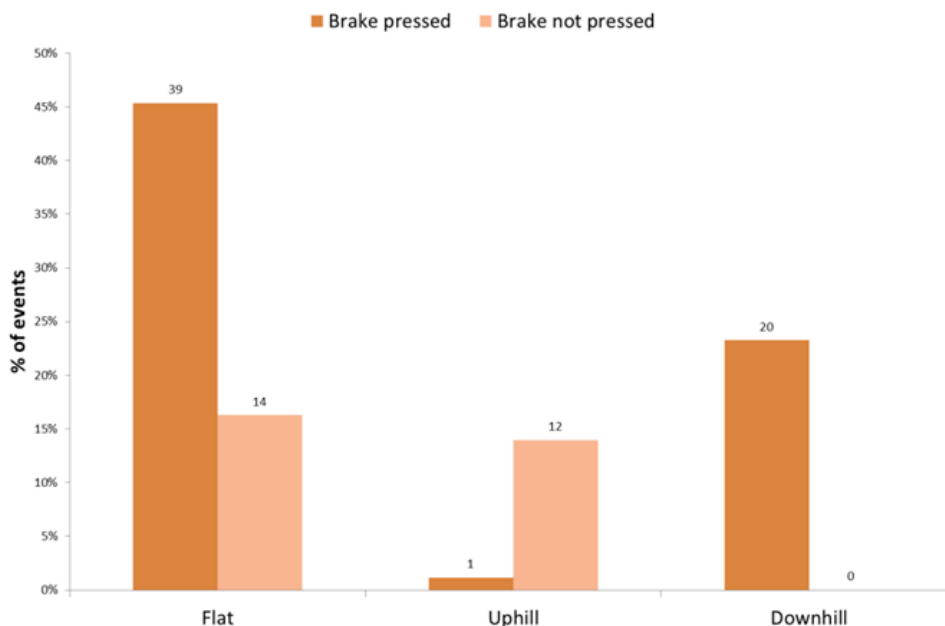
In most cases (95%, $n= 81$) the drivers' foot was on the accelerator when they heard the bus stop bell. One participant was already pressing the brake pedal and four were covering the brake pedal. As the aim of this task was to explore the time taken to move foot from the accelerator to the brake pedal, and the time taken to actually press the brake pedal after hearing the bus stop bell, the event where the participant was already braking was excluded from further analyses.

Figure 21: Use of the brake pedal (& not) to slow down according to road type

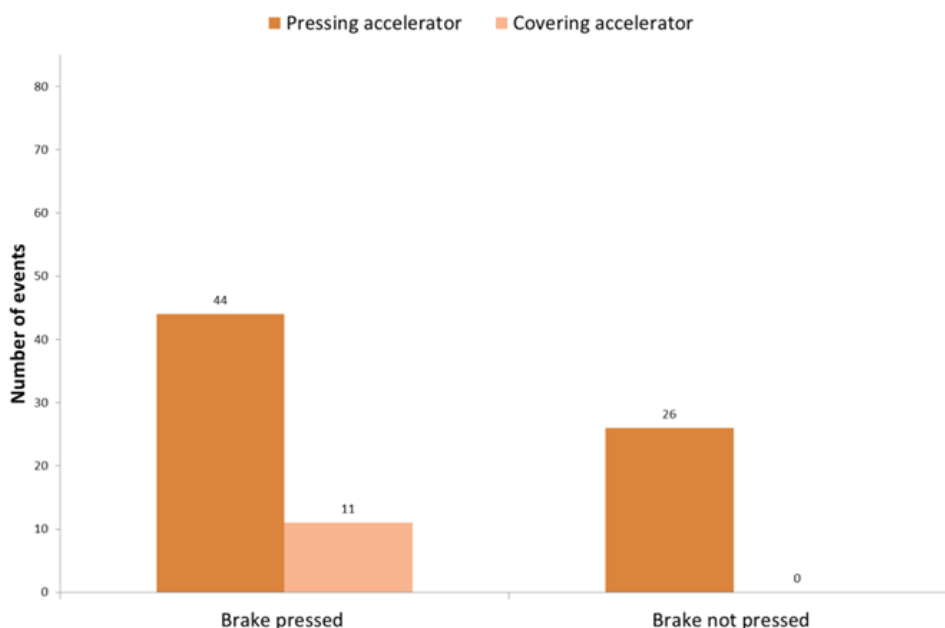
Not surprisingly all four participants whose foot was already covering the brake pedal (without pressing it) were driving downhill. During the majority of the events (86%) drivers were already pressing the accelerator when they heard the bus stop bell and more than half of them (63%) subsequently used the brake to slow down (see Figure 22). For a small number of events (n= 11) drivers were just covering the accelerator when they heard the bus stop bell and all of them subsequently used the brake to slow down.

Figure 22: Use of brake pedal (& not) to decrease speed for drivers whose foot was pressing or covering the brake pedal when the bus stop bell activated

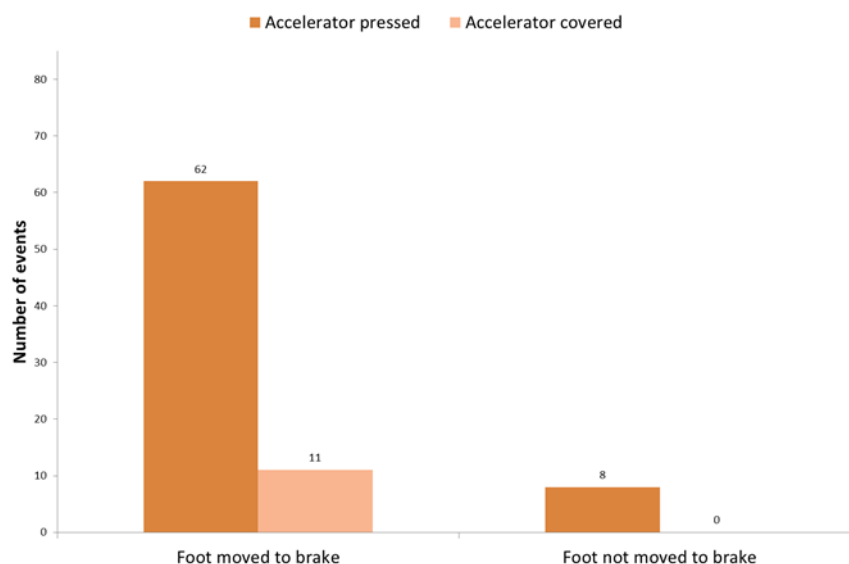
Independently of whether drivers were pressing or covering the accelerator, the large majority moved their foot to the brake after they heard the bus stop bell (see Figure 23), even though in 32% of the cases they didn't need to apply the brake to slow down (see Figure 22). Of those who were pressing the accelerator when the bus stop bell activated, only eight drivers never moved their foot to the brake pedal (see Figure 23).

Figure 23: Foot movement after bus stop bell press according to its initial position

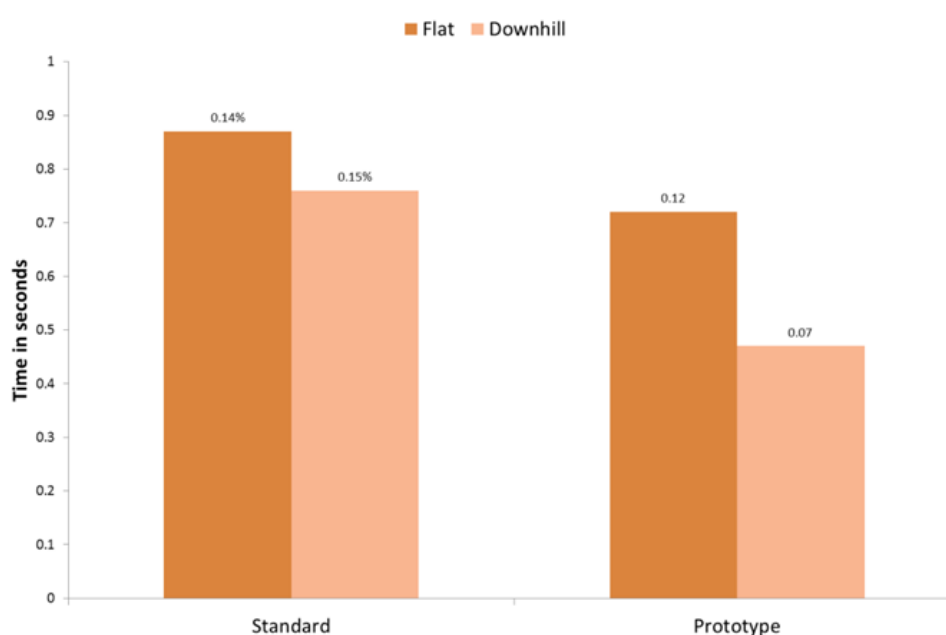
Looking at differences in the time spent covering the accelerator before moving foot to the brake pedal, the results suggest that drivers tend to move their foot faster while driving in prototype mode than while driving in standard mode. However, these differences were not statistically significant for this sample. As can be seen in Figure 25, participants took around four fifths of a second (0.79 seconds) to move their foot from the accelerator when driving in standard mode downhill, whereas when driving in prototype mode and downhill it took them on average 0.47 seconds. The same figure also shows the length of covering the accelerator in terms of percentage of the overall event time (i.e. time taken to slow down by 5mph), suggesting again that when driving downhill in prototype mode drivers spent a small proportion of time on the accelerator before moving their foot to the brake pedal.

Figure 25: Period of time covering the accelerator before moving foot to the brake pedal

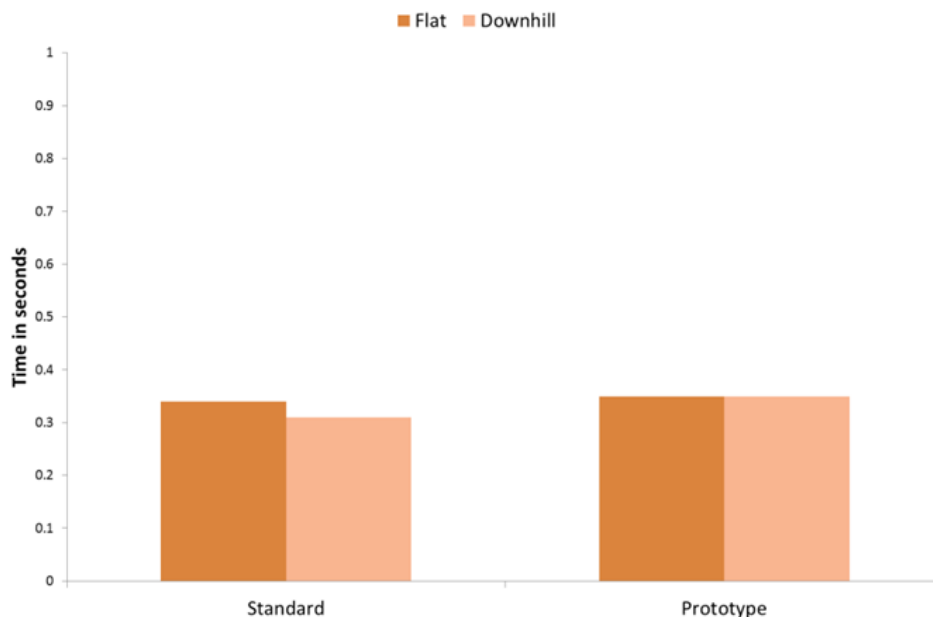
Analysis of the time taken to move the foot from the accelerator to the brake pedal did not show any significant differences between experimental conditions. As can be seen in Figure 26 it took drivers about one third of a second to find the brake pedal after moving their foot from the accelerator.

Figure 26: Average time taken to move foot from the accelerator to the brake pedal (before pressing it)

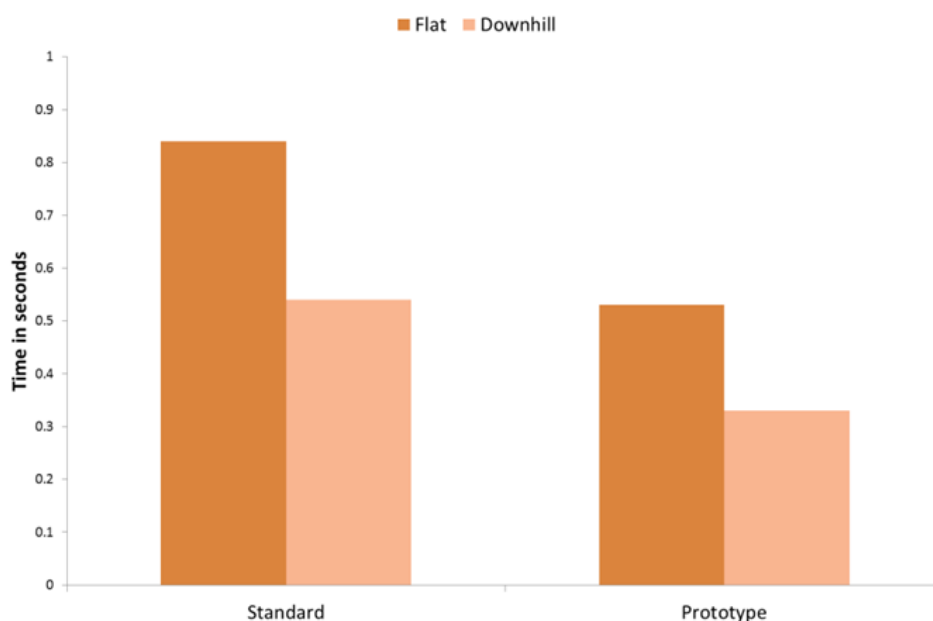
Finally we examined the time taken after drivers' foot was covering the brake pedal before actually pressing it. Again, no statistically significant differences were found even though as can be seen in Figure 27 below, drivers apparently spent longer covering the brake before pressing it when in standard mode for both flat and downhill route sections, compared with when driving in prototype mode. The small sample size in this study need to be taken into account when considering this apparent lack of any significant difference.

Figure 27: Average time covering brake pedal before pressing it for first time

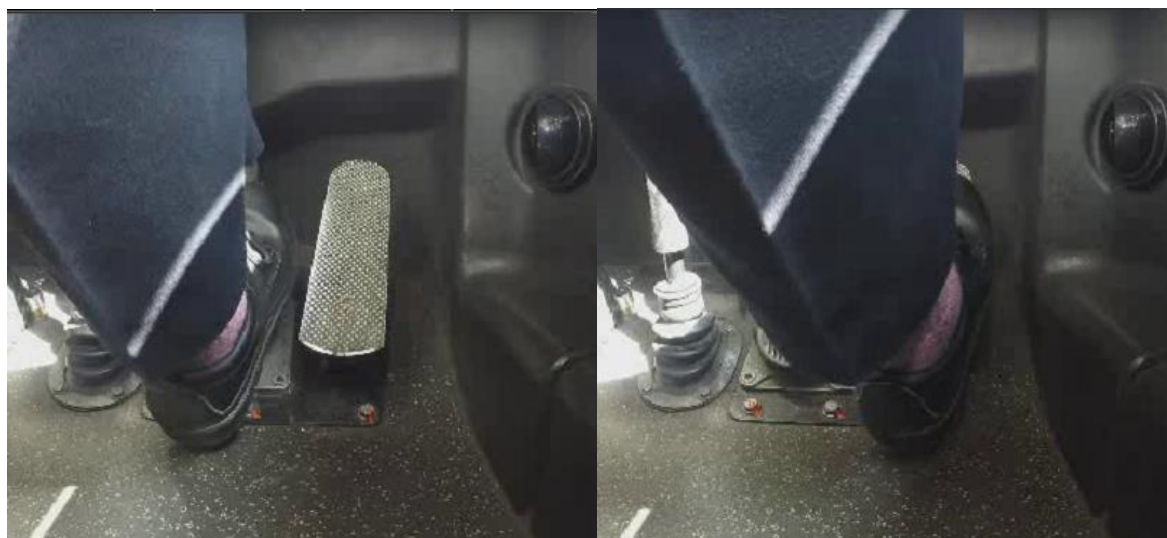
A potentially important observation from the user trial was the difference in how drivers positioned their foot when using the brake and accelerator pedals, and the potential impact this has on the likelihood of pedal application error incidents taking place. While some drivers placed their foot in line with the pedals, other drivers angled their foot in such a way that it was sometimes over both pedals simultaneously. This effect may be due to biomechanical differences between the drivers, experience driving buses with certain pedal layouts, as well as differences in training. Figure 29 provides an example of a driver who kept their foot positioned in-line with the pedals. Figure 30 provides an example of a driver who kept their foot positioned across the pedals.

Figure 29: In line foot placement with the brake (left) and accelerator (right)

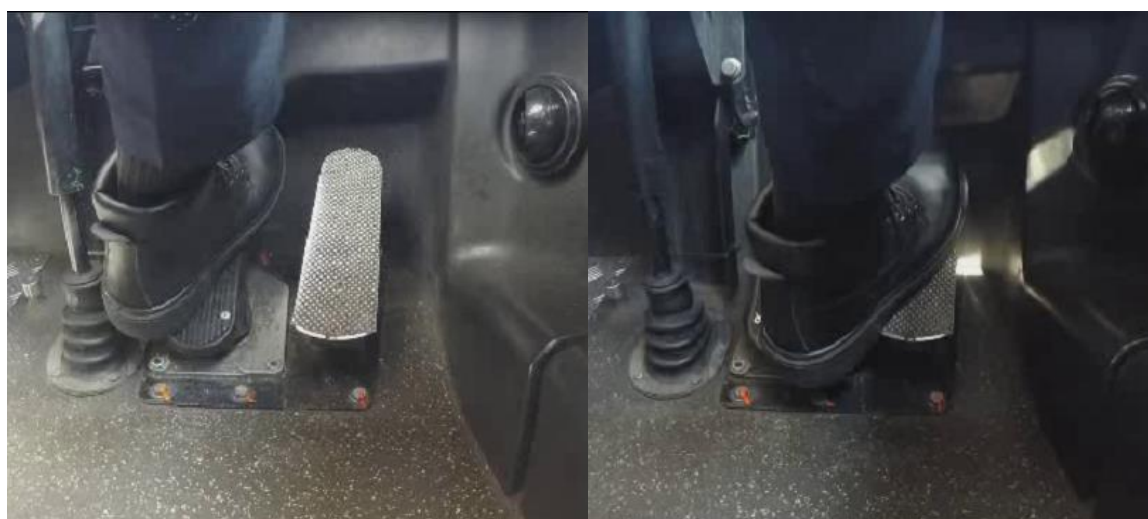
Figure 30: Angled foot placement with the brake (left) and accelerator (right)
