Pedal Cyclist Fatalities in London: Analysis of Police Collision Files (2007-2011)

**Undertaken on Behalf of:
Transport for London**

**Prepared by:
Transport Safety Research Centre, Loughborough University
Centre for Transport Studies, University College London**

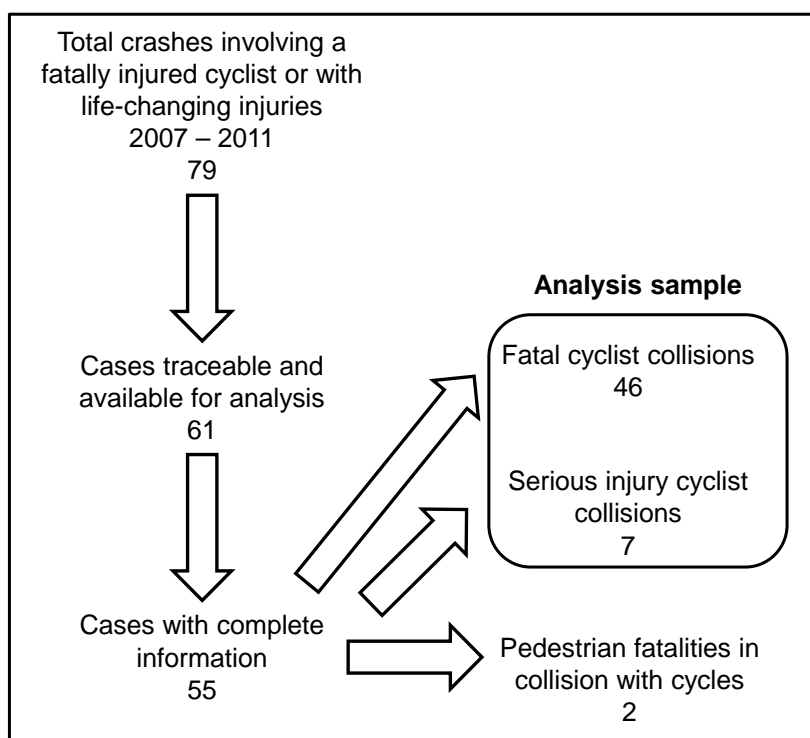
Figure 5: Derivation of analysis sample

The final sample therefore comprised 53 cases and is summarised in Figure 5. Forty-six were fatal pedal cyclist crashes, using the internationally accepted definition of death within 30 days. A further 7 involved a seriously injured pedal cyclist whose injuries were considered to be life threatening at the time of the crash. The ‘serious’ group includes one cyclist who died 2 months following the crash due to complications. For the purposes of this report, the fatal and serious crashes have been grouped together as the characteristics of these crashes, in terms of crash causation, are similar to those of the fatal crashes.

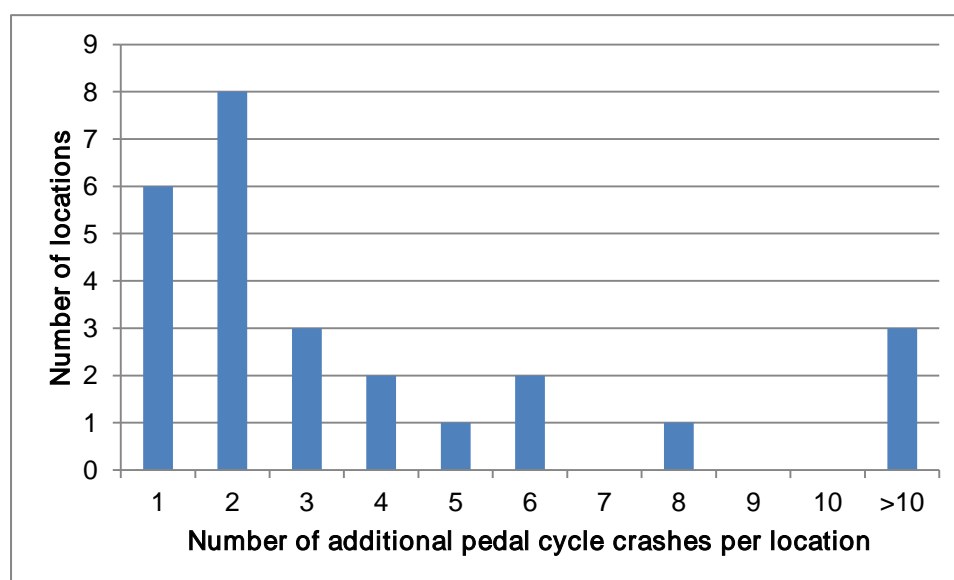
Figure 7: Pedal cycle collision history for sample crashes (36 months)

Twenty-six locations had a history of injury crashes involving pedal cycles within the 36 months leading up to the crash included in the sample. Figure 7 shows how many locations previously had 1 or more slight, serious or fatal crashes that involved a cyclist, excluding the crash included in the sample. Injury pedal cycle crashes had occurred once or twice at 14 locations and at 3 locations the number of previous injury crashes involving pedal cyclists was high – 14, 15 and 40 crashes respectively.

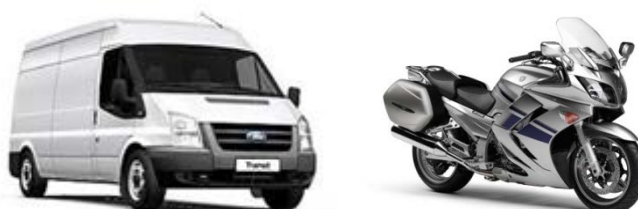
The group of 19 small vehicles comprised cars, vans below 3.5 tonne and motorcycles. The numbers in each group are shown in Table 12. Both vans in the sample were panel vans and the motorcycle was a Touring style, as illustrated in Figure 11.

Figure 11: Illustration of panel van and touring motorcycle

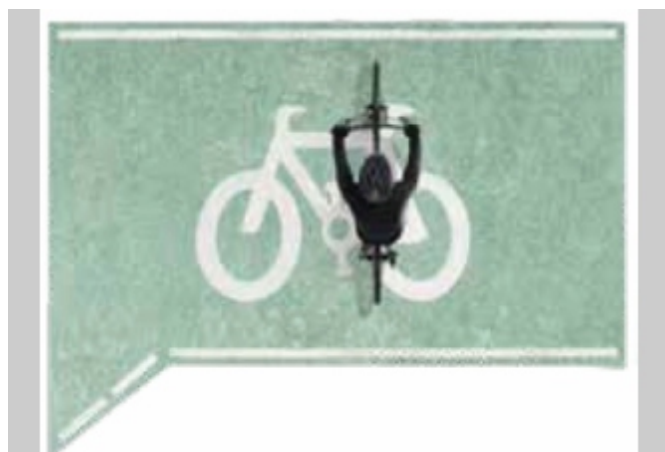
Figure 12: Example of an Advanced Stop line (Metropolitan police image⁵)

Four crashes occurred when both the cyclist and the truck set off in response to a green light, having previously been stationary, with the cyclist in an ASL area. ASLs are used at some signalised junctions to demark an area where cyclists can wait at a red light ahead of the motorised traffic (Figure 12).

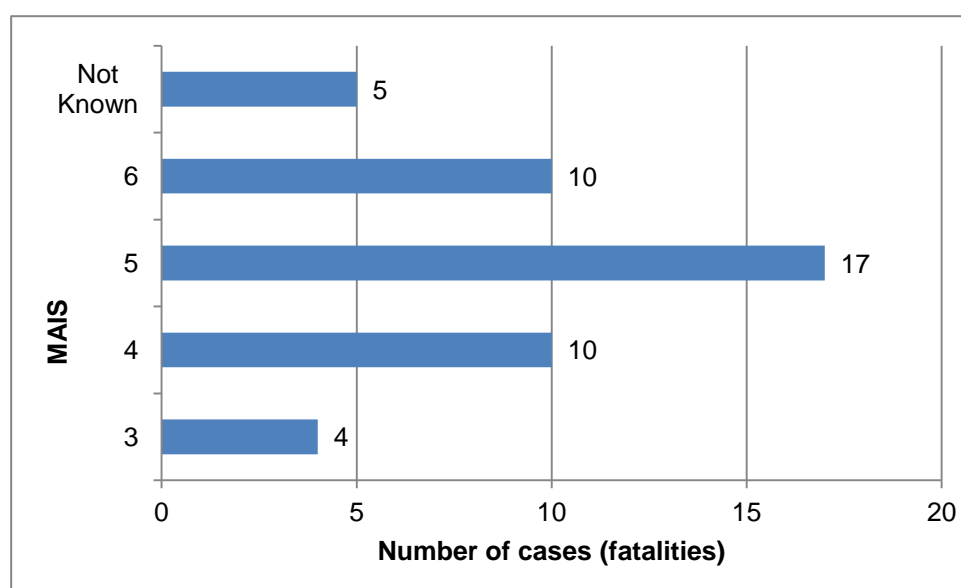
Figure 13: MAIS distribution of fatalities

Recordable injuries were available for 41 of the 46 of the fatally injured cyclists. Injuries were coded using AIS 2005 (2008 update) and where incomplete details of injuries were noted a conservative severity code was assigned. The Maximum AIS was assigned to each casualty and ranged between MAIS 3 and MAIS 6 (Figure 13).

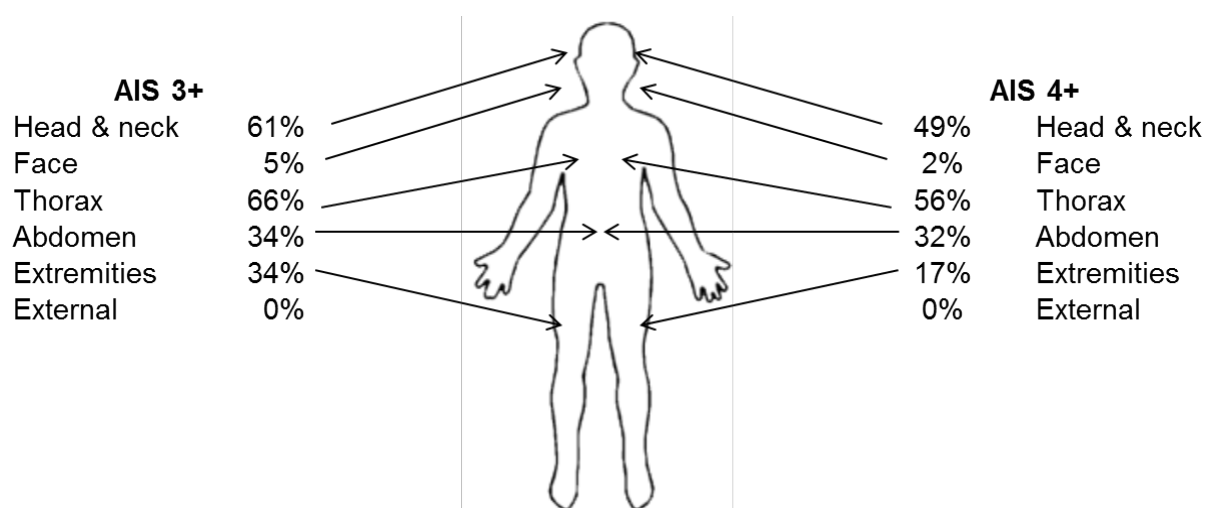
Figure 16: Distribution of body region AIS for cyclist casualties

Body region	Head & neck	Face	Thorax	Abdomen	Extremities	External
MAIS1	0	0	0	0	0	25
MAIS2	3	6	1	5	12	12
MAIS3	5	1	4	1	7	0
MAIS4	5	1	13	9	5	0
MAIS5	8	0	5	4	2	0
MAIS6	7	0	5	0	0	0
No injury	13	33	13	22	15	4
Not known	5	5	5	5	5	5
Total	46	46	46	46	46	46

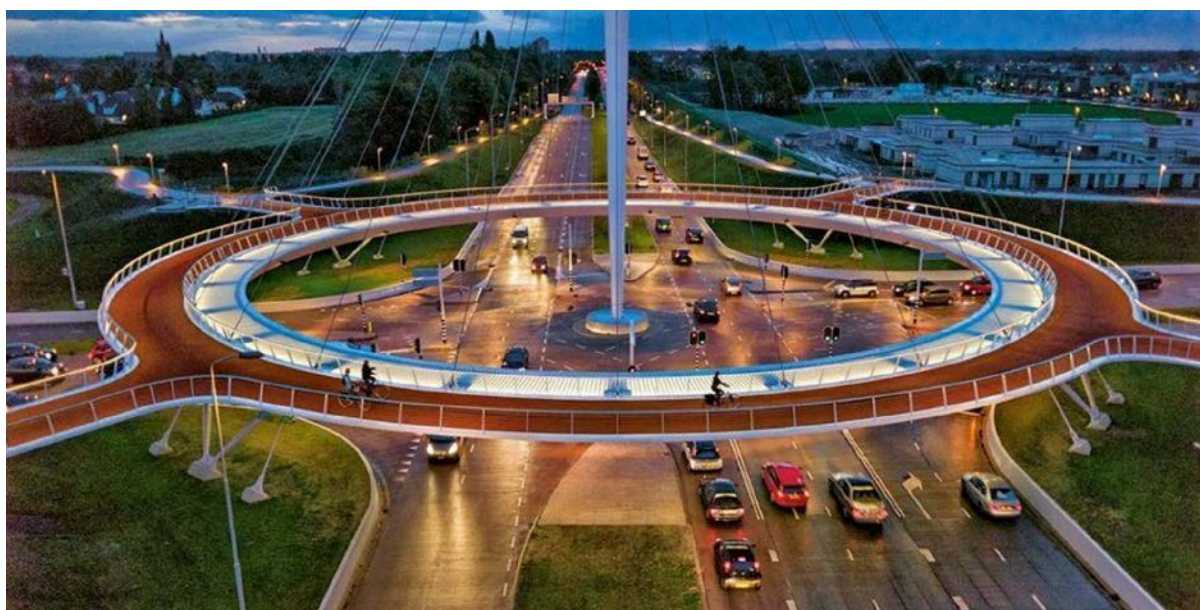
Figure 21: Example of grade separated cycle infrastructure in the Netherlands – the Hovenring

For busy complex junctions, one effective option may be to build specific cycling infrastructure that separates cyclists from other traffic without increasing their journey time. An example of the type of infrastructure that has been used in other countries is the Hovenring constructed in the Netherlands (Figure 21). Care has been taken to reduce the impact on cyclists by lowering the level of the road passing beneath it therefore allowing shallower grade entrance and exits ramps.

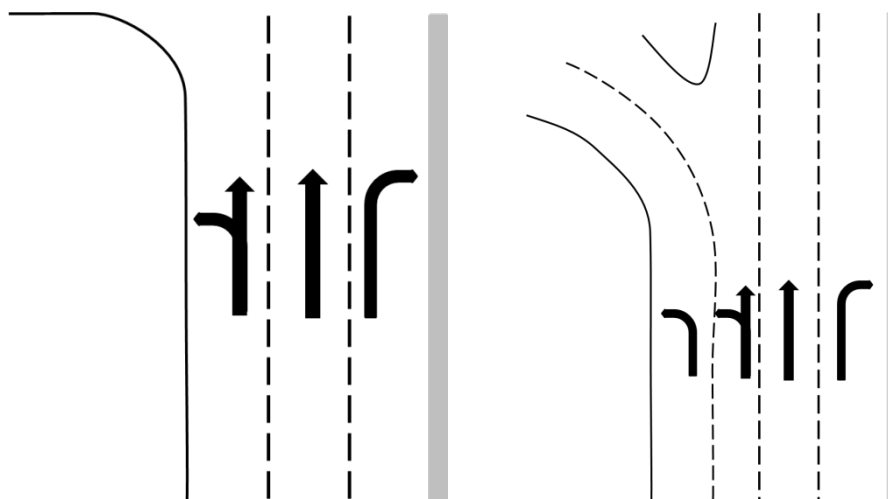
Figure 22: Road junctions with multiple lanes and dual priority markings

Evidence from the fatal and serious crashes also suggests a frequent conflict between cyclists riding down the nearside of a traffic lane and large vehicles turning left. The relative movement analysis described in Section 3 showed that in eight cases, the cyclist was undertaking a large vehicle that was turning left. The issue appears to be exacerbated with multiple lanes and dual priority markings, e.g. left turn and straight on traffic in the same lane, as illustrated by Figure 22:

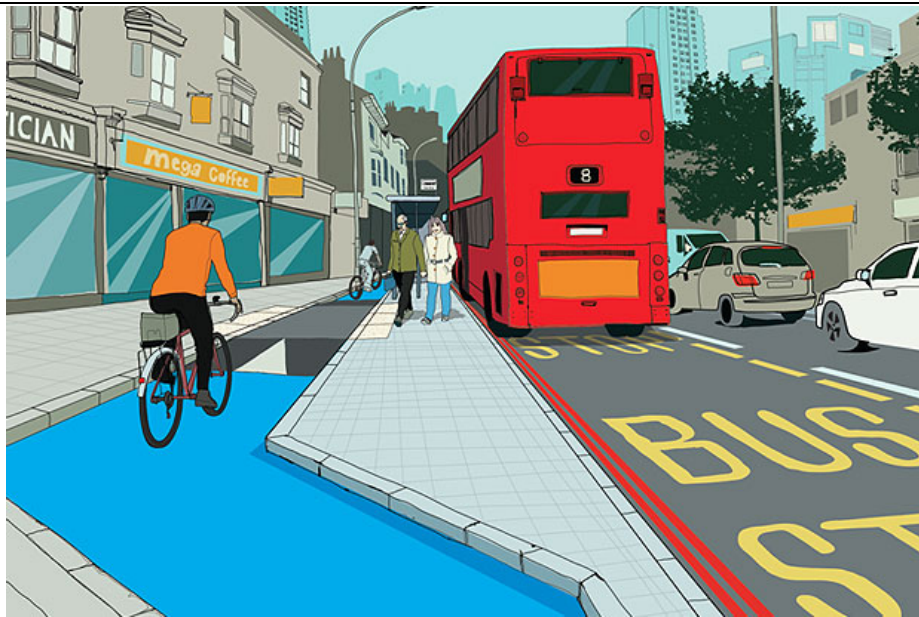
Figure 23: Bus stop bypass cycle lane (TfL image)

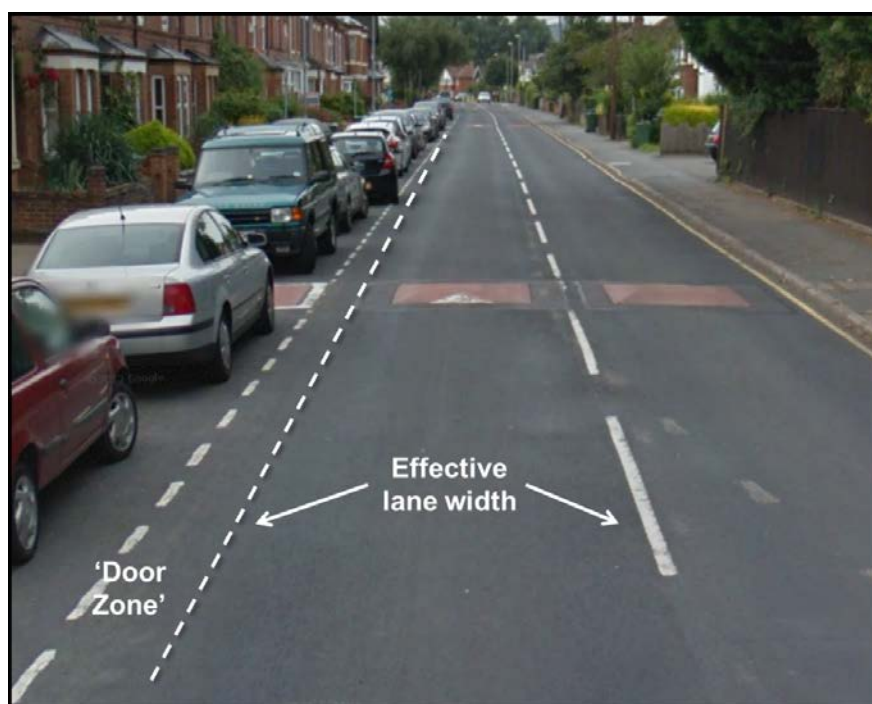
Figure 26: Speed cushion traffic calming adjacent to on street parking

Where traffic calming is introduced on a route which cyclists use, considerations of the impact to cyclists should be made. For example speed cushions can require the cyclist to change position. In addition speed cushions placed alongside parking bays may force the cyclist to travel in close proximity to parked cars and therefore be vulnerable to opening doors. Figure 26 shows how placing a speed cushion adjacent to on-street parking effectively encourages cyclists to cycle either side of the calming measure and could lead to conflicts with the 'door zone' of parked vehicles.

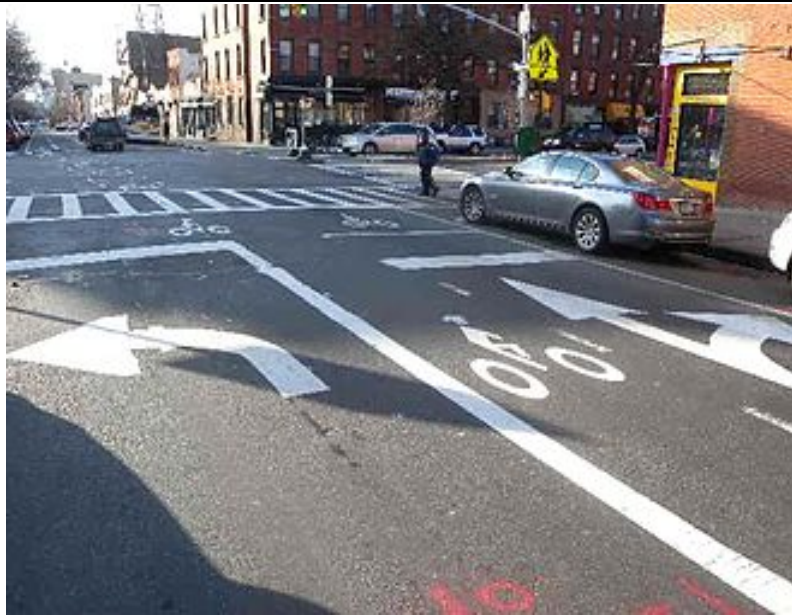
Figure 27: ASL with double stop line. Example from the Netherlands¹²

Another approach that could be used alongside advanced phasing is the introduction of double stop line creating a no vehicle zone between the motorised vehicle stop line and line demarking the start of the ASL (see Figure 27). This would increase the likelihood of cyclists being seen, allow for eye contact to be made between driver and cyclist, and increase the time available for cyclists to perform their manoeuvres before other traffic catches up.

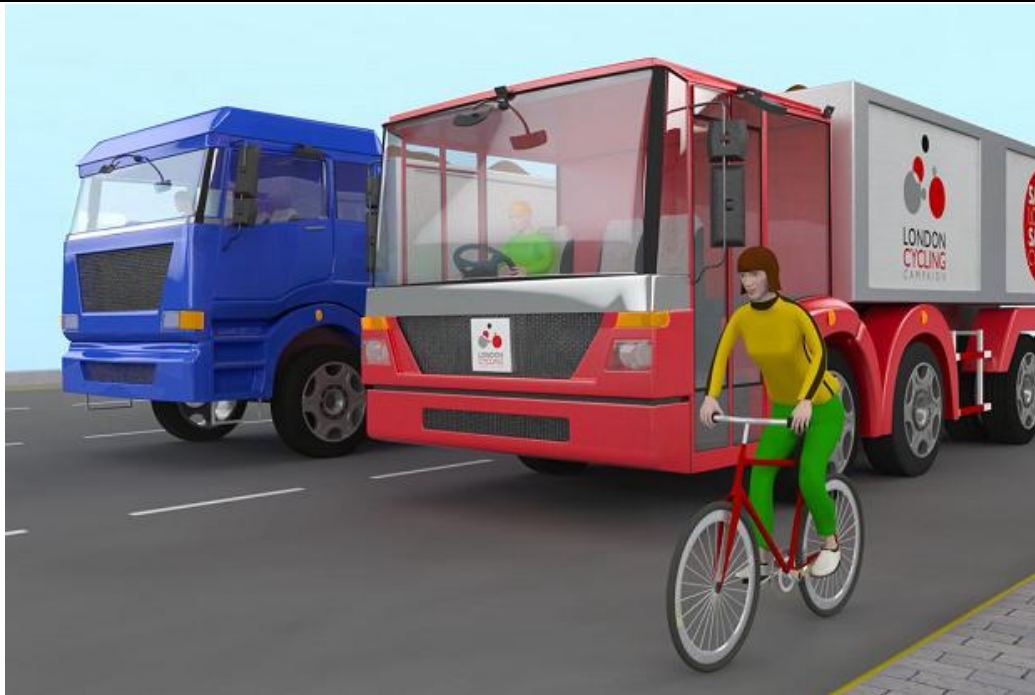
Figure 36: Redesigned lorry cab for improved direct vision of cyclists (London Cycling Campaign image)

Ways to increase the likelihood of the driver seeing the cyclist include, retrofitting mirrors known to increase vision (Class VI), decrease the reliance on mirrors, i.e. increase the area visible by direct vision to the front of the vehicle (Figure 36), and to explore ways of improving the vision provided by the existing mirrors.

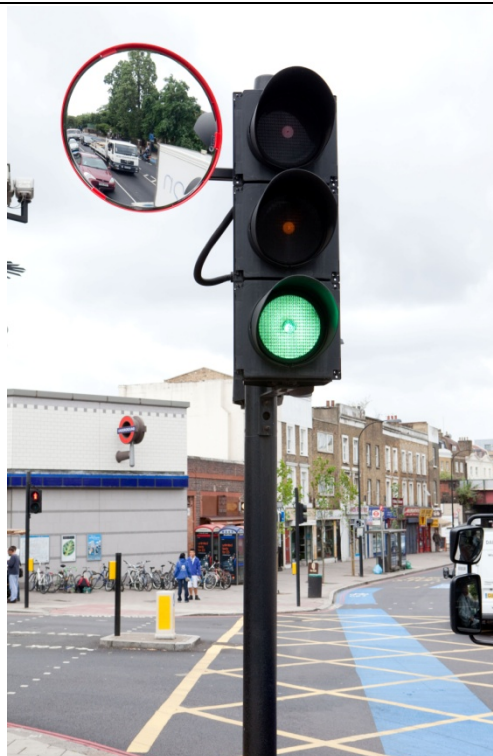
Figure 37: convex mirror situated adjacent to traffic signals (TfL image)

There is also anecdotal evidence from police interview records of the fatal and serious cycle collisions that drivers can be very focussed at signalised junctions. Most commonly attention appears to be directed towards the traffic signals themselves and as such there may be an advantage in installing convex mirrors on junctions. This has an additional benefit as there is also good anecdotal evidence from the same interview material that truck mirrors are used incorrectly (for example only for parking), not used, not fitted (i.e. retrofitted to older trucks) or are insufficient for providing adequate views around the vehicle. A mirror situated near the signal could resolve both of these issues; helping preoccupied drivers spot cyclists and enhancing the view around their vehicle (Figure 37).

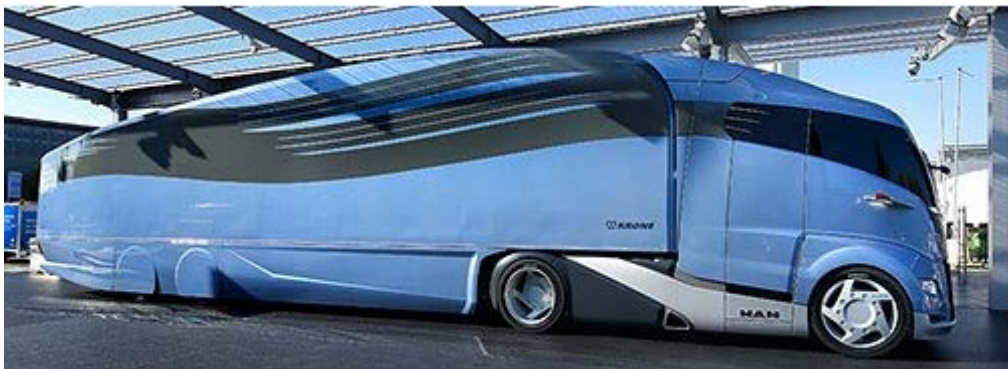
Figure 39: Concept truck design with extended side guards (MAN)

The height of the side guard (i.e. the distance of its lower edge to the ground) is critical in maintaining contact with a vulnerable road user as they fall to the ground; the current design allows a gap between the ground and the sideguard of up to 550mm which is large enough for a for a cyclist (or pedestrian) to fall beneath the vehicles' wheels. Likewise, continuous coverage down the side of a vehicle is advantageous as any hole in the protection (e.g. ending a side guard at a fuel tank) allows opportunity for a cyclist to fall to the ground under the vehicle.

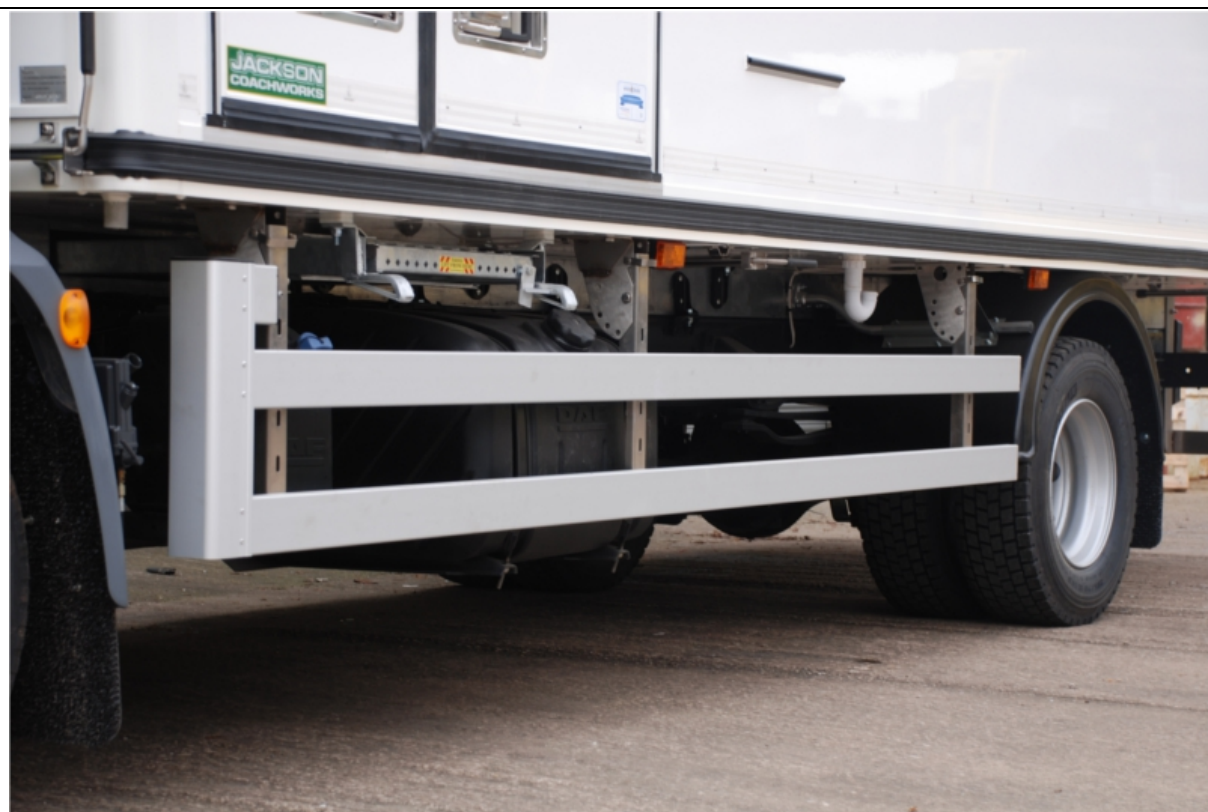
Figure 40: Basic side guard fitment compliant with current regulations

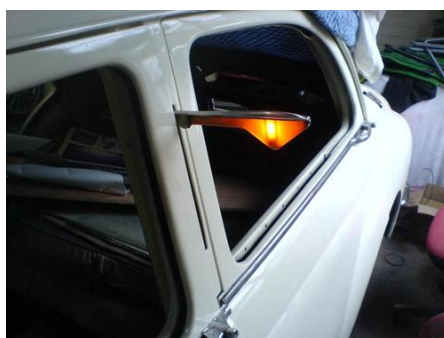
Figure 41: Trafficator

Indicators could be made more visible by using bigger repeaters and not obscuring repeaters by other vehicle elements such as mud guards and load. A more physical indicator such as a flexible, mechanically operated arm similar to trafficators (see Figure 41) could also achieve this.
