CONCEPT SITE INVESTIGATIONS									
Site Name:		Northern Line Extension					Job No. 10/2254		
Client:		REO (Powerstation) Ltd					Date: 11/06/10		
Determination of Moisture Content and Liquid and Plastic Limits									
Borehole No	Sample type	Sample No.	Depth m	Description	Natural Moisture Content %	1. Passing 425 µm sieve %	Liquid Limit %	Plastic Limit %	Plasticity Index %
BH04	U	13	7.50	Grey locally thinly laminated slightly micaceous CLAY with closely spaced laminations of light brown and greenish grey fine sand	25				
BH04	U	19	11.50	Grey locally thinly laminated slightly sandy CLAY with closely to medium spaced laminations of light brown sand and rare pockets of dark grey fine sand (55x20mm) and rare bioturbation	22				
BH04	U	28	17.50	Grey thinly laminated slightly CLAY with occasional bioturbation	27				
BH04	U	31	19.50	Extremely closely fissured grey CLAY with occasional bioturbation	28	100	83	28	55

<b>CONCEPT</b>	<b>PARTICLE SIZE DISTRIBUTION</b> BS 1377 : Part 2 : 1990 : Clause 9	Job/report no:	9597
		Borehole / Pit No	BH08
Location	Northern Line Extension	Sample No	13
	<b>Brown sandy GRAVEL (gravel is fmc and sub angular to sub rounded)</b>	Depth	3.70 - 4.20 m
		Sampl

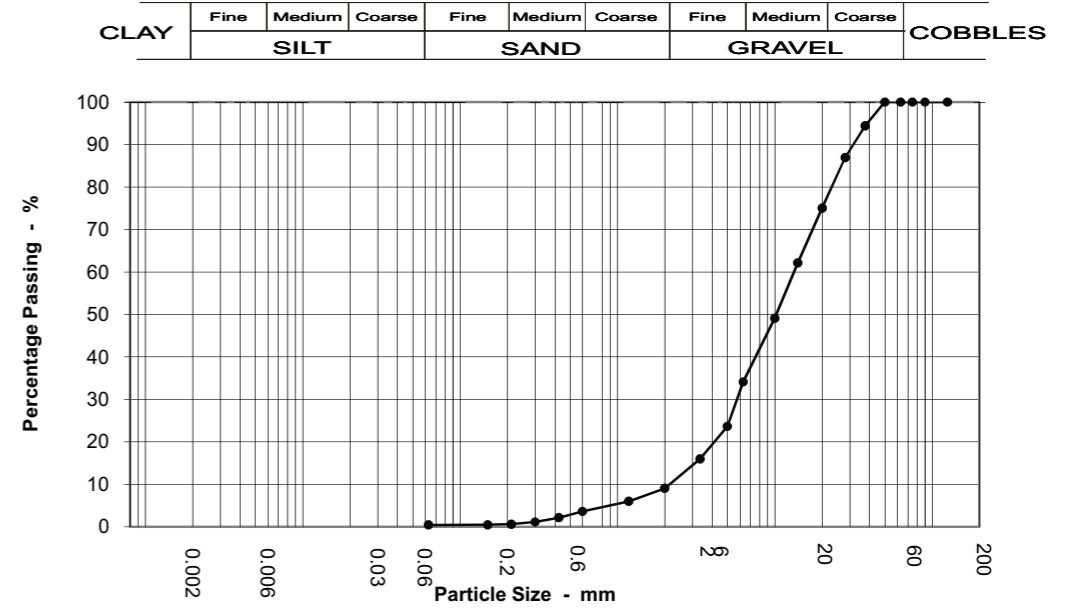
Sieving		Sedimentation	
Particle Size mm	% Passing	Particle Size mm	% Passing
125	100		
90	100		
75	100		
63	100		
50	100		
37.5	94		
28	87		
20	75		
14	62		
10	49		
6.3	34		
5	24		
3.35	16		
2	9		
1.18	6		
0.6	4		
0.425	2		
0.3	1		
0.212	1		
0.15	0		
0.063	0

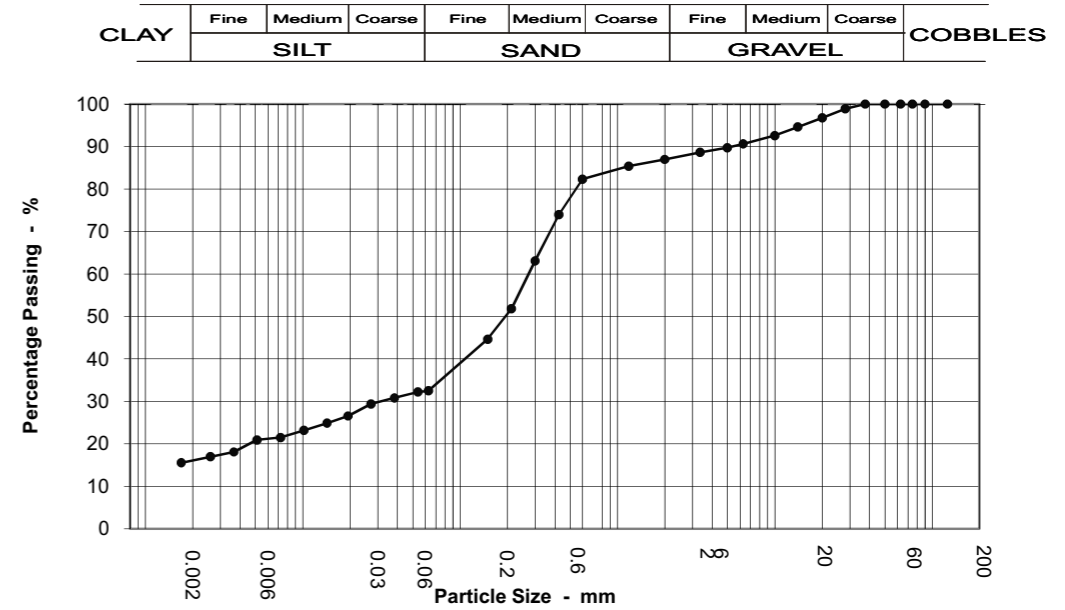
<b>CONCEPT</b>	<b>PARTICLE SIZE DISTRIBUTION</b> BS 1377 : Part 2 : 1990 : Clause 9	Job/report no:	9597
		Borehole / Pit No	BH10
Location	Northern Line Extension	Sample No	11
Visual Soil Description	Brown slightly gravelly clayey SAND (gravel is fmc and sub angular to sub rounded)	Depth	3.20 - 3.70 m
		Sample type	B

Sieving		Sedimentation	
Particle Size mm	% Passing	Particle Size mm	% Passing
125	100	0.054	32
90	100	0.038	31
75	100	0.027	29
63	100	0.019	27
50	100	0.014	25
37.5	100	0.010	23
28	99	0.007	21
20	97	0.005	21
14	95	0.004	18
10	93	0.003	17
6.3	91	0.002	16
5	90		
3.35	89		
2	87		
1.18	85		
0.6	82		
0.425	74		
0.3	63		
0.212	52		
0.15	45		
0.063	33

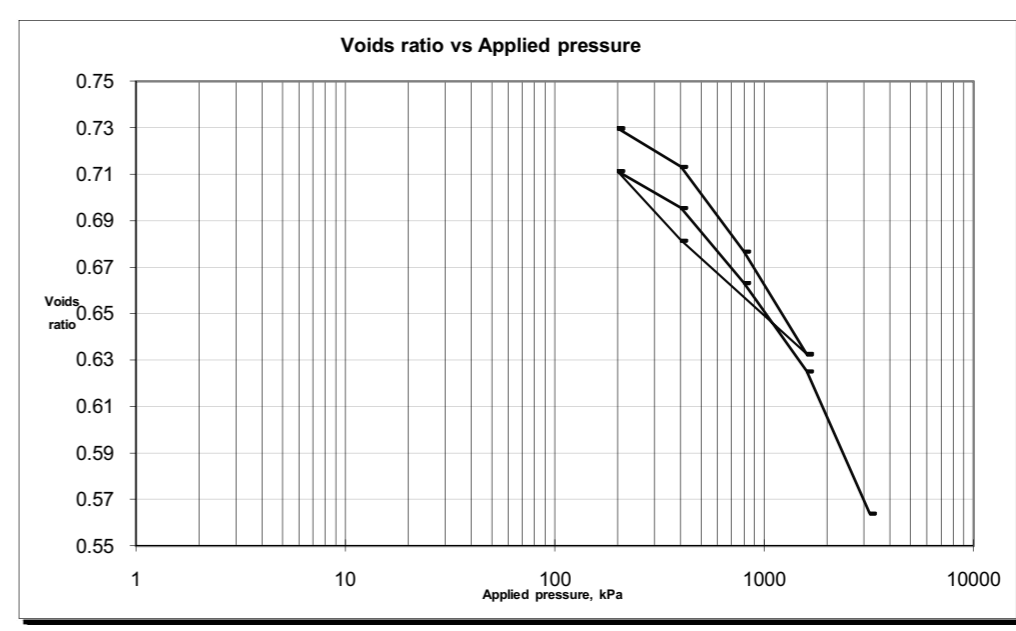
Particle density	Mg/m <sup>3</sup> :	2.75		-		-			
Swelling pressure	kPa :	0		-		-			
<b>Consolidation Stage</b>									
Stage number	Applied Pressure kPa	Voids Ratio	Coefficient of Consolidation m <sup>2</sup> /year	Coefficient of Compressibility m <sup>2</sup> /MN	Stage number	Applied Pressure kPa	Voids Ratio	Coefficient of Consolidation m <sup>2</sup> /year	Coefficient of Compressibility m <sup>2</sup> /MN
1	200	0.7297	6.95	0.068	11				
2	400	0.7132	3.48	0.048	12				
3	800	0.6767	0.37	0.053	13				
4	1600	0.6325	0.36	0.033	14				
5	400	0.6814	0.07	0.025	15				
6	200	0.7112	0.33	0.089	16				
7	400	0.6955	0.58	0.046	17				
8	800	0.6632	0.47	0.048	18				
9	1600	0.6251	0.31	0.029	19				
10	3200	0.5639	0.47	0.024	20

**Voids ratio vs Applied pressure**

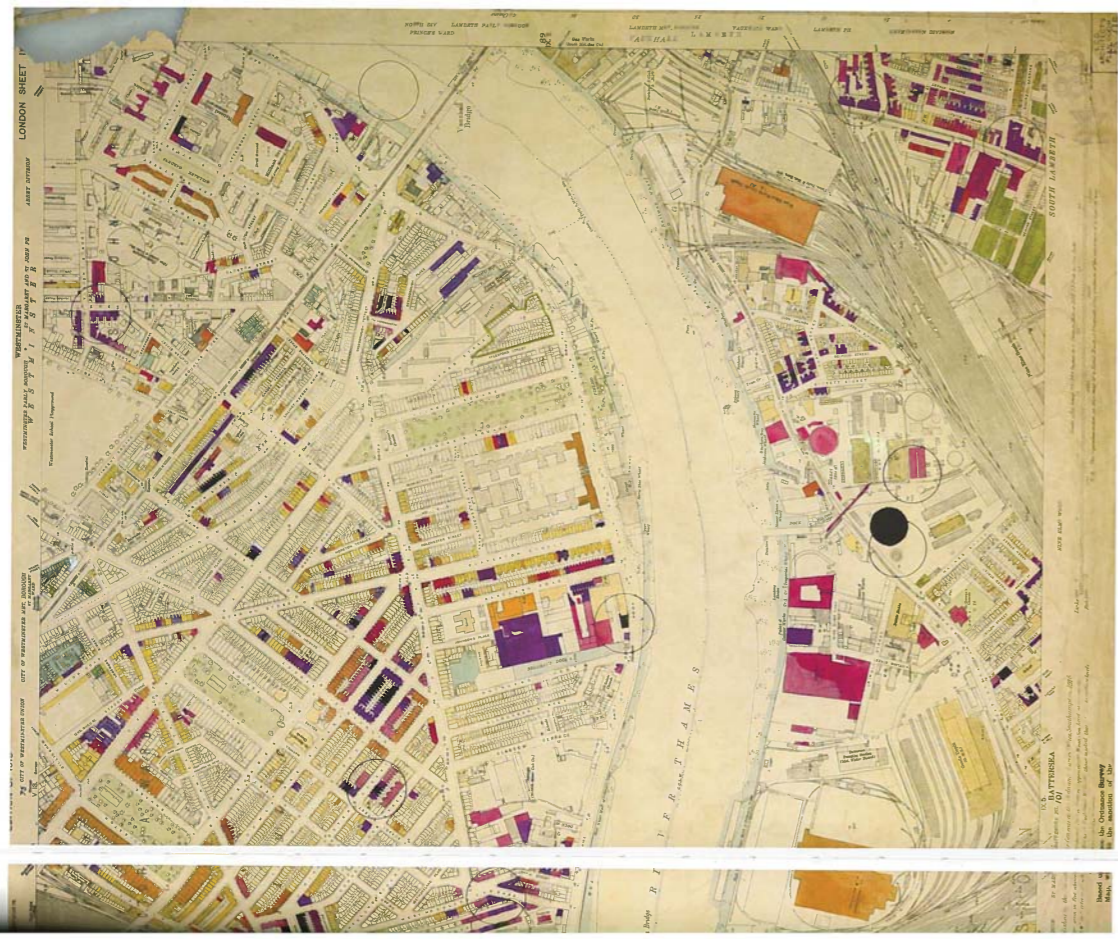
MAP 89

**Colour Key**  
*(for guidance only)*

**Black**  
Total destruction

**Purple**  
Damaged beyond repair

**Dark Red**  
Seriously damaged, doubtful if repairable

**Light Red**  
Seriously damaged, but repairable at cost

**Orange**  
General blast damage - not structural

**Yellow**  
Blast damage, minor in nature

**Light Blue**  
Clearance areas

**Light Green**  
Clearance areas

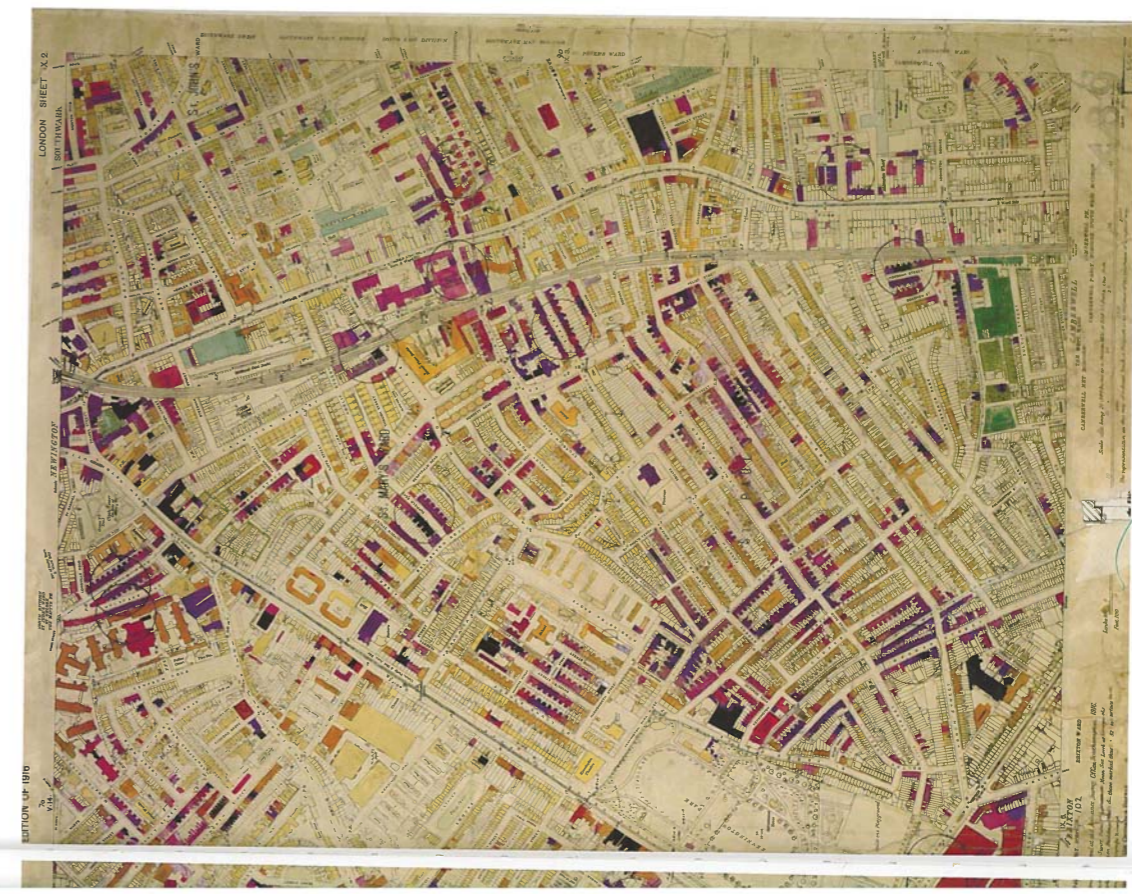
MAP 100

- Black Total destruction
- Purple Damaged beyond repair
- Dark Red Seriously damaged; doubtful if repairable
- Light Red Seriously damaged, but repairable at cost
- Orange General blast damage - not structural
- Yellow Blast damage, minor in nature
- Light Blue Clearance areas
- Light Green Clearance areas

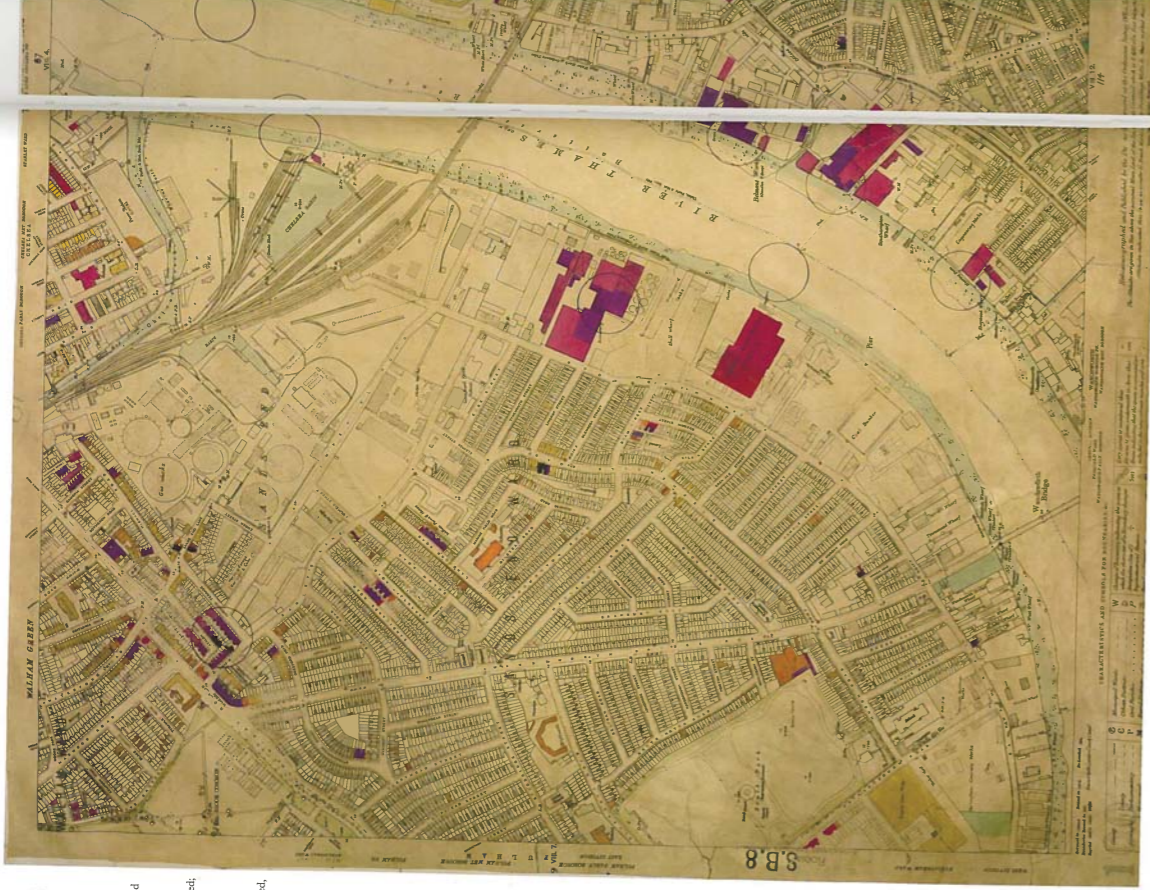
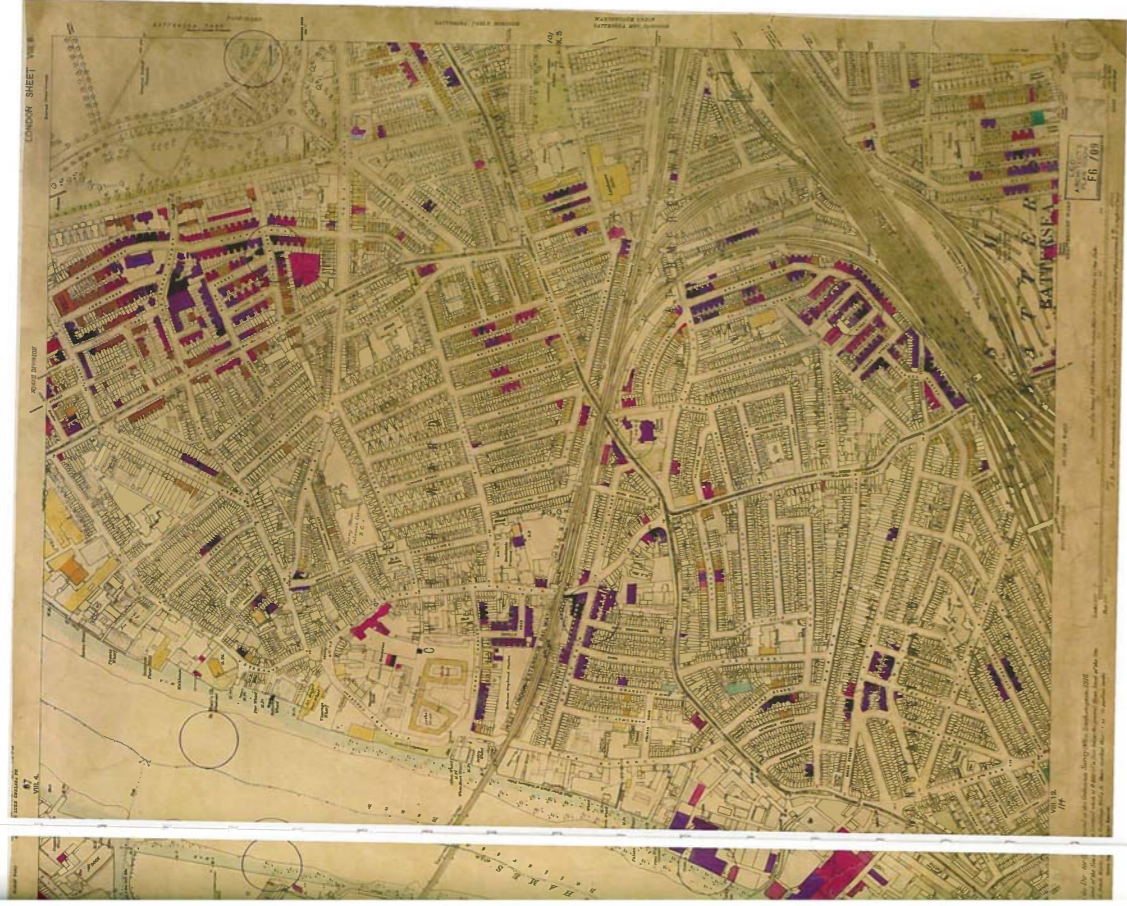
MAP 101

- Black Total destruction
- Purple Damaged beyond repair
- Dark Red Seriously damaged; doubtful if repairable
- Light Red Seriously damaged, but repairable at cost
- Orange General blast damage - not structural
- Yellow Blast damage, minor in nature
- Light Blue Clearance areas
- Light Green Clearance areas

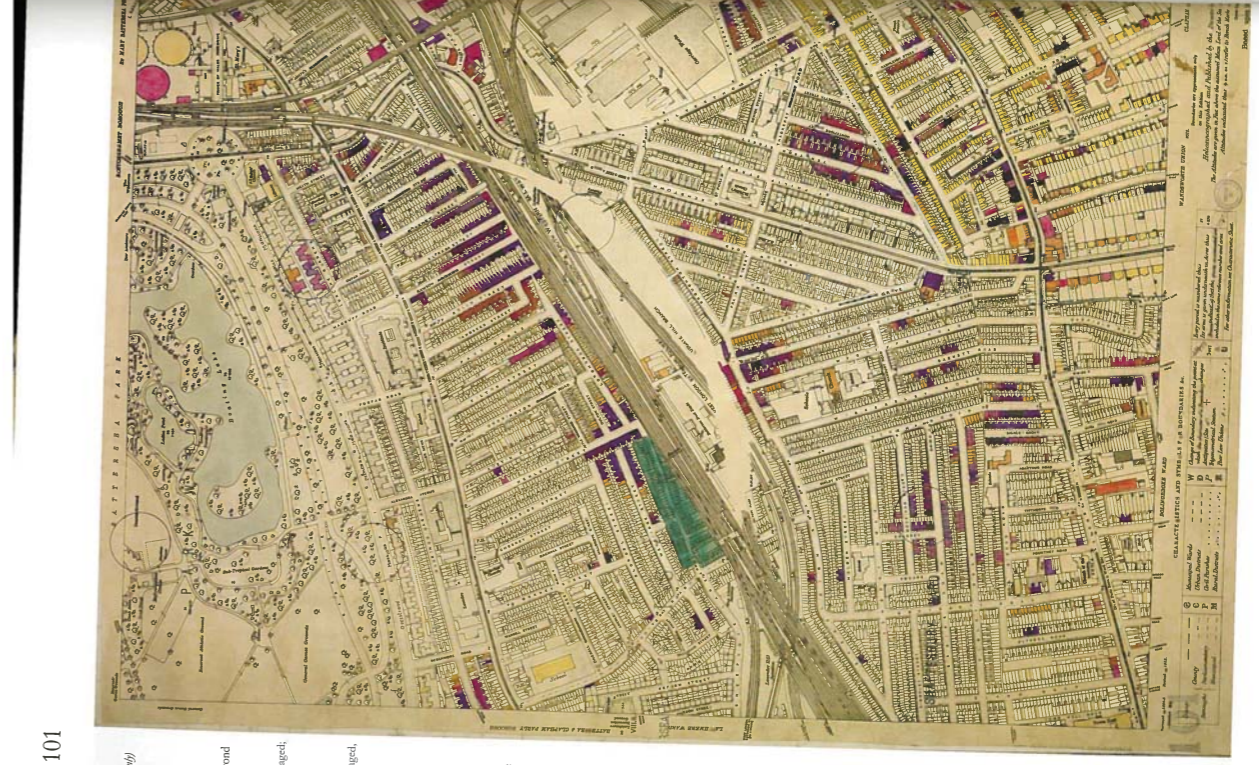
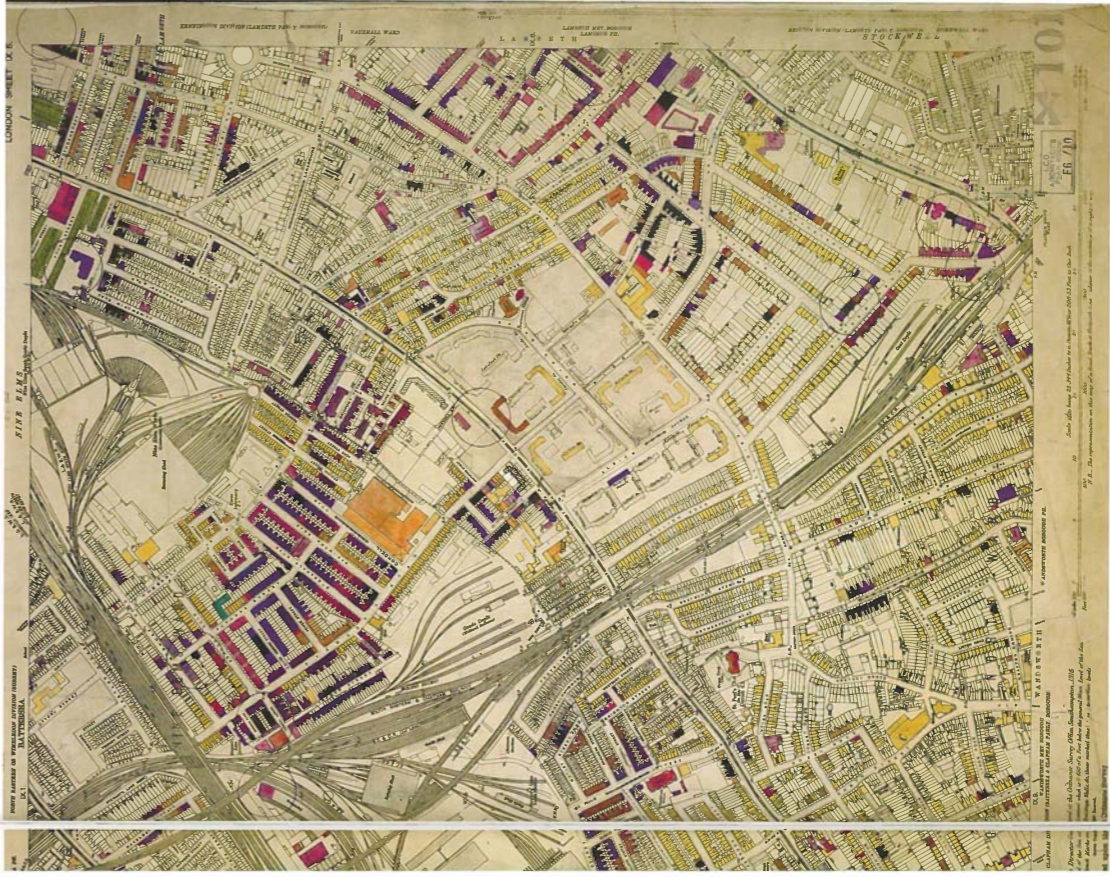
MAP 114

- References  
*(for guidance only)*
- Black**  
Total destruction
- Purple**  
Destroyed beyond repair
- Dark Red**  
Seriously damaged; structural repairs required
- Light Red**  
Seriously damaged, but repairable at cost
- Orange**  
General blast damage - not structural
- Yellow**  
Blast damage, minor in nature
- Light Blue**  
Clearance areas
- Light Green**  
Clearance areas
-

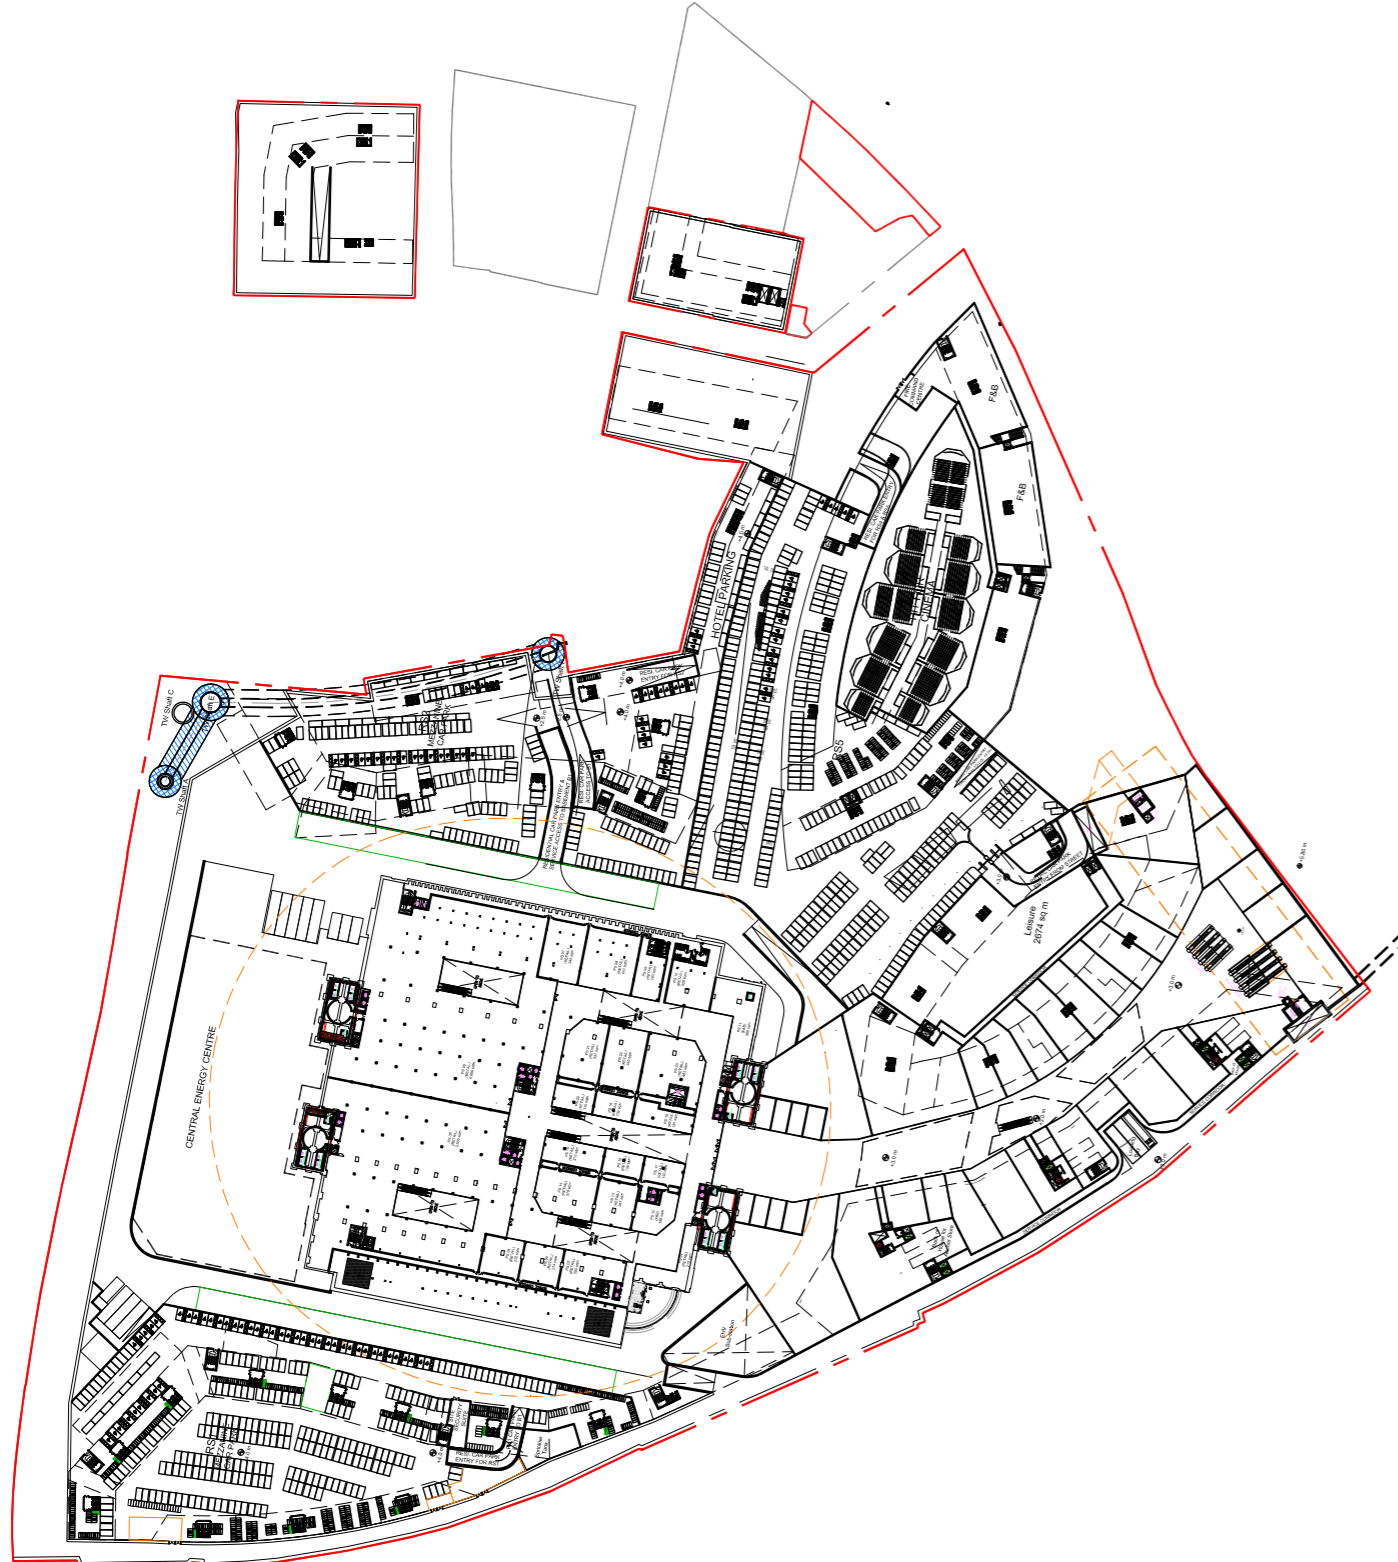
Job No: **023000**  
Drawing No: **FIGURE 2**  
Rev: **01**

The site is located at Battersea, London at the approximate National Grid Reference TQ 290 775 (Figure 1) and occupies an area of about 3 ha. The layout of the site is presented in Figure 2.

Buro Happold Limited was requested by REO Powerstation (REO) to undertake a summary of the previous land contamination reports undertaken at the proposed Battersea Power Station site (hereafter referred to as 'the site'). The summary contaminated land risk assessment and geotechnical assessment for the proposed development at Battersea is in support of the detailed planning application. The site location plan is shown on Figure 1, and the current site layout is shown on Figure 2.
