Puffin crossing operation and behaviour study

PPR239

PUBLISHED PROJECT REPORT

**Prepared for:Project Record: Puffin Crossing Operation and Behaviour Study
SC.0388.006**

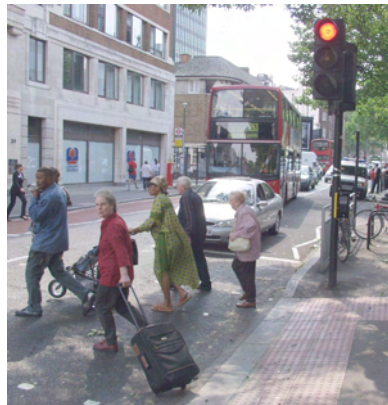
Figure 1: Pelican crossing

The Pelican crossing has a signal demand button mounted on the traffic signal pole that gives a message “WAIT” when pressed by a pedestrian. The red man signal on the far side of the crossing changes to a green man to indicate to the pedestrian that it is safe to cross the road and a red light is shown to traffic (Figures 1 and 2).

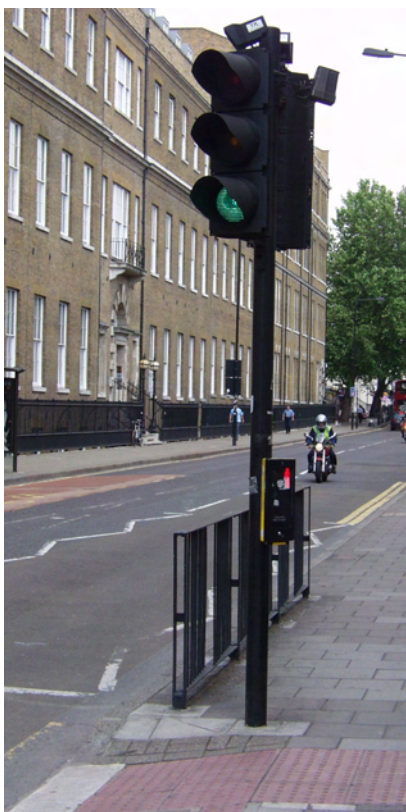
Figure 4: Puffin crossing

Puffin crossings (Figure 4) have been introduced at a steady pace since the introduction of The Zebra, Pelican and Puffin Pedestrian Crossings Regulations and General Directions 1997.

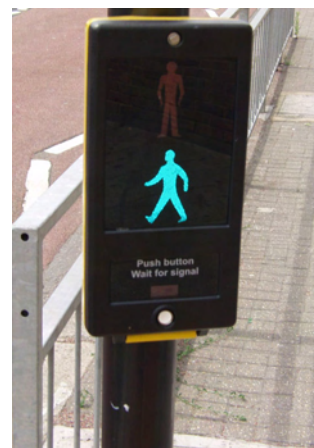
Figure 5: Puffin crossing nearside pedestrian signal head.

A Puffin crossing differs from a Pelican crossing in several respects. In particular, at a Puffin crossing, the red man / green man indicator is positioned above the push button on the upstream signal pole (push button units without the pedestrian aspects are often mounted on upstream poles, Figure 5). These nearside pedestrian signals are intended to facilitate crossing for people with visual impairments and encourage pedestrians to watch approaching traffic and the pedestrian signal simultaneously. Puffin crossings also aim to reduce delays to vehicles by using kerbside detectors to detect when a pedestrian has made the signal demand to cross, but subsequently finds an opportunity to cross before the commencement of the green pedestrian phase, or when the pedestrian moves away from the crossing. In these situations the signal demand for the pedestrian phase is cancelled.

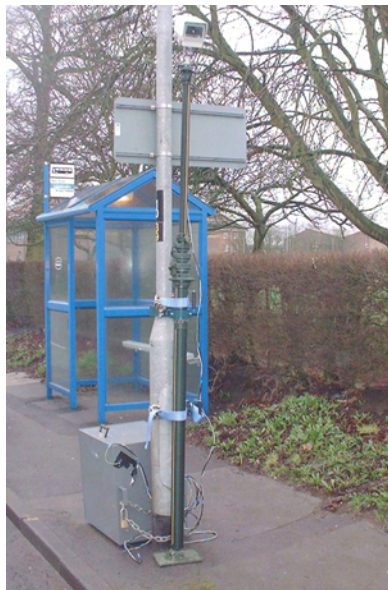
Figure 9: Freestanding camera and video enclosure.

The video surveys were conducted on weekdays for a period of 12 hours commencing at 7:00am and finishing at 7:00pm. Freestanding pole mounted cameras (Figure 9) recorded the activity at each crossing from four different locations.

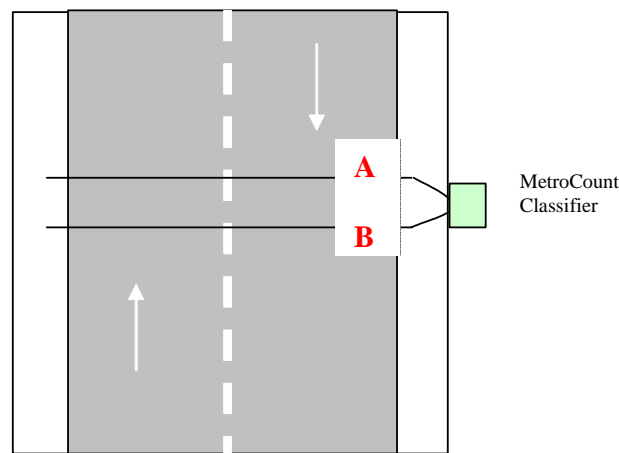
Figure 11: Tube layout for speed data collection

Traffic data was collected in both directions of flow, at the approach to the crossings within the restricted area (i.e. within the zigzag markings) as vehicles were less likely to stop and park on the sensor tubes and cause the logging to cease.

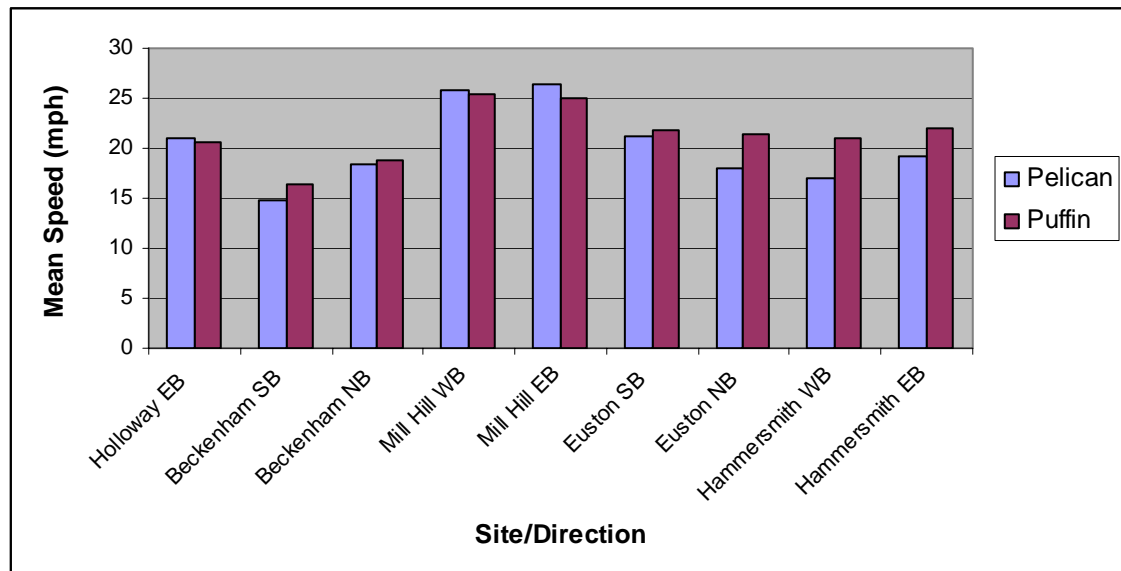
Figure 14: Mean speed distributions

A summary of the traffic statistics is given in Table 5 below. The vehicle data suggests that the site pairs (e.g. Mill Hill Puffin and Pelican crossings) were well matched in terms of vehicle speeds and flows (Figure 14 and Figure 15). Average and 85th percentile speeds at all the crossings apart from Mill Hill were well below the posted limit of 30mph. While there are differences in vehicle speeds at different sites, the differences have not been tested for statistical significance as they are only seen as

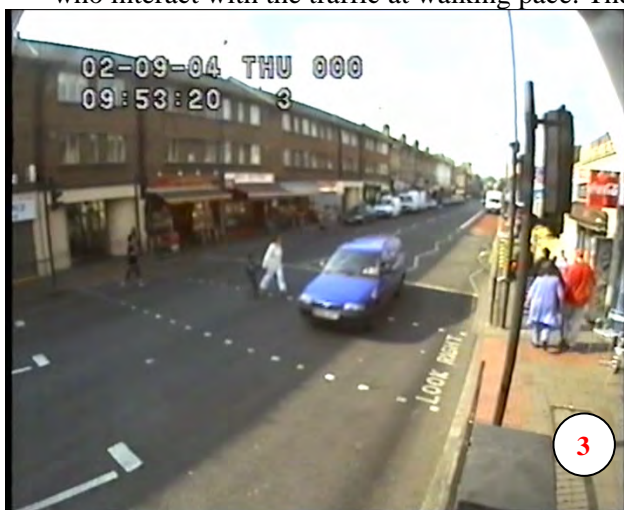
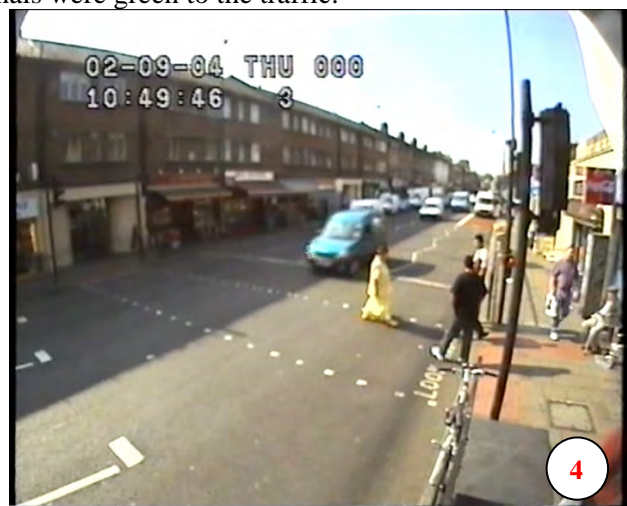
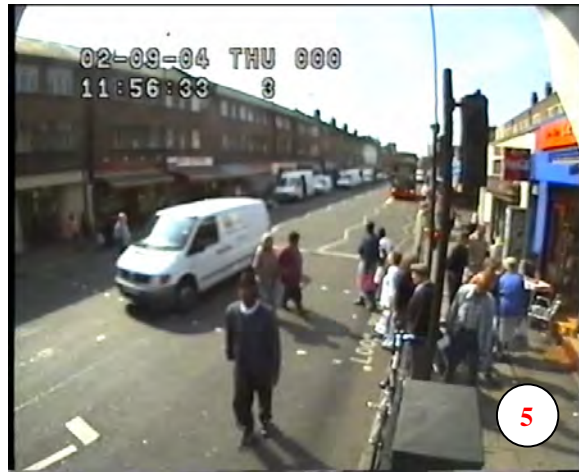
5.1.2 Observation B (puffin)

A pedestrian with a child (Image 3) and other pedestrians (Images 4, 5) are examples of pedestrians who interact with the traffic at walking pace. The signals were green to the traffic.

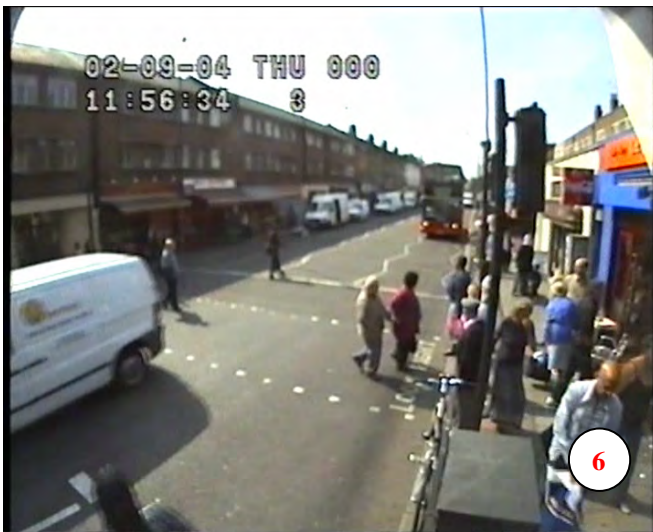
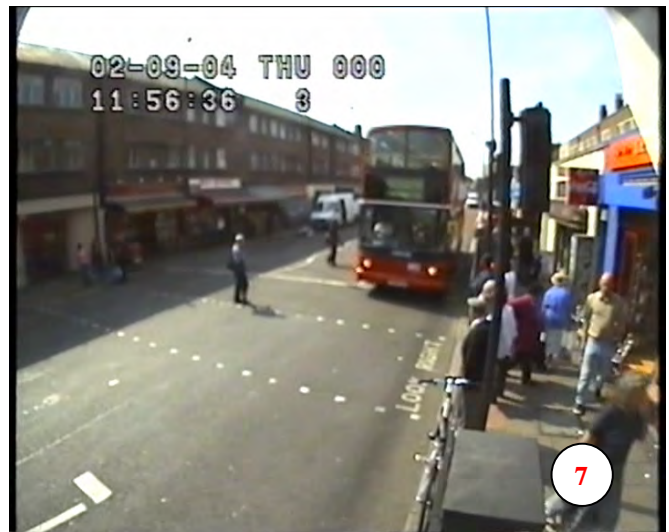
5.1.3 Observation C (puffin)

A senior citizen crosses against the lights (Images 6, 7) and is forced to wait in the road for a bus to pass.

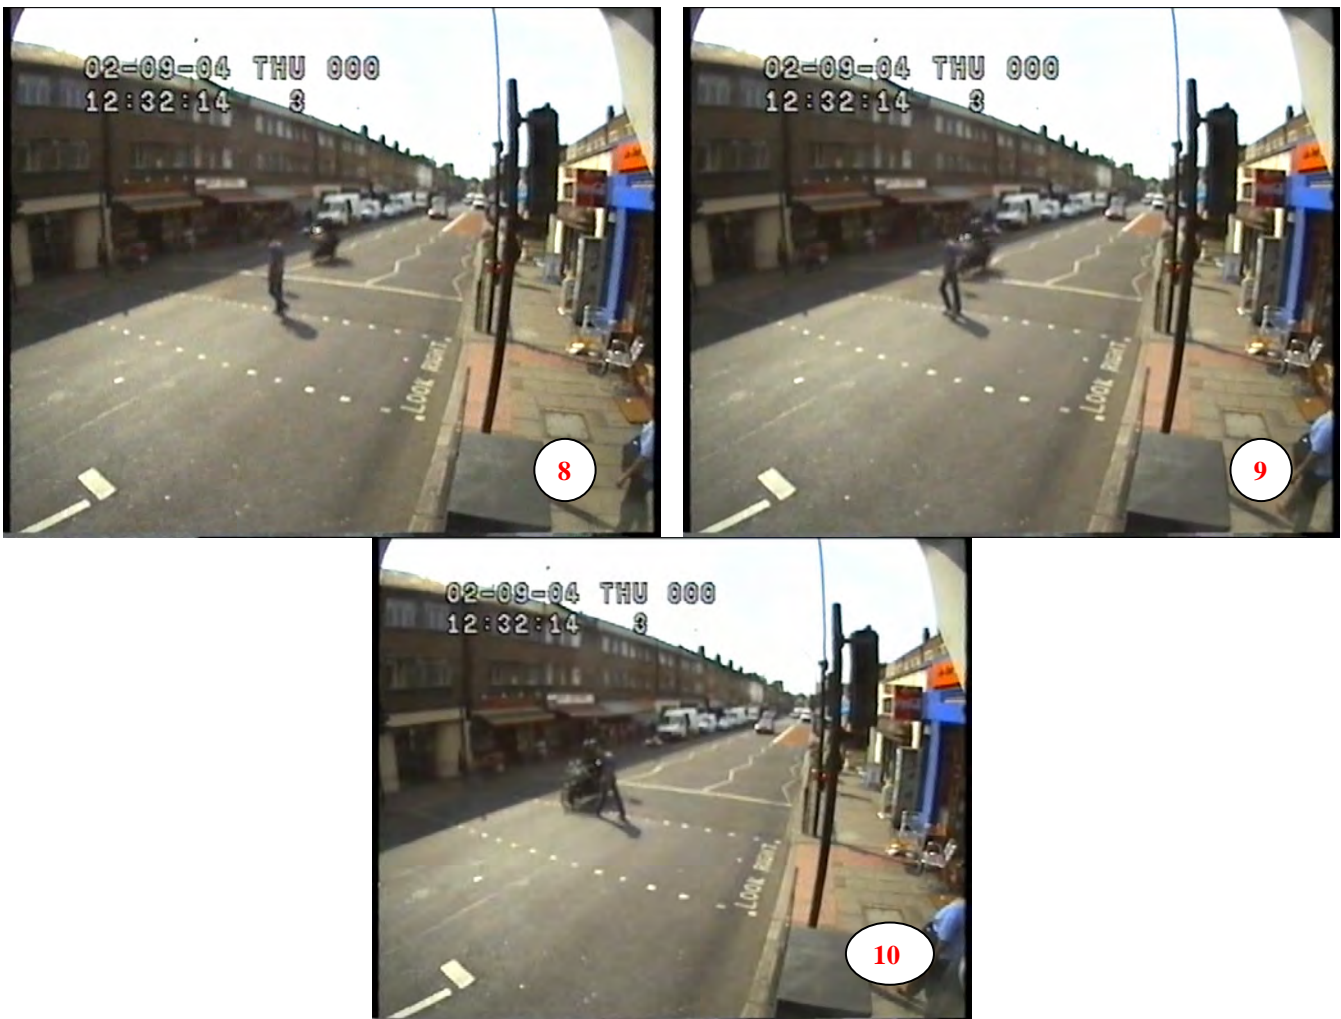
The pedestrian crossing against the lights stops to allow a motorcyclist to pass in front of him (Images 8 to 10).

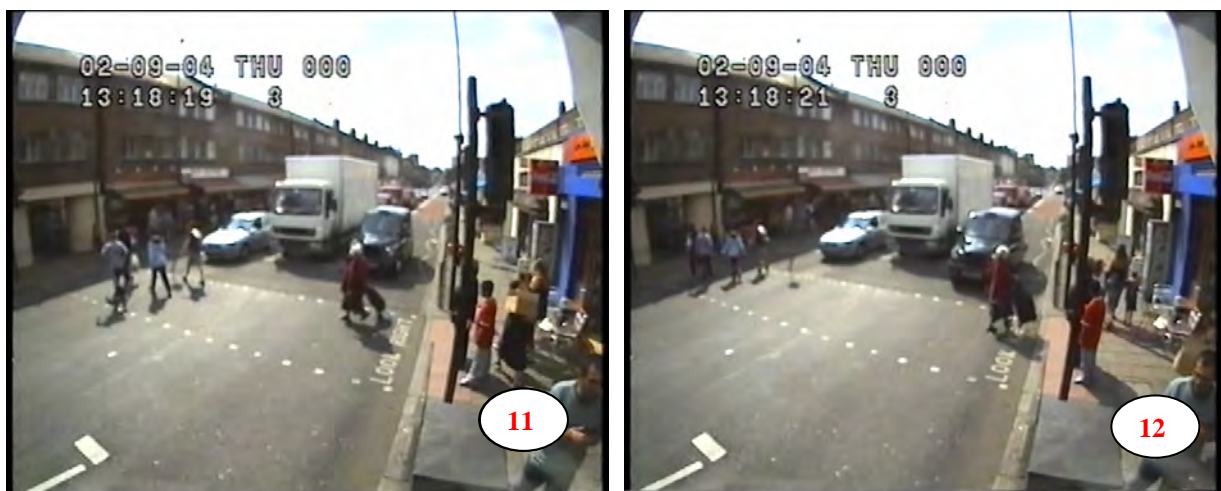
Following an initial platoon that crosses the road a second platoon begins to cross at the start of the pedestrian red phase. An older pedestrian joins this platoon (Image 11) but is forced to return to the kerb once the traffic lights change and the stationary traffic begins to move off (Images 12, 13). No extension occurs as the crossing is clear before the second platoon begins to cross.

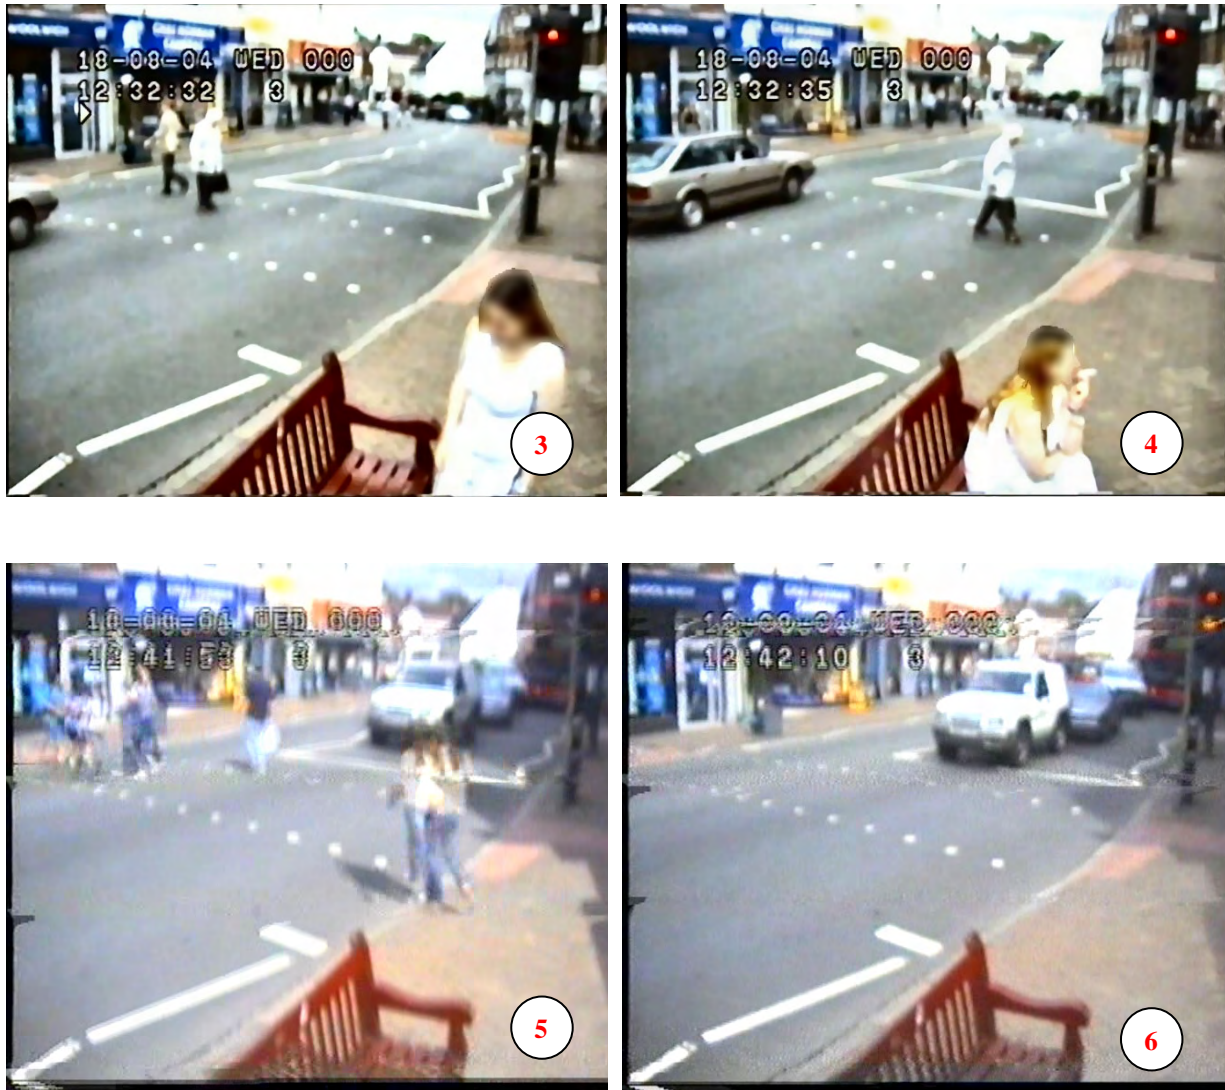
The vehicles can be seen to have moved during the vehicle red phase (Images 1 and 2, 3 and 4, 5 and 6 show 3 instances of this occurring before and after the violation).

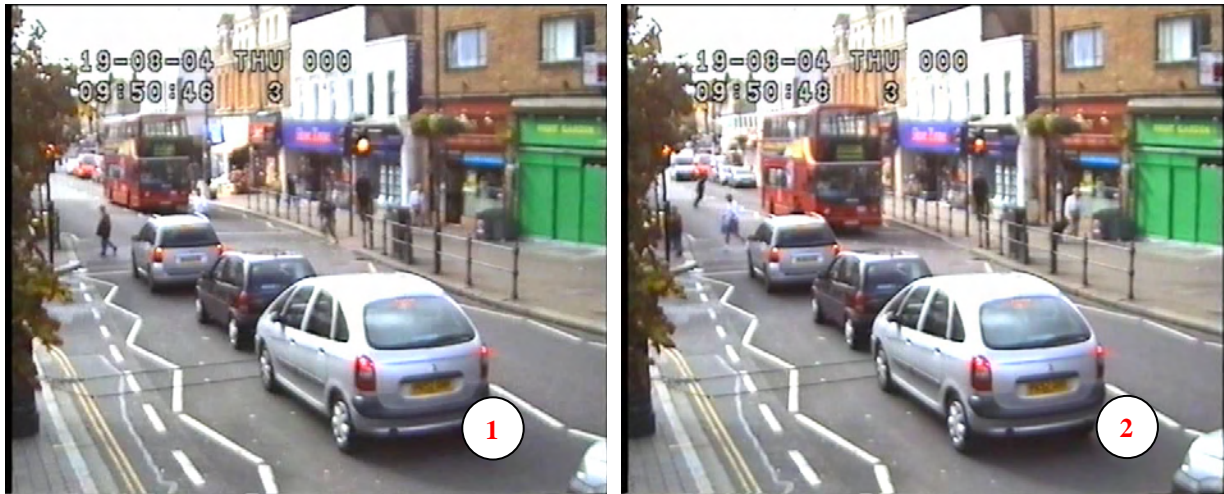
The bus can be seen to be moving through the crossing on flashing amber (event classified as a violation) while the pedestrians were clearing the crossing (Images 1 and 2).

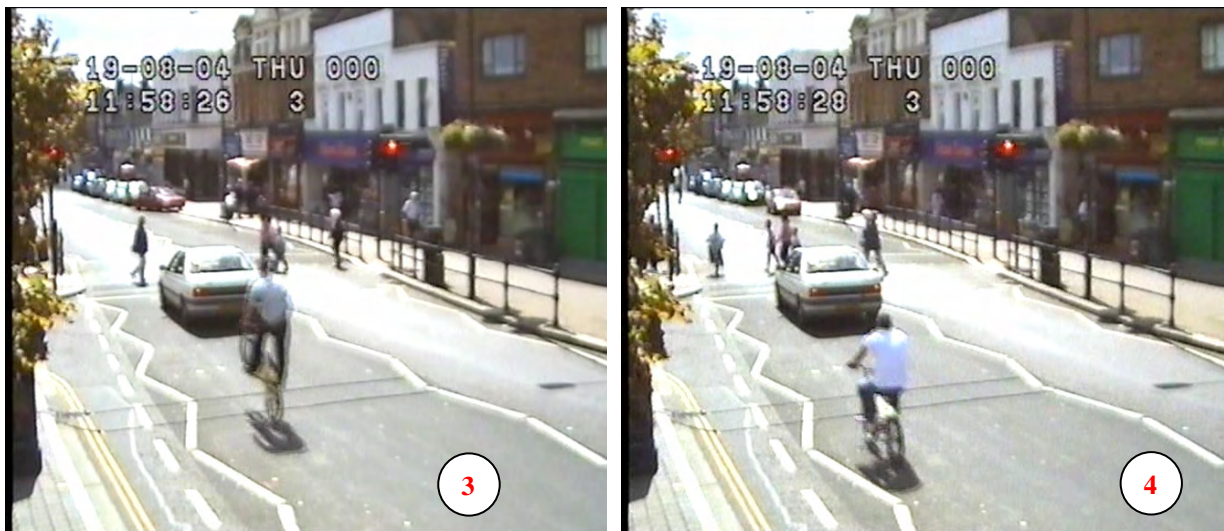
A cyclist can be seen approaching the crossing at speed and running the red light (images 3 and 4).

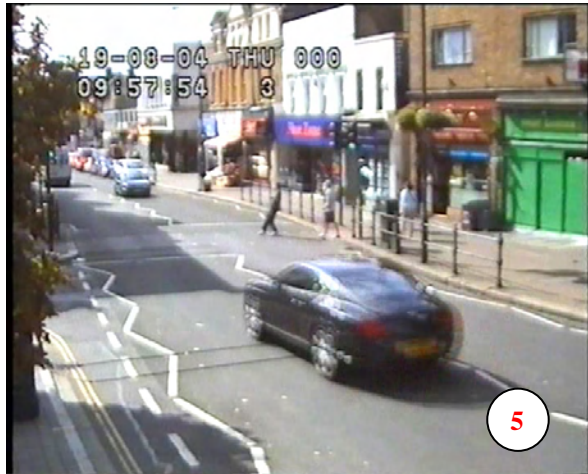
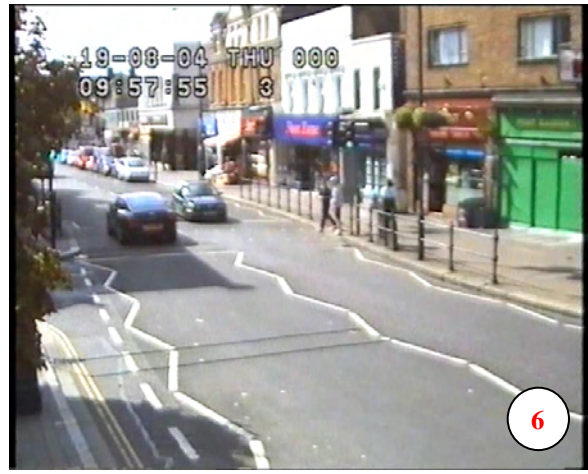
5.3.3 Observation C (pelican)

There was a tendency for pedestrians to create a signal demand (press the WAIT button) and move onto the crossing almost immediately. In many cases the traffic gave way to the pedestrians but not always. In images 5 and 6 below, the pedestrian having made the signal demand to cross, walks onto the crossing on a pedestrian red man signal, sees the vehicle and steps back to the kerb. This event was classified as a conflict.

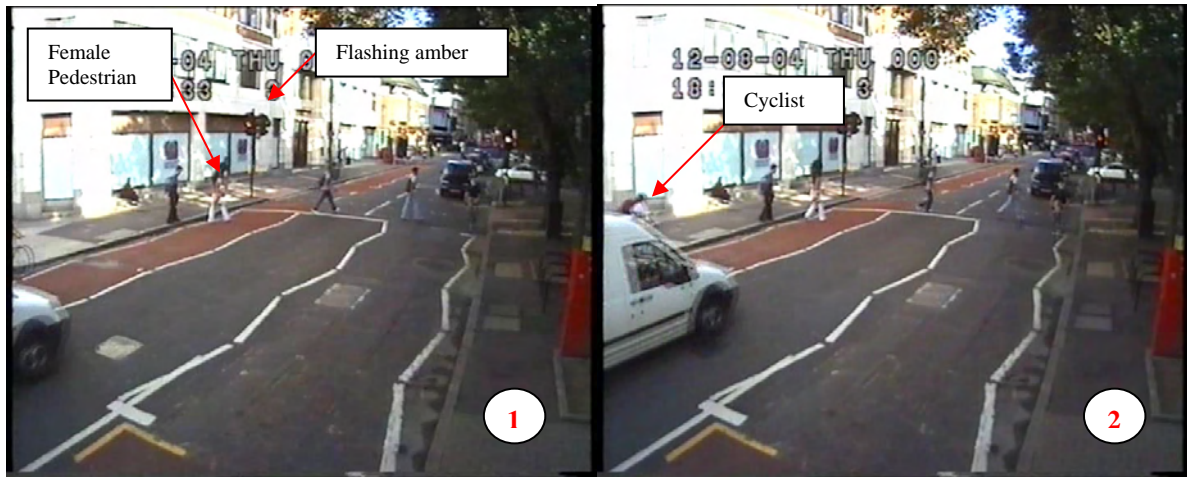
The following describes a conflict between a pedestrian and a cyclist. The female in white trousers follows a platoon of pedestrians and begins crossing on the flashing amber (Image 1) while a cyclist is approaching in the red bus lane (Image 2).

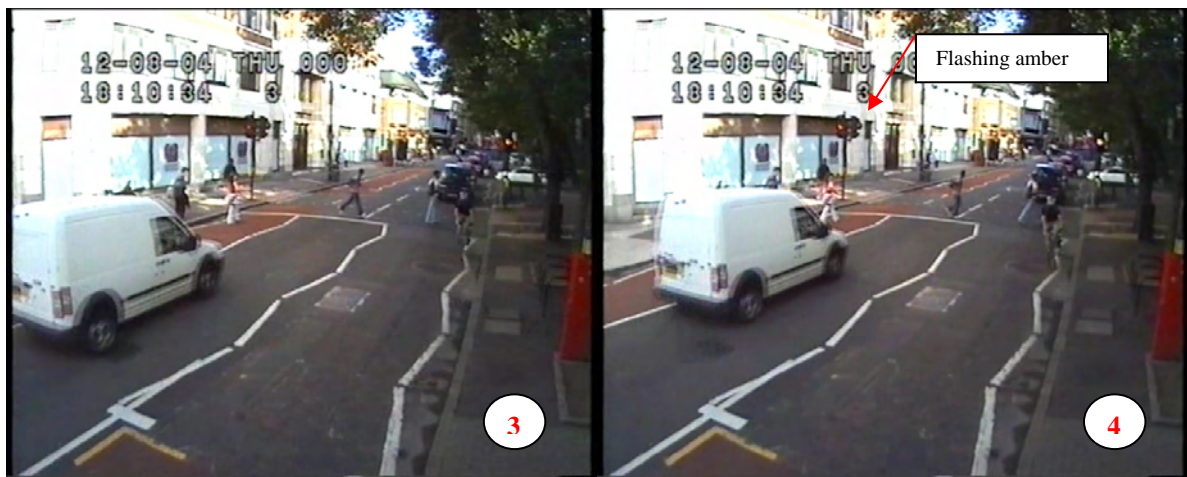
The white van makes no attempt to reduce speed even though the pedestrians still have priority on the crossing (Image 3). One pedestrian glances back over her right shoulder and looks at the van (Image 4).

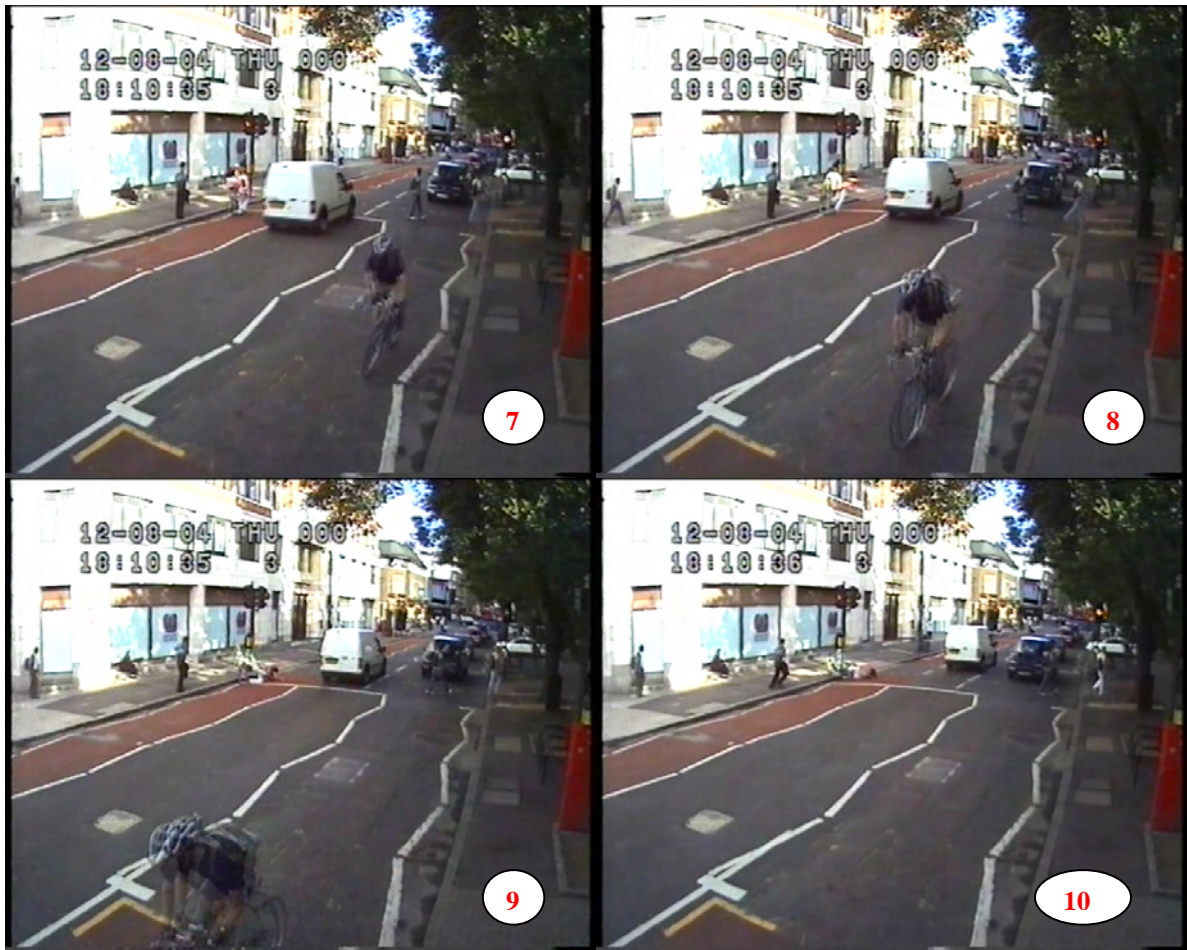
The pedestrian is thrown forward head first into the road and the cyclist appears to strike the kerb before being thrown off of his cycle (Images 7, 8, 9, 10).

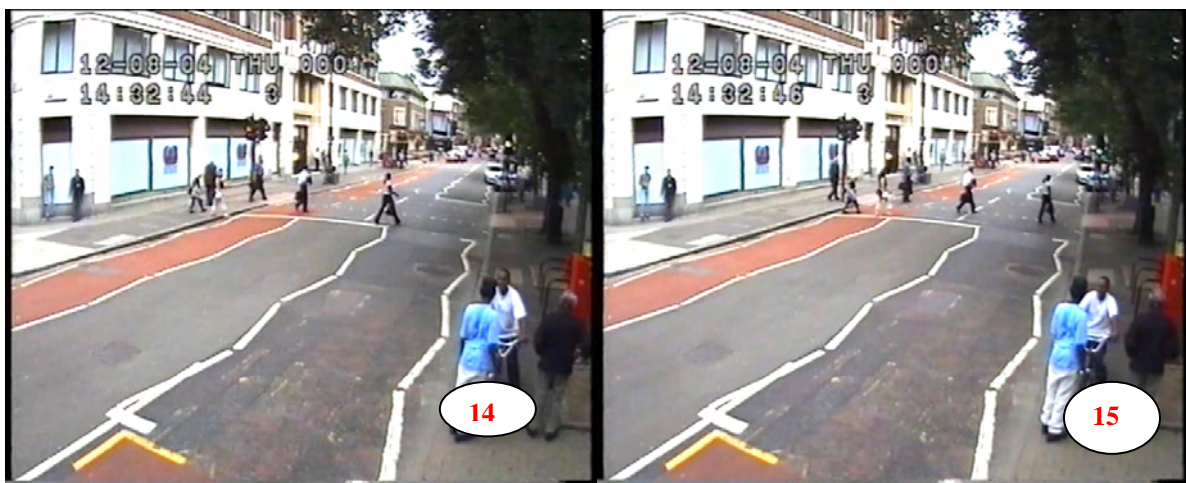
The following sequence of clips (Images 13 to 17) shows a similar pattern of crossing behaviour where the pedestrians platoon onto the crossing during the flashing amber sequence.

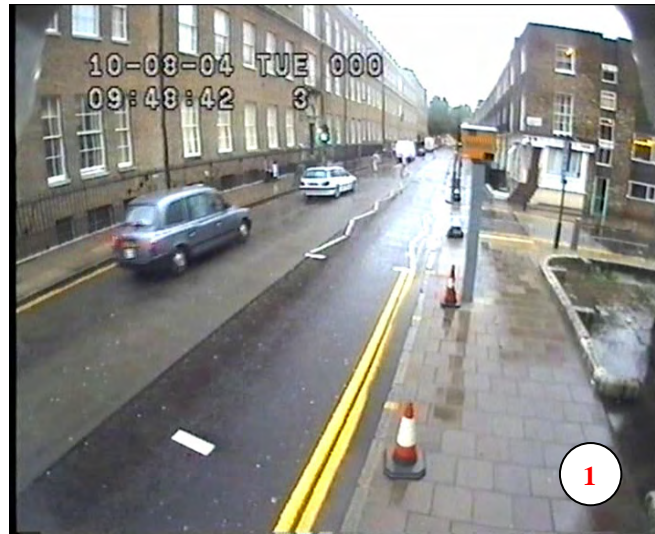
5.6.1 Observation A (puffin)

The vehicle flows were relatively low at this location and it is possible that pedestrians took advantage of this to cross on the vehicle green signal without making a pedestrian demand (image 1). This event was classified as an encounter.

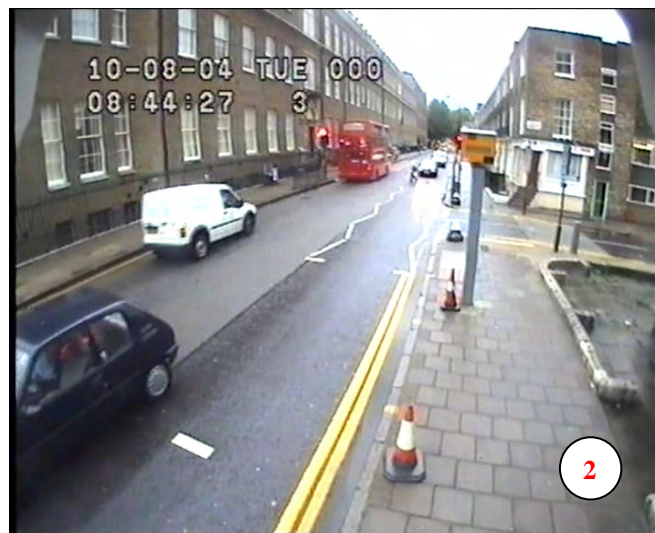
5.6.2 Observation B (puffin)

Vehicles did not always obey the signals and in image 2 a bus can be seen running the red light.

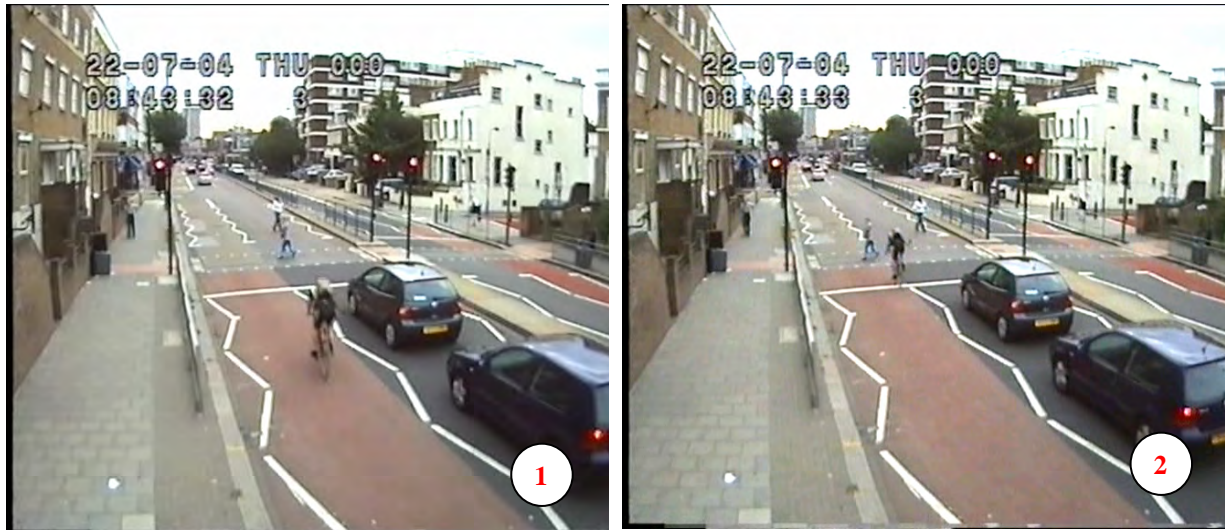
This crossing was characterised by the indiscipline of cyclists, many of whom ran the red light (Images 1 and 2).

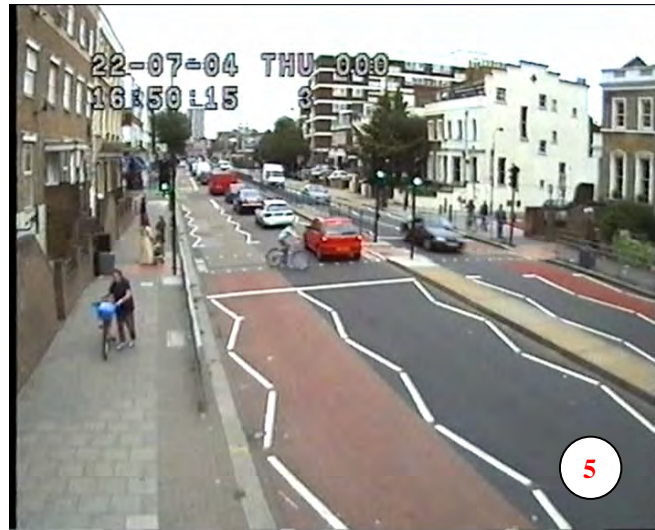
Cyclists were also observed cycling against the traffic to the crossing point (Images 3, 4 where the vehicle signals are changing to red and 5 on the vehicle green).

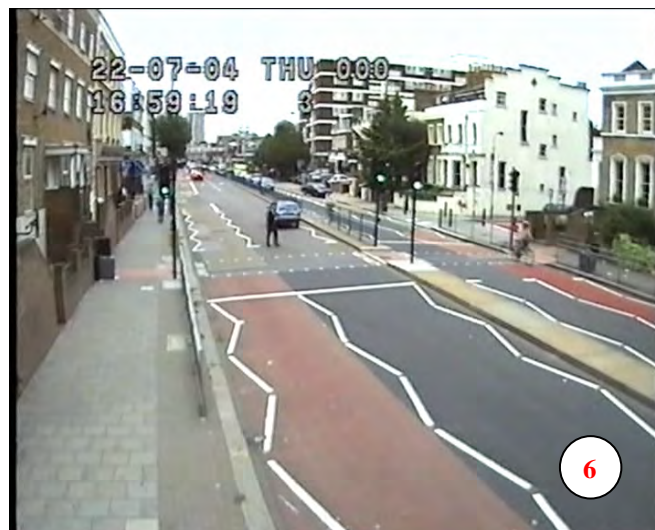
Pedestrians were also seen to walk along the carriageway in the road (outside of the guard rail) to the crossing point (Image 6). The signals were green to the traffic. These events were classified as encounters.

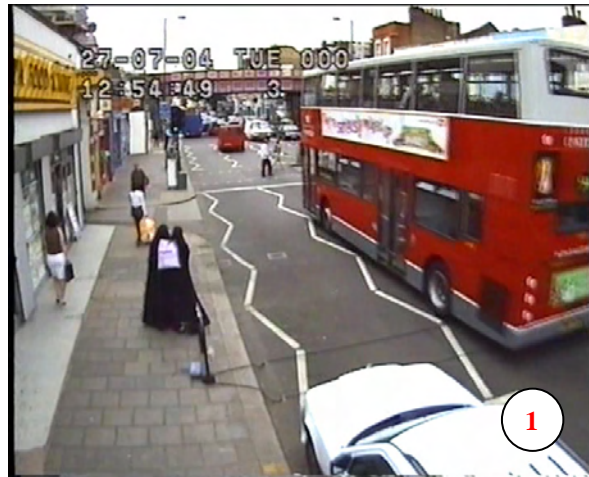
5.8.1 Observation A (pelican)

Image 1 shows a conflict between a pedestrian crossing on the vehicle green signal and the bus not slowing down, causing the pedestrian to run to the central refuge.

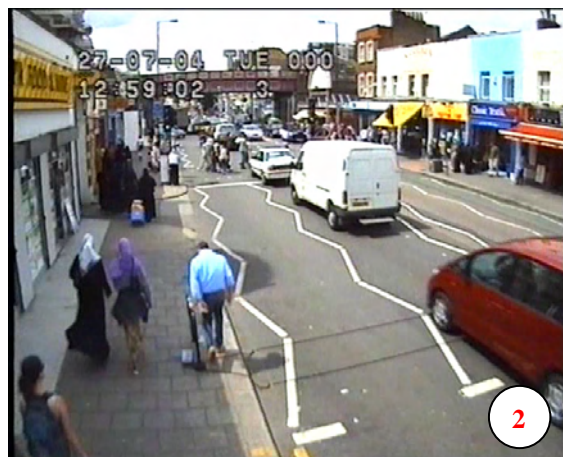
Image 2 shows a typical platoon of pedestrians crossing against the lights and the traffic giving way, possibly due to queuing vehicles ahead. At this location pedestrians crossed in platoons against the lights but were mostly crossing within the boundary of the Pelican crossing (despite the opportunity to cross elsewhere due to lack of guardrails). The formal crossing place was the preferred crossing location.
