**PUBLISHED PROJECT REPORT PPR240**

**BEHAVIOUR AT CYCLE ADVANCED STOP LINES**

**Prepared for:** Transport for London

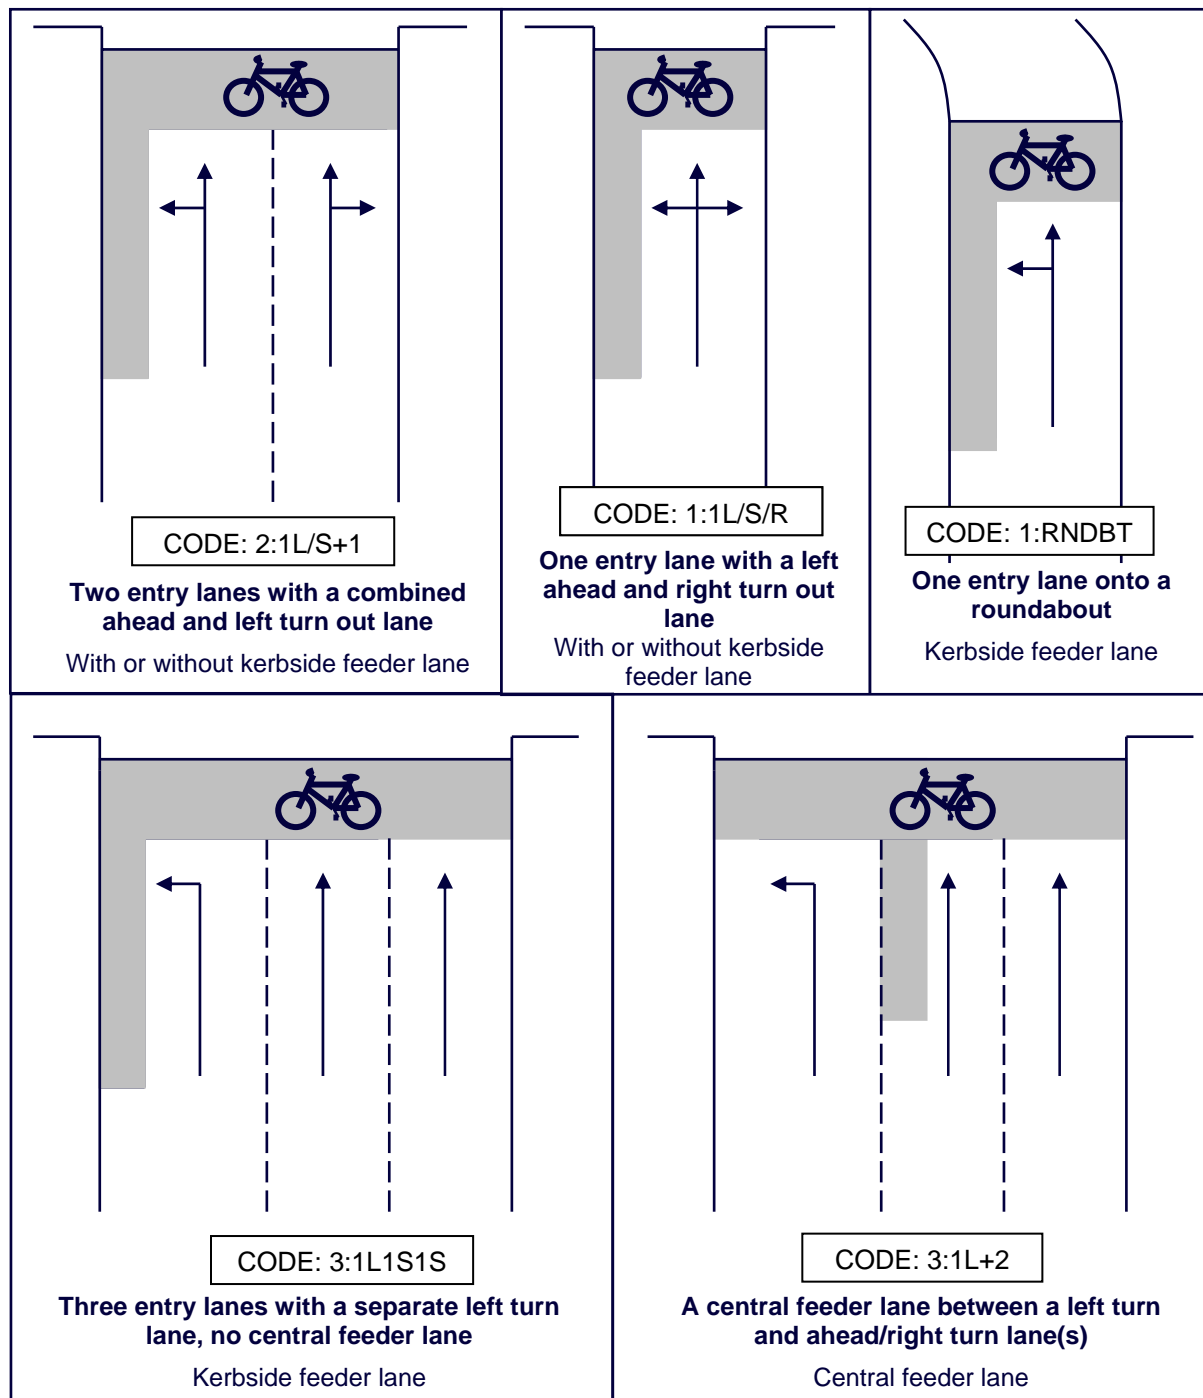
**Figure 3.1: Layout of sites with ASLs present**

Figures 3.1 and 3.2 provide a schematic representation of each of the ‘typical’ layouts studied and their shorthand codes. For codes 2:1L/S+1 and 3:1L+2, the last digit denotes an additional lane(s) which may be a straight ahead only or a straight ahead/right lane depending upon the site. It should be noted that one of the two control sites prohibited left turns. For ease of reference, the diagrams below are provided as a fold-out page in Appendix C.

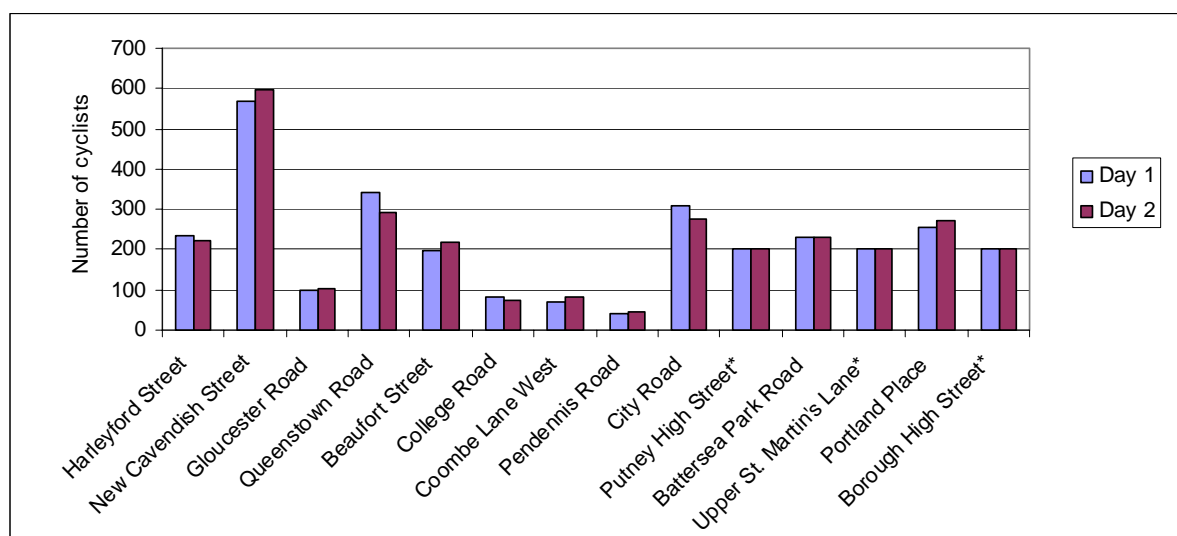
**Figure 4.1 Cyclist flows by day for each site (\*capped sites)**

The table shows that at all but one of the sites surveyed, the number of cyclists monitored exceeded the requirement of 100 per site (from 11 hours footage for each of the 2 days, 7am-6pm). Cyclist flows were particularly high at New Cavendish Street, City Road, Queenstown Road, Portland Place and the three capped sites. In total, 6,041 cyclists were observed for this study.

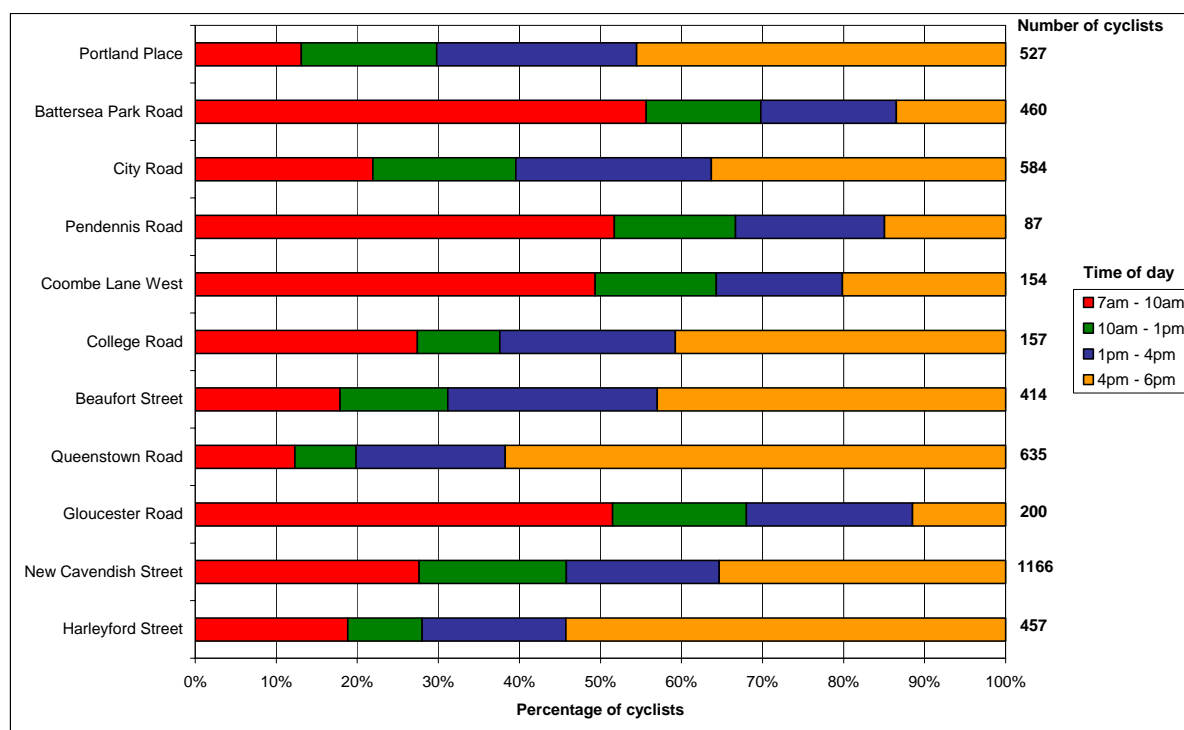
**Figure 4.2 Cyclist flows by time of day for each site**

For the purpose of the analysis, peak hours were defined as 07:00 to 10:00 and 16:00 to 18:00 and off-peak hours as 10:00 to 16:00. As would be expected, cyclist flows at all of the sites were found to be higher during peak periods than off-peak periods as shown in Table 4.3. Of those sites for which data collection was not capped, peak flows were proportionally highest at Queenstown Road and Harleyford Street. Of the ASL sites, overall 63% of cyclists recorded were during the peak hours. Including the control sites, the number of cyclists recorded during the peak hours was 62%.

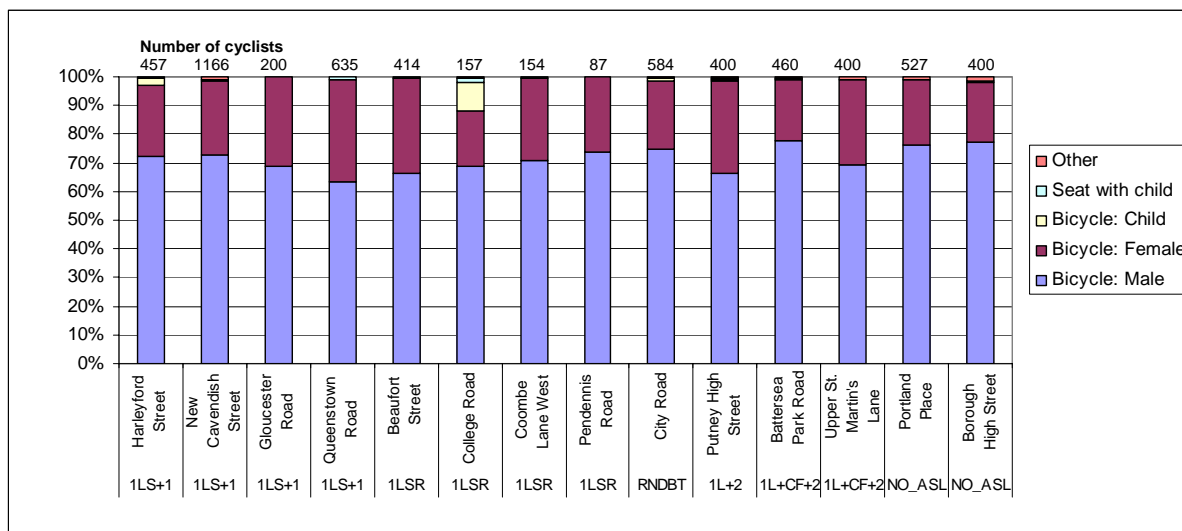
**Figure 4.3 Cyclist characteristics for each site**

Figure 4.3 provides an analysis of cyclist flows by cyclist details (i.e. gender and estimated age). A child cyclist was a cyclist estimated by the video analyst to be 16 years old or less. Figure 4.3 indicates that the majority of cyclists at all sites were adult males (71%). In

contrast to other sites, a higher proportion of child cyclists was observed at College Road. This could be attributed to the close proximity of Dulwich College. The ‘other’ category equates to more unusual pedal cycle details, for example, a recumbent or a tandem (a recumbent cycle is a machine with two or more wheels, where the rider sits in a seat with legs in a horizontal position).

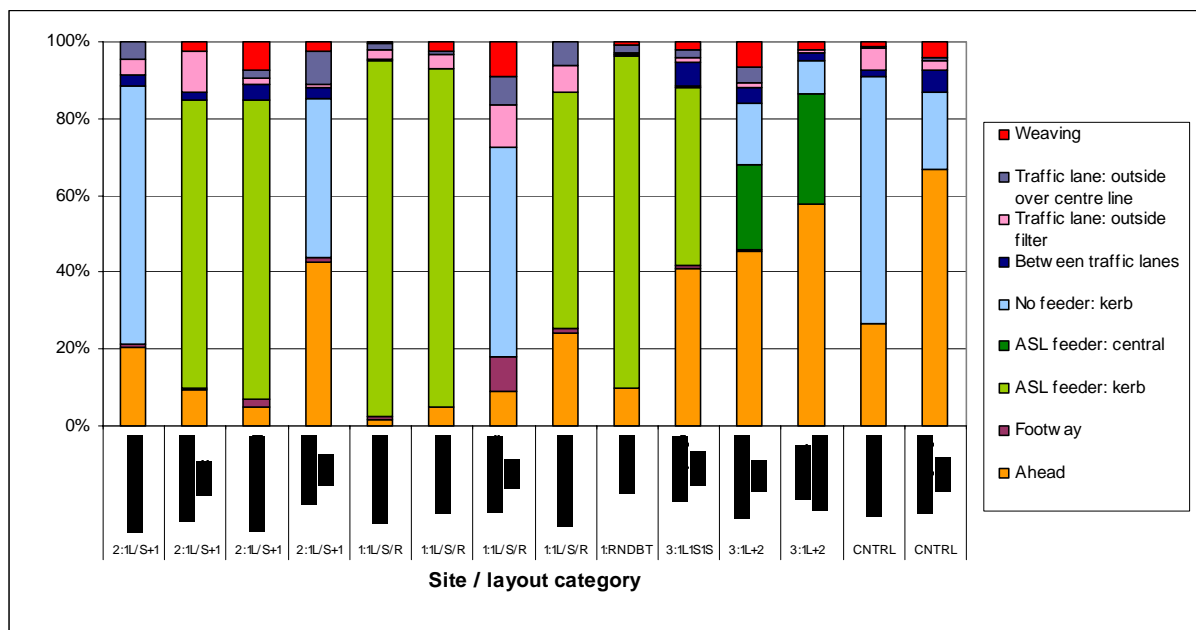
**Figure 4.4 Approach methods of cyclists by site**

Approaching ahead of the traffic stream was relatively common, particularly at layout 3:1L+2 sites and the control sites. At Coombe Lane West, nearly 10% of cyclists approached the junction using the footway, perhaps due to heavy traffic, fear, vehicle encroachment on the ASL/feeder lane or a narrow layout. It should be noted that Coombe Lane West was the only category 1:1L/S/R type junction that did not have an ASL feeder lane. At the Battersea Park Road and Upper St. Martin’s Lane category 3:1L+2 sites, where a feeder lane was in place, approximately 25% of cyclists used the central feeder lane to approach the junction. However, 51% of cyclists at this site type approached the junction ahead of the traffic stream and therefore did not need to contend with other traffic. Approaching between the traffic lanes occurred at all sites with more than one lane. Weaving by the cyclist was found to take place at all of the layout types, but, of the ASL sites, occurred the most at category 3:1L+2 type junction layouts. The separate left turn lane might be a factor in this increased level of weaving as cyclists manoeuvre away from the kerbside into the traffic flow.

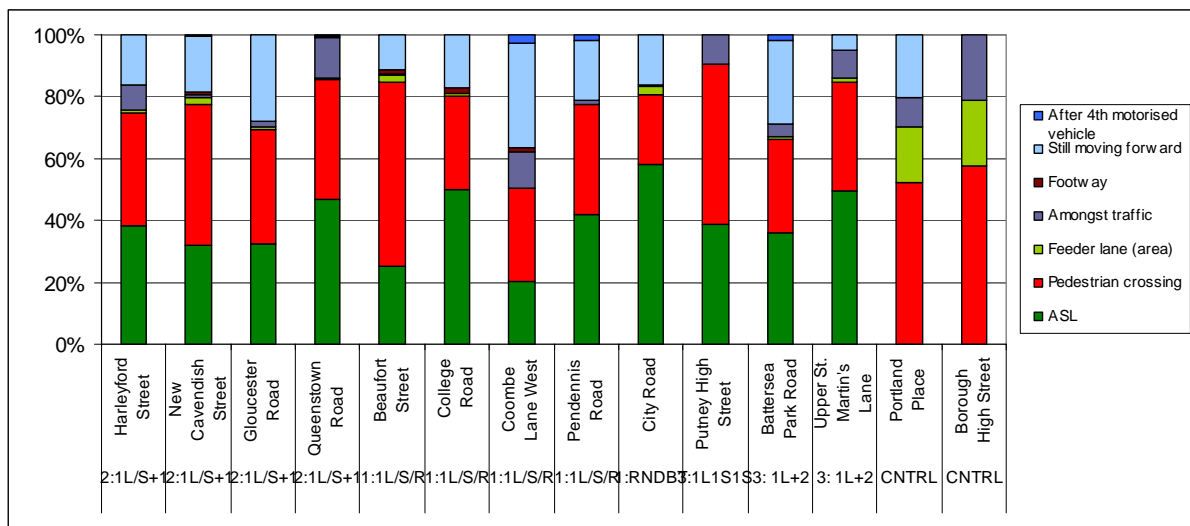
**Figure 4.8 Positioning of cyclists who waited at each site**

Note: 'After 4<sup>th</sup> motorised vehicle' refers to cyclists stopping/waiting after the 4<sup>th</sup> motorised vehicle in the traffic stream. This indicates those cyclists who have stopped further back in the traffic queue.

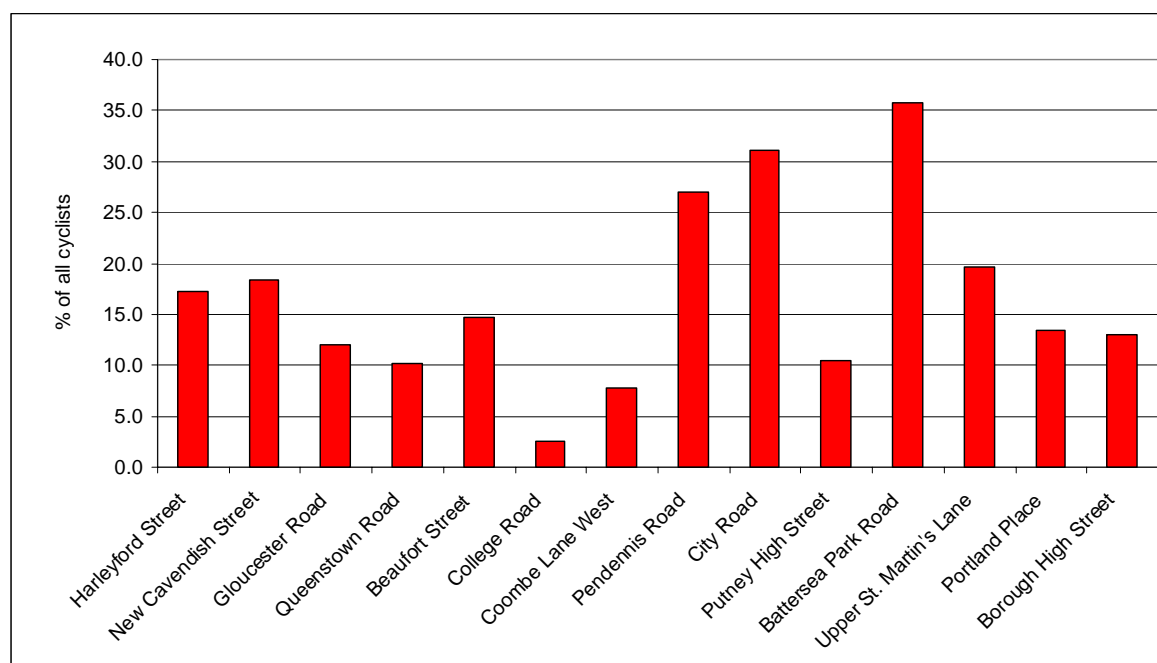
**Figure 4.10 Proportion of red light violation by cyclists**

Note: Traffic signals at Beaufort Street and Battersea Park Road were not in camera view, due to constraints on camera mounting points. Cycle red light violation was gauged by other vehicle movements, such as vehicles stopping and starting from stationary.

Table 4.12 below further informs the Figure 4.10 by showing the number of violations by cyclists against the number of observed cyclists per site. Across all ASL sites an average of 17% of cyclists violated red lights.

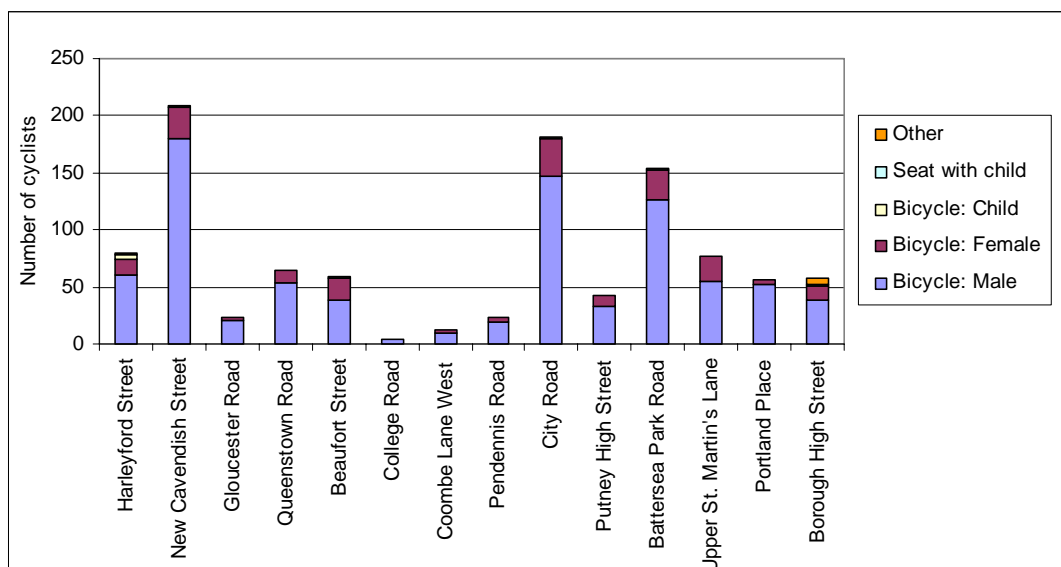
**Figure 4.13 Red light violation by cyclist details for each site**

As Figure 4.13 shows, the majority of cyclists violating red lights were adult males. This was the case at every site analysed. A notable observation was the proportionally large number of under 16 cyclists violating red lights at Harleyford Street (5%) and several ‘other’ violating the red lights at Borough High Street. The majority of cyclists violating red lights were adult males, contributing almost 80% of violations. By considering the total numbers of cyclists surveyed, 20% of male cyclists violated the red light across all sites compared with 12% of female cyclists; this suggests that any educational approach to encourage compliance should be targeted particularly at male cyclists.

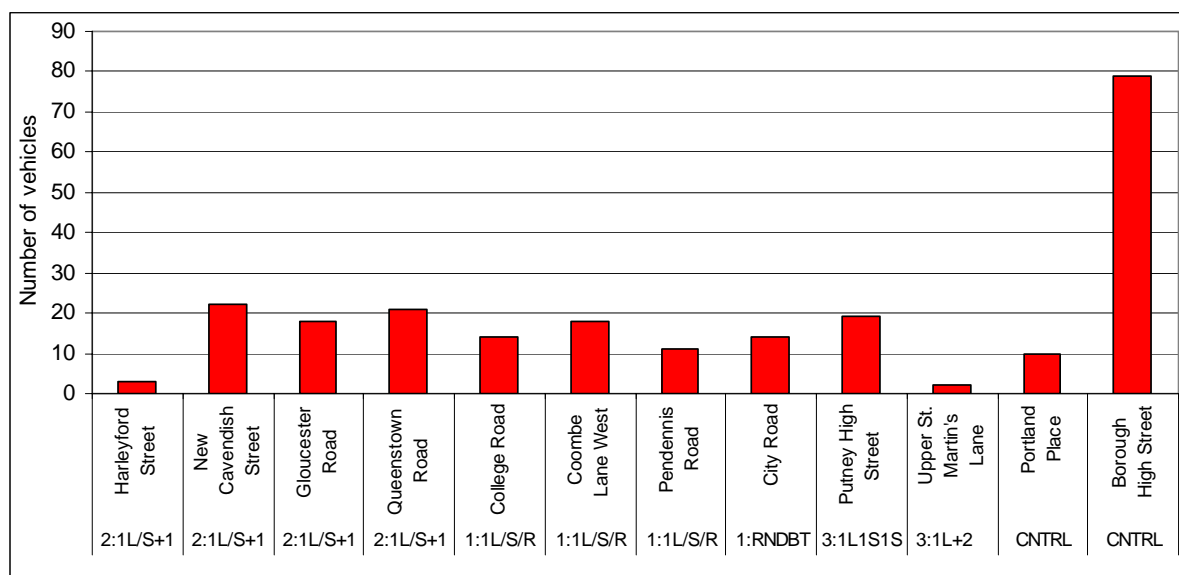
**Figure 4.14 Red light violation for each site (all vehicle types) based on 1 in 5 traffic light cycles**

Figure 4.14 below shows the number of vehicles violating red lights at each of the sites. Borough High Street (a control site), showed a noticeably higher proportion of red light violation than any of the other sites. This could be due to site-specific factors such as:

Table 4.14 supports the data shown in Figure 4.14 and illustrates the level of red light running by vehicles (for every fifth traffic light phase for one day) by the number of traffic light phases monitored. It shows the average number of red light violations per traffic light phase ranged from 0.02 to 0.65. There appears to be no correlation between the level of red light running and the lane layout.

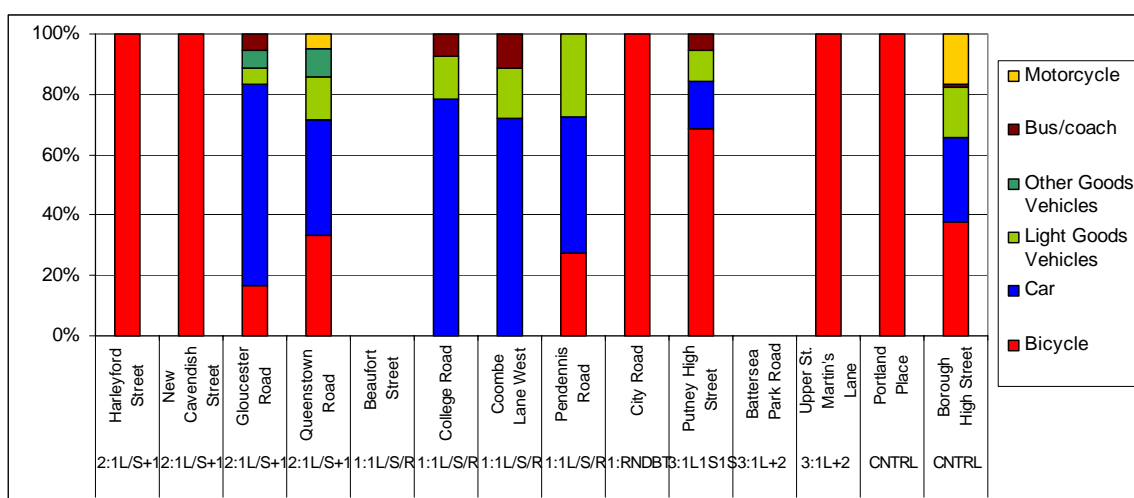
**Figure 4.15 Percentage of red light violations by vehicle type for each site**

Note: This data is taken from every one in five traffic light phases. No data was available for Beaufort Street and Battersea Park Road because the traffic light was not in the camera view

Table 4.15 below supports Figure 4.15 by showing the actual number of vehicles violating the red lights at each of the sites based on the sample of red phases.

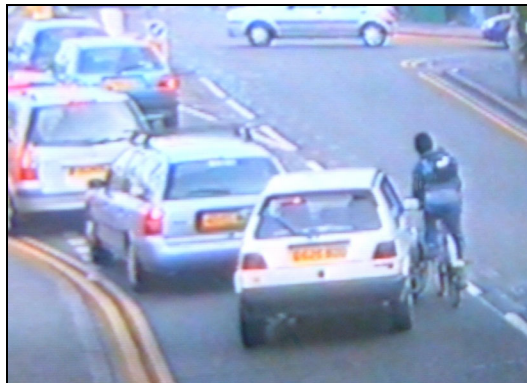
**Plate 4.1: Gloucester Road conflict level 5**

**Incident Description:** The cyclist moved towards the rear of the traffic and manoeuvred to outside the lane near the centre line. A car started to turn right into the outside lane, and whilst doing so hit the cyclist who wobbles but does not fall off. The cyclist stops to check the bicycle, signals to the driver and then carries on with the journey.

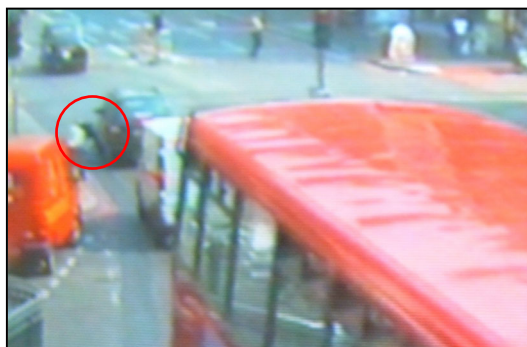
**Plate 4.2: Borough High Street conflict level 5**

**Incident Description:** The cyclist approached the ASL behind a car which braked suddenly. The cyclist, travelling at speed, cycled into the back of the car and fell off the bike.

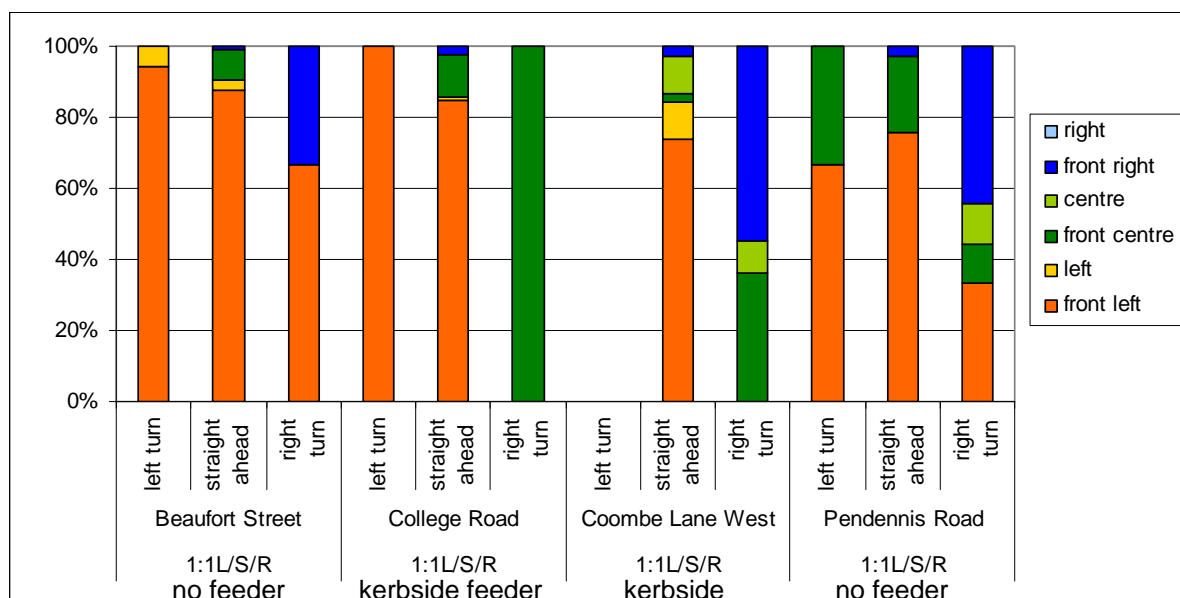
**Figure 4.19 Position cyclists wait at junction by manoeuvre made on exit – Category 1:1L/S/R**

Table 4.38 and Figure 4.19 show that for all single lane (1:1L/S/R) layouts, the majority of cyclists were travelling straight on. It can be determined that 85% of cyclists across all the sites continued straight ahead from a front left position, whilst 92% of the left-turners located themselves at the front left. It should be noted however the overall number of cyclists making a left turn was relatively small (38 cyclists). Of the cyclists turning right, there was more variation. At Coombe Lane West there was a mixture between front right, centre and front centre whereas at Pendennis Road 44% (4 cyclists) were able to locate to the front right. Although trends can be identified within the data it should be highlighted that in some cases sample sizes are small.

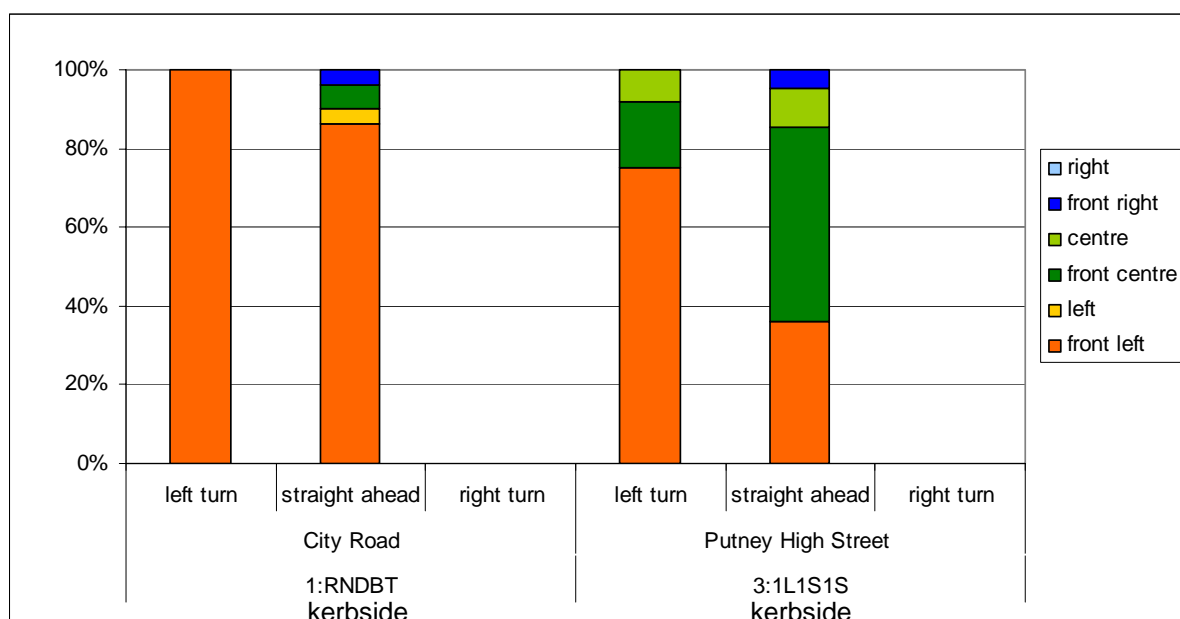
**Figure 4.20 Position cyclists wait at junction by manoeuvre made on exit Categories 1:RNDBT and 3:1L1S1S**

Table 4.39 and Figure 4.20 below show the layout categories 1:RNDBT and 3:1L1S1S. The large majority of cyclists were travelling straight ahead. At City Road, for both travelling straight on and left, it can be determined that 86% of cyclists positioned themselves front left. At Putney High Street, for turning left 9 out of 12 cyclists (75%) were situated front left whereas for travelling straight on, the positions varied, mainly between front left (36%) and front centre (49%) which indicates they managed to reach the front of the traffic (it should be noted that in this instance the number of cyclists travelling straight on from front left and front centre is relatively small at 30 and 41 cyclists respectively). It also shows that cyclists travelling straight on were able to manoeuvre away from the separate left turn lane.

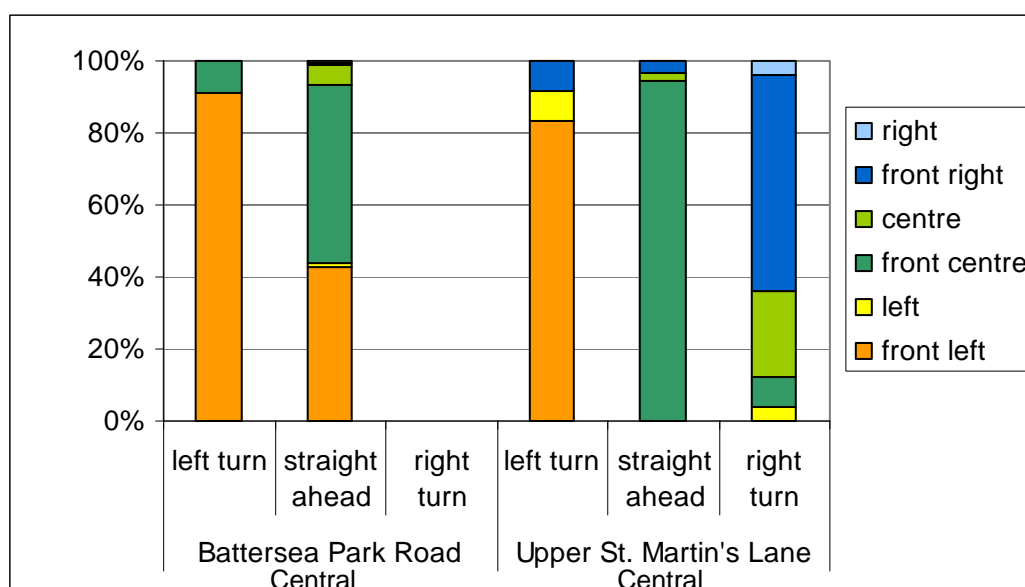
**Figure 4.21 Position cyclists wait at junction by manoeuvre made on exit  
Category 3:1L+2**

For layout category 3:1L+2 sites with a central feeder lane as shown below (Table 4.40 and Figure 4.21), exiting straight on was the most common manoeuvre (81% of all manoeuvres). At Upper St Martins lane the ASL reservoir was split in two: there was an ASL reservoir in front of the left hand lane, for all cyclists turning left. There was another ASL reservoir which was separated by a traffic island for the remaining two lanes for cyclists going straight on or right. Of the cyclists turning left at layout category 3:1L+2 sites, it can be determined that 87% of cyclists positioned themselves front left (also shown in Table 4.42). However, for travelling straight on, at Upper St. Martin's Lane, 95% (53 out of 56 cyclists) of cyclists positioned themselves front centre (which is the left position of the second ASL in this case), whilst at Battersea Park Road they either predominantly located front left (43%) or front centre (49%) (which indicates that they were able to manoeuvre out of the left turn lane). At Upper St Martins Lane, those cyclists that went straight on approached via the central feeder or ahead of the traffic stream. For turning right (only relevant to Upper St. Martin's Lane), 60% (15 out of 25 cyclists) of cyclists managed to position themselves front right, ahead of the traffic.

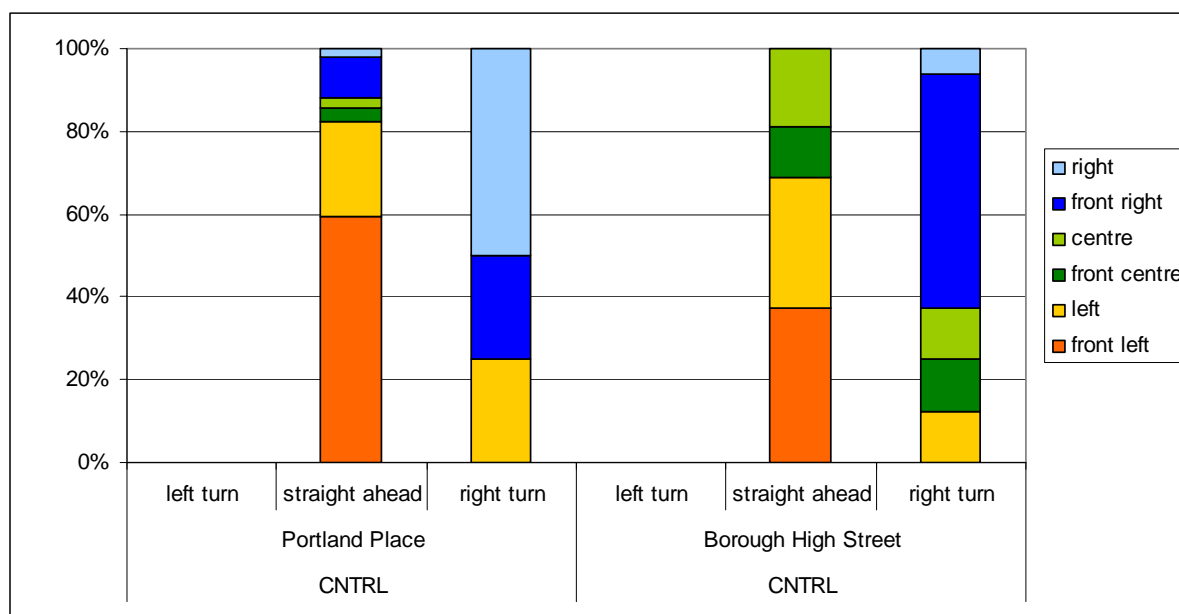
**Figure 4.22 Position cyclists wait at junction by manoeuvre made on exit Control sites**

Table 4.41 and Figure 4.22 show the position waited by manoeuvre made of cyclists at the two control sites. At Portland Place there was no left turn allowed. At Borough High Street a left turn was allowed, but no cyclists made this manoeuvre. The data shows a strong variability in the positing of cyclists at control sites.

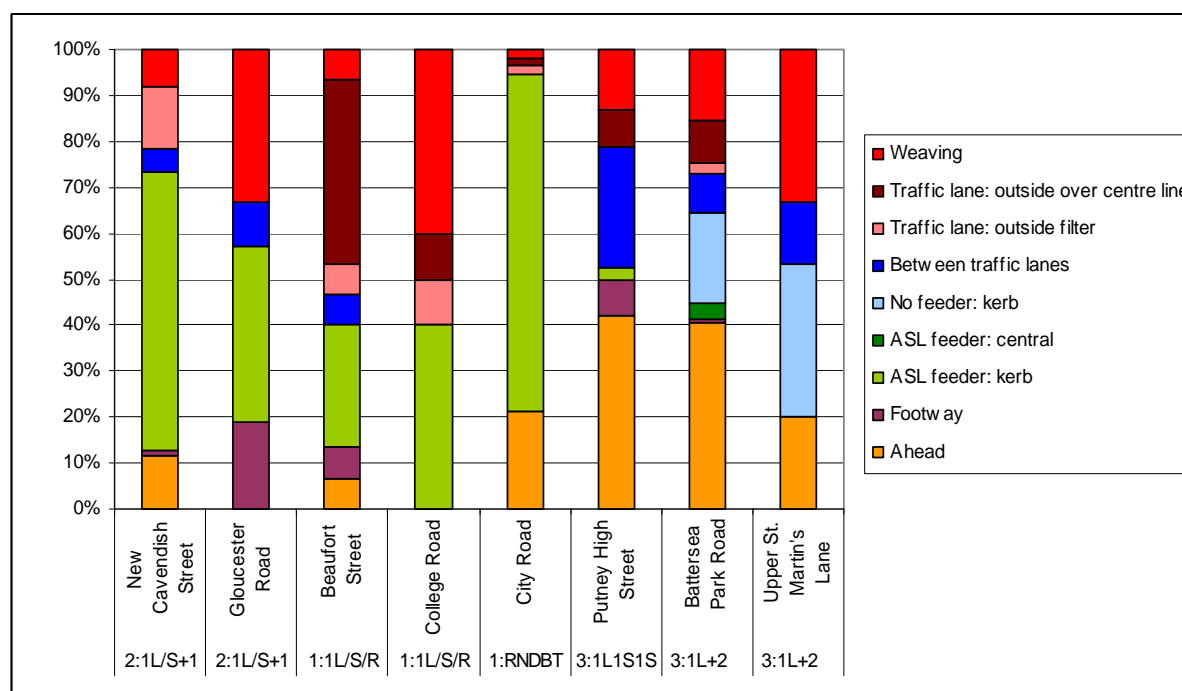
**Figure 4.25 Approach method when the feeder lane was blocked**

Table 4.46, summarised in Table 4.47, and illustrated in Figure 4.25, shows the method of approach by cyclists who experienced a blocked feeder lane. It indicates that across all sites, when the feeder lane is partially or fully blocked, the proportion of cyclists weaving increases from 1% of cyclists to 13% of cyclists. There is also a higher level of footway cycling when the feeder lane is blocked. The ASL kerbside feeder lane is used by 62% of cyclists when it is free compared to 35% when it is blocked. Likewise the central feeder lane is used by 7% of cyclists when it is free compared to 1% when it is blocked. This represents a 33% decrease of feeder lane use (kerbside or central) when the feeder lane is blocked.

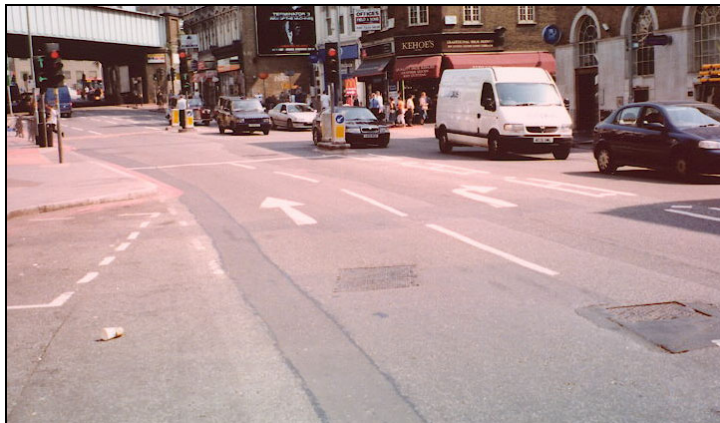
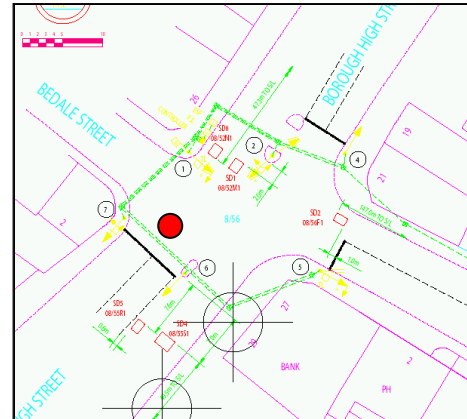
**Borough High Street CODE: CNTRL (no ASL reservoir or feeder)**

Note: Left turns are allowed at this site, but no vehicles turned left over the 2 days analysed.
