The effect of re-timed invitation to cross periods on road users at signalised junctions in London

PUBLISHED PROJECT REPORT PPR411

Prepared for: Project Record: The effect of re-timed invitation to cross periods on road users at junctions in London
Client: Transport for London, London Road Safety Unit (Peter Sadler)

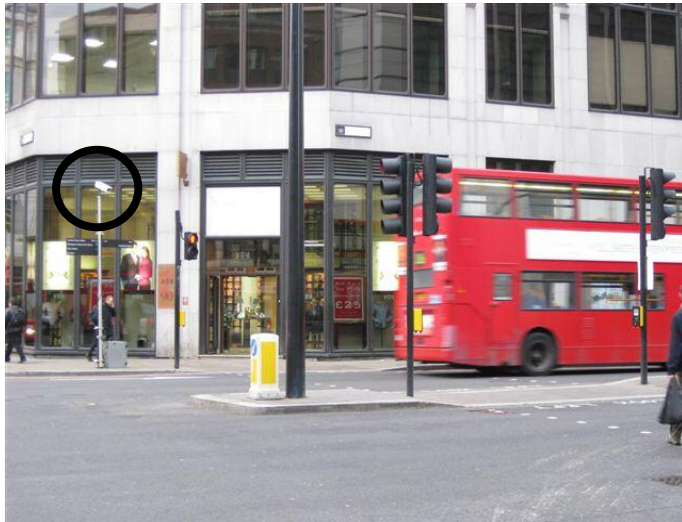
Two cameras were mounted at each site and these were located at a minimum height of about 3-4 metres on existing street furniture or on free-standing poles so as to provide an optimal view of the crossing. One camera was on each side of the carriageway with both cameras directed transversely across the road at the pedestrian crossing point (see Figure 2-11).

Figure 2-11 – Camera mounted on free-standing pole

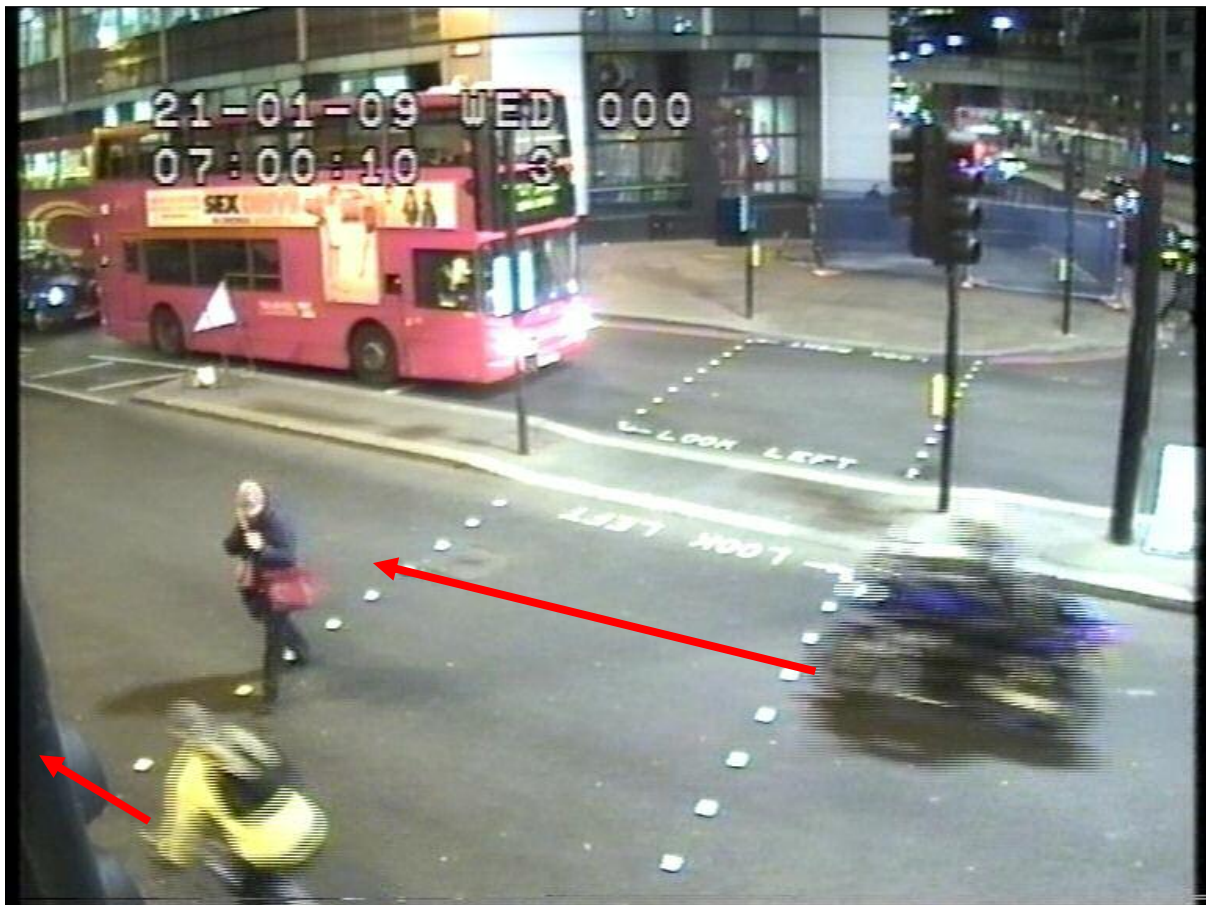
The example in Figure 2-12 was taken from site 00/025 Bishopsgate by Wormwood Street junction. It represents the type of incident that was categorised as being a conflict grade 1. In this example the pedestrian was crossing the carriageway whilst the pedestrian signals were indicating a red man. They modified their pace to allow the motorcyclist to pass behind them and the cyclist to cross in front of them.

Figure 2-12 Conflict grade 1

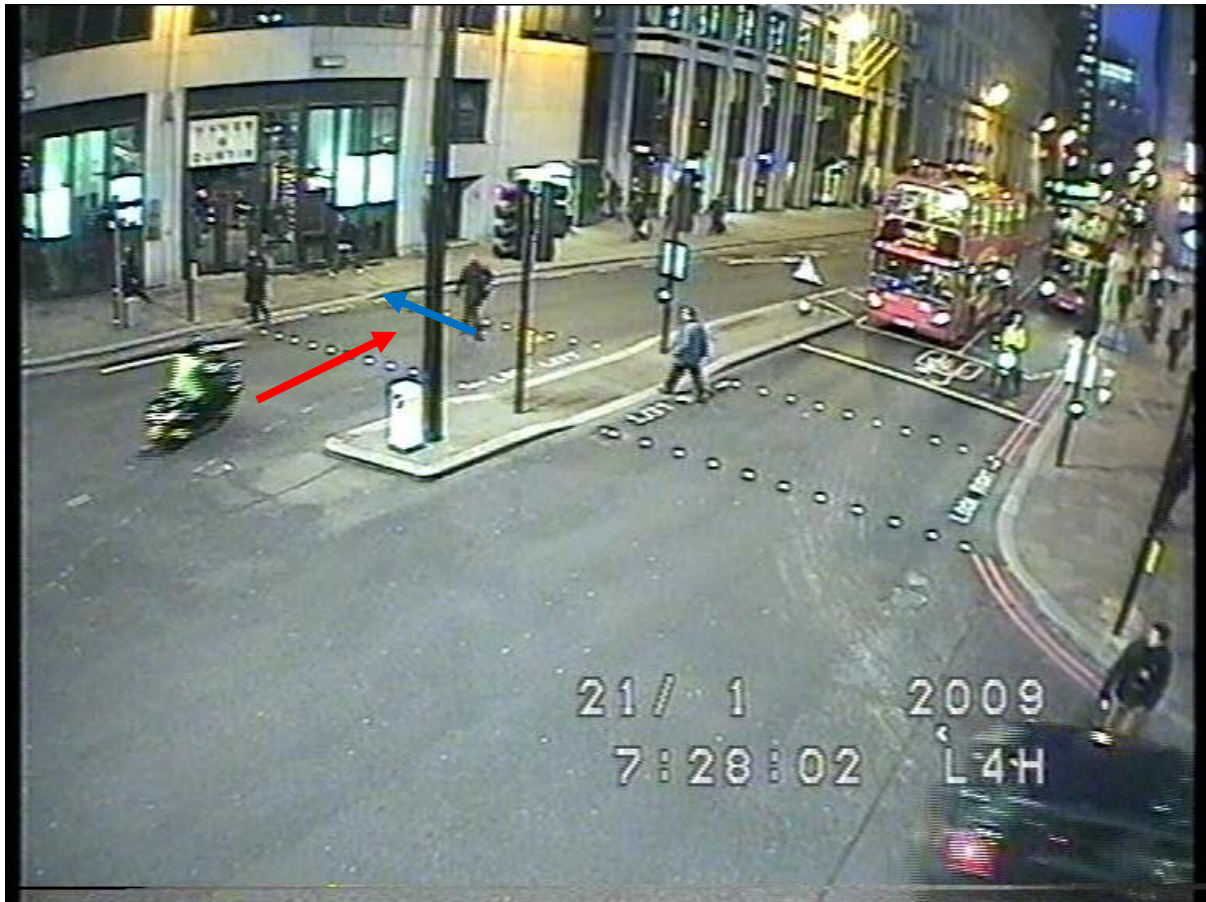
Figure 2-13 represents an incident which has been categorised as being a conflict grade 2. In this example the pedestrian uses controlled action to speed up and avoid being in the path of the approaching motorcyclist. The video footage does not suggest that the motorcyclist needed to change his path or speed as a result of the pedestrian's presence.

Figure 2-13 Conflict grade 2

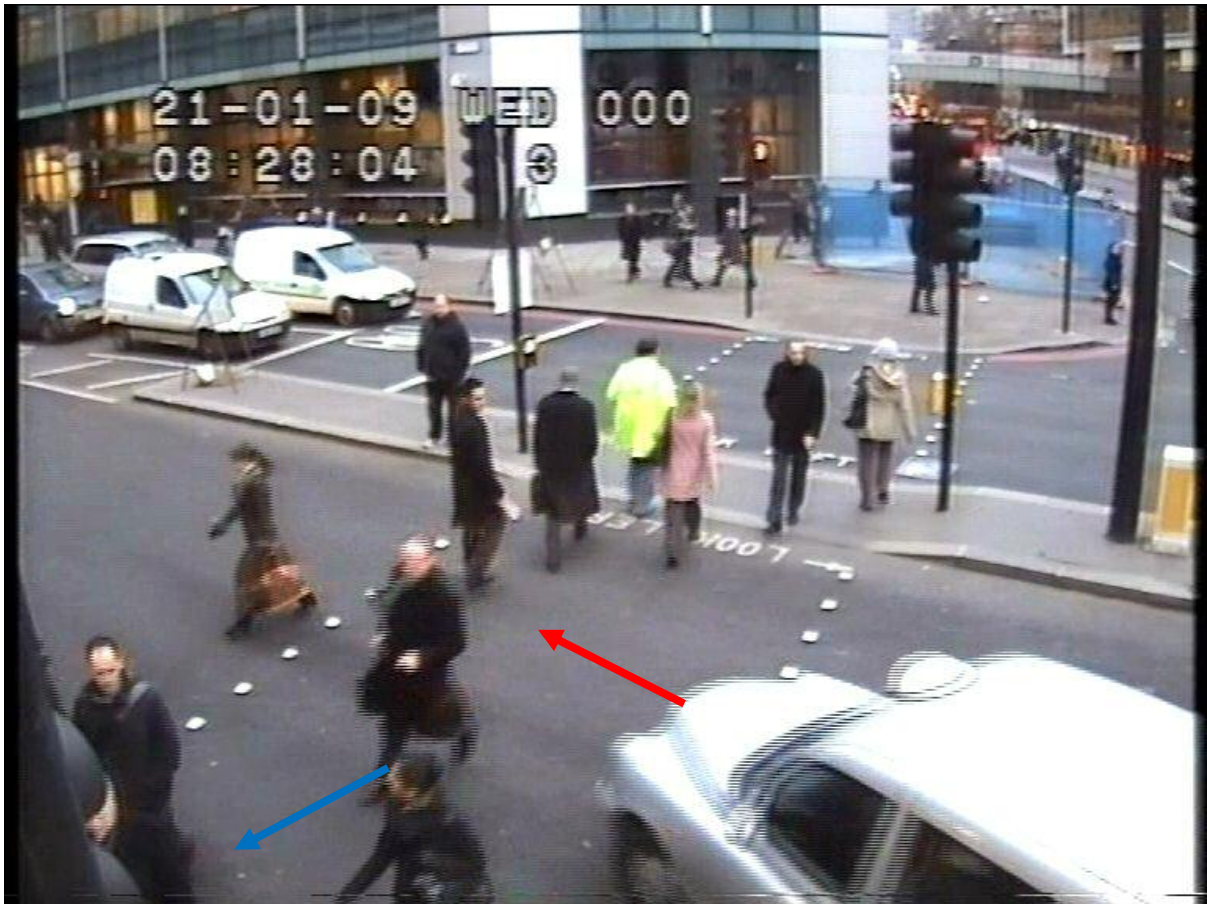
An example of a conflict graded as a 3 under this study, can be seen in Figure 2-14. It shows many pedestrians crossing the carriageway under red man conditions. As the taxi approaches from Wormwood Street heading South onto Bishopsgate, the pedestrian rapidly changes his path and his speed to avoid the conflict. Additionally the taxi slowed.

Figure 2-14 Conflict grade 3

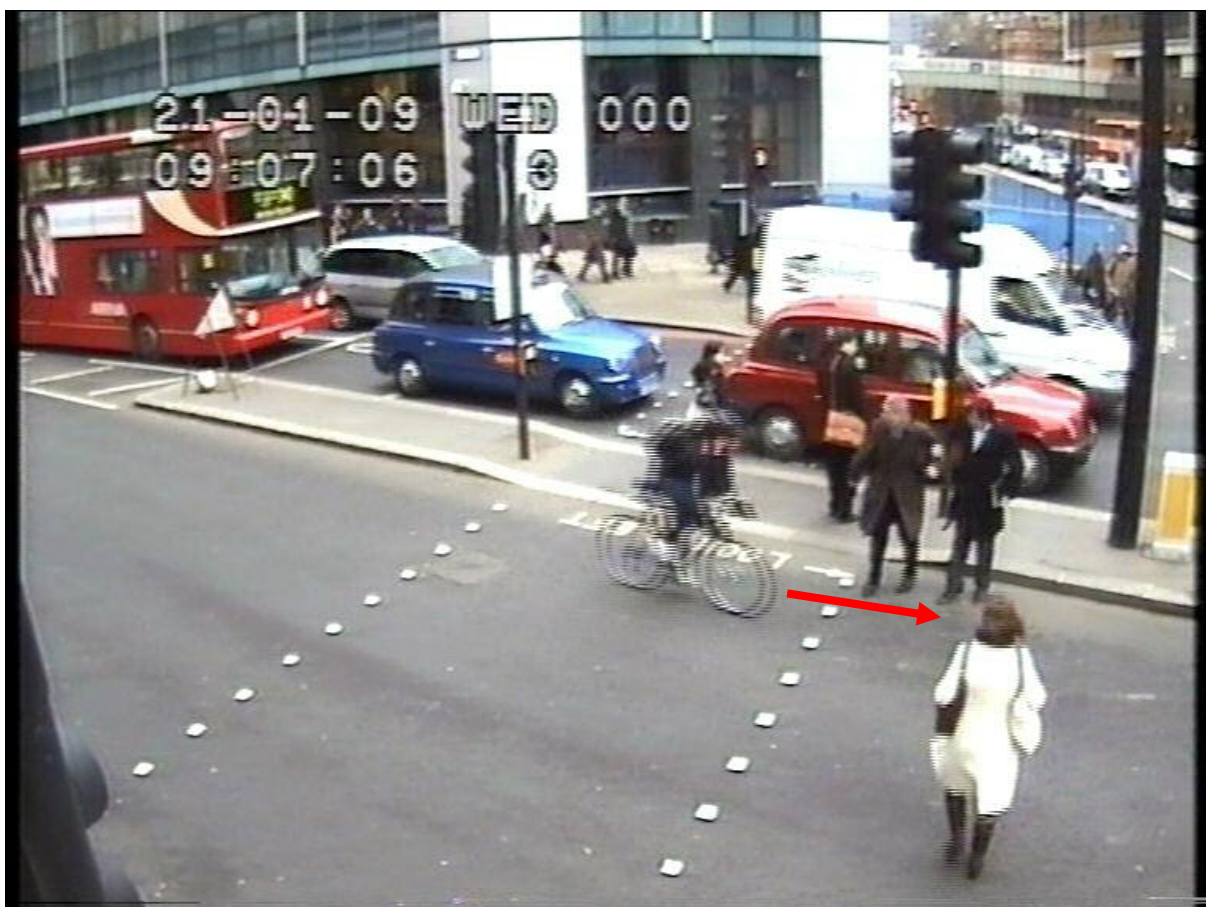
Figure 2-15 is a screenshot from the video footage that shows a conflict graded 4 under this study. It shows the cyclist travelling north on the southbound carriageway to avoid the queued traffic. The pedestrians have crossed the road under a red man period and have waited on the central refuge. Having checked for traffic on their left, they have proceeded to cross. The conflict shows a very near miss between them and the cyclist, a collision is only avoided because one of the pedestrians stops abruptly to avoid the cyclist.

Figure 2-15 Conflict grade 4

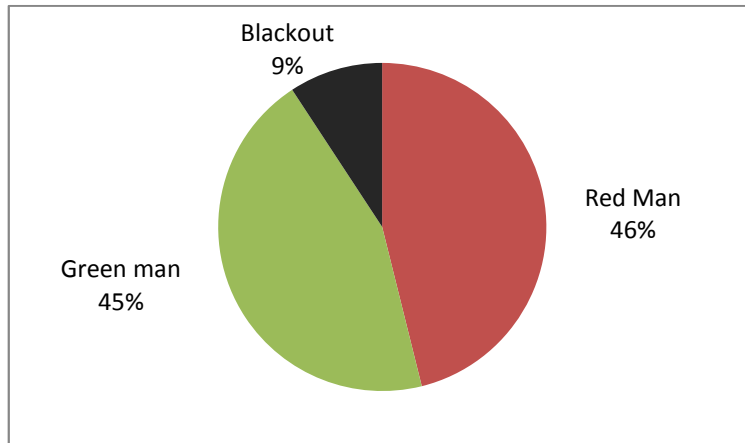
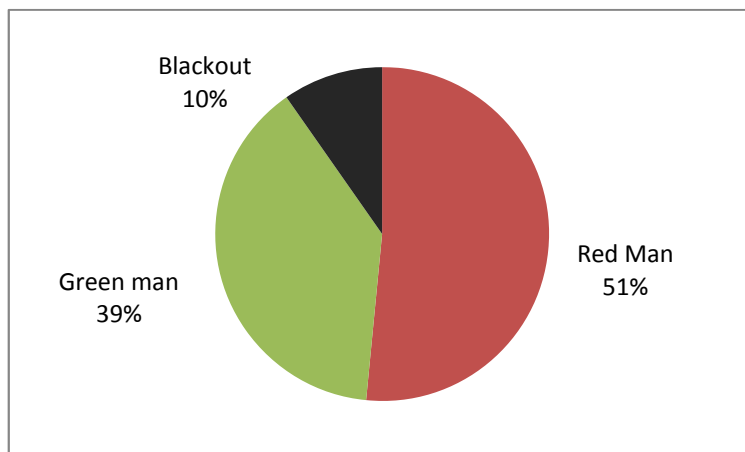
Figure 3-1 and Figure 3-2 show the variation between the before and after studies. In the first study, when the pedestrian invitation period was set at its original level the proportion of pedestrians that crossed under red man and green man periods was roughly equal. In the second study however, the results show that the numbers of pedestrians obeying the signals and waiting for the invitation period before crossing has reduced in comparison to those crossing under the red man period. In both the before and after study the proportion of pedestrians crossing under the blackout period was similar.

Figure 3-1 Compliance with pedestrian signals, Before period

Figure 3-2 Compliance with pedestrian signals, After period

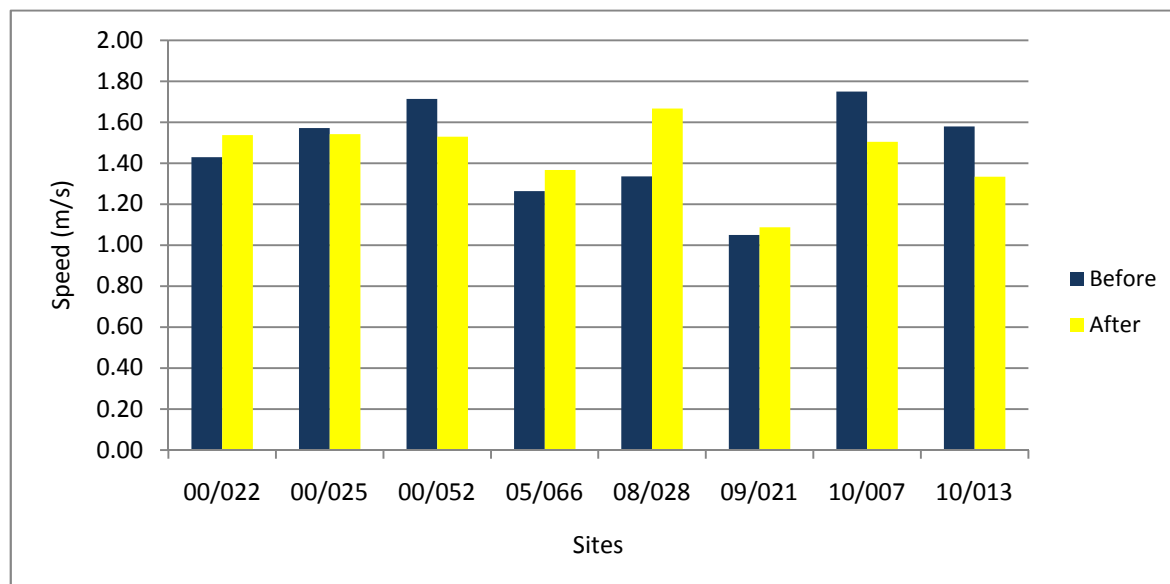
Figure 3-3 Average crossing speeds

Figure 3-3 shows that the average pedestrian crossing speed varied somewhat from site to site. There was a range in raw figures of 0.91 to 3.13 m/s in the before study and 0.93 to 2.51 m/s in the after study. It should be noted that the frequency of pedestrians crossing at the slowest speeds was extremely small. Figure 3-4 shows the distribution of the crossing speeds observed at all sample sites.

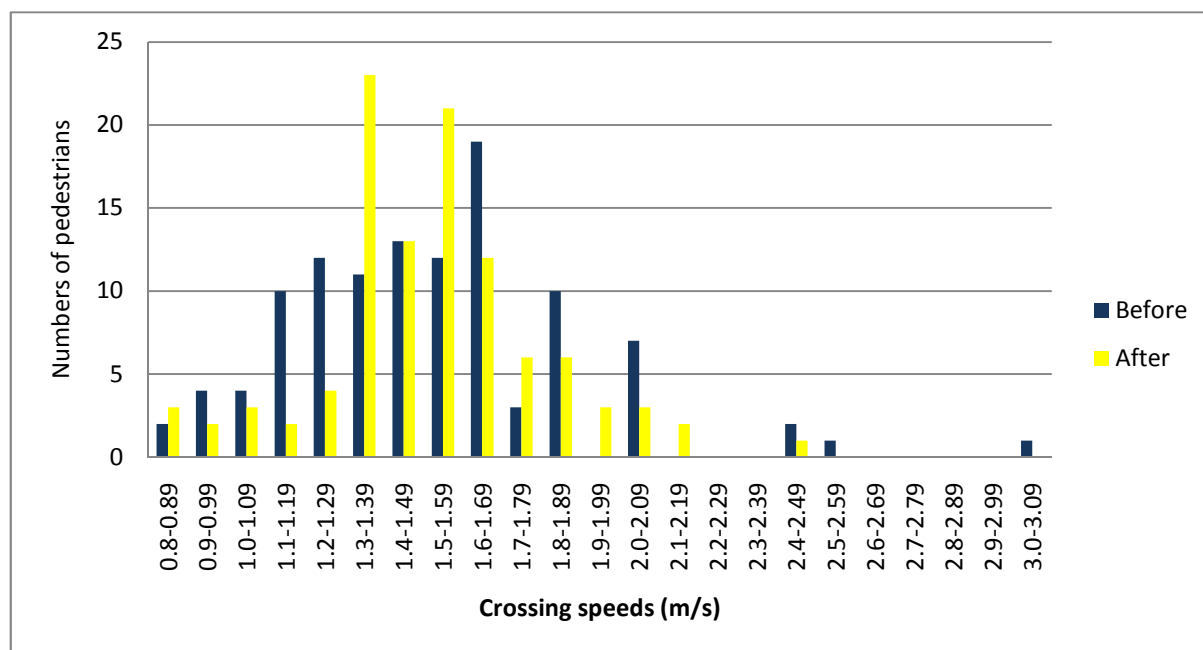
Figure 3-4 Distribution of crossing speeds at all sites

The overall average speed, and the average speeds at individual sites, did not change significantly and was generally well in excess of the assumed crossing speed of 1.2m/s. This indicates that slower pedestrians or pedestrians with mobility impairments should be effectively provided for by the assumed crossing speed.

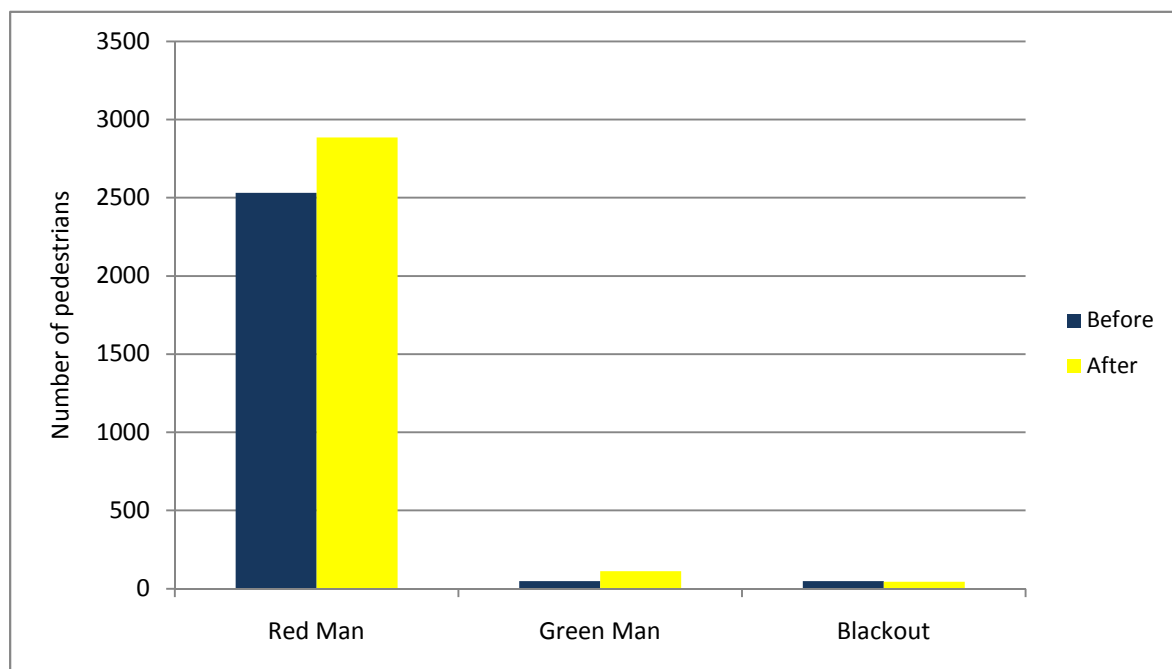
Figure 3-5, shows a cumulative number for all sites for both the before and after studies.

Figure 3-5 Pedestrians stopping in the central refuge, after starting to cross in the red man, green man and blackout periods

Table 3-4 and Figure 3-5 show that there was an overall increase of 15.8% in the number of pedestrians who stopped in the central refuge (3,042 compared to 2,627).

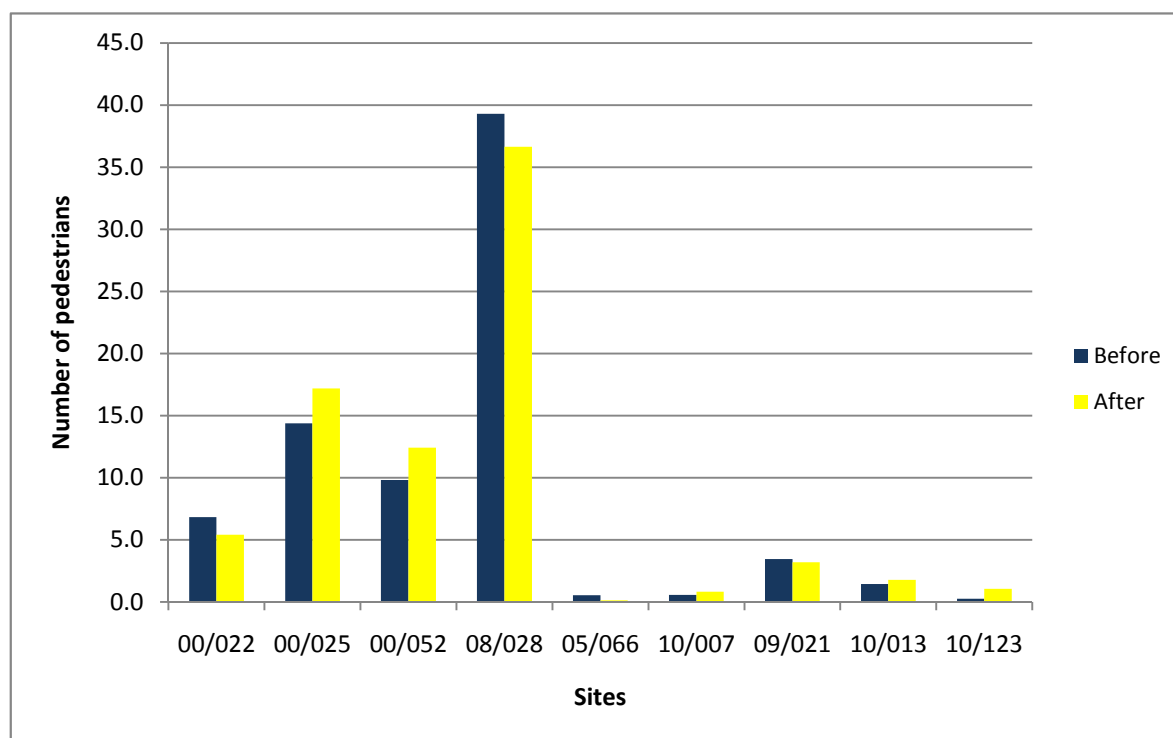
Figure 3-6 Number of pedestrians crossing on each green man period

Figure 3-6 shows that by plotting the average numbers of pedestrians crossing per green man invitation period for both the before and after study, it can be seen that this rate has not fluctuated much between the two studies. It is also clear that some of the study sites were considerably busier than others.

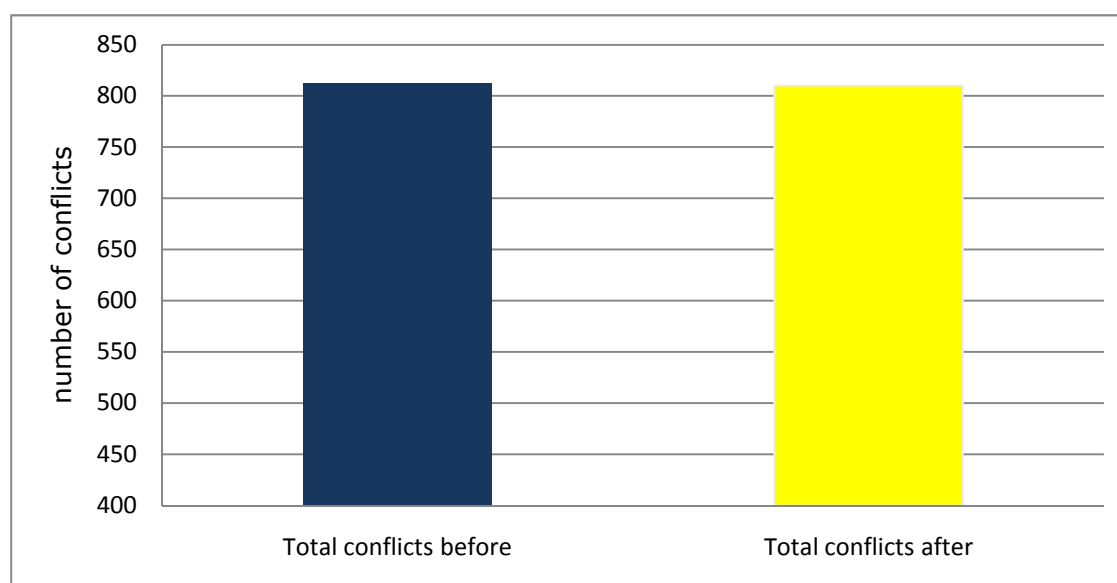
Figure 3-7 shows the total numbers of conflicts that were observed in the before and the after studies. It shows that reducing the pedestrian invitation period was not associated with the total numbers of conflicts changing very much. The before study observed a total of 813 conflicts whereas the after study recorded 810 conflicts.

Figure 3-7 Total number of conflicts, all sites

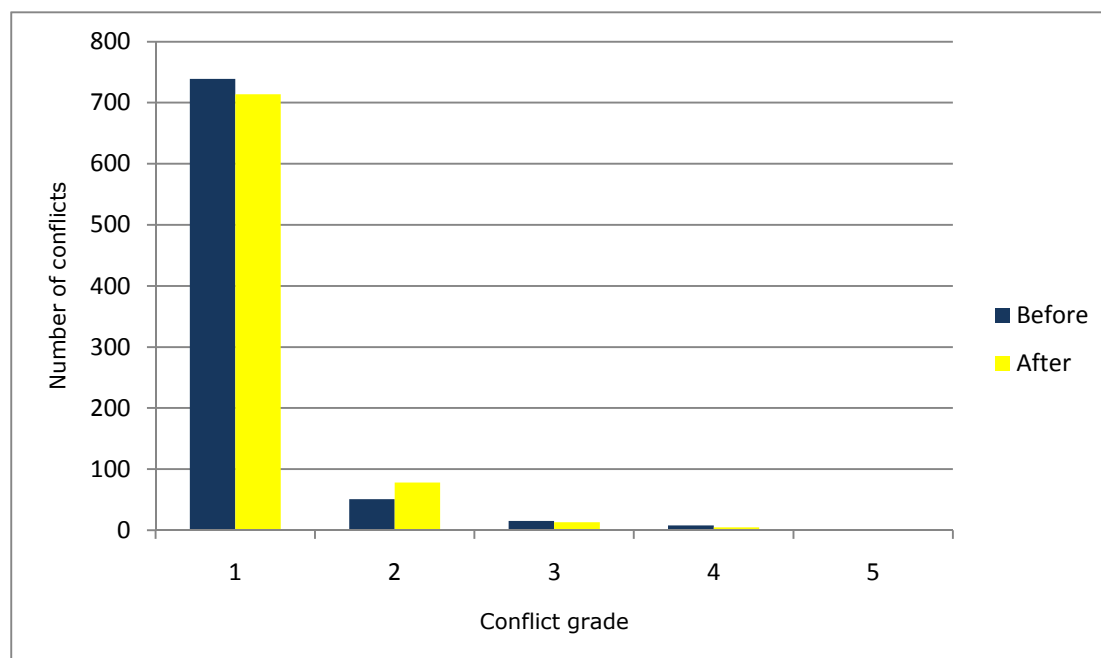
Figure 3-8 shows the proportion of each grade of conflict for all sites, in both the before study and the after. As would be expected, there were more minor conflicts than serious ones. There were no conflicts graded as a 5 (collisions) recorded.

Figure 3-8 Conflict severity

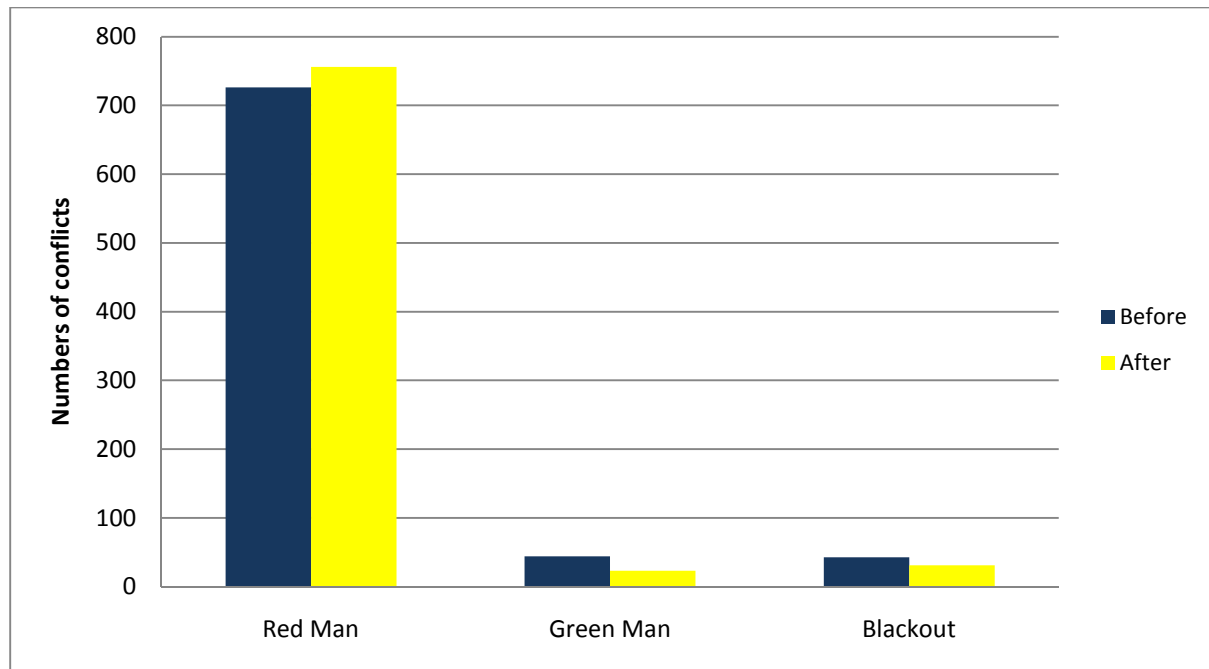
Figure 3-9 Compliance of pedestrians involved in conflicts

The results show that approximately 90% of conflicts occurred when the pedestrian began to cross when the pedestrian signals were red. This is perhaps unsurprising as during the green man and blackout periods pedestrians have right of way and therefore should not experience any conflicts with traffic. The conflicts recorded during this time were a result of vehicles turning during the intergreen and not clearing the crossing in time, as well as cyclists disobeying red signals. The problem of vehicles not clearing the crossings before the pedestrians were given right of way was noted at site 00/025 Bishopsgate – Wormwood Street.

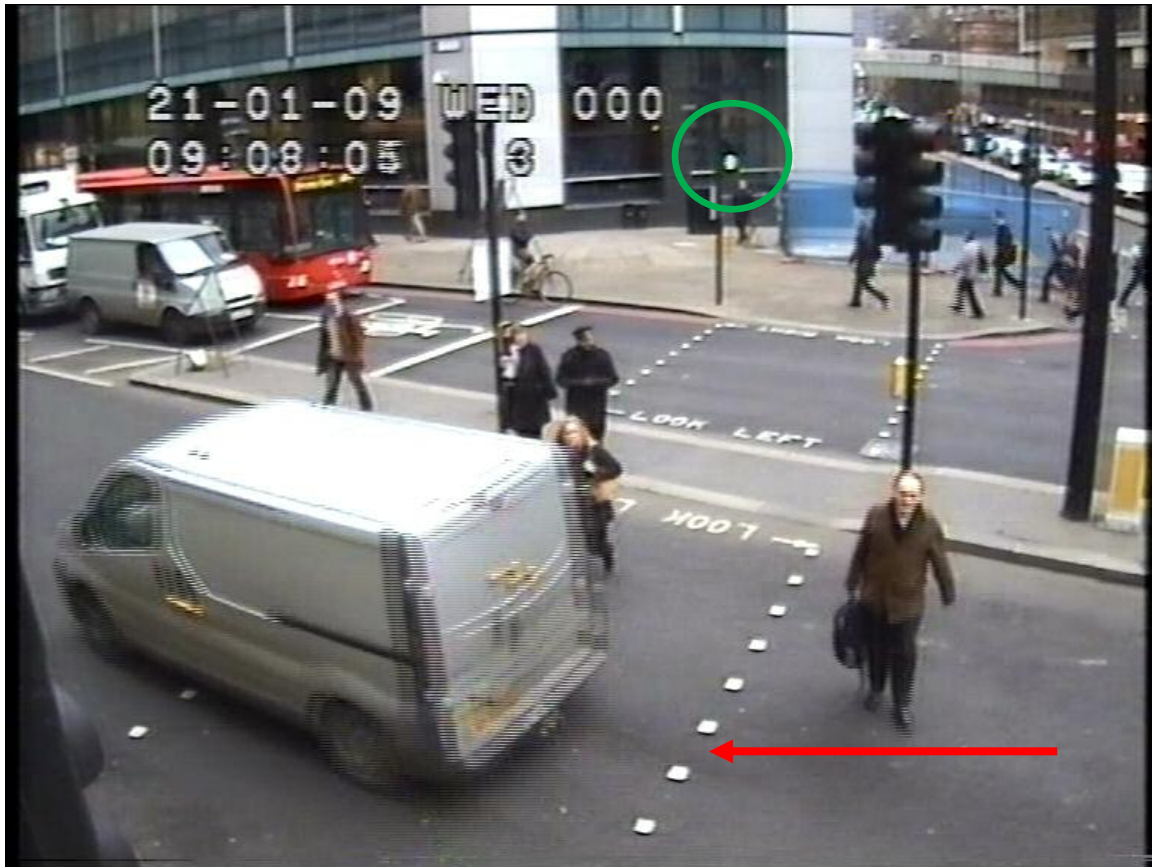
It is also notable that there was an increase in the number and proportion of conflicts associated with pedestrians crossing on a red man and a corresponding decrease in the number and proportion of conflicts associated with pedestrians crossing on a green man or during the blackout period in the after study.

Figure 3-10 Bishopsgate green man conflict

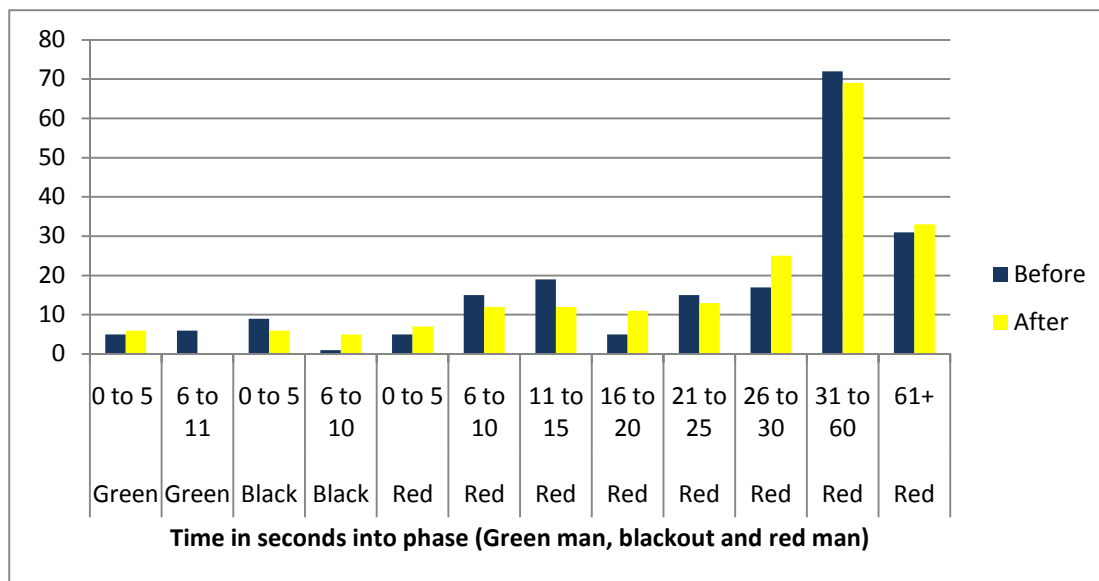
Period	Green Man		Blackout		Red Man							
	0 to 5	6 to 11	0 to 5	6 to 10	0 to 5	6 to 10	11 to 15	16 to 20	21 to 25	26 to 30	31 to 60	61+
Before	5	6	9	1	5	15	19	5	15	17	72	31
After	6	0	6	5	7	12	12	11	13	25	69	33

Figure 3-11 Number of conflicts grade 1 per time segment

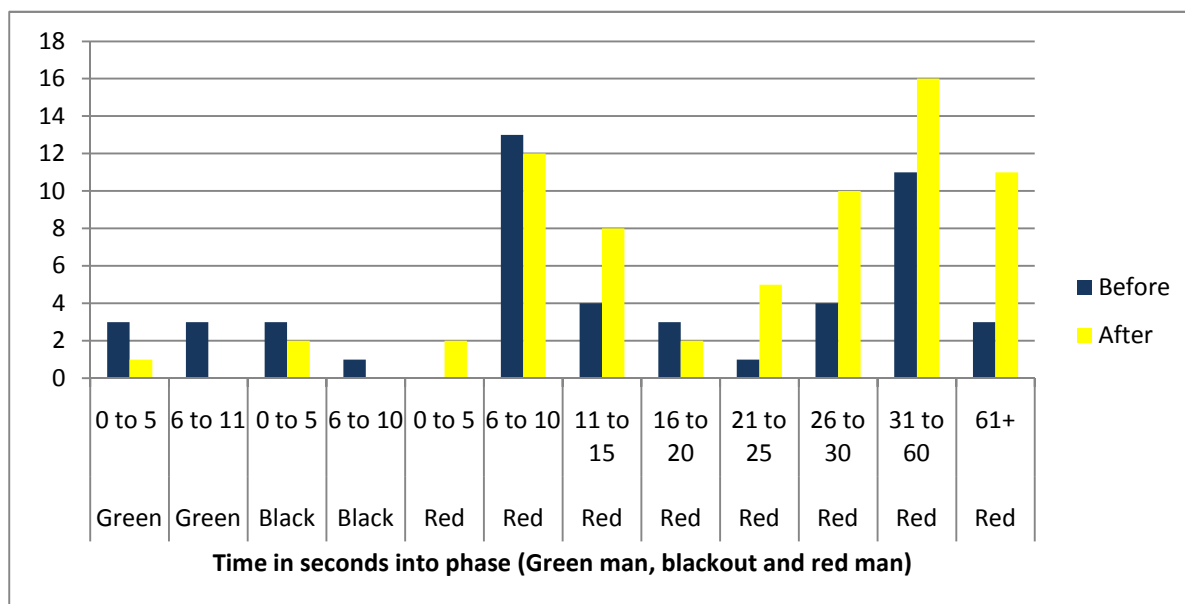
Period	Green Man		Blackout		Red Man							
	0 to 5	6 to 11	0 to 5	6 to 10	0 to 5	6 to 10	11 to 15	16 to 20	21 to 25	26 to 30	31 to 60	61+
Before	3	3	3	1	0	13	4	3	1	4	11	3
After	1	0	2	0	2	12	8	2	5	10	16	11

Figure 3-12 Number of conflicts grade 2 per time segment

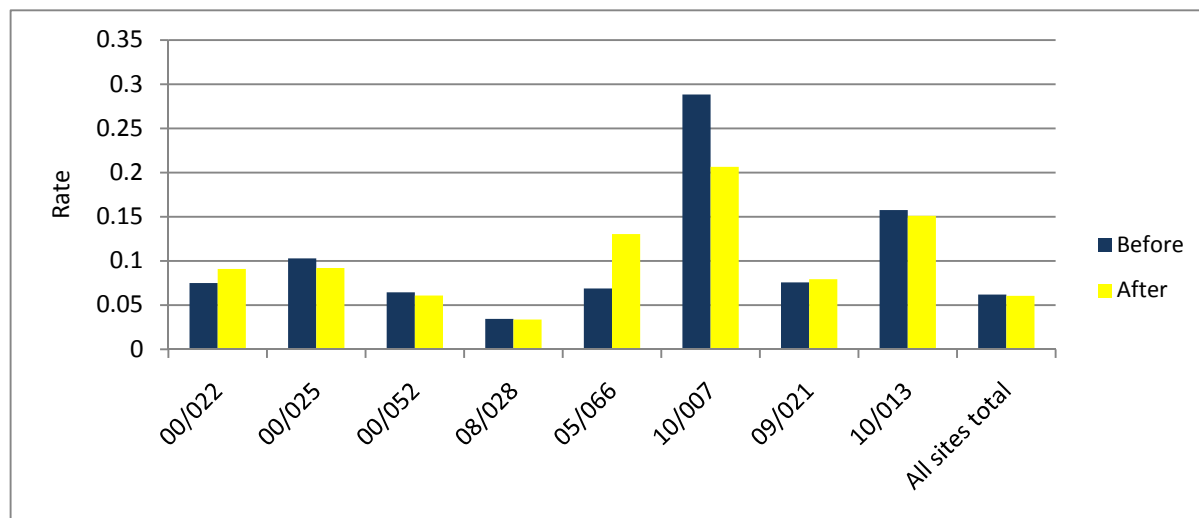
Figure 3-13 Rate of conflict per pedestrian

Figure 3-13 shows that the rate of conflicts per pedestrian has not altered by much between the before and after studies.

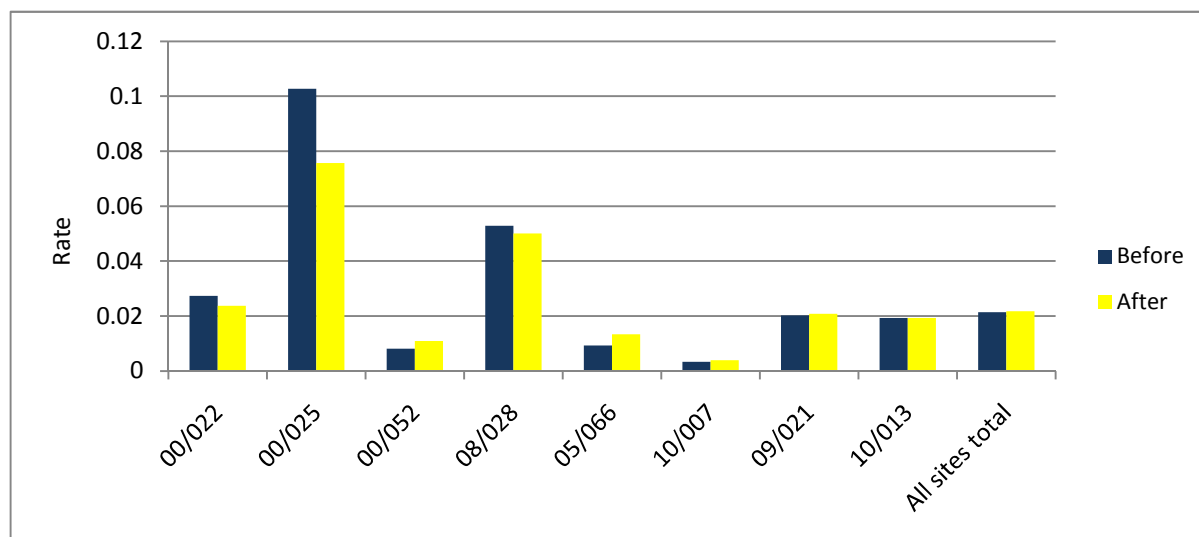
Figure 3-14 rate of conflict per vehicle

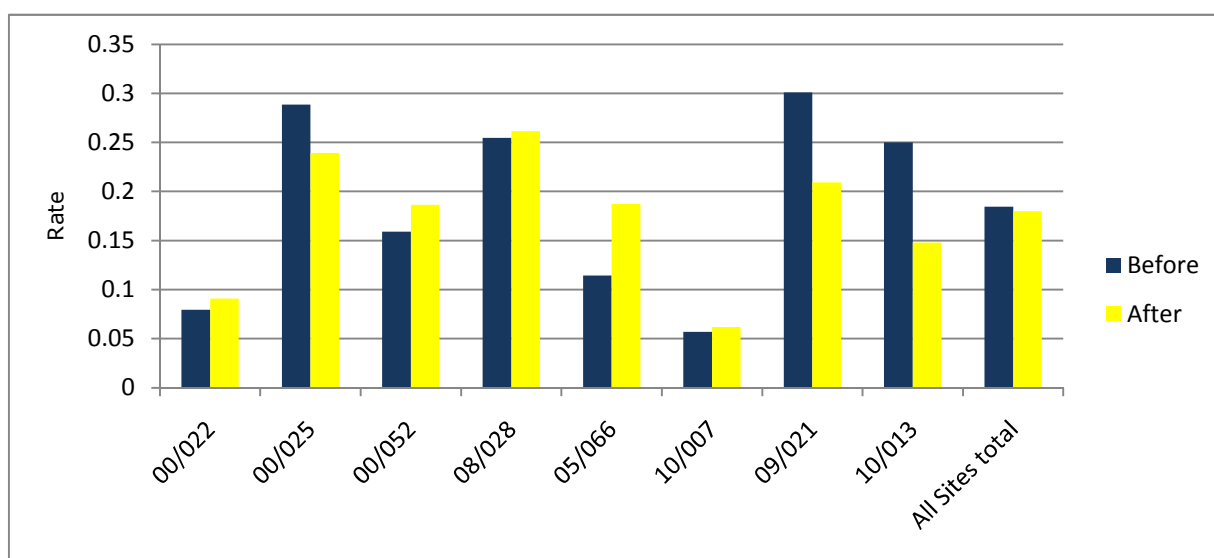
Figure 3-15 shows the rate of conflict per cyclist at each site. From the data collected during the conflict study, it was noted that cyclists made up 31.4% of the vehicles in conflict during the before study and 27.4% during the after study. This data is presented in greater depth in section 3.2.5.

Figure 3-15 rate of conflict per cyclist

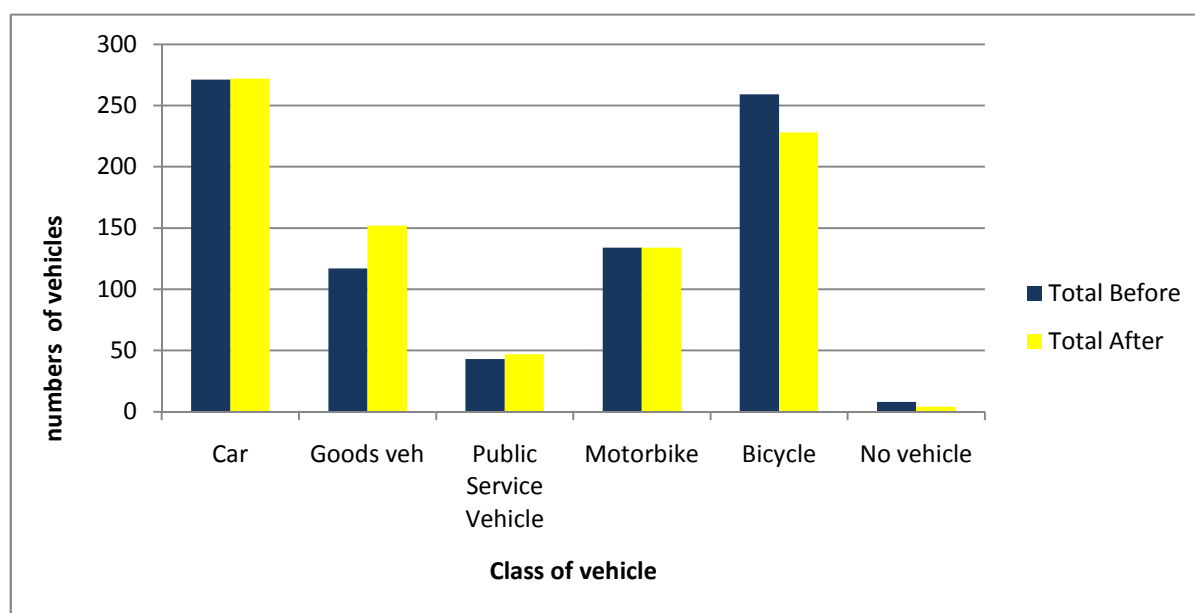
Car	Goods vehicle	Public Service Vehicle	Motorbike	Bicycle	No vehicle visible
Total Before	271	117	43	134	259	8
Total After	272	152	47	134	228	4

**Figure 3-16 Vehicle class in conflict with pedestrians**

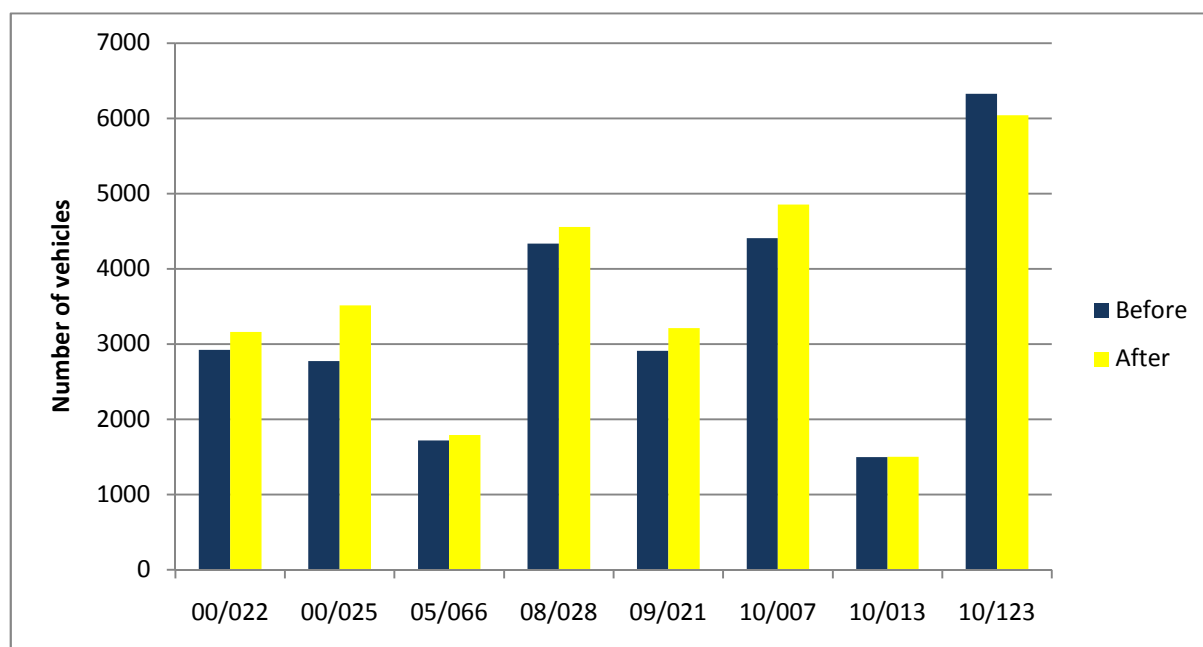
The increased throughput at seven of the nine sites is consistent with the view that by reducing the invitation period to pedestrians, an increase in capacity can be achieved for vehicular traffic. Site 00/052 (the most busy site) showed a substantial decrease in vehicle throughput during the after study. This decrease was sufficiently large to offset the total gain in throughput at all the other sites. It has been noted that during the after study there were long term streetworks some distance upstream from site 00/052 which were beyond the field of view of the video camera and which resulted in a loss of lane capacity from two lanes down to one. The results from this site have therefore been discounted as they have been shown to be anomalous. Overall (excluding site 00/052) a significant ($p < 0.01$) increase in vehicle throughput was observed in the after study.

Figure 3-18 Vehicle throughput

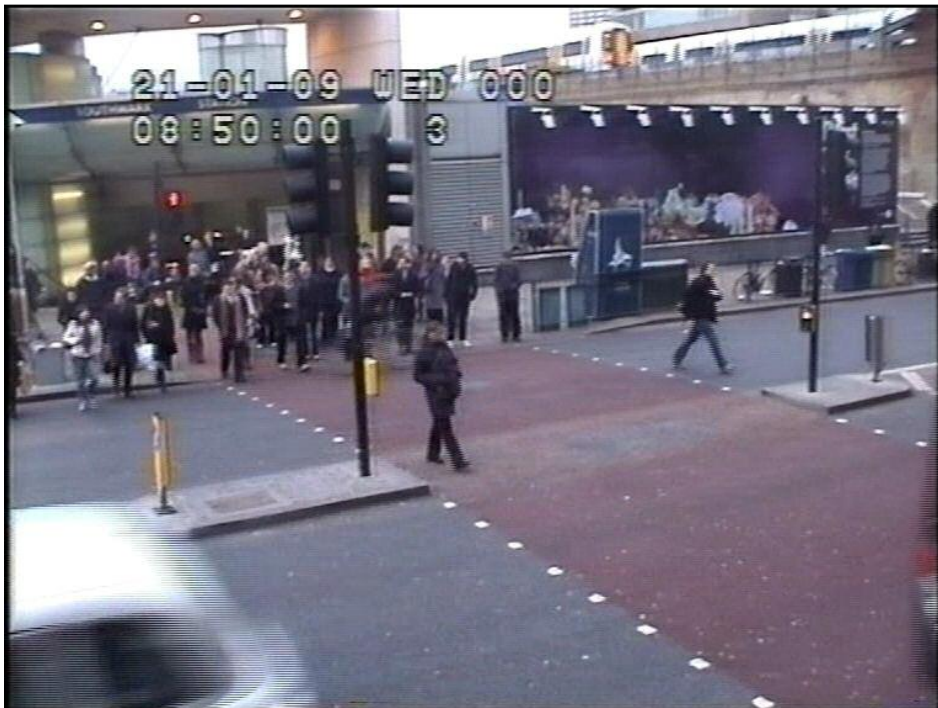
It was noted however, that congestion only occurred at some of the study sites. Specifically these were the three located in the City of London (00/022, 00/025 and 00/052) and the two located directly outside of Underground Stations (08/028 and 09/021).

Figure 3-19 Illustration of congestion in waiting area

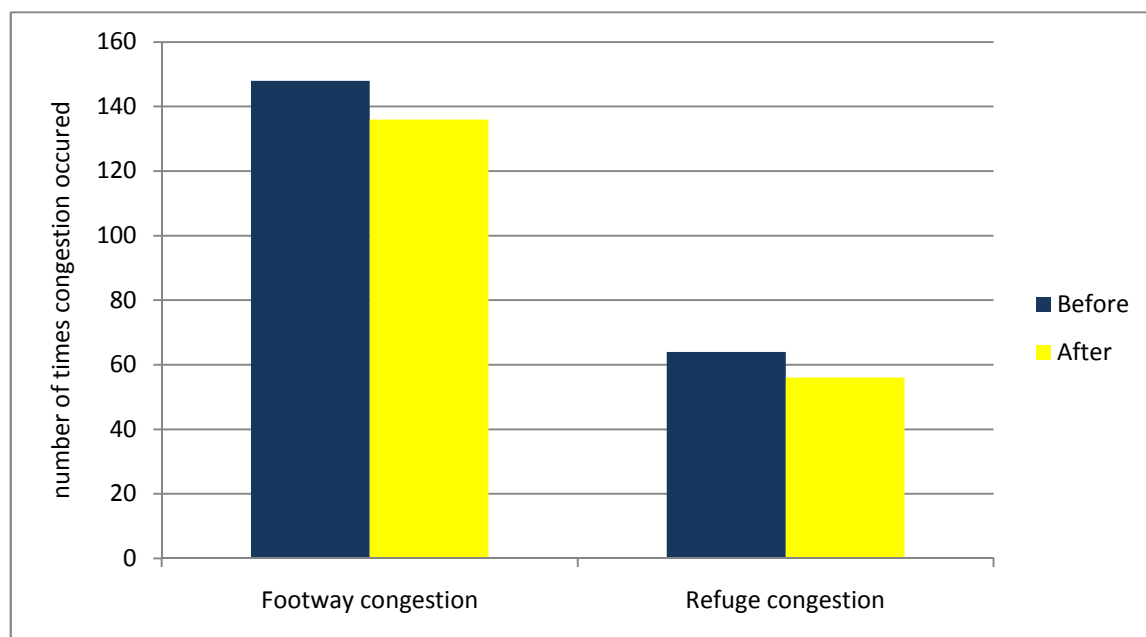
Figure 3-20 Congestion of pedestrian waiting areas
