Road safety standards for construction, supply and waste sites

This report details research undertaken for Transport for London by AECOM, as part of the Construction Logistics and Cyclist Safety (CLOCS) research programme. The aim of the study is to identify the minimum standards for site accessibility and develop a framework to quantify the criteria to rate construction, supply and waste sites, and create a directory of sites. Recent research demonstrates the requirement for a single specific standard linking site operational conditions to vehicle specifications¹ to reduce the number of incidents involving heavy goods vehicles (HGV) and vulnerable road users, specifically cyclists, on London's road network.

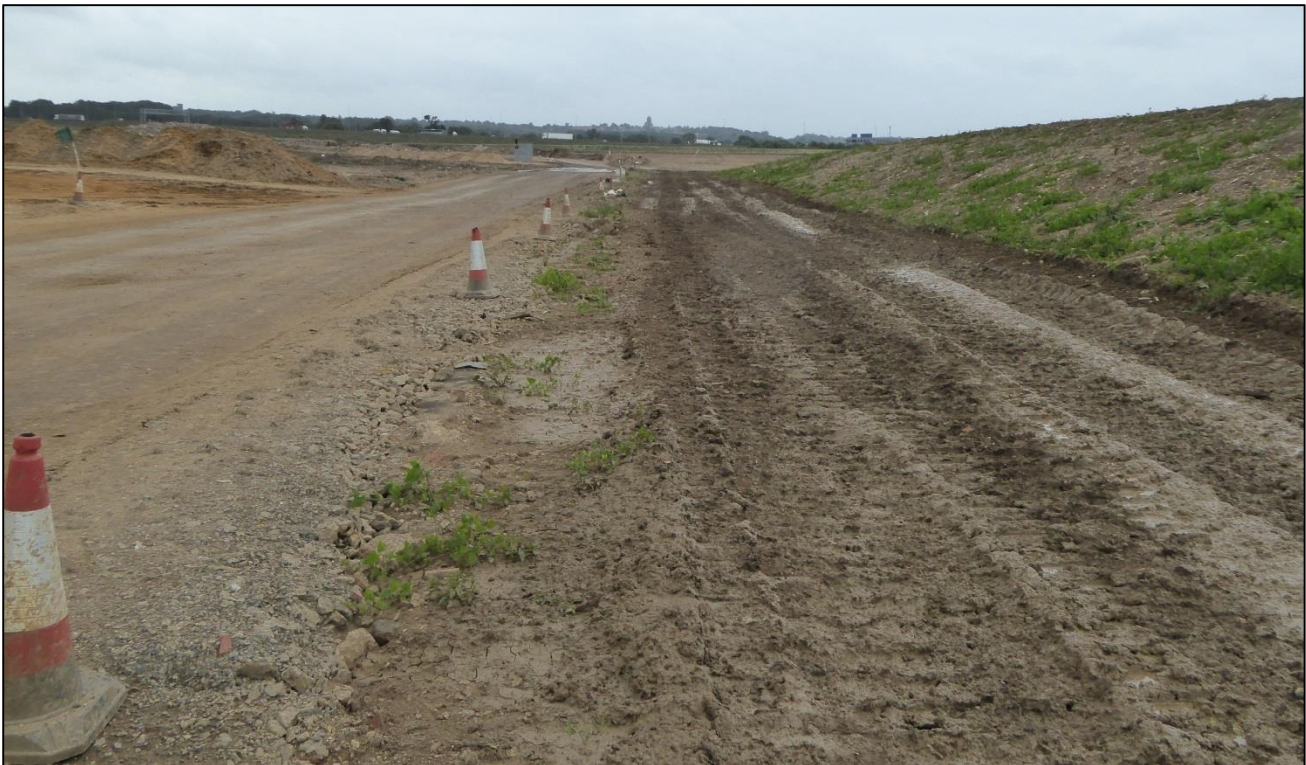
Tyttenhanger landfill had installed a mechanically stabilised haul road up to the tipping area which created much improved ground conditions. Crushed concrete was mixed into the subsurface and subsequently reinforced with geotextiles on a particular area of the site which was prone to loss of traction in adverse weather conditions. The surface condition was much improved compared to the majority of landfills visited, where this level of maintenance had not been undertaken. N3 vehicles were able to traverse the reinforced haul road on this particular site in all weather conditions. This investment has led to additional business for the site, where vehicles that cannot otherwise access competitor sites in poor weather conditions, can come to complete their run. Figure 3-3 shows a comparison between the mechanically stabilised haul road to the left and unbound material to the right.

Figure 3-3 Mechanically stabilised soil (left of cones) and unbound soil (right of cones)

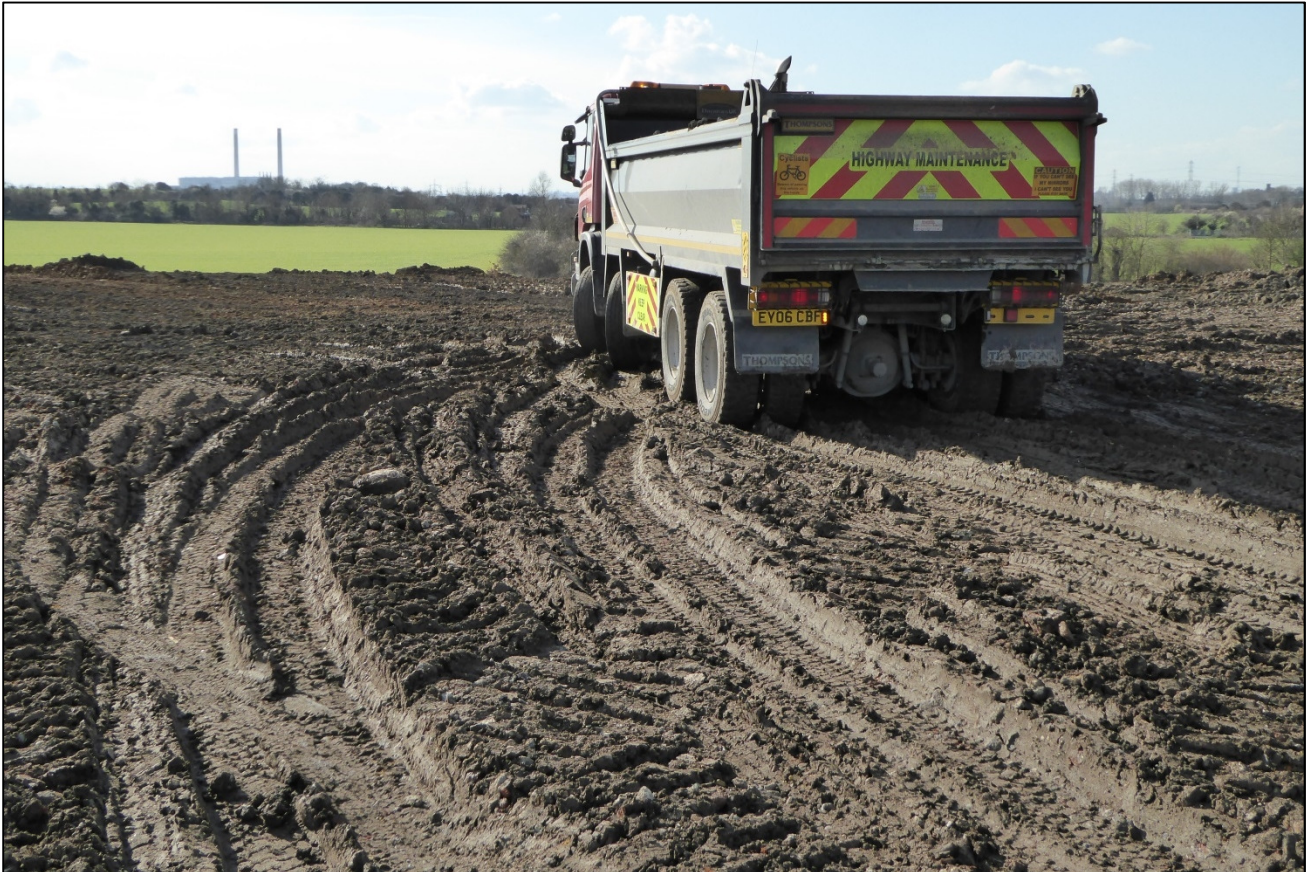
The materials encountered on-site were dependant on the nature of the site and if any maintenance had been carried out. Landfills visited mainly consisted of cohesive material, particularly near the final tipping destination. Loss of traction and reduced ride quality was witnessed in these areas. Site plant was used to regularly grade haul roads although conditions deteriorated after one or two tipper truck movements, where vehicles follow in the wheel path of previous vehicles (see 3.4 Rutting). Figure 3-4 shows cohesive material present at a tipping area where significant flexing of the surface and loss of traction were witnessed. N3 or N3G vehicles would be required in such areas due to the risk of grounding LEC vehicles.

Figure 3-4 Cohesive material present at tipping area of landfill

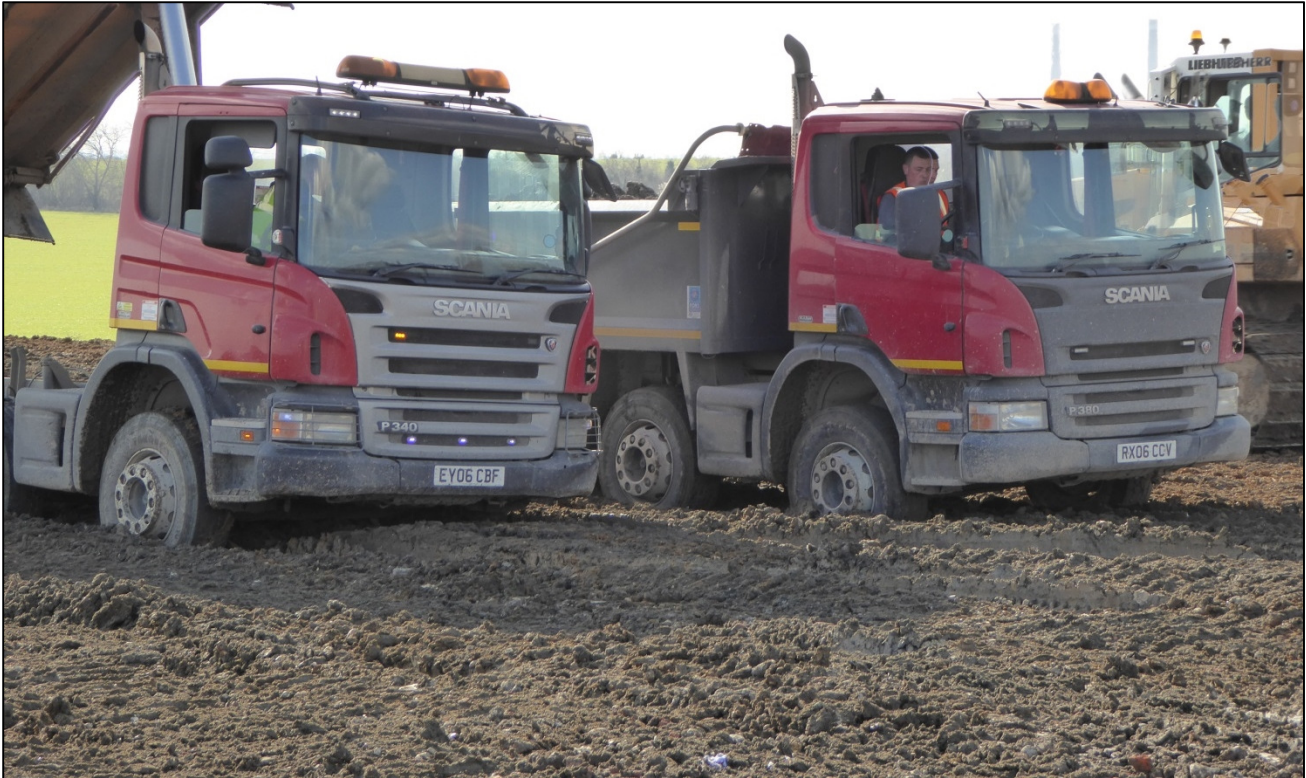
Rutting was an issue on unpaved sites where continuous vehicle movements led to poor ground conditions. The depths of ruts were generally shallow, particularly on sites that had invested in reinforced haul roads. Ruts where an N3G vehicle would be required were rarely encountered. The most severe instance of rutting, as shown in Figure 3-5, proved difficult for even N3Gs to operate on. The other sites visited would be able to operate LEC or N3 vehicles equipped with air suspension, which can be activated if required. Generally, on paved areas of sites, rutting was not encountered at a significant depth to cause damage to any vehicle.

Figure 3-5 Ruts with the potential to cause damage to vehicles at tipping area

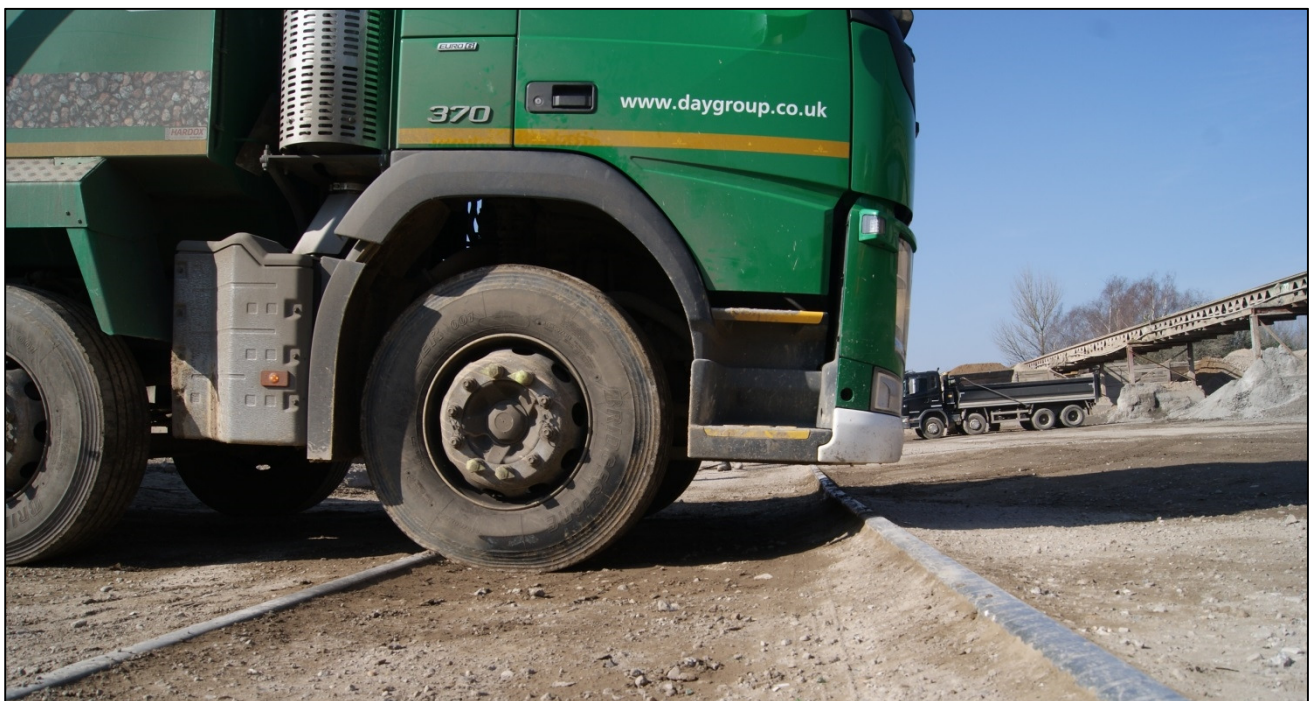
Change in gradients encountered during site visits did not generally exceed the approach angle capabilities of an N3 vehicle, although reports of construction sites within London possessing sharp gradients have caused concern. Figure 3-6 shows an approach angle on a vehicle providing sufficient clearance over the railhead on which an LEC vehicle lost its front bumper. This railhead is present at the bottom of a slope which exacerbates the problem when fully laden. Many of the issues documented, such as in Figure 3-6, could be resolved with small earthworks to allow for the use of LECs.

Figure 3-6 Vehicle approach angle sufficient to clear railhead

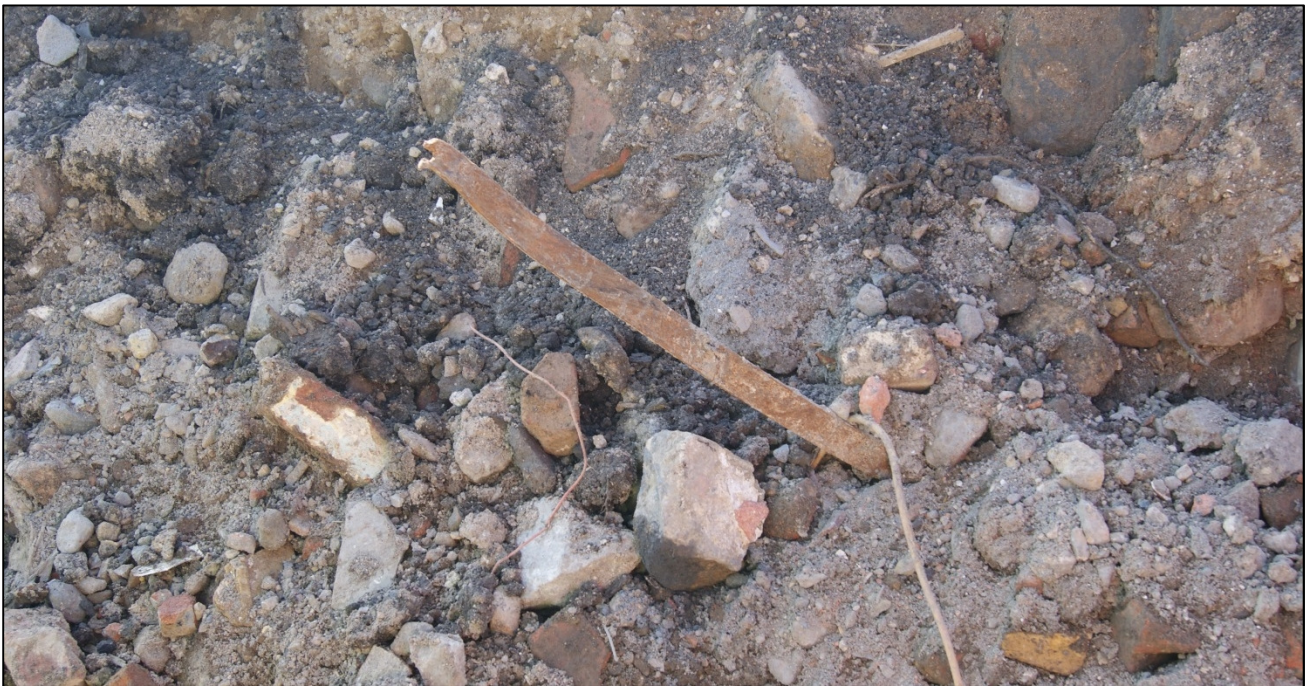
Loose material was also present at the edge of most sites where material is swept or graded. Whilst not in the haul road, this material has the potential to damage vehicles that stray from the defined road due to careless driving or on sites where there are no passing places. Figure 3-7 shows loose aggregate and metal present at the edge of an aggregate supply site.

Figure 3-7 Loose material, including metal bar, present at edge of haul road

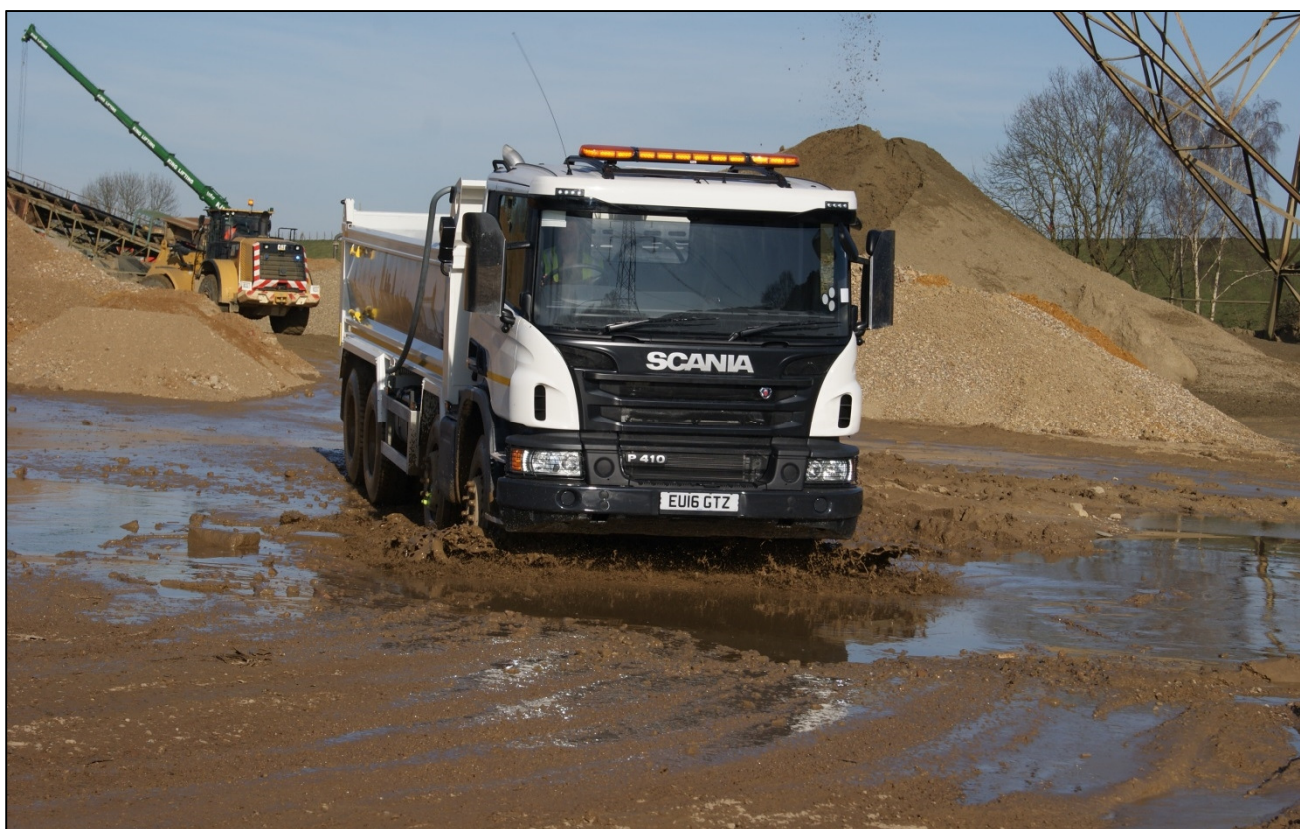
The level of water present on-site is dependent on the levels of precipitation, so the site visits conducted were a snap shot in time. However, many of the sites did possess the required drainage or had areas which allowed ponding of water where vehicles do not travel. Vehicles were seldom witnessed traveling through significant levels of water that have the potential to hide features that may cause damage. Figure 3-8 shows surface water present on an aggregate supply site. The use of an N3G in this situation was required due to the depth of the water, the underlying material and the inability to accurately judge the depth of water. Ponding of water will also influence the performance of the underlying materials, which will often turn to slurry, affecting traction.

Figure 3-8 Ponding of surface water at an aggregate supply site

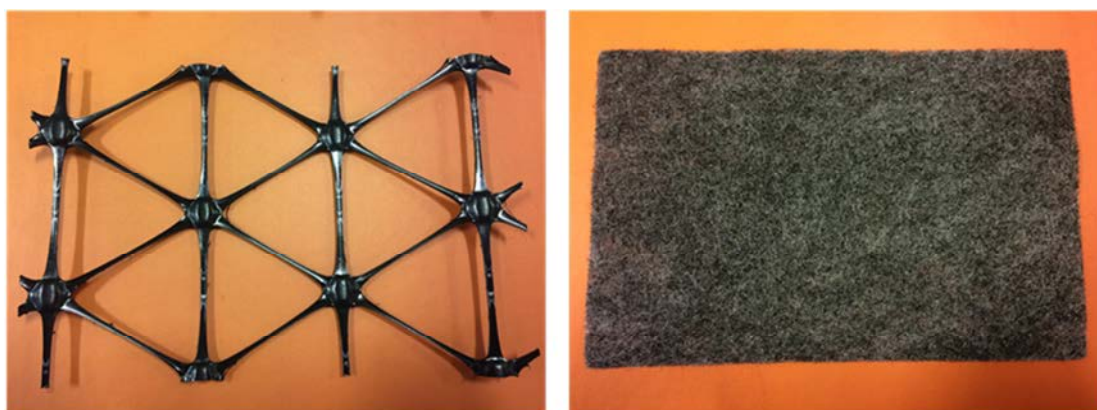
Mechanical stabilisation can be defined as the improvement of the mechanical behaviour of an in-situ unbound granular material by including one or more geosynthetics layers such that deformation under applied loads is reduced by minimising movements within the unbound granular material²³. There are two primary types of geosynthetics that can be used for mechanical stabilisation of haul roads; geogrids and geotextiles (Figure 6-2).

Figure 6-2 Geogrid (left) and geotextile (right)

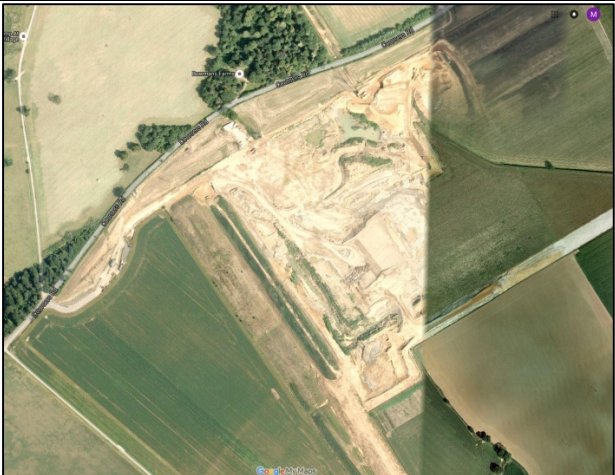
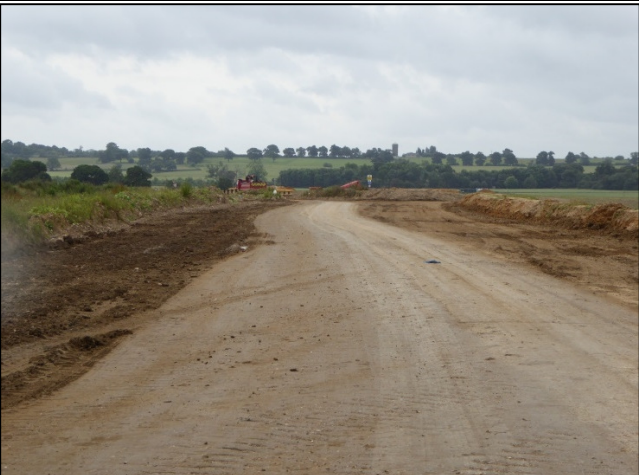
CLOCS Ground Condition Assessment			
Approach Angle	Material Type	Rutting and Bumps	Water
C5	C4	C4	C4

Figure A 1 Tythenhanger landfill site case study

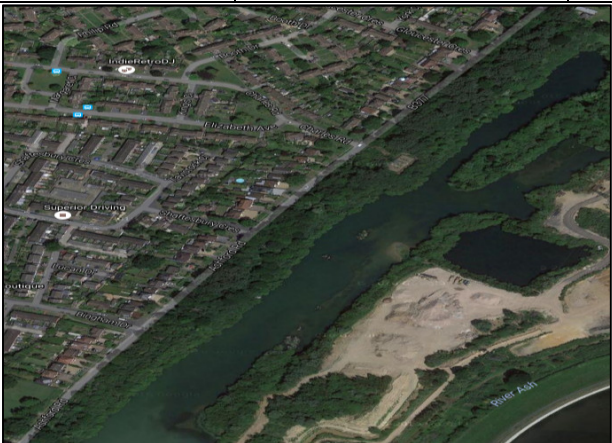
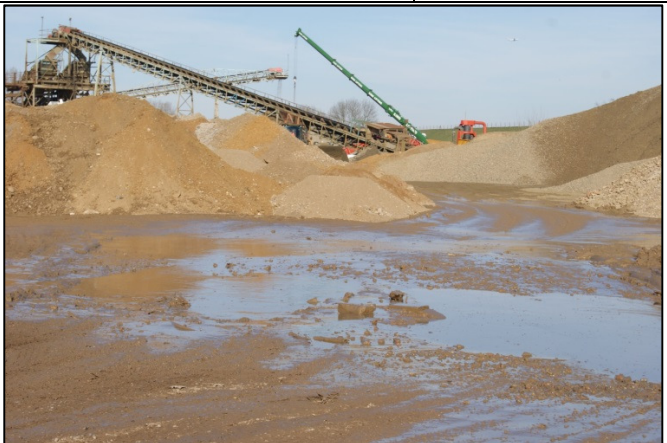
CLOCS Ground Condition Assessment			
Approach Angle	Material Type	Rutting and Bumps	Water
C4	C3	C3	C3

Figure A 3 Queen Mary Quarry site case study

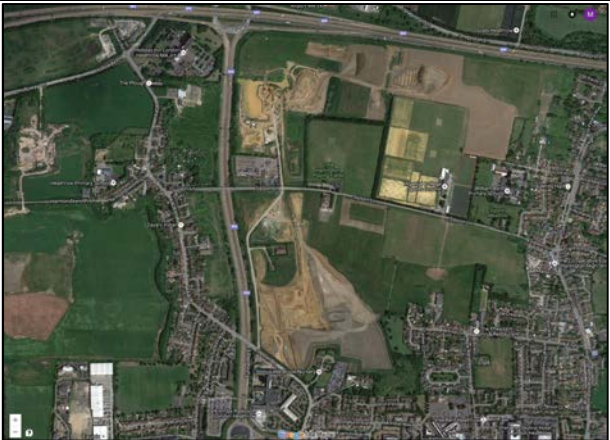
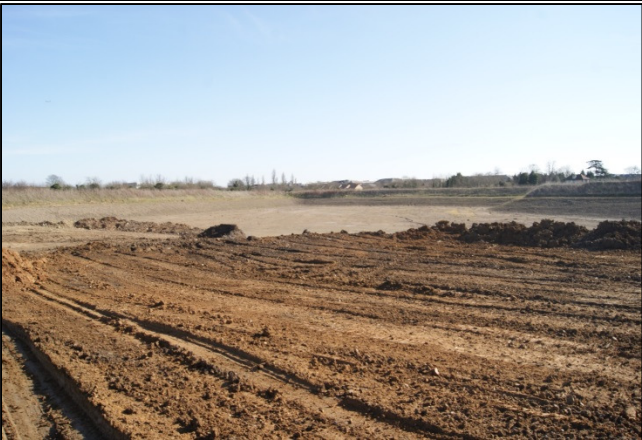
CLOCS Ground Condition Assessment			
Approach Angle	Material Type	Rutting and Bumps	Water
C5	C3	C3	C5

Figure A 4 Sipson Landfill site case study

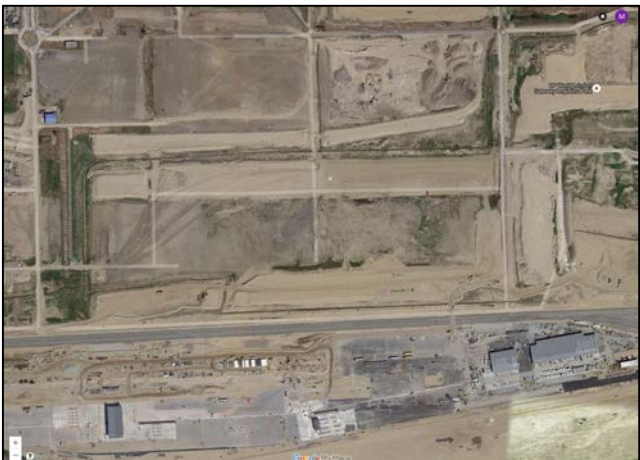
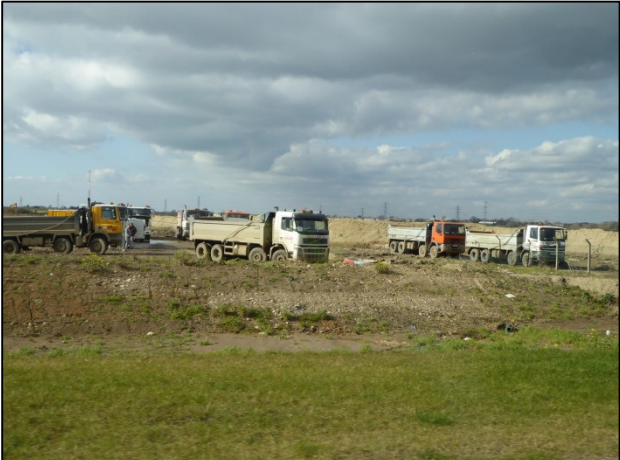
CLOCS Ground Condition Assessment			
Approach Angle	Material Type	Rutting and Bumps	Water
C4	C3	C3	C3

Figure A 6 London Gateway Port Landfill case study

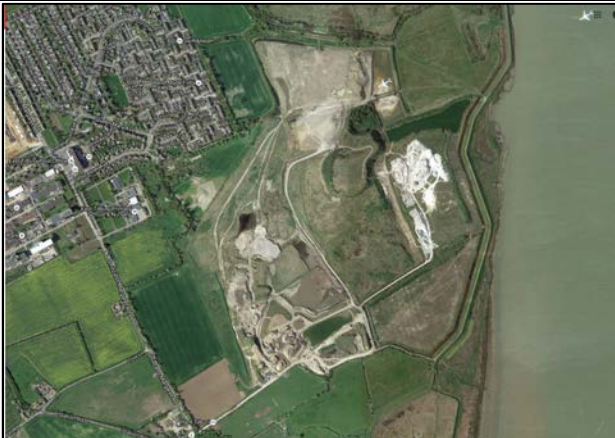
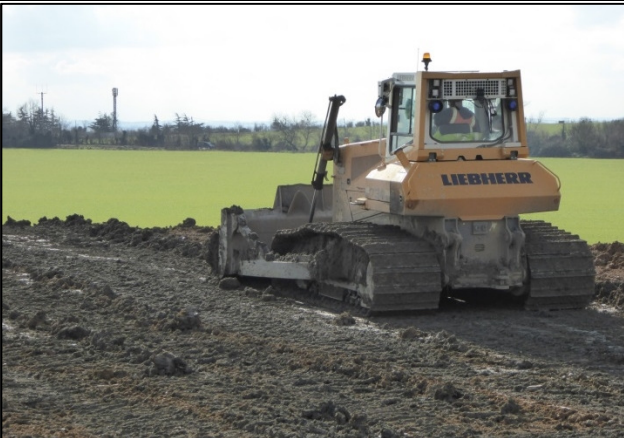
CLOCS Ground Condition Assessment			
Approach Angle	Material	Rutting and Bumps	Water
C4	C2	C3	C4

Figure A 7 Easy Tilbury Landfill site case study

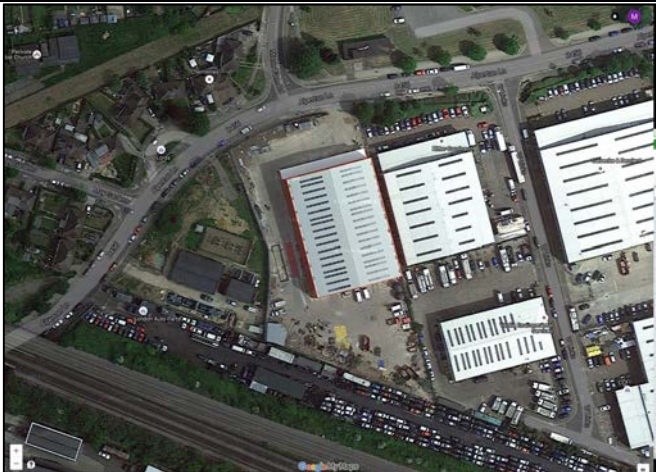
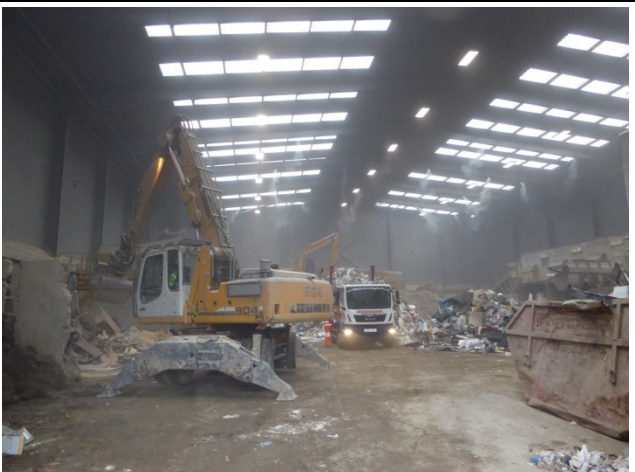
CLOCS Ground Condition Assessment			
Approach Angle	Material	Rutting and Bumps	Water
C5	C5	C5	C5

Figure A 8 Alperton Waste Transfer Station site case study

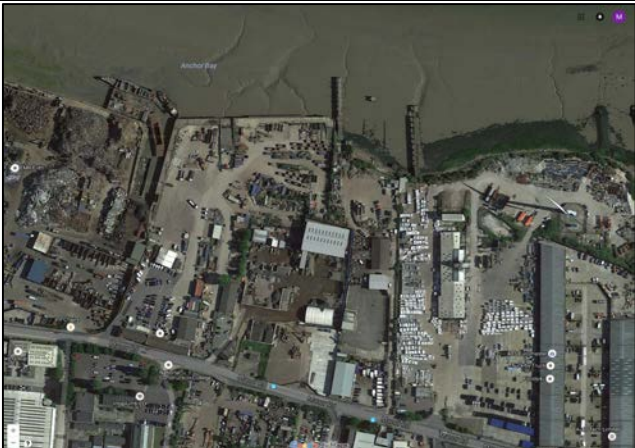
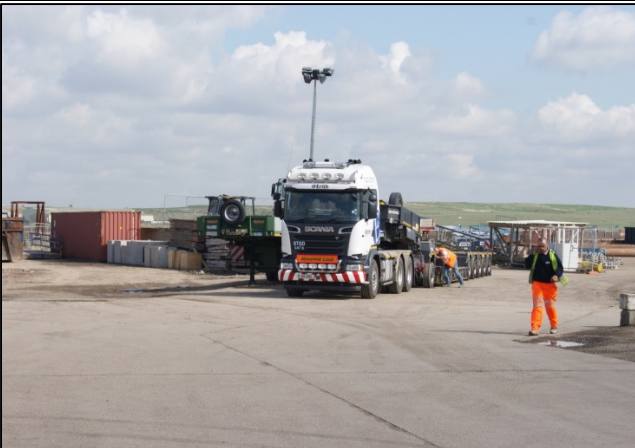
CLOCS Ground Condition Rating			
Approach Angle	Material Type	Rutting and Bumps	Water
C5	C5	C5	C5

Figure A 9 Anchor Bay Wharf site case study

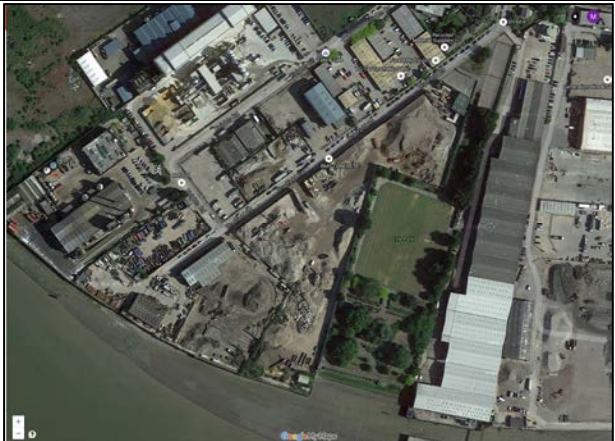
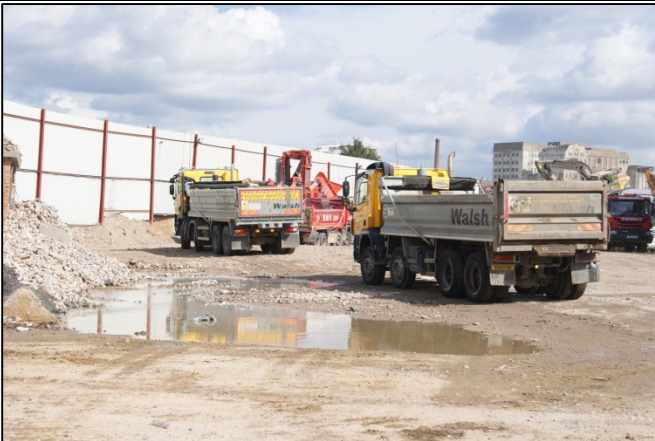
CLOCS Ground Condition Assessment			
Approach Angle	Material Type	Rutting and Bumps	Water
C5	C4	C4	C4

Figure A 10 R.M.S Bradfield Road site case study

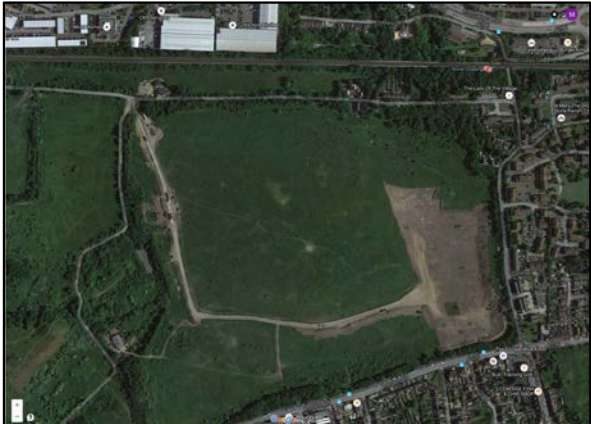
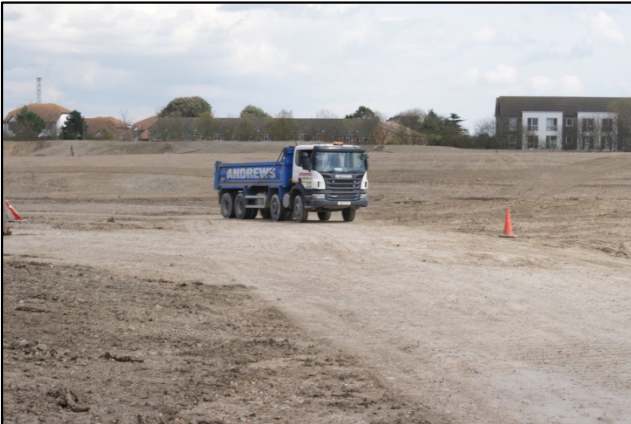
CLOCS Ground Condition Assessment			
Approach Angle	Material Type	Rutting and Bumps	Water
C2	C3	C4	C4

Figure A 11 Stone Pit 1 site case study

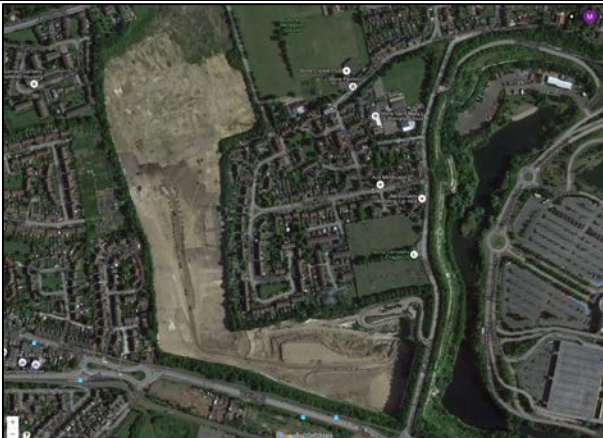
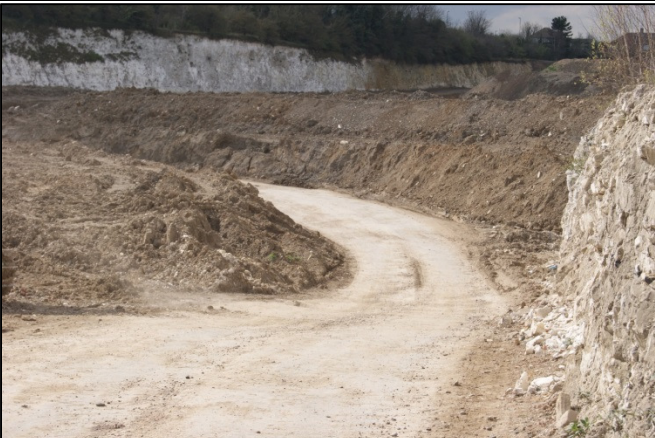
CLOCS Ground Condition Assessment			
Approach Angle	Material Type	Rutting and Bumps	Water
C2	C3	C4	C4

Figure A 12 Stone Pit 2 site case study

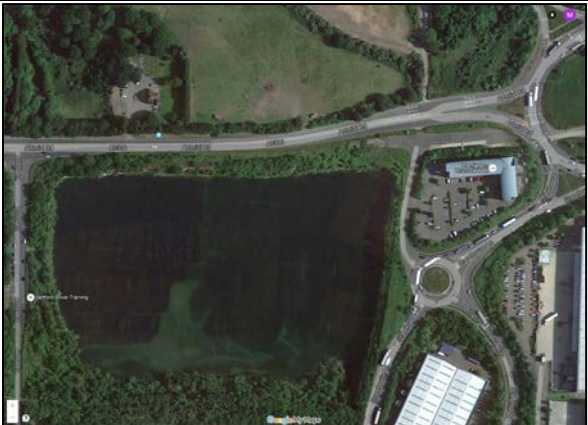
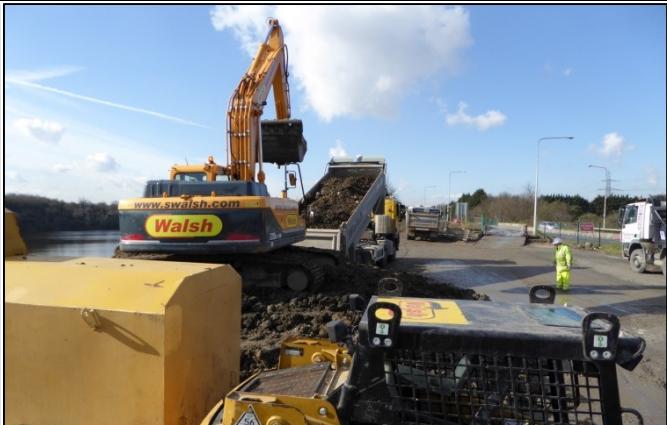
CLOCS Ground Condition Assessment			
Approach Angle	Material Type	Rutting and Bumps	Water
C5	C4	C5	C5

Figure A 13 Blueland Quarry site case study

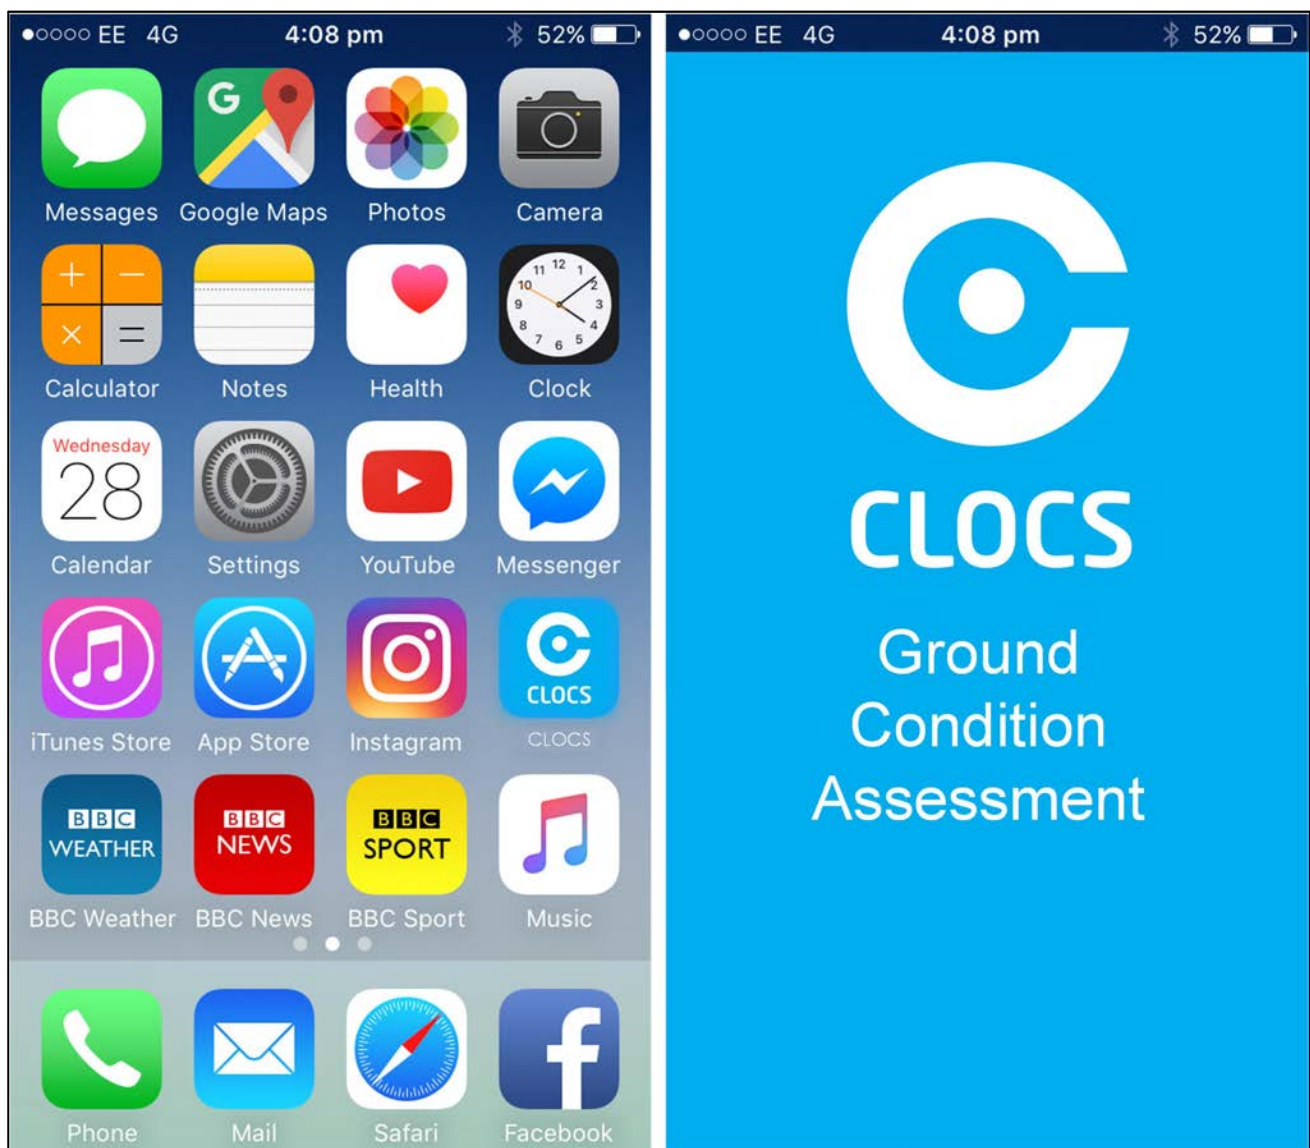
Users will be able to select the app from the home screen of their smart phone/tablet and immediately view the latest assessed sites and exemplar sites. Whilst the concepts presented here are specifically tailored for this particular project, the app could be expanded to include CLOCS compliance and training. Figure E 1 shows the app selection and loading screens.

Figure E 1 App selection and loading screen

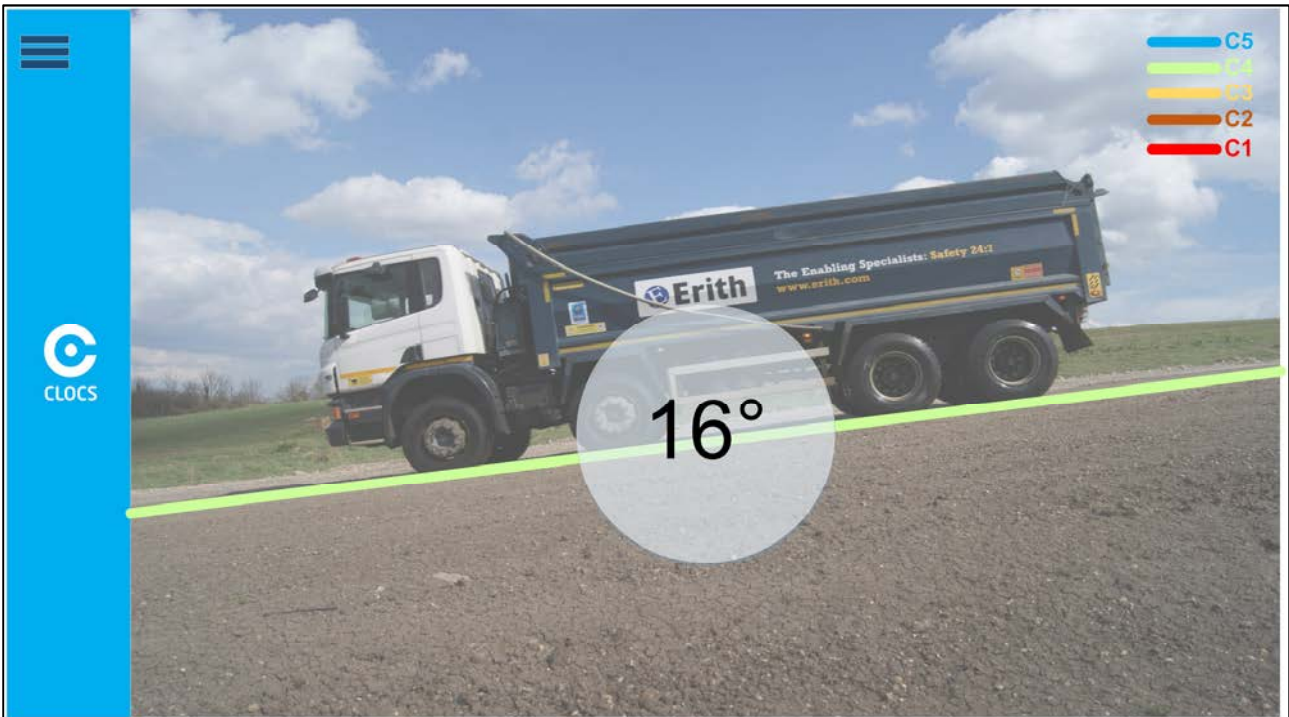
The app will hopefully lead to the widest uptake of the standards as it is quick and simple to complete. This will also allow for use of built in features of the device, such as overlaying camera images with an inclinometer, right from within the app (Figure E 4). Photos can be attached to each assessment criteria and uploaded to the server to be viewed and commented on by all.

Figure E 4 Example of gyroscope and image overlay functionality
