Northern Line Extension

Existing Pedestrian Conditions

Report

April 2013

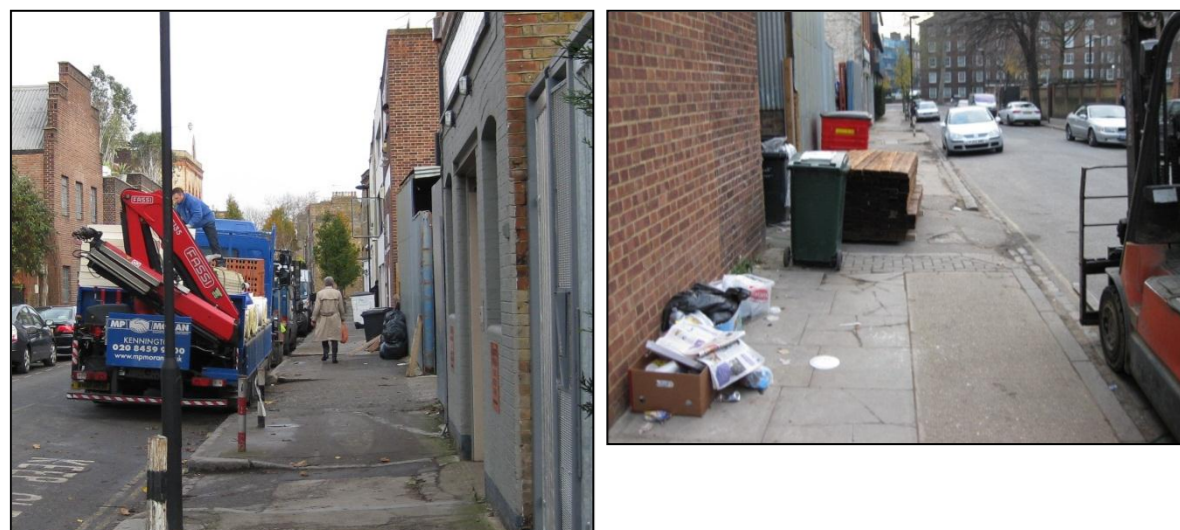
FIGURE 3.4 PHOTOGRAPHS OF LINK 2-1

- User conflict with builders merchant;
- Footway in need of repair; and
- Cluttered footway.

- 3.11 The major issue with this link is the footway near the building merchant. The merchant only has sufficient space on site to accommodate one delivery vehicle. Any additional delivery vehicles are loaded and unloaded from the street. This causes conflicts with pedestrians as forklifts and workers are constantly crossing and occupying the footway. Additionally, customers load purchased goods into their vehicles from the footway. This causes a temporary obstruction which could impede a wheelchair, pushchair and pedestrians.

- 3.12 The footway and kerbs are also in need of repair in front of the building merchant and other businesses. Cracked and uneven paving stones occur throughout this link. Dropped kerbs are uneven and would be an impediment to a wheelchair.

- Discuss ways to improve the building merchants delivery area to limit the number of trucks loaded on the street;
- Repair footways and kerbs to a standard that allows HGVs to occasionally drive on them (when manoeuvring into the yard); and
- Prevent residents and businesses from using the footway as a storage area for rubbish.

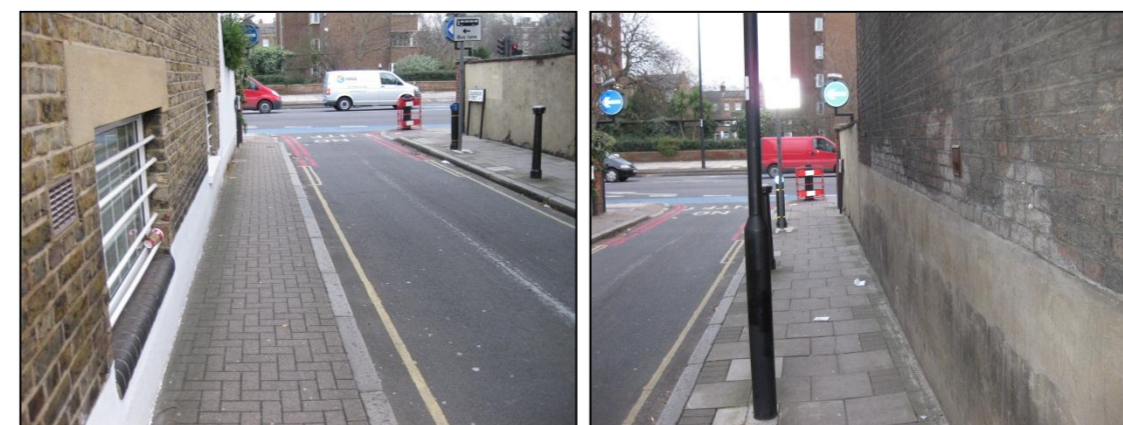
FIGURE 3.5 PHOTOGRAPHS OF LINK 2-7

- Street lamp and bollards obstruct footway;
- Footway is not wide enough for large wheelchairs or pushchairs; and
- Lighting is inadequate.

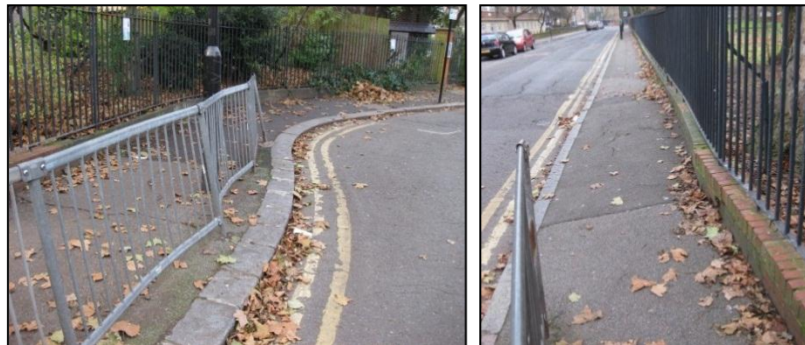
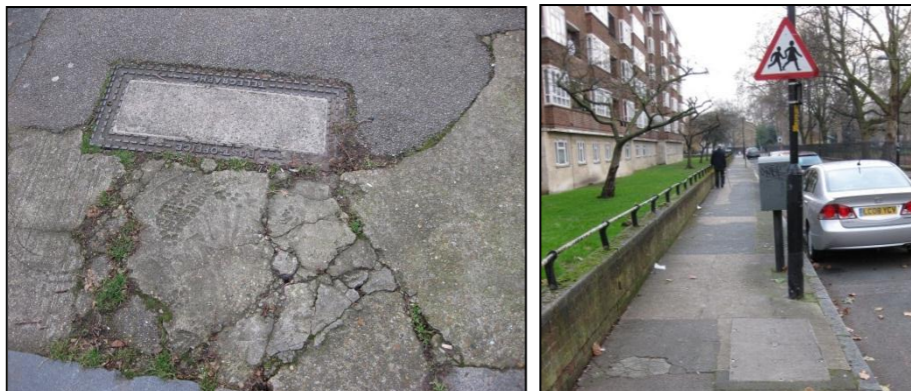
- 3.20 There is a pedestrian barrier at the entrance to the park at the junction with Royal Road. The barrier is heavily damaged from multiple impacts by cars and encroaches on pedestrian space.

- █ Remove pedestrian barrier, replace with bollards;
- █ Install dropped kerbs at junction with Royal Road; and
- █ Improve maintenance on footway adjacent to park.

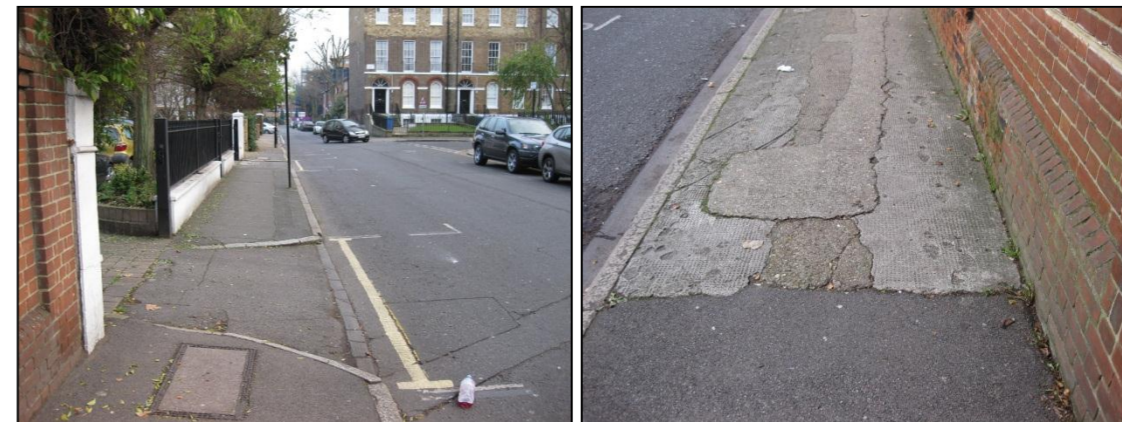
FIGURE 3.8 PHOTOGRAPHS OF LINK 3-4

- 3.21 At the junction with Kennington Park Road, dropped kerbs and associated tactile information have been installed. However, at entrances to private drives, kerbs remain an obstacle to those in wheelchairs and with pushchairs.
- 3.22 There are a number of obstructions between De Laune Street and Kennington Park Road which significantly reduce the clear width of the footway (electrical boxes).
- 3.23 The surface of the footway has been repaired and patched many times. This has resulted in many different surface treatments that do not always match evenly. This creates a trip hazard and is visually distracting.

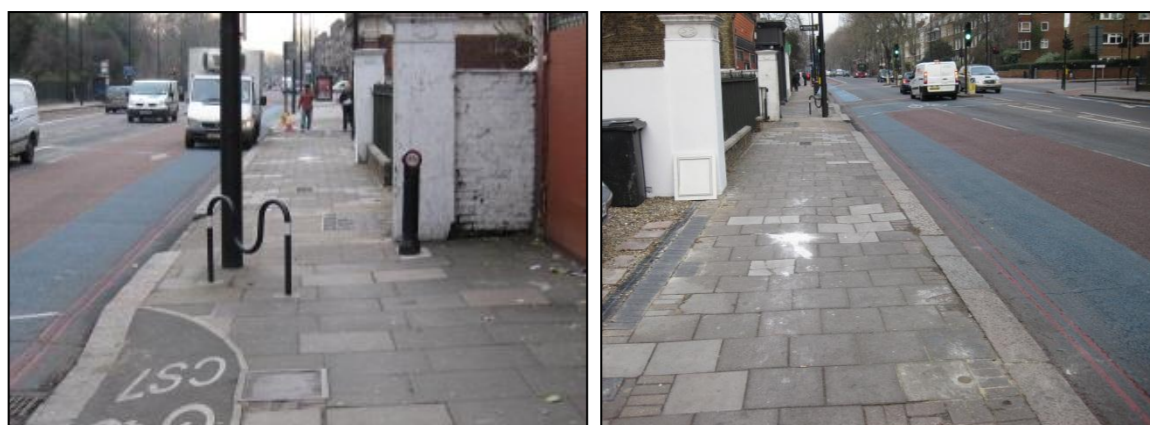
FIGURE 3.9 PHOTOGRAPHS OF LINK 3-6

- 3.24 There are many areas within the link that need improvement. Except for a pinch point due to a poorly placed cycle rack, there is sufficient width for wheelchairs, pushchairs and flows of pedestrians in both directions. There are empty frontages near the junction with Kennington Park Place that cause the footway to narrow.
- 3.25 A recently removed pedestrian barricade gives the impression that there may be more improvements scheduled for this junction.

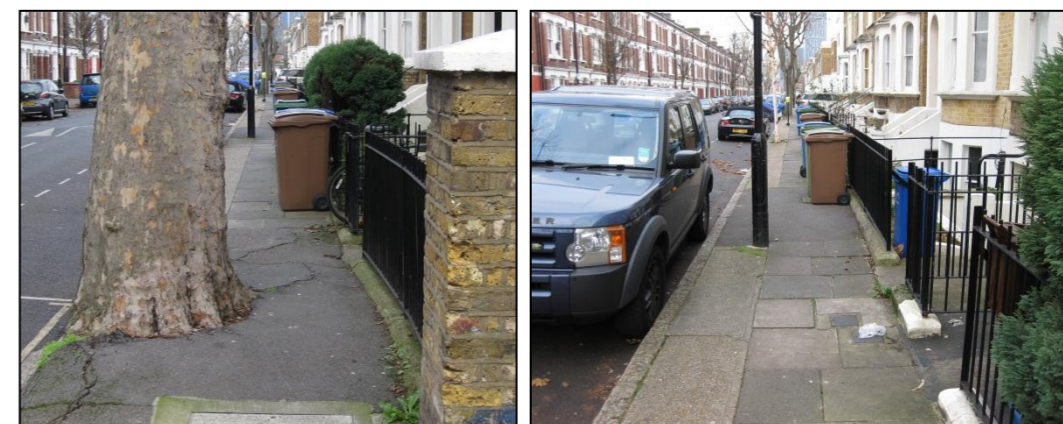
FIGURE 3.10 PHOTOGRAPHS OF LINK 3-8

- 3.26 The footway is of an acceptable width along most of this link. A tree trunk has grown so large that it has reduced the footway width so much so that a wheelchair would have difficulty navigating around it. The roots of this tree have also caused the surface to become uneven and a trip hazard.
- 3.27 Although the footway is of adequate width, the storage of wheelie bins and the presence of street lamp columns in the footway reduce the clear width significantly.

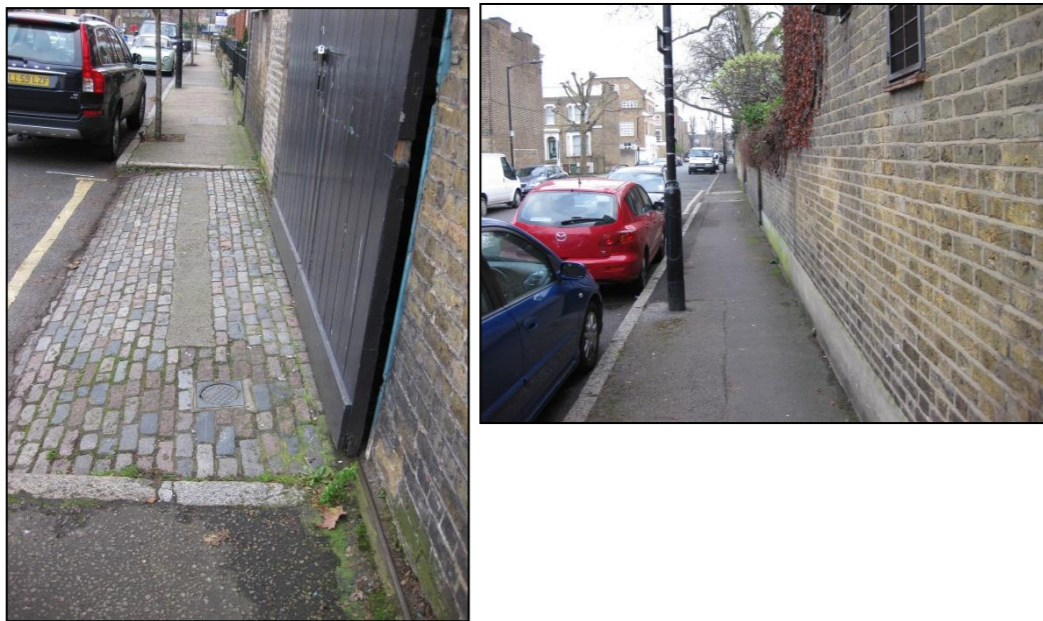
FIGURE 3.11 PHOTOGRAPHS OF LINK 3-9

- 3.28 The major issue with this footway is its substandard width along its length. With the addition of street lamps, the footway would be difficult to navigate a wheelchair or pushchair through.
- 3.29 The footway is bordered almost entirely by a brick wall. This, with the addition of parked cars, causes this narrow footway to feel even more constrained.
- 3.30 There is also a driveway that does not have dropped kerbs and would be difficult for a wheelchair or pushchair to cross.

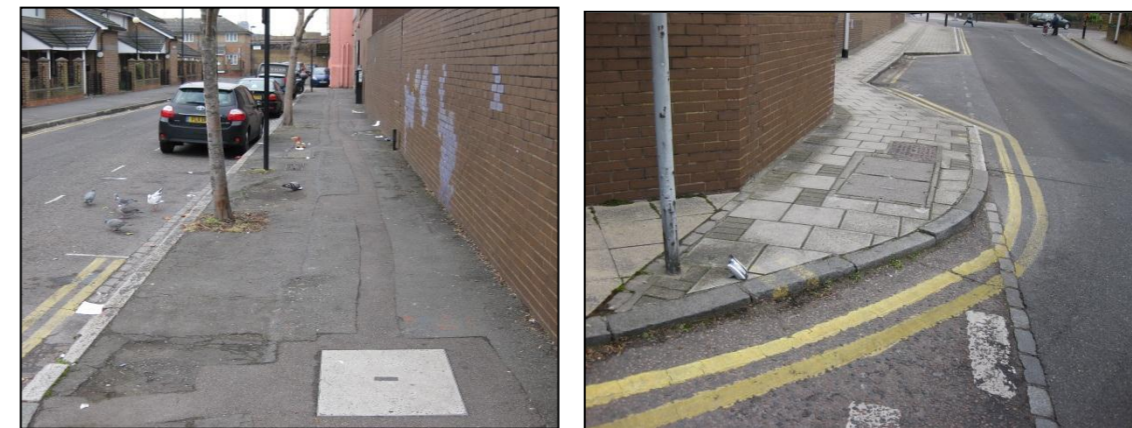
FIGURE 3.12 PHOTOGRAPHS OF LINK 4-3

- No dropped kerbs;
- Poor lighting;
- Footway degrades and stops to the west of Wandsworth Road; and
- Maintenance and quality of environment are very poor (e.g. graffiti, rubbish).

- 3.31 This footway is adjacent to the Sainsbury's car park and is bordered by a brick wall. The surface quality between Wandsworth Road and the entrance to Sainsbury's is generally very good. On the west side of the entrance, the surface degrades until the footway ends abruptly at a loading bay while the roadway continues for an additional 40 meters. In most instances, the footway ending would be unacceptable, but, given that this is a dead end road with nothing to access beyond the loading bay, a footway is likely not needed.
- 3.32 There are no dropped kerbs at the entrance to the Sainsbury's car park which will impede the movement of those in a wheelchair.

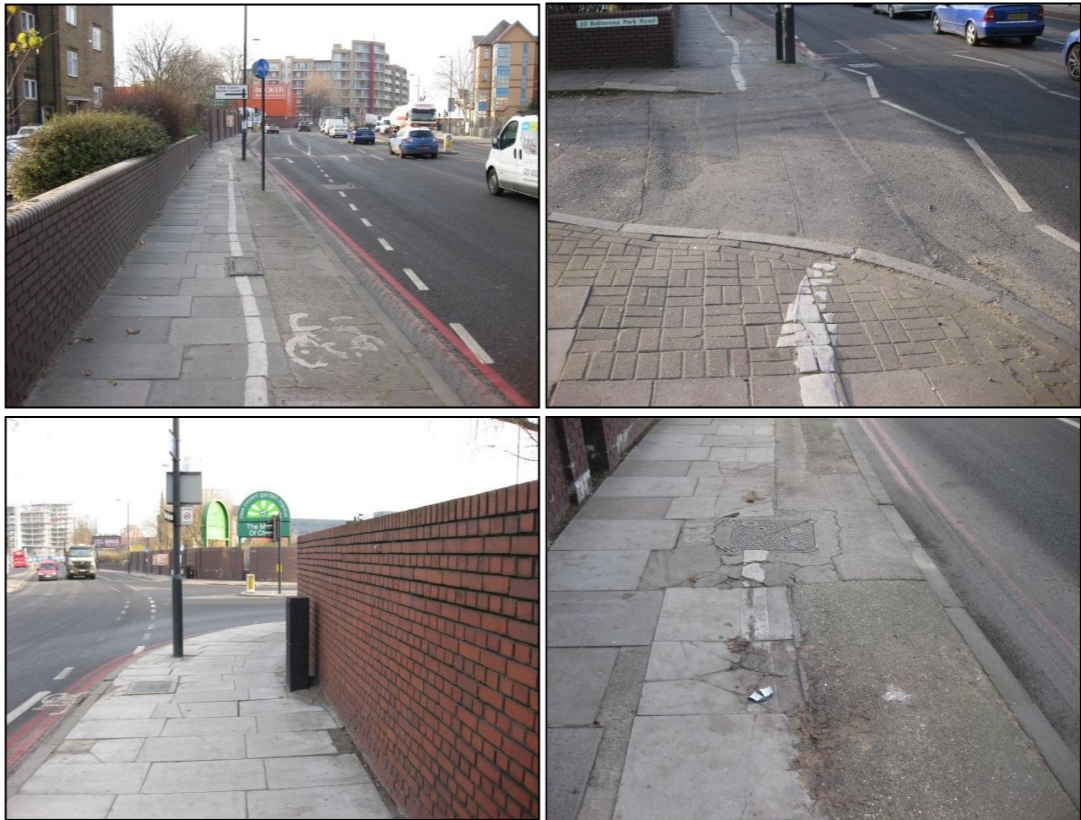
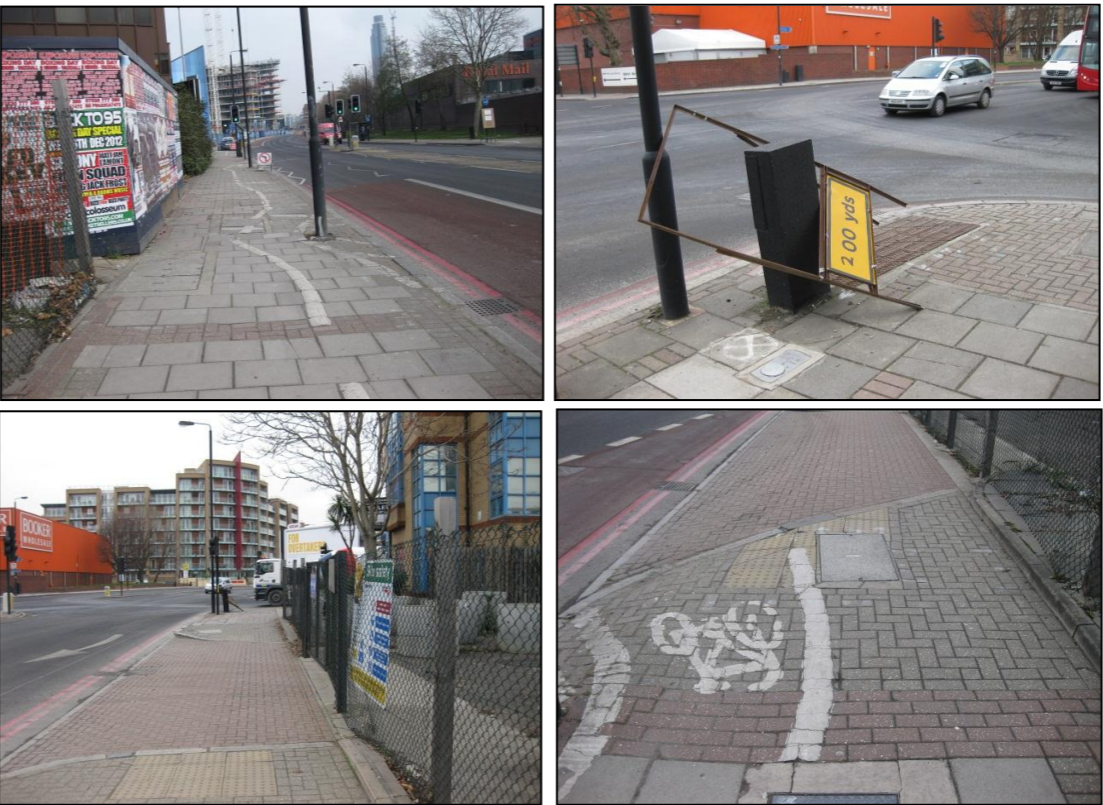
- 3.34 The density of residential, retail and work place destinations in the area is low. The footway is in generally poor condition with a poorly implemented shared cycle lane on the footway that weaves around lamp poles and sign posts. The painted line that delineates the cycle lane is so thick with paint that it becomes a hazard to both pedestrians and cyclists.

- 3.35 The surface of these footways is average. When installed, they would have been of high quality. However, due to a lack of maintenance they have degraded. There are areas where water collects and much of the footway is covered in sand and dirt.

- 3.36 There is dropped kerb and tactile information, but again, due to a lack of maintenance they are in poor condition.
- 3.37 Personal security in this area is a major concern. As there are few destinations in the area, and very few pedestrians use the foot way (50 per hour) the area feels deserted at times. There are also no frontages along the footway and the area is characterised by brick walls, chain link fences and an empty office building.

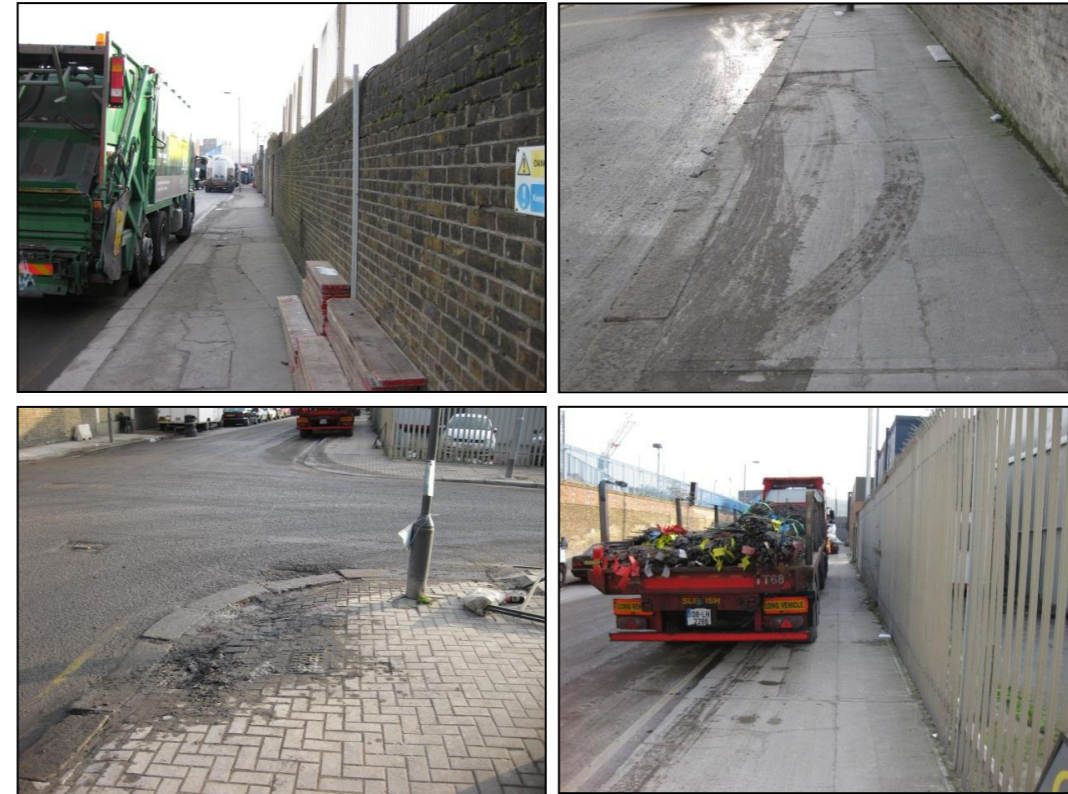
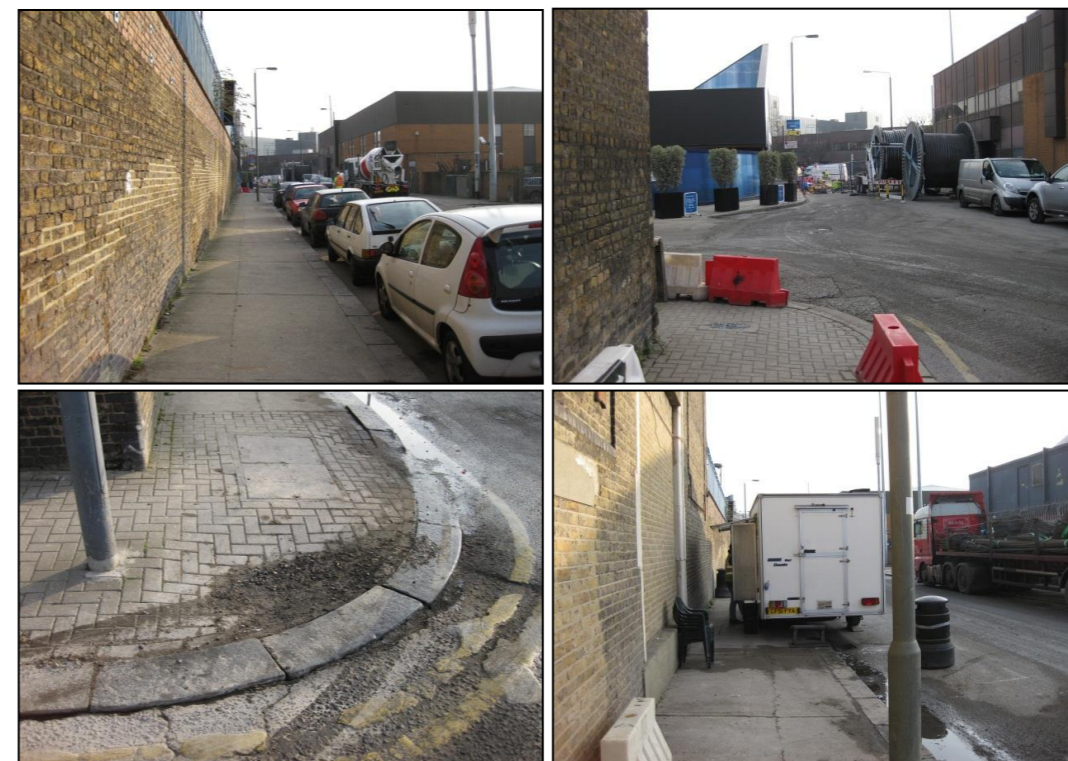
- Intimidating pedestrian environment;
- Footways in generally poor condition; and
- HGVs often use footways as extension of roadway.

- 3.38 The pedestrian environment on Cringle Street more closely resembles a construction site than a public footway.
- 3.39 HGVs are continuously accessing the nearby industrial sites and the biggest danger for pedestrians in this area is that these vehicles use the footway to manoeuvre and park on. As the footways are used as road space, they are in very poor condition. Paving stones are broken and uneven and there is enough dirt accumulated in areas that it is not possible to see the paving stones underneath. There are dropped kerbs but many are of such poor quality that a wheelchair would not be able to use them.

- Encourage redevelopment and a change in land use in the area;
- Increase maintenance to reduce tripping hazards and improve aesthetics;
- Prevent lorries from driving on footway; and
- Rebuild dropped kerbs.

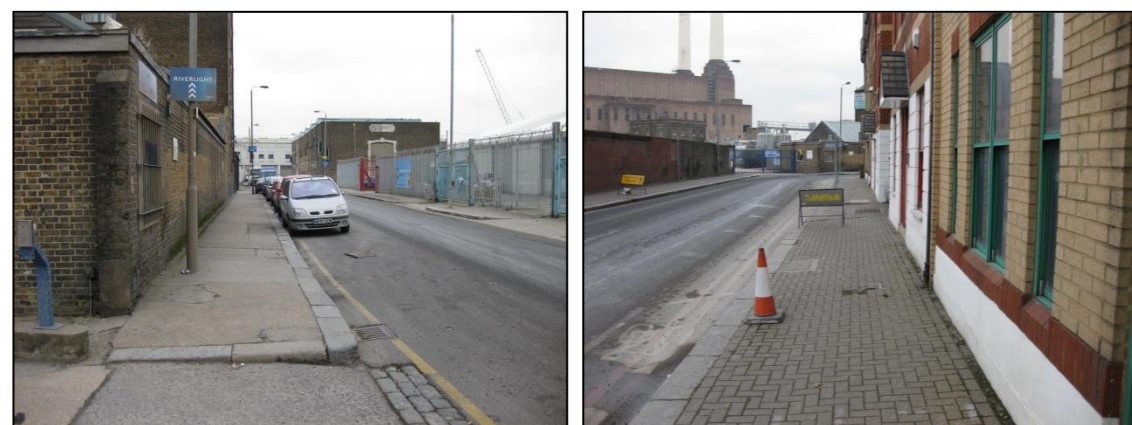
FIGURE 3.17 PHOTOGRAPHS OF LINK 5-5 & 5-6

- 3.45 With the almost continuous stream of lorries using the roadway, the pedestrian environment is severely degraded. The pollution, noise and danger associated with this volume of lorries is a key factor reducing personal security, the quality of the environment, permeability and increasing user conflict of these two footways.

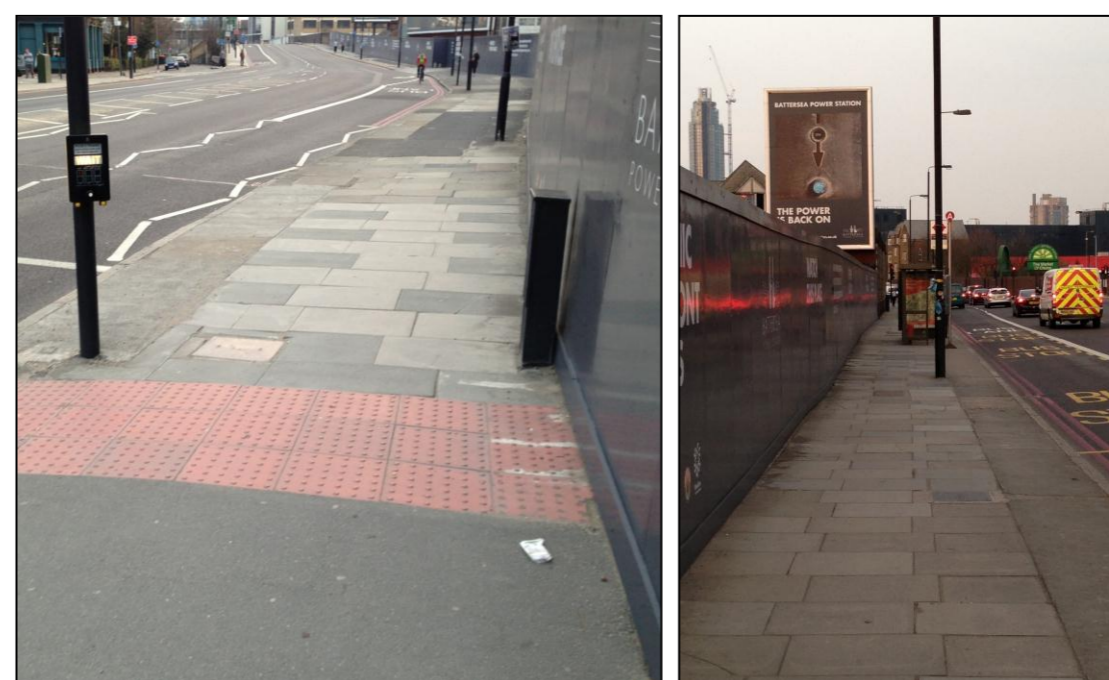
Figure 3.18 Photographs of Link 5-7

- 3.49 The surface of this footway is poor. There are many different textured surfaces where the footway has been patched. These surfaces do not always meet evenly which creates a tripping hazard.

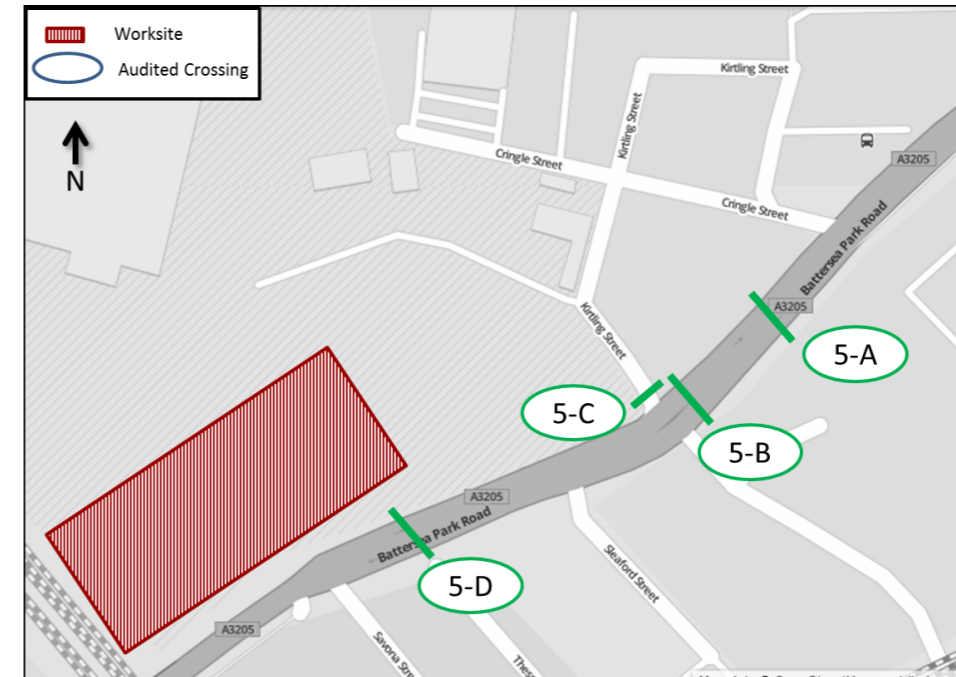
- 3.54 As seen in Table 3.1 and Figure 3.22 - Figure 3.24 all of the pedestrian crossings audited received a green rating.
- 3.55 Crossing 2-C and 5-A received the lowest ratings in this audit. Although both scored a green rating, these crossing could benefit from improvement.

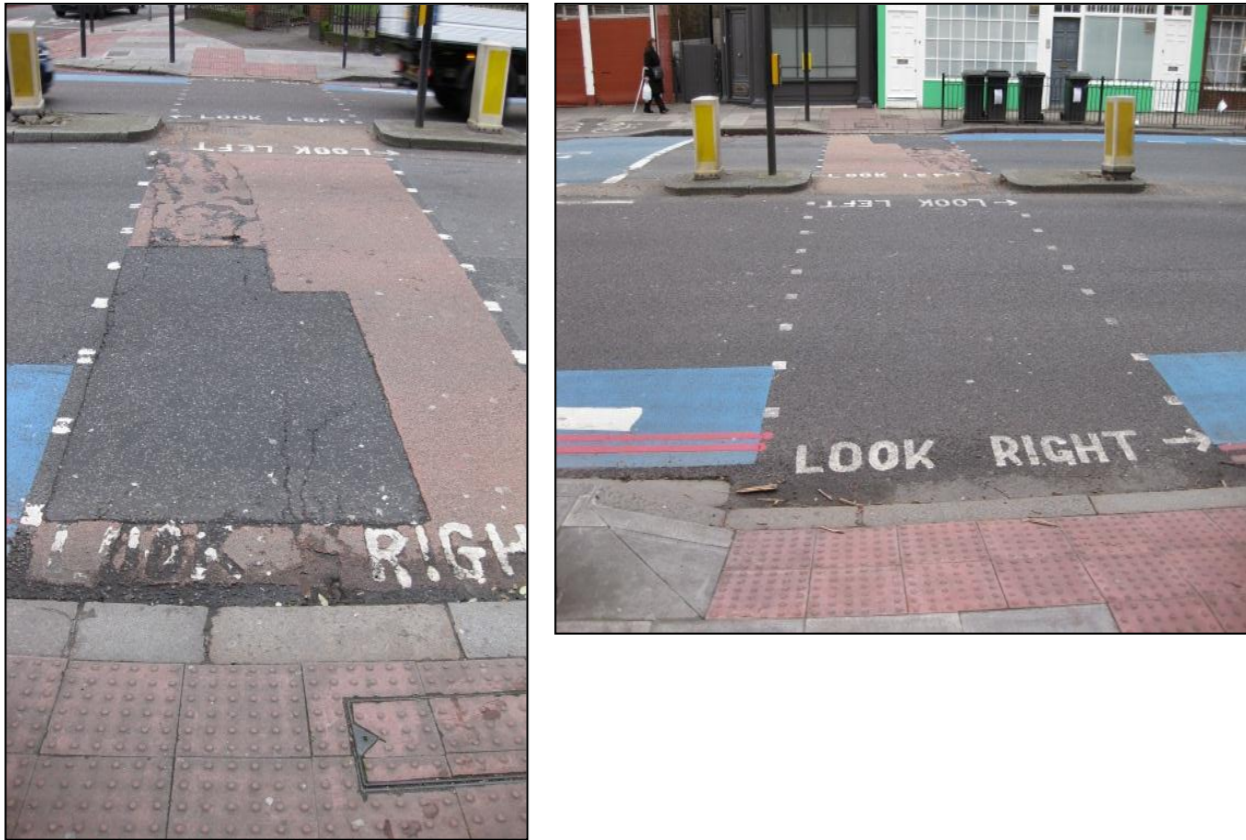
FIGURE 3.25 PHOTOGRAPHS OF CROSSING 2-C

- 3.56 Crossing 2-C has dropped kerbs, tactile information and proper signalling equipment. Its deficiency lies in the overall width of the crossing and the surface treatment in the roadway. Although the crossing is of adequate width, when compared to the other crossings at this junction, it seems very narrow. The crossing surface, where it crosses the northbound traffic lane, has a colour contrasting surface that is damaged and missing where some repair work has been completed.

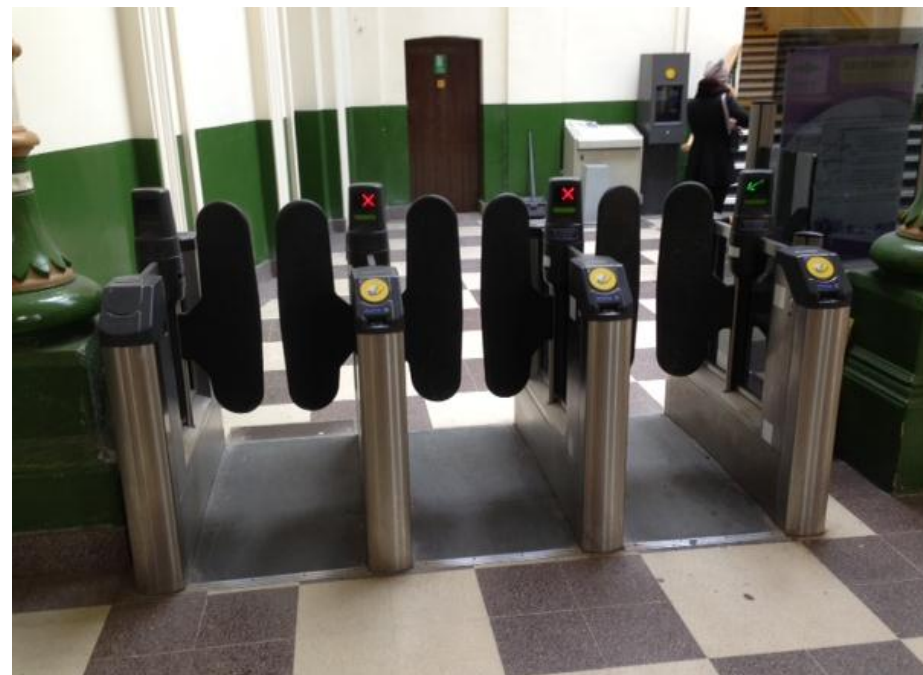
FIGURE 2.2 UTS GATES AT BATTERSEA PARK STATION

2.18 Table 10 presents the assessment of the UTS ticket gate requirements for passenger entry and exit during the AM peak hour. The existing gateline is shown in Figure 2.2.

2.19 Table 10 shows that the existing layout with three gates does not comply with LUL standards now or in 2031 without the NLE. For 2031 with NLE, two additional UTS Gates should be provided for a total of five.

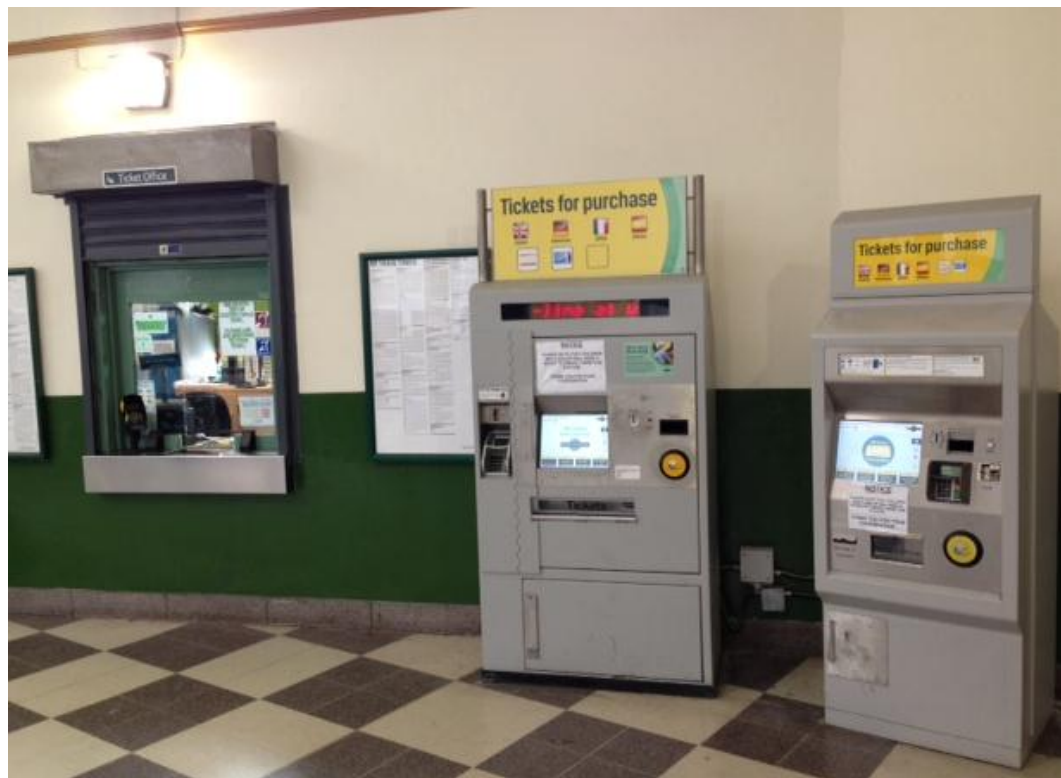
FIGURE 2.3 TIWS AND POMS AT BATTERSEA PARK STATION

2.22 Table 12 presents the assessment of the number of Ticket Issuing Windows (TIW) and Passenger Operated Machines (POM) required, based on LUL guidelines. It should be noted that these have been assessed based on 'City' category of station, contained within SPSG, rather than actual sales figures at the station. The existing arrangement at the station is shown in Figure 2.3.

2.24 The positioning of any new Gatelines, POMs and TIWs should take into account the required queuing and run-off areas.
