**Pedestrian Guard Railing:  
A Review of Criteria for Installation**

## **FINAL REPORT**

**Transport for London**

**October 2003**

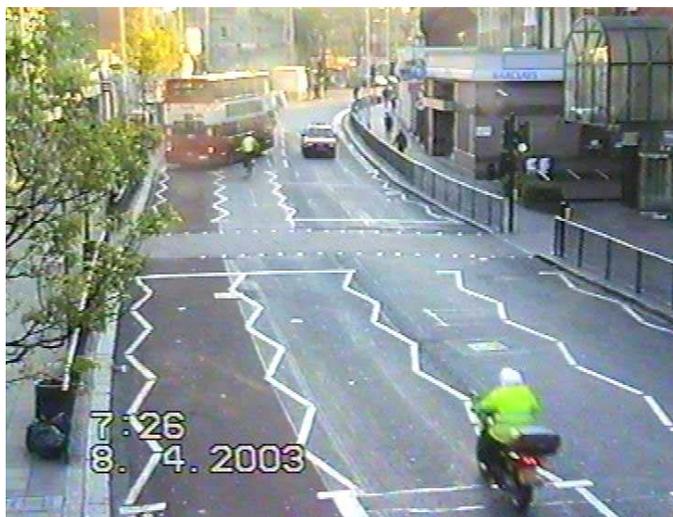
**Figure 4.1: Snapshot of a Video Image (Site 1P02)**

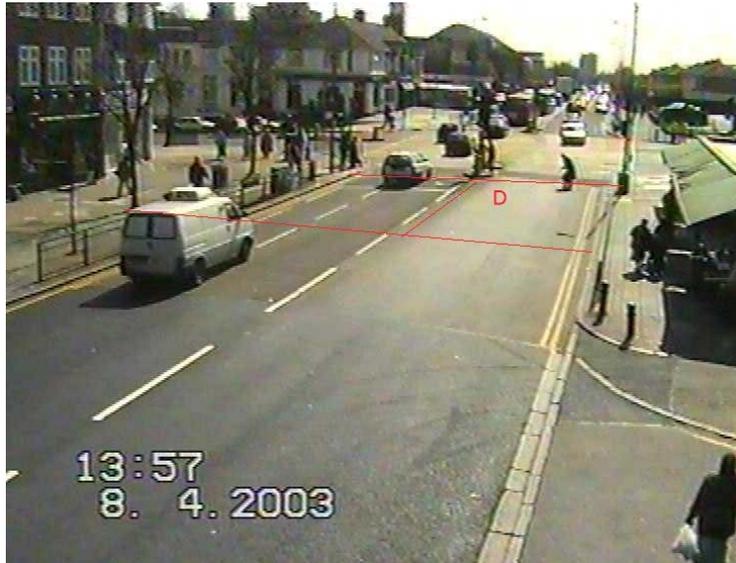
Vehicle speeds were measured using a computer controlled video recording play-back system. The working principle is illustrated in Figure 5.1. Two reference lines a known distance apart on the site were first drawn on the TV screen. By measuring the time spent for a vehicle to travel between the two reference lines, the speed of the vehicle could be calculated. The time measurement method using the computer controlled video recording play-back system is detailed in Appendix A.

**Figure 5.1: Reference Lines used for Speed Measurement**

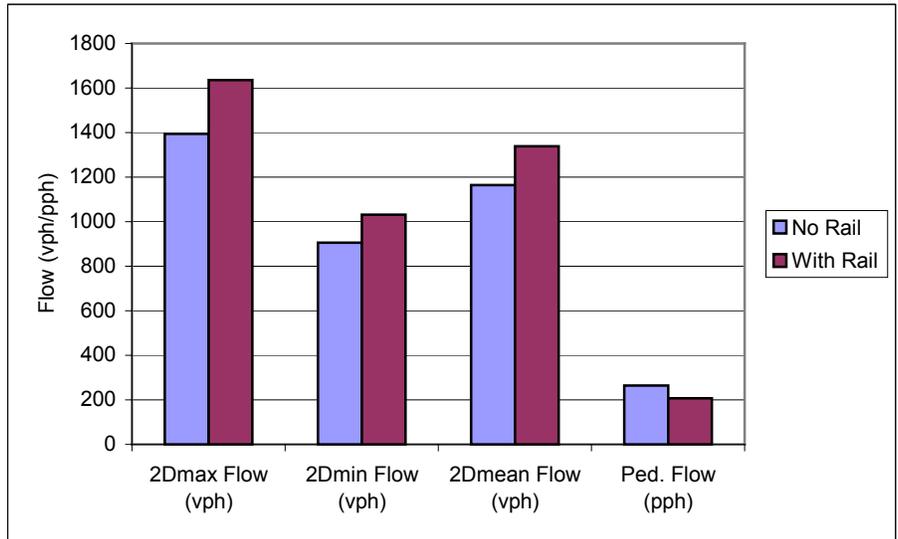
The conclusion is that the observed sites with and without railing do not differ significantly in terms of traffic flow, traffic speed and pedestrian flow.

**Figure 5.3: Traffic and Pedestrian Flows at Sites with and without Guard rails**

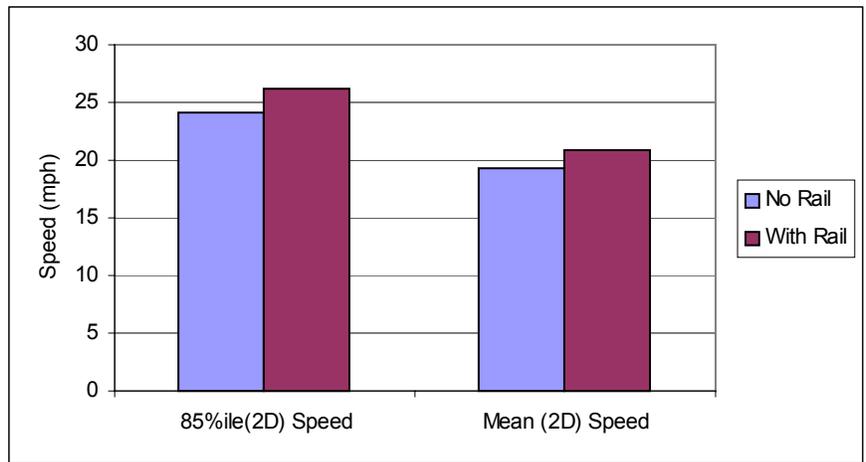
**Figure 5.4: Traffic Speeds at Sites with and without Guard rails**

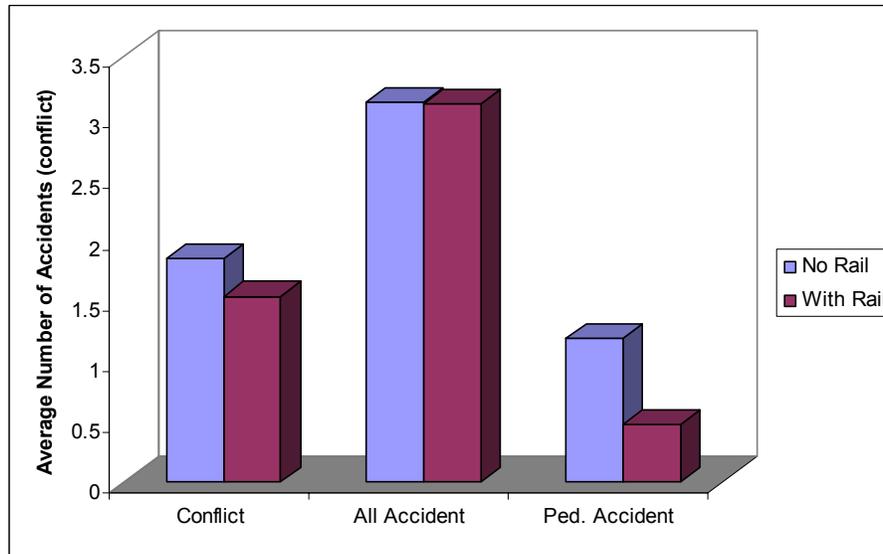
- Pedestrian accidents at sites without railing are 2.5 times that at sites with railing, and the difference is statistically significant (at 5% level,  $t=2.1$ ).
- The total of all accidents at sites without railing are the same as that at sites with railing, and the difference is not statistically significant ( $t=0.01$ ).
- Conflicts at sites without railing are 1.2 times that at sites with railing, but the difference is not statistically significant ( $t=0.51$ ).

Figure 5.5: Average Numbers of Accidents and Conflicts at All Sites

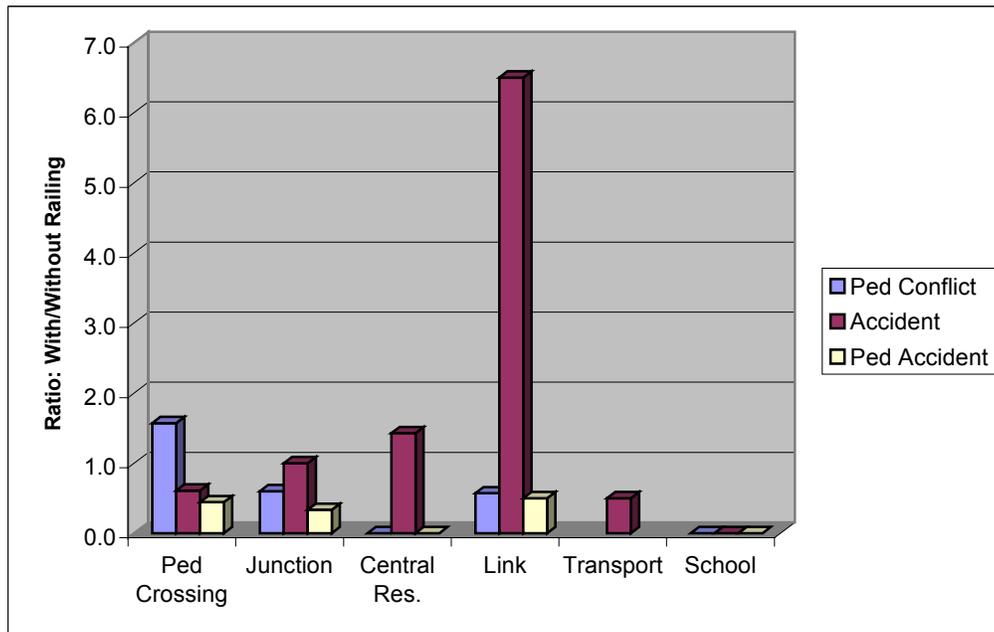
- Conflicts are lower at sites with railing for all types of site except pedestrian crossings where the conflict rate is slightly higher than at sites without railing.
- Accident rates are much higher at link sites and slightly higher at central reservation sites with railing, than at sites without railing.
- Pedestrian accidents are fewer at all types of sites with railing.
- At transportation interchange sites without railing, there were no pedestrian accidents and conflicts, so the ratios will be infinite and are not depicted.
- At school sites with railing, no conflicts or accidents were recorded, and at central reservation sites with railing, no pedestrian conflicts or pedestrian accidents were recorded, so the ratios are all zero.

**Figure 5.6: Accident and Conflict Ratios (with/without guard railing)**  
 (Note: values less than 1.0 indicate railing is beneficial)

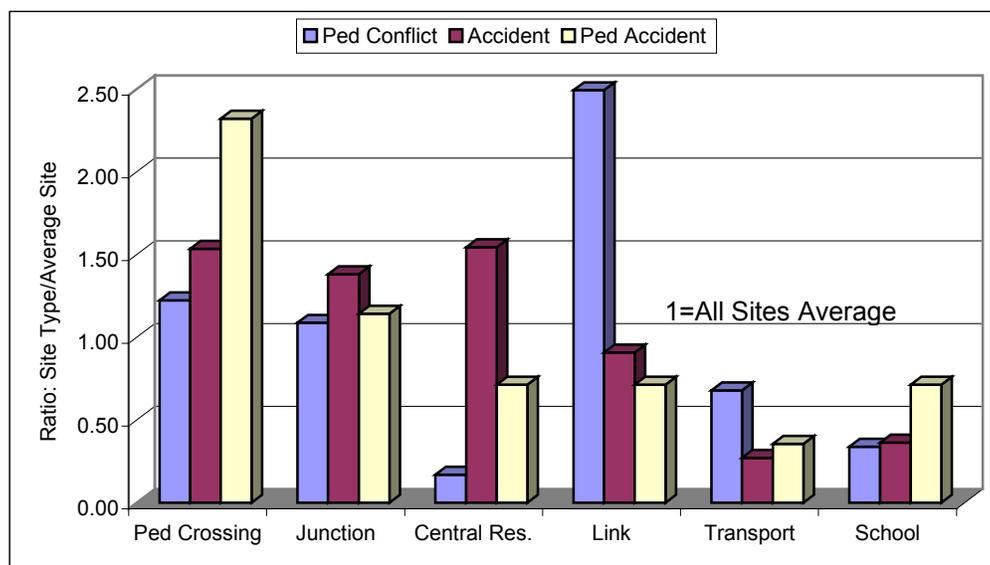
- At pedestrian crossing and junction sites, conflicts, accidents and pedestrian accidents are more than the average of all types of sites.
- At transportation interchange and school sites, conflicts, accidents and pedestrian accidents are lower than the average.
- Pedestrian crossing sites have the highest pedestrian accident rate.
- Link sites have the highest conflict rate.
- Central reservation sites have the highest accident rate.

**Figure 5.7: Accident and Conflict Rate Ratios of Site Type to the Average Site**

The pedestrian crossing sites have the highest overall pedestrian accident rate (Figure 5.7), and there are fewer accidents and pedestrian accidents at the sites with railing than at sites without railing. Overall, installation of guard railing may be of benefit by helping to guide pedestrians to the designated crossing place.

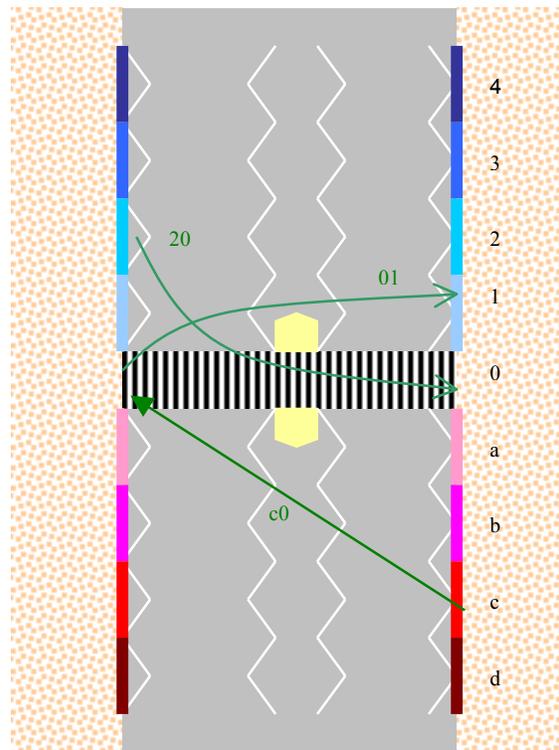
The crossing was fully used in the first type of movement and partly used in the second type of movement. It was not used at all in the third type of movement. With the erection of guard railing, the first and the second type of pedestrian movements should be expected to increase while the third type of movements should reduce.

**Figure 5.8: Grid Coordinate System used for Pedestrian Crossing Sites**

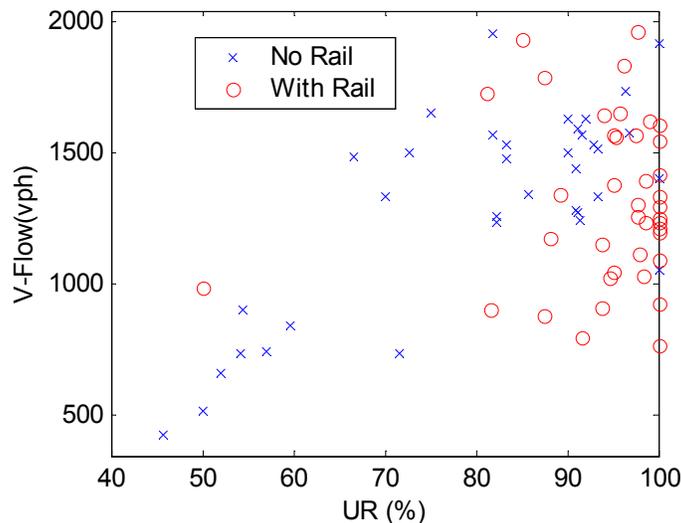
Correlation coefficients between the five pedestrian crossing attributes, i.e., Utilisation Rate, Correct Use Rate, vehicle flow, vehicle speed and pedestrian flow, were calculated for sites with and without railing respectively, and are shown in Table 5.4. From the correlation between Utilisation Rate and traffic flow (UR vs. V-Flow), it can be found that at sites without railing more pedestrians tend to use the pedestrian crossings at higher traffic flow than at lower traffic flow (correlation coefficient = 0.76). The plot is shown in Figure 5.9. It is likely that crossing opportunities are easier to find at low traffic flow so pedestrians could be tempted to cross at a more convenient place. At sites with railing, pedestrian flow is higher when traffic speed is low (P-Flow vs. 85%ile Speed, correlation coefficient = - 0.51). This seems to be reasonable as traffic speed could be restricted at some busy pedestrian crossings. No other strong correlations were found.

Figure 5.9: Plot of Utilisation Rate vs. Vehicle Flow at Pedestrian Crossing Sites

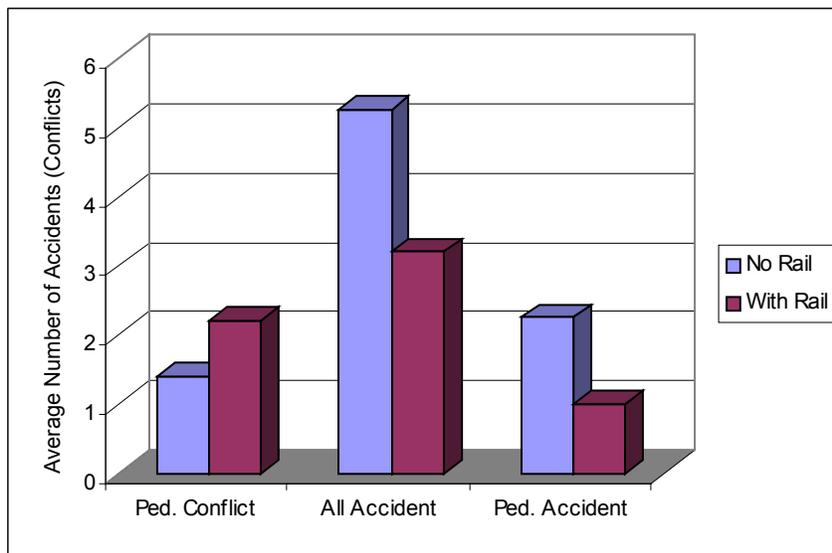
Figure 5.10: Average Numbers of Accidents and Conflicts at Pedestrian Crossing Sites

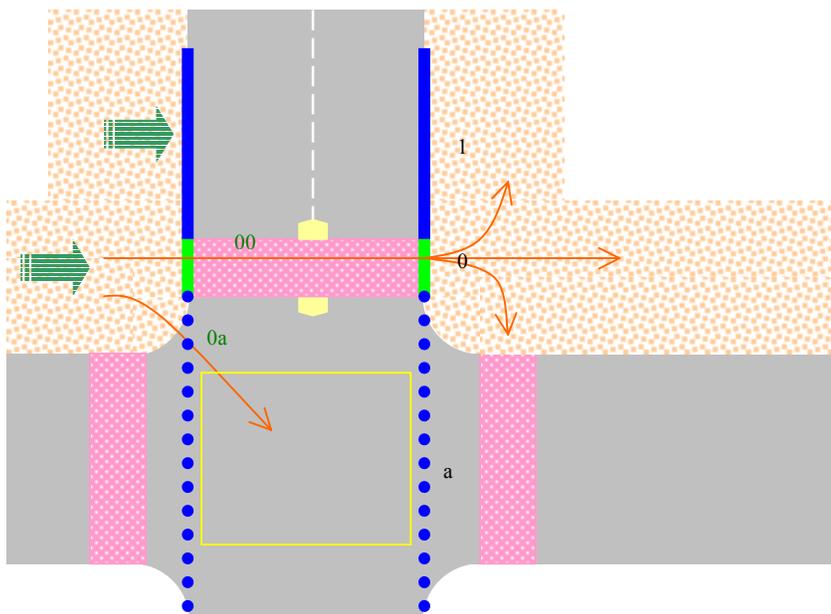
Figure 5.11: Grid Coordinate System used for Junction Sites

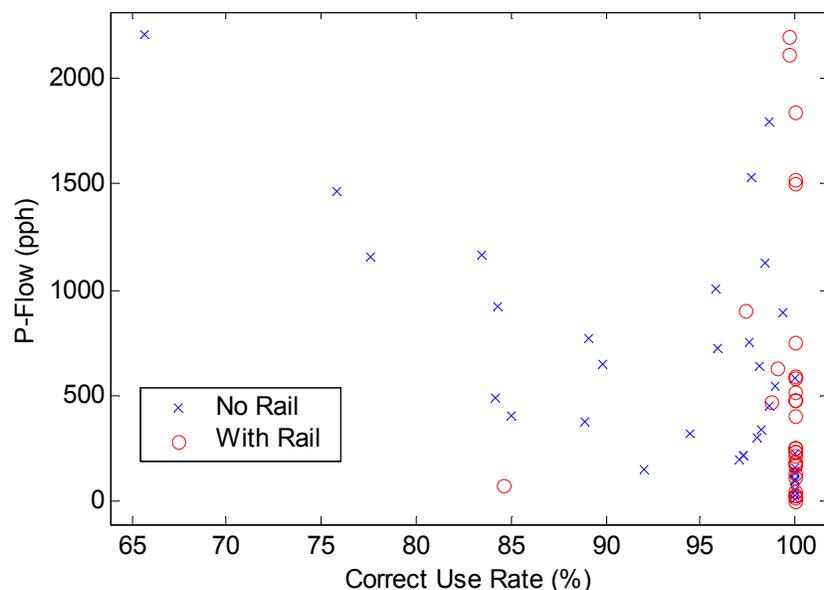
- Sites with railing have a higher Utilisation Rate (87.2%) than those without railing (85.2%), but the difference was found to be not significant ( $t=0.64$ ).
- Sites with railing have higher Correct Use Rate (99.4%) than those without railing (94.1%), and the difference was found to be significant (at the 1% level,  $t=3.74$ ).
- Sites with railing have higher Formal Use Rate (86.9%) than those without railing (79.8%), and the difference was found to be significant (at the 5% level,  $t=2.36$ ).

Figure 5.12: Plot of Correct Use Rate vs. Pedestrian Flow at Junction Sites

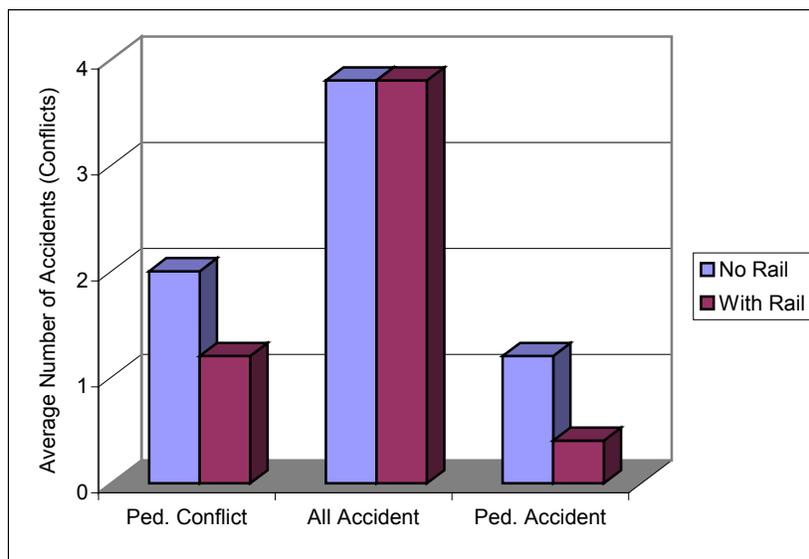
The numbers of conflicts, accidents and pedestrian accidents at the junction sites are shown in Figure 5.13. The accident rates are the same for sites with and without railing. There are fewer conflicts and pedestrian accidents at sites with railing, but the difference is not statistically significant ( $t=1.79$  for conflicts,  $t=1.46$  for pedestrian accidents).

**Figure 5.13: Average Numbers of Accidents and Conflicts at Junction Sites**

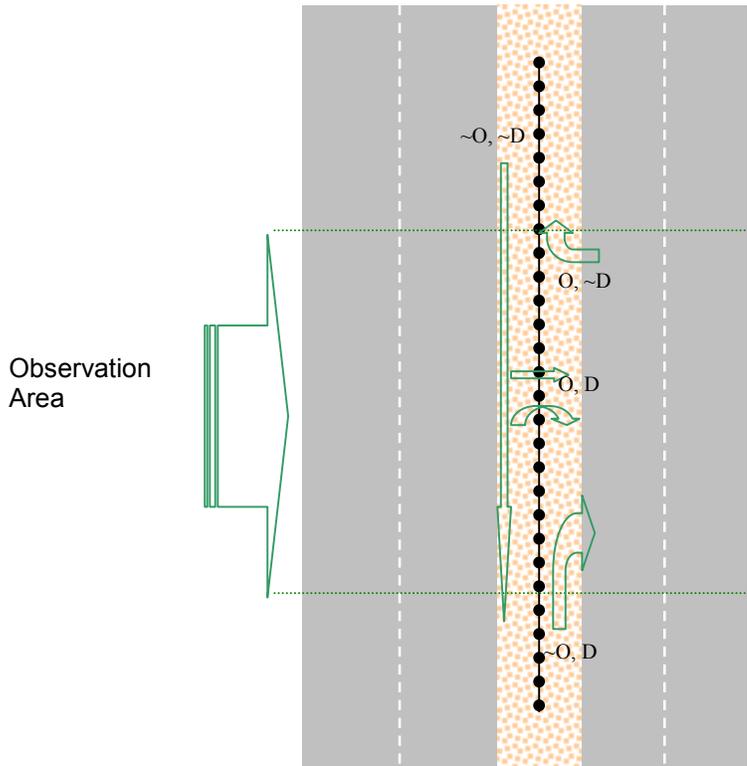
At central reservation sites, pedestrians can enter and leave the observation area on the carriageway or on the central reservation, while at link sites, they can only enter or leave on the carriageway. The pedestrian groups analysed included those observed in the observation area whose movements fell into one of the four categories defined above.

**Figure 5.14: Pedestrian Movements at Central Reservation Sites**

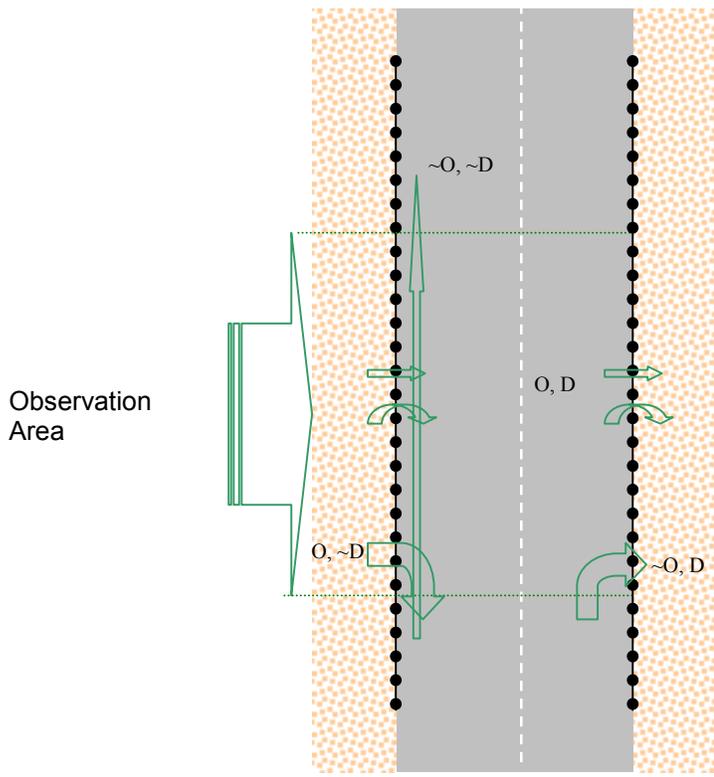
**Figure 5.15: Pedestrian Movements at Link Sites**

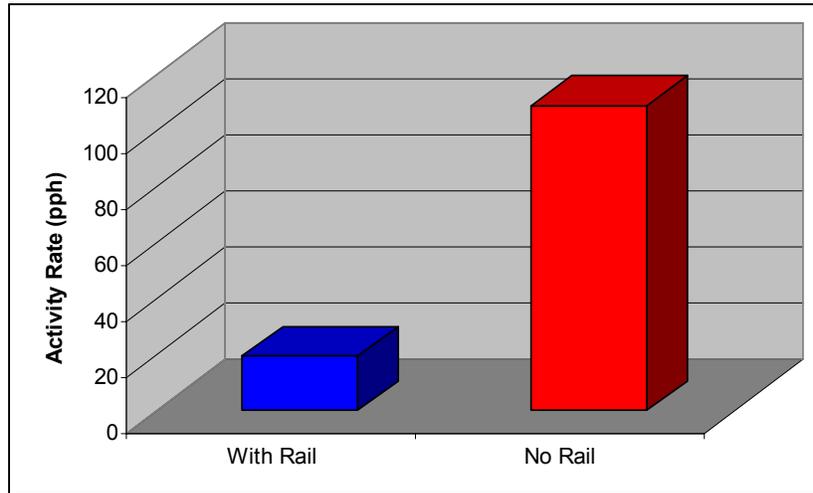
**Figure 5.16: Comparison of Activity Rate at Sites with and without Railing**

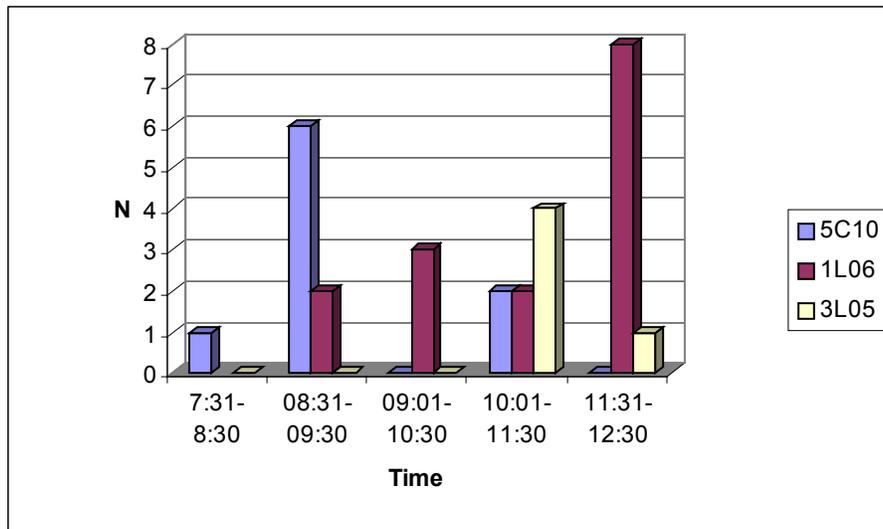
**Figure 5.17: Time Distribution of Climbing Railing Activities**

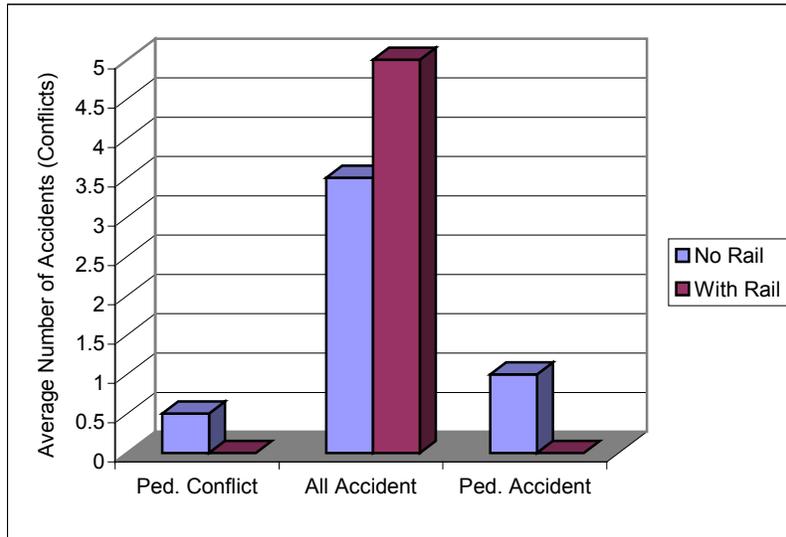
Of the two observed central reservation sites with railing, no pedestrian conflicts and accidents were recorded. Of the two sites without railing, two pedestrian accidents and one conflict were recorded at one site. No statistical comparison has been made because of small samples, though the indication is that at the sites surveyed, pedestrian accidents and conflicts are lower at sites with railing, but total accidents are higher.

**Figure 5.18: Average Numbers of Accidents and Conflicts at Central Reservation Sites**

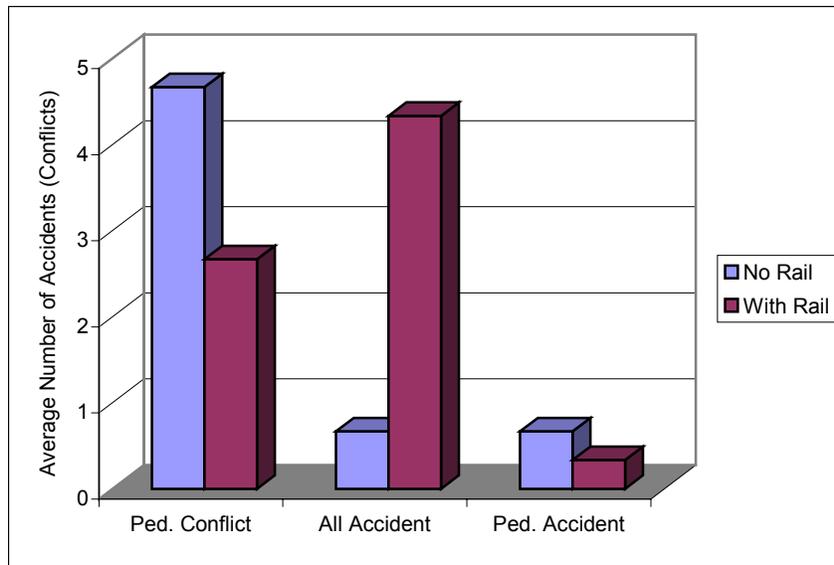
At the Link sites, the observed conflicts and pedestrian accidents are fewer at sites with railing than at sites without railing, as shown in Figure 5.19, though the number of accidents is higher at sites with railing. However, none of these differences are statistically significant at 5% confidence level ( $t=1.81$  for conflicts,  $t=-2.29$  for accidents,  $t=0.45$  for pedestrian accidents).

**Figure 5.19: Average Numbers of Accidents and Conflicts at Link Sites**

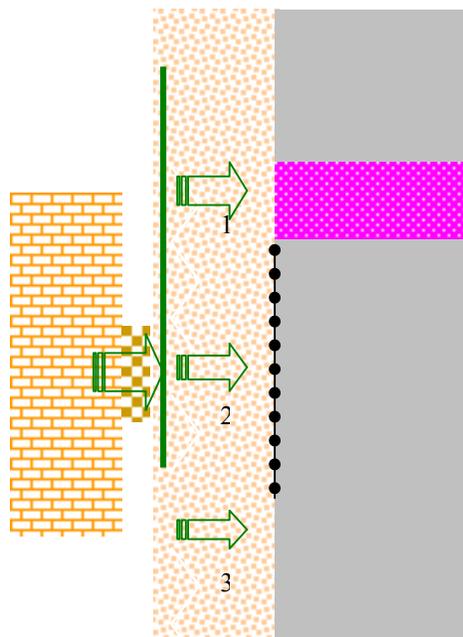
At school sites, entrances/exits are often far from a pedestrian crossing. At some sites, long guard rails are erected which extend to a pedestrian crossing, while at some other sites, only a short section of guard rail is installed directly in front of the school entrance/exit.

**Figure 5.20: Pedestrian Movements at Transportation Interchange and School Sites**

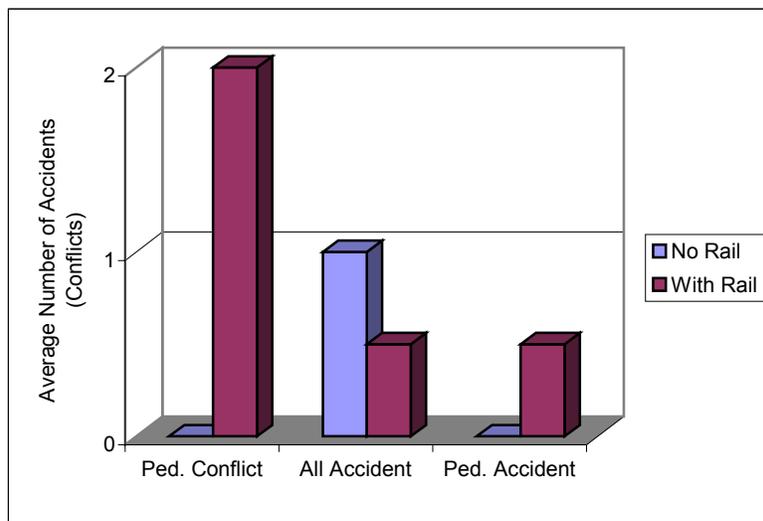
The average number of conflicts, accidents and pedestrian accidents at the observed transportation interchange and school sites are shown in Figure 5.21 -22. The overall rate of conflicts, accidents and pedestrian accidents is low. No pedestrian accidents and conflicts are observed at transportation interchange sites without railing and at school sites with railing. The number of conflicts and pedestrian accidents is higher at transportation interchange sites with railing than at sites without railing. School sites with railing show a better safety record in terms of conflicts, accidents and pedestrian accidents. However, these results are based on a very small sample, and should be interpreted with caution.

**Figure 5.21: Average Numbers of Accidents and Conflicts at Transportation Interchange Sites**

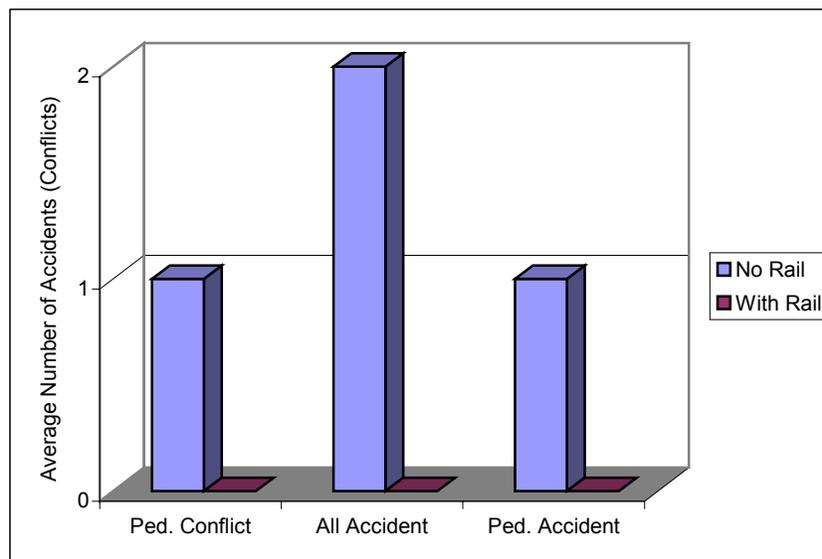
**Figure 5.22: Average Numbers of Accidents and Conflicts at School Sites**

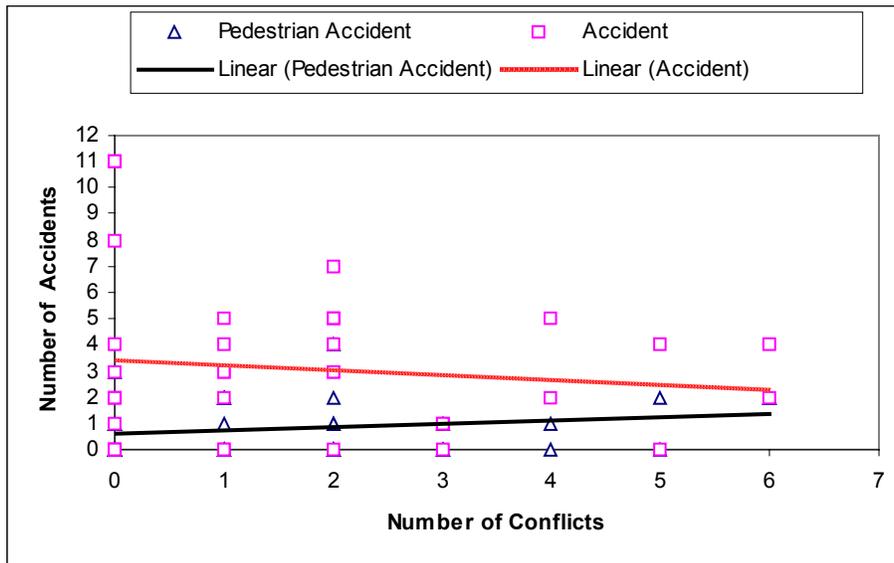
**Figure 5.23: Relationship between Accident and Conflict Rates**

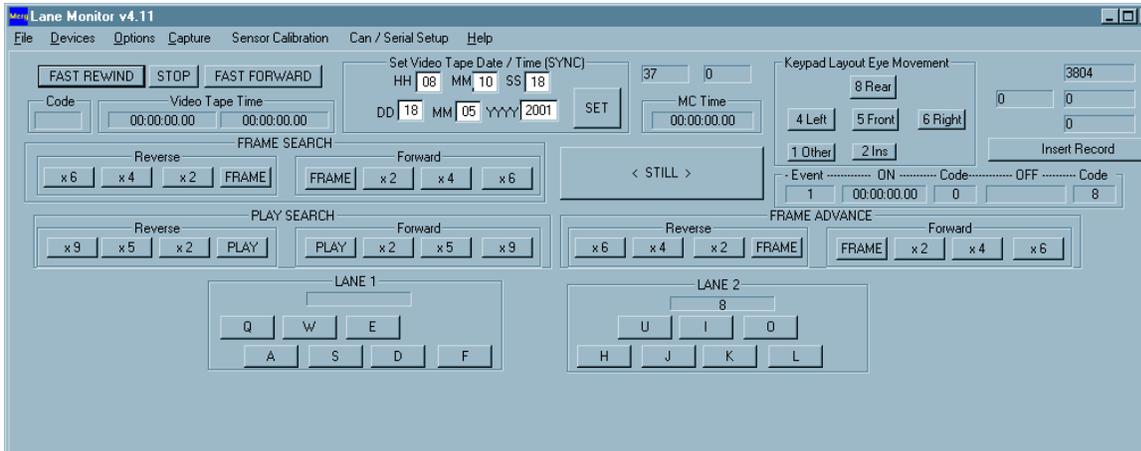
Figure A.3: A Screenshot of Lane Monitor

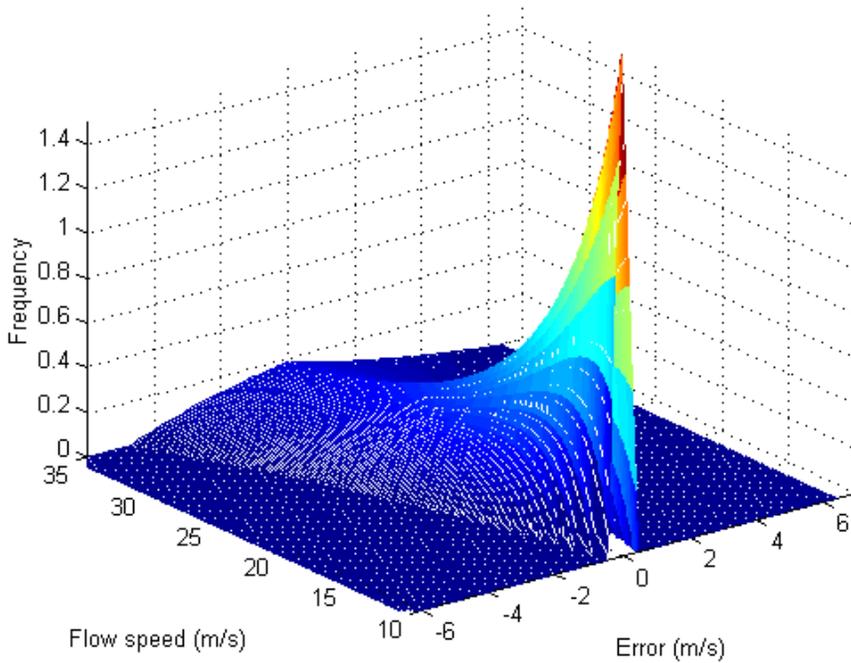
**Figure A.4: Distribution of Speed Measurement Error**

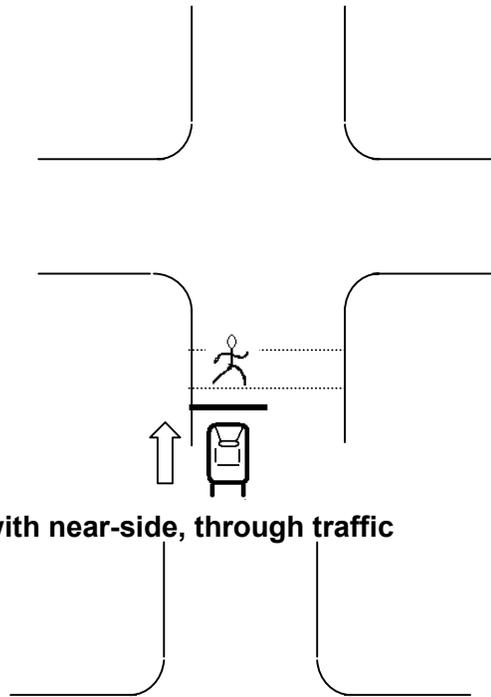
**Figure B.5: Conflict with near-side, through traffic**

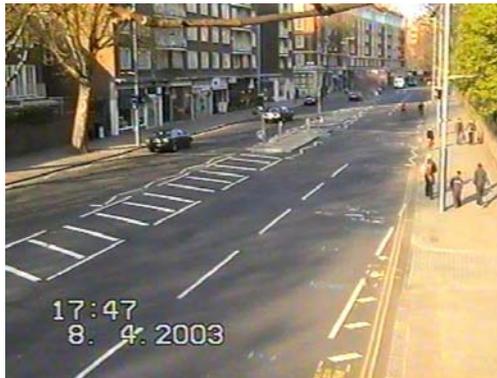
Site	3P10	Pelican	
Location	Kensington High Street near Melbury Road		
Guard Rail	No		
Vehicle flow	1379 vph		
85%ile Speed	36.2 mph		
Crossing pedestrian flow	70 pph		
Pedestrian Conflicts (in 4 hours)	0		
All Accidents (3 years)	4		
Pedestrian Accidents (3 years)	1		
Behaviour indices	UR(%)	CUR(%)	FUR(%)
	84.3%	93.2%	78.5%

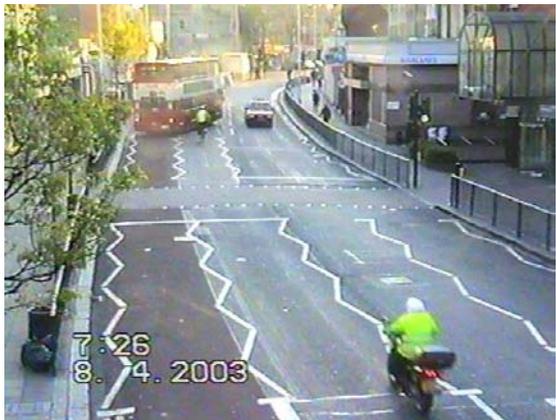
Site	1P02	Pelican	
Location	The Broadway (Ealing) near Haven Street		
Guard Rail	Yes		
Vehicle flow	1637 vph		
85%ile Speed	22.8 mph		
Crossing pedestrian flow	558 pph		
Pedestrian Conflicts (in 4 hours)	6		
All Accidents (3 years)	4		
Pedestrian Accidents (3 years)	2		
Behaviour indices	UR(%)	CUR(%)	FUR(%)
	92.9%	99.2%	92.1%

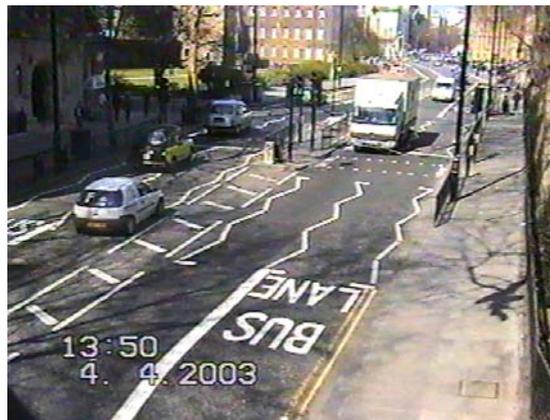
Site	2P11	Pelican		
Location	Millbank near College Street			
Guard Rail	Yes			
Vehicle flow	1529 vph			
85%ile Speed	38.1 mph			
Crossing pedestrian flow	233 pph			
Pedestrian Conflicts (in 4 hours)	2			
All Accidents (3 years)	5			
Pedestrian Accidents (3 years)	1			
Behaviour indices	UR(%)	CUR(%)	FUR(%)	
	93.0%	92.4%	86.0%

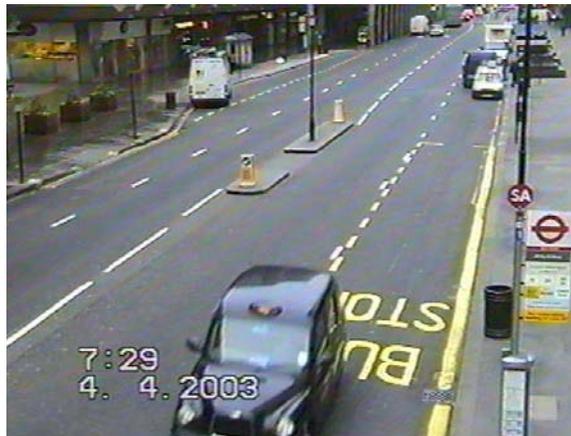
Site	2R03	Refuge		
Location	Victoria Street near Buckingham Gate			
Guard Rail	No			
Vehicle flow	1201 vph			
85%ile Speed	27.6 mph			
Crossing pedestrian flow	541 pph			
Pedestrian Conflicts (in 4 hours)	5			
All Accidents (3 years)	4			
Pedestrian Accidents (3 years)	2			
Behaviour indices	UR(%)	CUR(%)	FUR(%)	
	55.6%	97.6%	54.2%

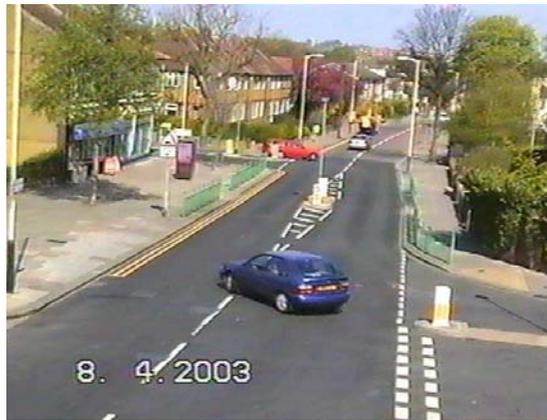
Site	1R04	Refuge	
Location	Oldfields Lane near Croyde Avenue		
Guard Rail	Yes		
Vehicle flow	693 vph		
85%ile Speed	33.0 mph		
Crossing pedestrian flow	43 pph		
Pedestrian Conflicts (in 4 hours)	3		
All Accidents (3 years)	1		
Pedestrian Accidents (3 years)	0		
Behaviour indices	UR(%)	CUR(%)	FUR(%)
	93.0%	100%	93.0%

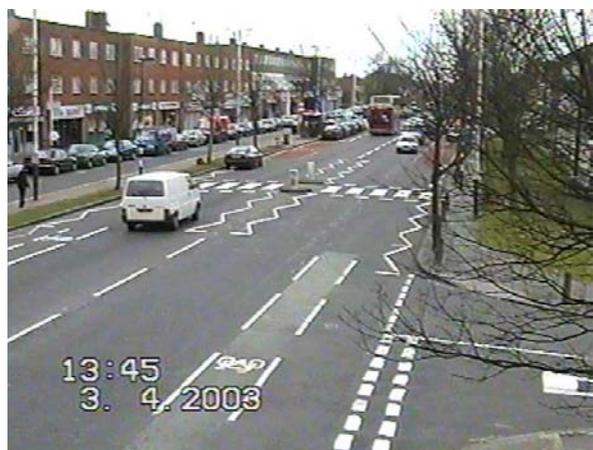
Site	1Z06	Zebra	
Location	Lady Margaret Road near Kenilworth Gardens		
Guard Rail	No		
Vehicle flow	1493 vph		
85%ile Speed	37.6 mph		
Crossing pedestrian flow	27 pph		
Pedestrian Conflicts (in 4 hours)	0		
All Accidents (3 years)	1		
Pedestrian Accidents (3 years)	0		
Behaviour indices	UR(%)	CUR(%)	FUR(%)
	93.4%	90.3%	84.3%

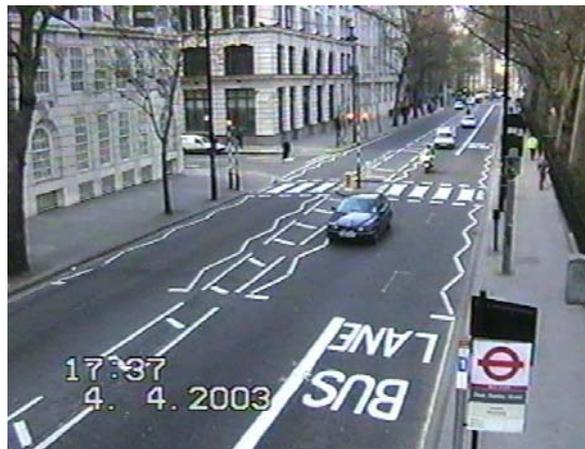
Site	2Z07	Zebra		
Location	Millbank / Dean Stanley Street			
Guard Rail	No			
Vehicle flow	1488 vph			
85%ile Speed	36.9 mph			
Crossing pedestrian flow	210 pph			
Pedestrian Conflicts (in 4 hours)	0			
All Accidents (3 years)	11			
Pedestrian Accidents (3 years)	3			
Behaviour indices	UR(%)	CUR(%)	FUR(%)	
	90.1%	85.8%	77.3%

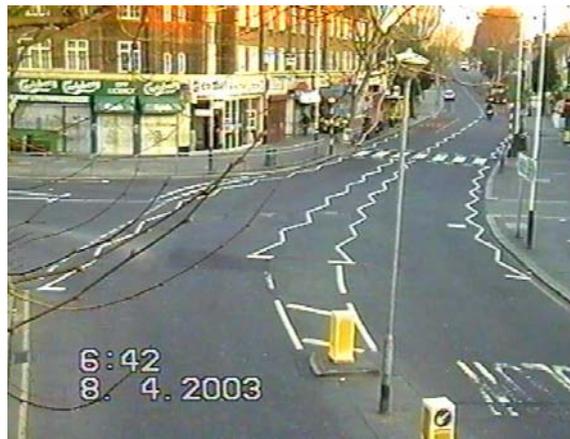
Site	1Z09	Zebra		
Location	Northfield Avenue / Windmill Road			
Guard Rail	Yes			
Vehicle flow	1206 vph			
85%ile Speed	23.6 mph			
Crossing pedestrian flow	306 pph			
Pedestrian Conflicts (in 4 hours)	0			
All Accidents (3 years)	4			
Pedestrian Accidents (3 years)	1			
Behaviour indices	UR(%)	CUR(%)	FUR(%)	
	98.3%	100.0%	98.3%

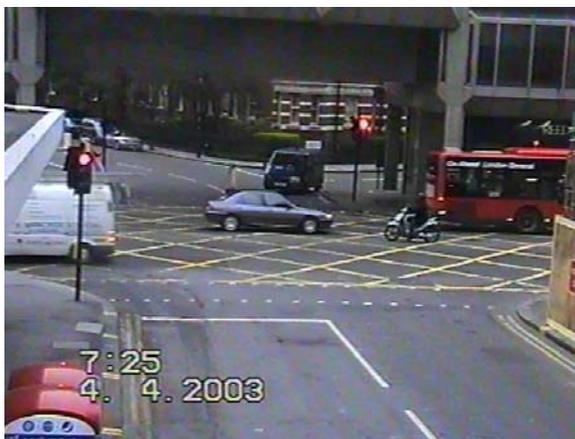
Site	2J11	Junction - Signals		
Location	Victoria Street / Palace Street			
Guard Rail	No			
Vehicle flow	233 vph			
85%ile Speed	12.3 mph			
Crossing pedestrian flow	1133 pph			
Pedestrian Conflicts (in 4 hours)	1			
All Accidents (3 years)	3			
Pedestrian Accidents (3 years)	2			
Behaviour indices	UR(%)	CUR(%)	FUR(%)	
	96.4%	81.2%	78.3%

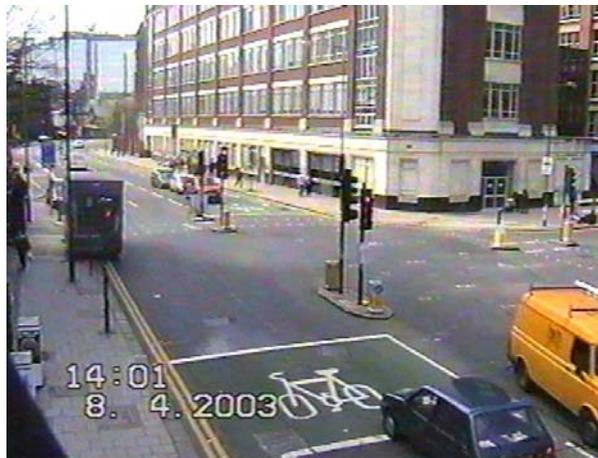
Site	4J16	Junction	
Location	Hammersmith Road / Brook Green		
Guard Rail	No		
Vehicle flow	1226 vph		
85%ile Speed	22.8 mph		
Crossing pedestrian flow	94 pph		
Pedestrian Conflicts (in 4 hours)	2		
All Accidents (3 years)	5		
Pedestrian Accidents (3 years)	2		
Behaviour indices	UR(%)	CUR(%)	FUR(%)
	83.8%	94.7%	79.4%

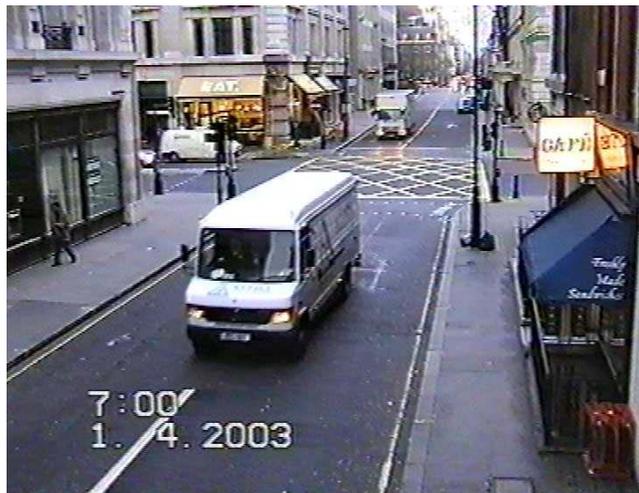
Site	2J19	Junction	
Location	Regent Street / Cavendish Place		
Guard Rail	No		
Vehicle flow	842 vph		
85%ile Speed	19.4 mph		
Crossing pedestrian flow	749 pph		
Pedestrian Conflicts (in 4 hours)	1		
All Accidents (3 years)	3		
Pedestrian Accidents (3 years)	2		
Behaviour indices	UR(%)	CUR(%)	FUR(%)
	91.4%	96.5%	88.2%

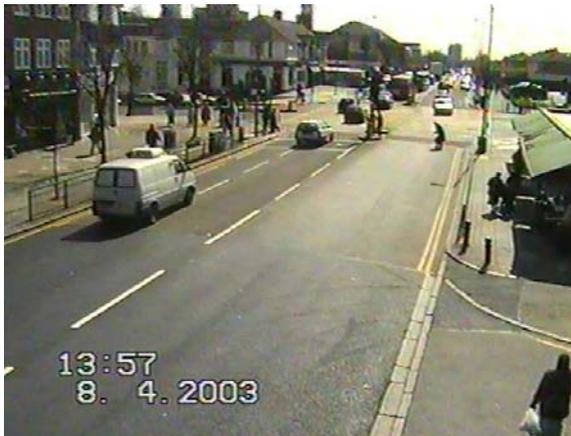
Site	1J05	Junction	
Location	Ruislip Road / Greenford Avenue		
Guard Rail	Yes		
Vehicle flow	1541 vph		
85%ile Speed	21.9 mph		
Crossing pedestrian flow	656 pph		
Pedestrian Conflicts (in 4 hours)	0		
All Accidents (3 years)	11		
Pedestrian Accidents (3 years)	1		
Behaviour indices	UR(%)	CUR(%)	FUR(%)
	88.8%	99.4%	88.3%

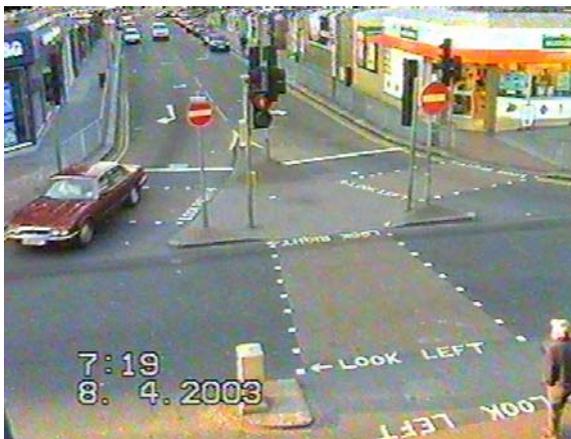
Site	1J06	Junction	
Location	New Broadway / Bond Street (Ealing)		
Guard Rail	Yes		
Vehicle flow	620 vph		
85%ile Speed	19.7 mph		
Crossing pedestrian flow	536 pph		
Pedestrian Conflicts (in 4 hours)	2		
All Accidents (3 years)	3		
Pedestrian Accidents (3 years)	1		
Behaviour indices	UR(%)	CUR(%)	FUR(%)
	91.4%	99.9%	91.4%

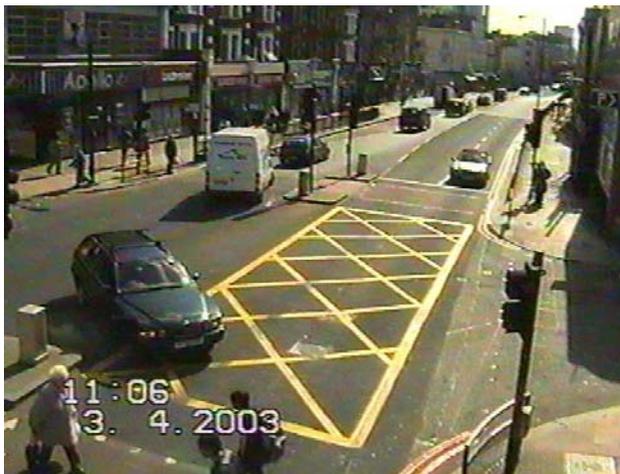
Site	2J12	Junction	
Location	Edgware Road / Church Street		
Guard Rail	Yes		
Vehicle flow	1889 vph		
85%ile Speed	24.5 mph		
Crossing pedestrian flow	214 pph		
Pedestrian Conflicts (in 4 hours)	1		
All Accidents (3 years)	5		
Pedestrian Accidents (3 years)	0		
Behaviour indices	UR(%)	CUR(%)	FUR(%)
	97.3%	100.0%	97.3%

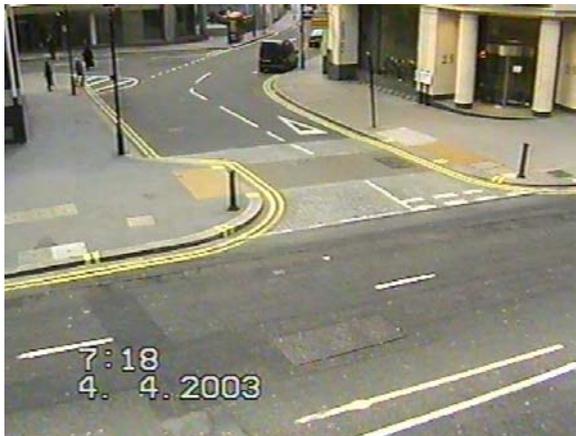
Site	2J18	Junction		
Location	Victoria Street / Abbey Street			
Guard Rail	No			
Vehicle flow	144 vph			
85%ile Speed	11.0 mph			
Crossing pedestrian flow	387 pph			
Pedestrian Conflicts (in 4 hours)	2			
All Accidents (3 years)	3			
Pedestrian Accidents (3 years)	0			
Behaviour indices	UR(%)	CUR(%)	FUR(%)	
	71.2%	98.9%	70.4%

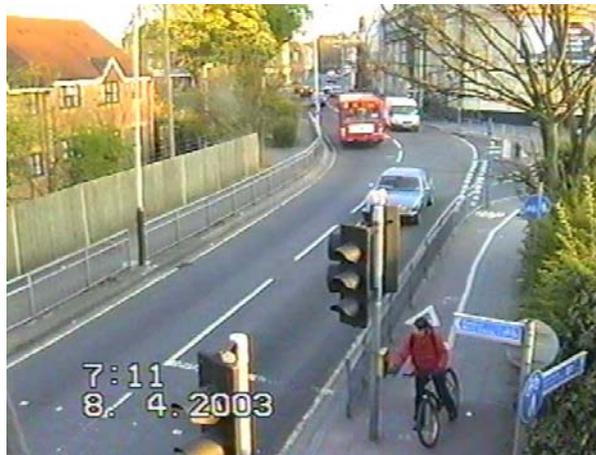
Site	1J17	Junction		
Location	Northfield Avenue / Mattock Lane			
Guard Rail	Yes			
Vehicle flow	1125 vph			
85%ile Speed	27.1 mph			
Crossing pedestrian flow	3 pph			
Pedestrian Conflicts (in 4 hours)	1			
All Accidents (3 years)	0			
Pedestrian Accidents (3 years)	0			
Behaviour indices	UR(%)	CUR(%)	FUR(%)	
	93.8%	100.0%	93.8%

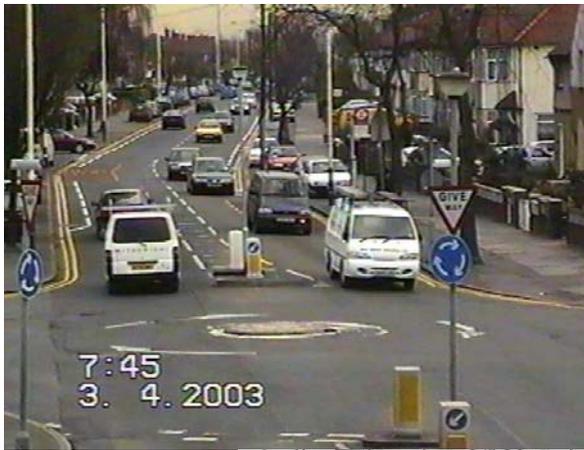
Site	1J20	Junction	
Location	Lady Margaret Road / Carlyle Avenue		
Guard Rail	No		
Vehicle flow	1221 vph		
85%ile Speed	25.2 mph		
Crossing pedestrian flow	36 pph		
Pedestrian Conflicts (in 4 hours)	4		
All Accidents (3 years)	5		
Pedestrian Accidents (3 years)	0		
Behaviour indices	UR(%)	CUR(%)	FUR(%)
	81.4%	100.0%	81.4%

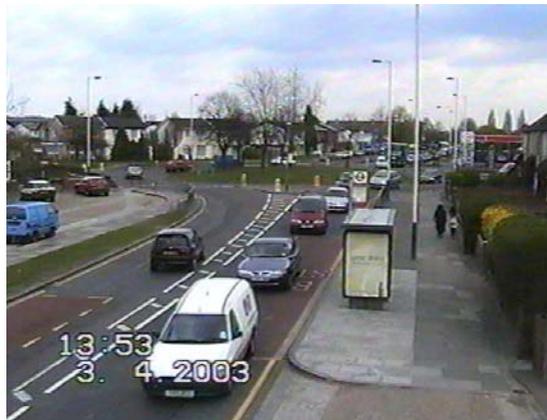
Site	1J21	Junction	
Location	Ruislip Road / Lady Margaret Road		
Guard Rail	Yes		
Vehicle flow	2813 vph		
85%ile Speed	23.4 mph		
Crossing pedestrian flow	54 pph		
Pedestrian Conflicts (in 4 hours)	2		
All Accidents (3 years)	0		
Pedestrian Accidents (3 years)	0		
Behaviour indices	UR(%)	CUR(%)	FUR(%)
	69.7%	98.1%	68.4%

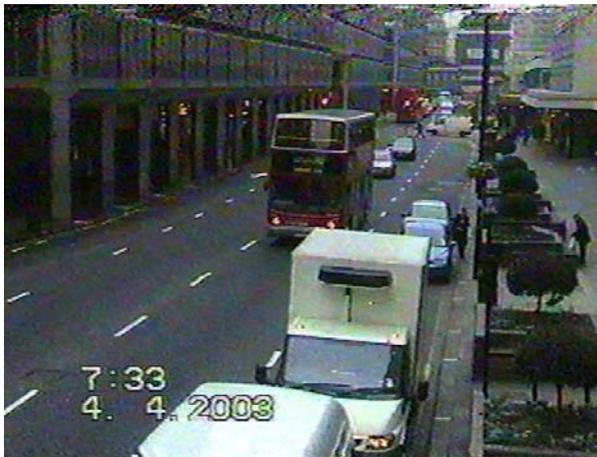
Site	2L03	Link
Location	Victoria Street near Palace Street	
Guard Rail	No	
Vehicle flow	1209 vph	
85%ile Speed	28.0 mph	
Crossing pedestrian flow	170 pph	
Pedestrian Conflicts (in 4 hours)	5	
All Accidents (3 years)	0	
Pedestrian Accidents (3 years)	0	
Behaviour indices	AR	
	170 pph

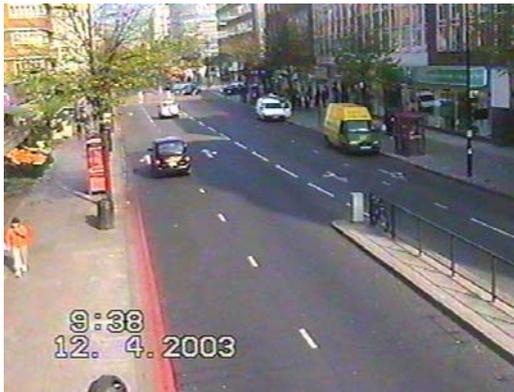
Site	2L07	Link
Location	Edgware Road near Kendal Street	
Guard Rail	No	
Vehicle flow	1433 vph	
85%ile Speed	15.6 mph	
Crossing pedestrian flow	33 pph	
Pedestrian Conflicts (in 4 hours)	3	
All Accidents (3 years)	0	
Pedestrian Accidents (3 years)	0	
Behaviour indices	AR	
	33 pph

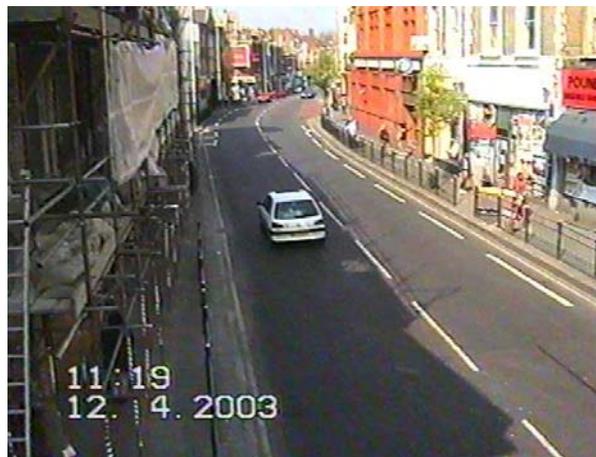
Site	1L01	Link
Location	Acton High Street near Church Road / Horn Ln.	
Guard Rail	Yes	
Vehicle flow	1293 vph	
85%ile Speed	26.6 mph	
Crossing pedestrian flow	70 pph	
Pedestrian Conflicts (in 4 hours)	4	
All Accidents (3 years)	2	
Pedestrian Accidents (3 years)	1	
Behaviour indices	AR	Total Climbing
	70 pph	0

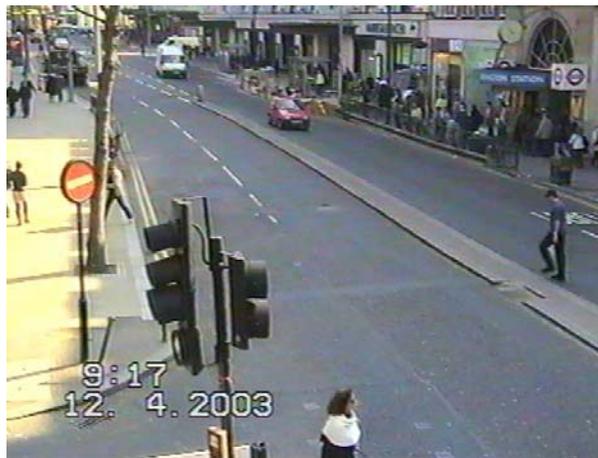
Site	3L05	Link
Location	Kensington High Street near Horton Street	
Guard Rail	Yes	
Vehicle flow	1587 vph	
85%ile Speed	23.1 mph	
Crossing pedestrian flow	18 pph	
Pedestrian Conflicts (in 4 hours)	2	
All Accidents (3 years)	4	
Pedestrian Accidents (3 years)	0	
Behaviour indices	AR	Total Climbing
	18 pph	5

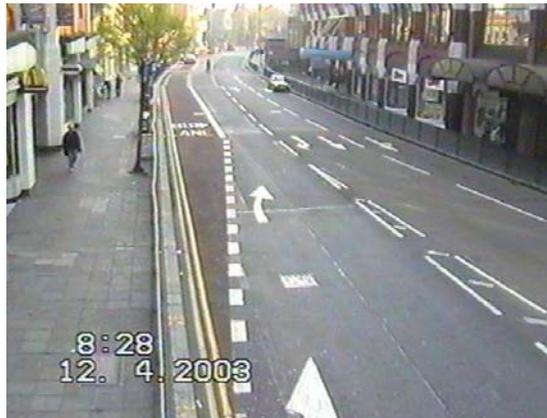
Site	1L06	Link
Location	The Broadway (Ealing) near High Street	
Guard Rail	Yes	
Vehicle flow	1259 vph	
85%ile Speed	25.7 mph	
Crossing pedestrian flow	5 pph	
Pedestrian Conflicts (in 4 hours)	2	
All Accidents (3 years)	7	
Pedestrian Accidents (3 years)	0	
Behaviour indices	AR	Total Climbing
	5 pph	15

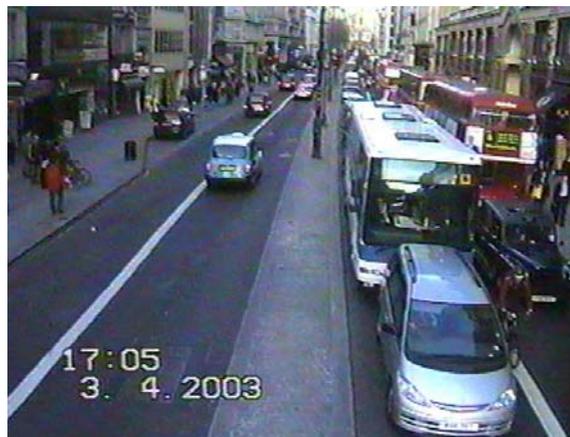
Site	2C08	Central Reservation
Location	The Strand near Adam Street	
Guard Rail	No	
Vehicle flow	1541 vph	
85%ile Speed	22.2 mph	
Crossing pedestrian flow	165 pph	
Pedestrian Conflicts (in 4 hours)	1	
All Accidents (3 years)	6	
Pedestrian Accidents (3 years)	2	
Behaviour indices	AR	
	165 pph
