**Pedestrian Guard Railing:  
A Review of Criteria for Installation**

## **FINAL REPORT**

**Transport for London**

**October 2003**

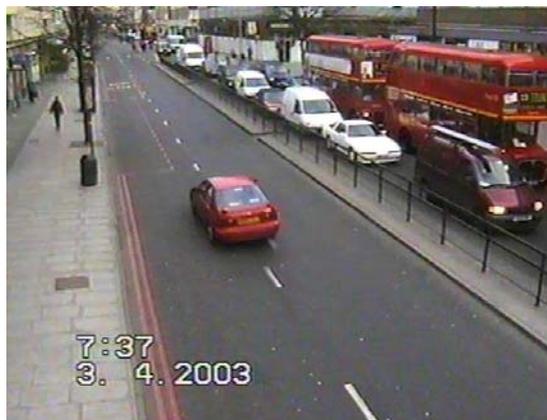
Site	2C04	Central Reservation
Location	Edgware Road near Kendal Street	
Guard Rail	Yes	
Vehicle flow	2379 vph	
85%ile Speed	20.9 mph	
Crossing pedestrian flow	2 pph	
Pedestrian Conflicts (in 4 hours)	0	
All Accidents (3 years)	8	
Pedestrian Accidents (3 years)	0	
Behaviour indices	AR	Total Climbing
	2 pph	0

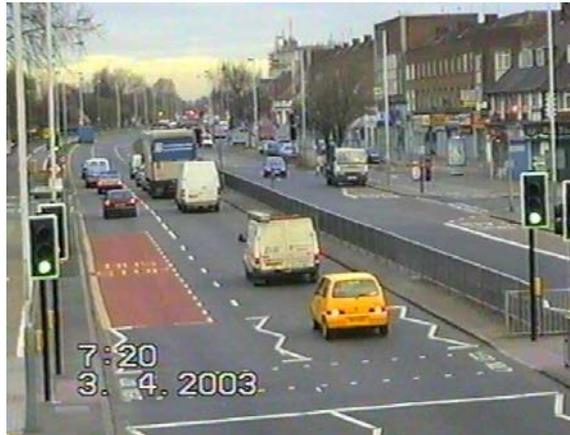
Site	5C10	Central Reservation
Location	Uxbridge Road near Central Avenue	
Guard Rail	Yes	
Vehicle flow	2381 vph	
85%ile Speed	38.7 mph	
Crossing pedestrian flow	2 pph	
Pedestrian Conflicts (in 4 hours)	0	
All Accidents (3 years)	2	
Pedestrian Accidents (3 years)	0	
Behaviour indices	AR	Total Climbing
	2 pph	9

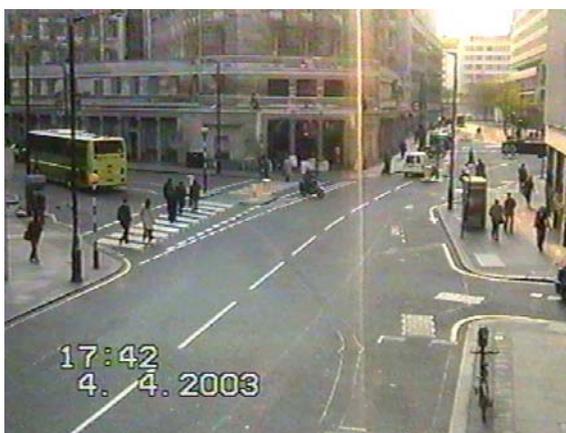
Site	2T08	Transport Interchange	
Location	Tothill Street / Broadway		
Guard Rail	No		
Vehicle flow	572 vph		
85%ile Speed	17.3 mph		
Crossing pedestrian flow	305 pph		
Pedestrian Conflicts (in 4 hours)	0		
All Accidents (3 years)	0		
Pedestrian Accidents (3 years)	0		
Behaviour indices	CRO(%)	CRC(%)	DCR(%)
	8.6%	91.4%	0.0%

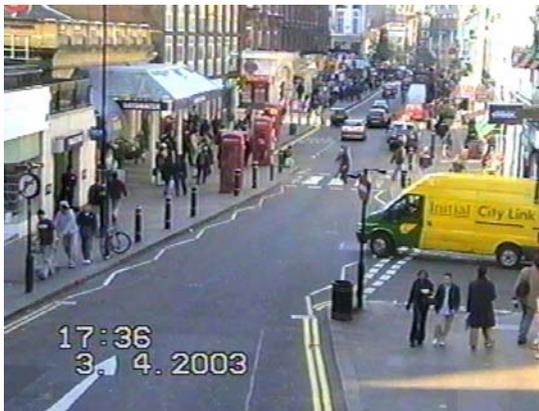
Site	2T09 Transport Interchange		
Location	Queensway Road near Inverness Place		
Guard Rail	No		
Vehicle flow	570 vph		
85%ile Speed	17.0 mph		
Crossing pedestrian flow	249 pph		
Pedestrian Conflicts (in 4 hours)	0		
All Accidents (3 years)	2		
Pedestrian Accidents (3 years)	0		
Behaviour indices	CRO(%)	CRC(%)	DCR(%)
	11.8%	88.2%	0.0%

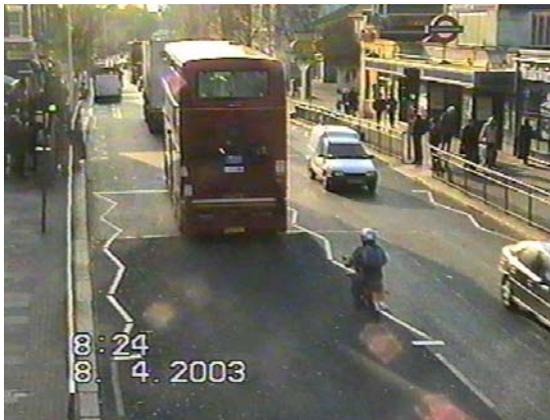
Site	1T03	Transport Interchange	
Location	Uxbridge Road near Granville Gardens		
Guard Rail	Yes		
Vehicle flow	1472 vph		
85%ile Speed	26.4 mph		
Crossing pedestrian flow	278 pph		
Pedestrian Conflicts (in 4 hours)	3		
All Accidents (3 years)	1		
Pedestrian Accidents (3 years)	1		
Behaviour indices	CRO(%)	CRC(%)	DCR(%)
	5.6%	94.4%	0.0%

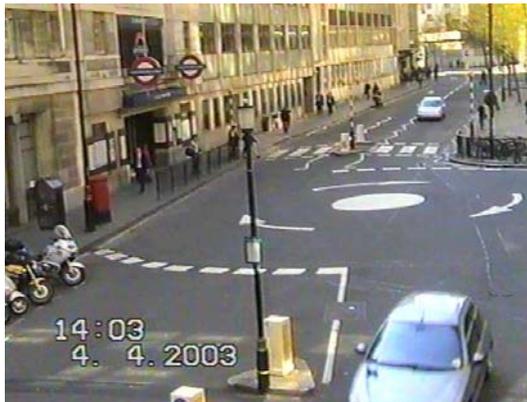
<b>Site</b>	<b>2T06</b>	<b>Transport Interchange</b>	
Location	Tothill Street / Queen Annes Gate		
Guard Rail	Yes		
Vehicle flow	425 vph		
85%ile Speed	17.3 mph		
Crossing pedestrian flow	512 pph		
Pedestrian Conflicts (in 4 hours)	1		
All Accidents (3 years)	0		
Pedestrian Accidents (3 years)	0		
Behaviour indices	CRO(%)	CRC(%)	DCR(%)
	15.2%	84.8%	0.0%

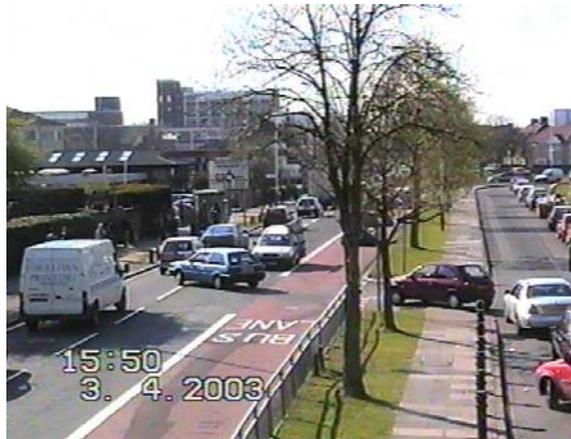
Site	1S05	School	
Location	Ruislip Road near Ferrymead Avenue		
Guard Rail	No		
Vehicle flow	1728 vph		
85%ile Speed	25.1 mph		
Crossing pedestrian flow	346 pph		
Pedestrian Conflicts (in 4 hours)	1		
All Accidents (3 years)	2		
Pedestrian Accidents (3 years)	1		
Behaviour indices	CRO(%)	CRC(%)	DCR(%)
	4.3%	95.7%	0.0%

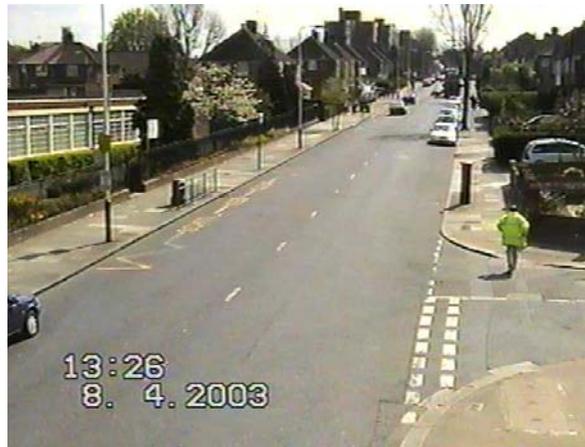
Site	1S01	School	
Location	Greenford Avenue near Brookbank Avenue		
Guard Rail	Yes		
Vehicle flow	1016 vph		
85%ile Speed	30.4 mph		
Crossing pedestrian flow	41 pph		
Pedestrian Conflicts (in 4 hours)	0		
All Accidents (3 years)	0		
Pedestrian Accidents (3 years)	0		
Behaviour indices	CRO(%)	CRC(%)	DCR(%)
	0.0%	92.7%	7.3%

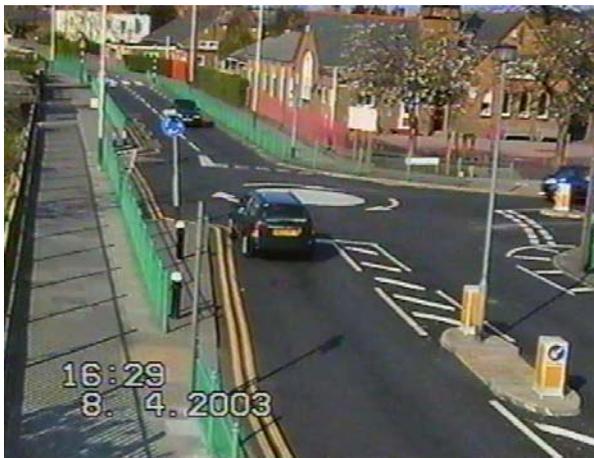
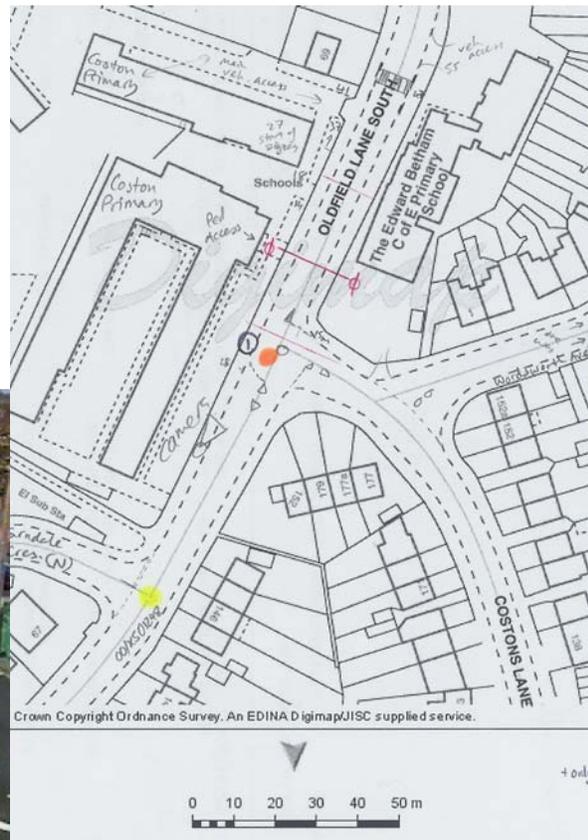
Site	1S03	School	
Location	Oldfield Lane near Costons Lane		
Guard Rail	Yes		
Vehicle flow	575 vph		
85%ile Speed	25.8 mph		
Crossing pedestrian flow	324 pph		
Pedestrian Conflicts (in 4 hours)	0		
All Accidents (3 years)	0		
Pedestrian Accidents (3 years)	0		
Behaviour indices	CRO(%)	CRC(%)	DCR(%)
	0.0 %	100.0 %	0.0 %
