SILVERTOWN TUNNEL

**Preliminary Environmental Information
Report: Appendix 16.D**

**River Wall
Structural
Condition Survey**

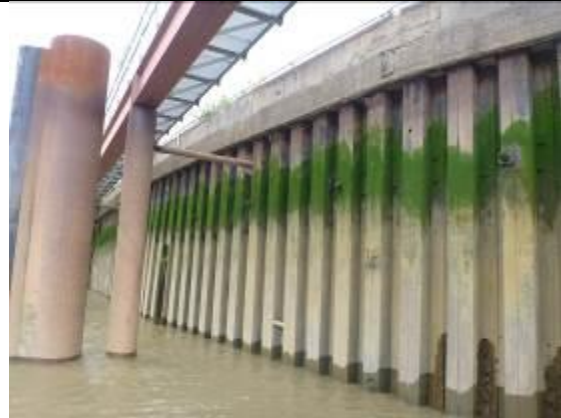
Figure 16 - Steel sheet pile with large diameter fender piles (left) and frame supporting rails for spoil hopper (behind)

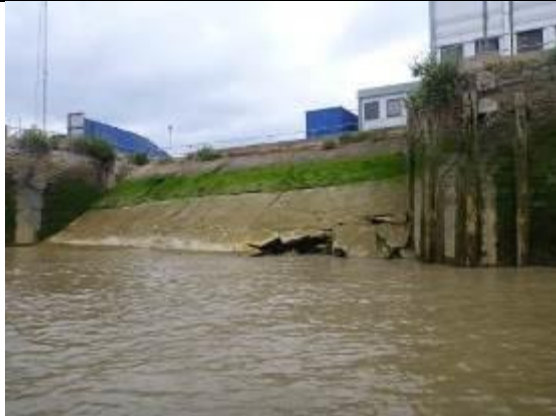
Figure 24 - Concrete apron and masonry abutments

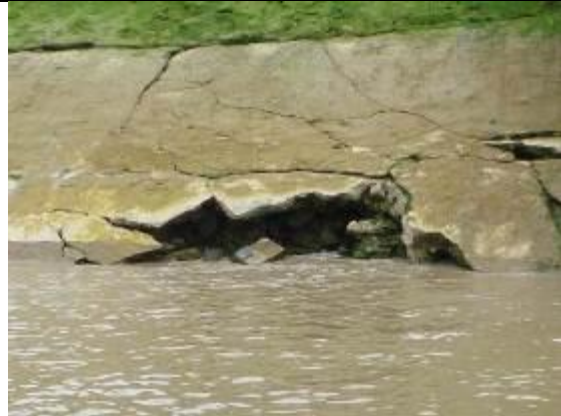
Figure 25 - Void in concrete apron

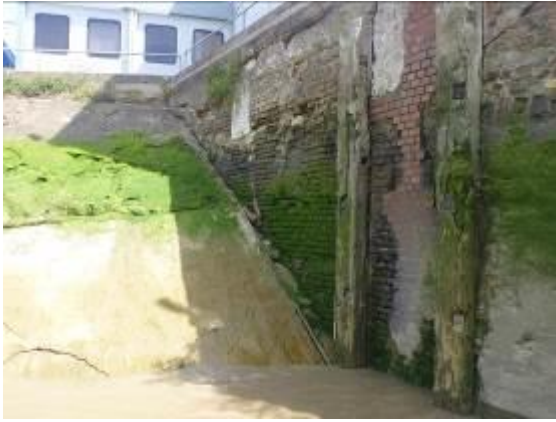
Figure 29 - Interface between masonry wall and masonry abutment. View of large sections of replacement masonry

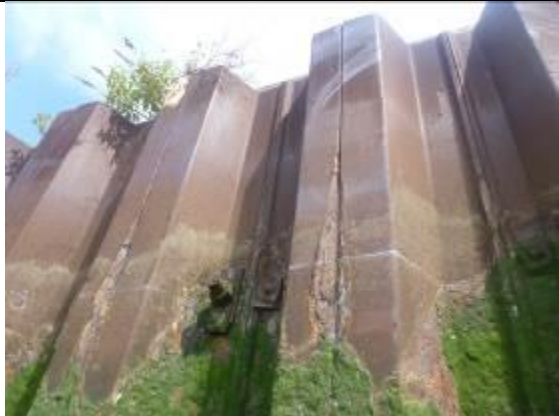
Figure 33 - Waling bolt on sheet pile wall

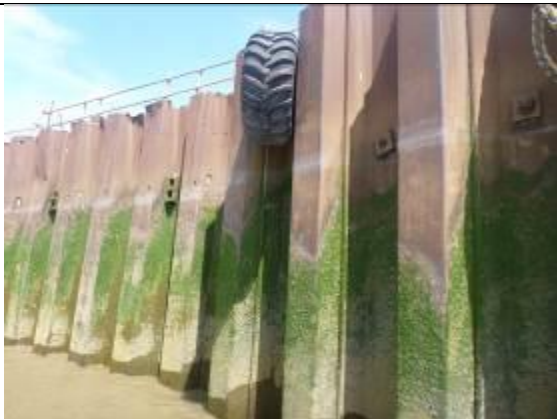
Figure 45 – View of upstream end of asset, showing how the piles have been driven in front of existing frontage

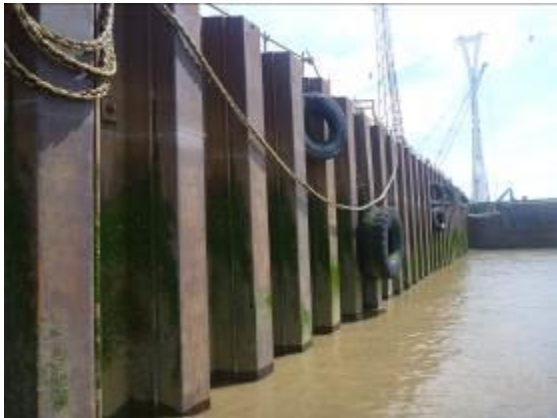
Figure 47 - Steel sheet pile wall

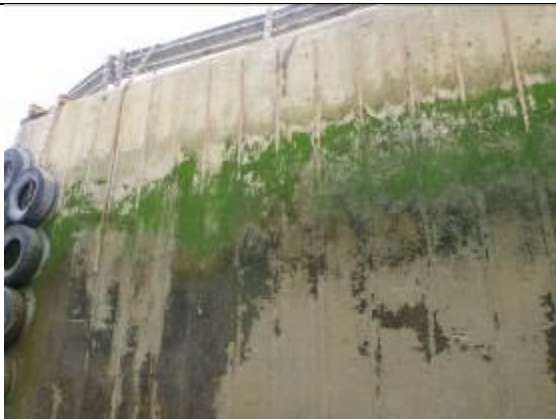
Figure 53 - Concrete abutments with steel railing reinforcement

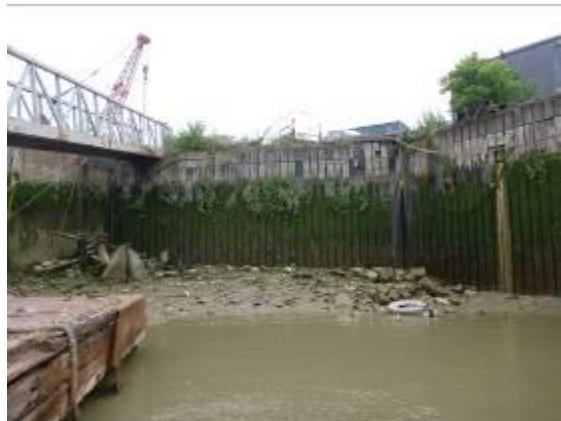
Figure 54 - Steel lock gates with close centred timber cladding

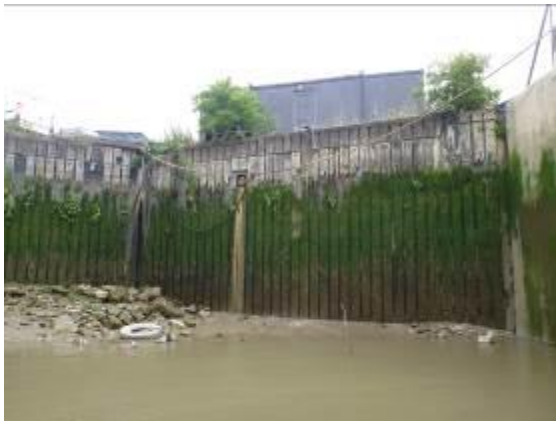
Figure 55 - Steel lock gates with close centred timber cladding

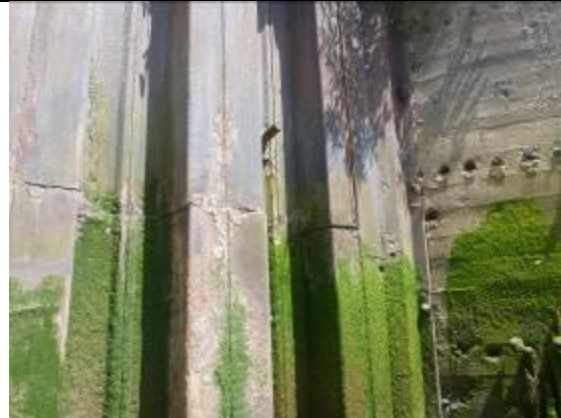
Figure 62 - Section of sheet piles which have been horizontally spliced

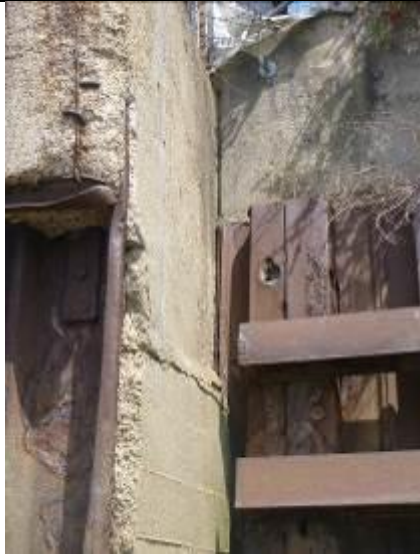
Figure 63 - Interface between steel sheet pile wall and adjacent upstream asset

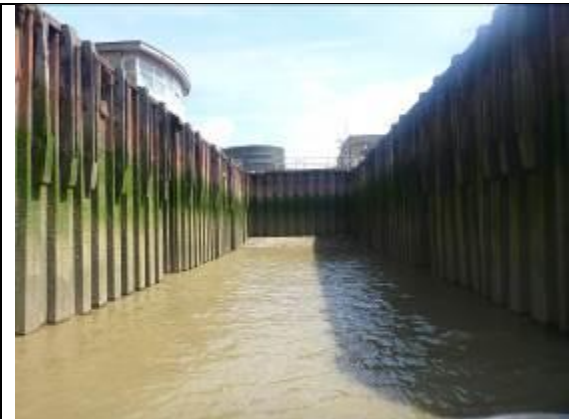
Figure 69 - Steel sheet pile dock

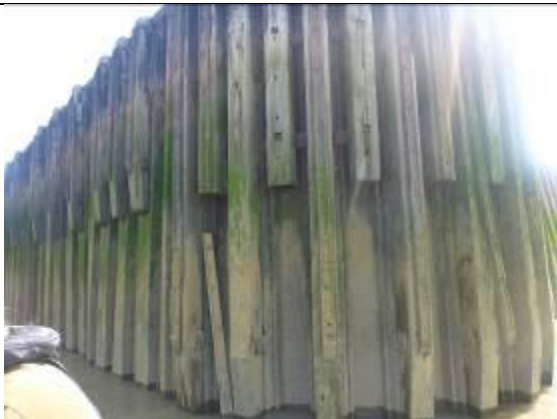
Figure 70 - Timber fenders on entrance to the dock

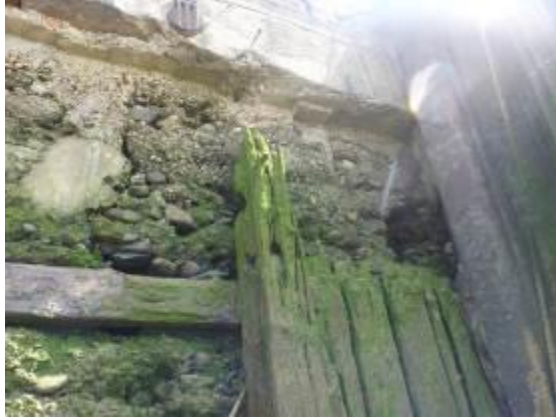
Figure 75 - Timber wall and voids in concrete at intersection with steel sheet piling
