Bank Station Capacity Upgrade

29 Martin Lane Heritage Statement

September 2014

LUL Document Reference:
LUL-8798-STT-G-002117

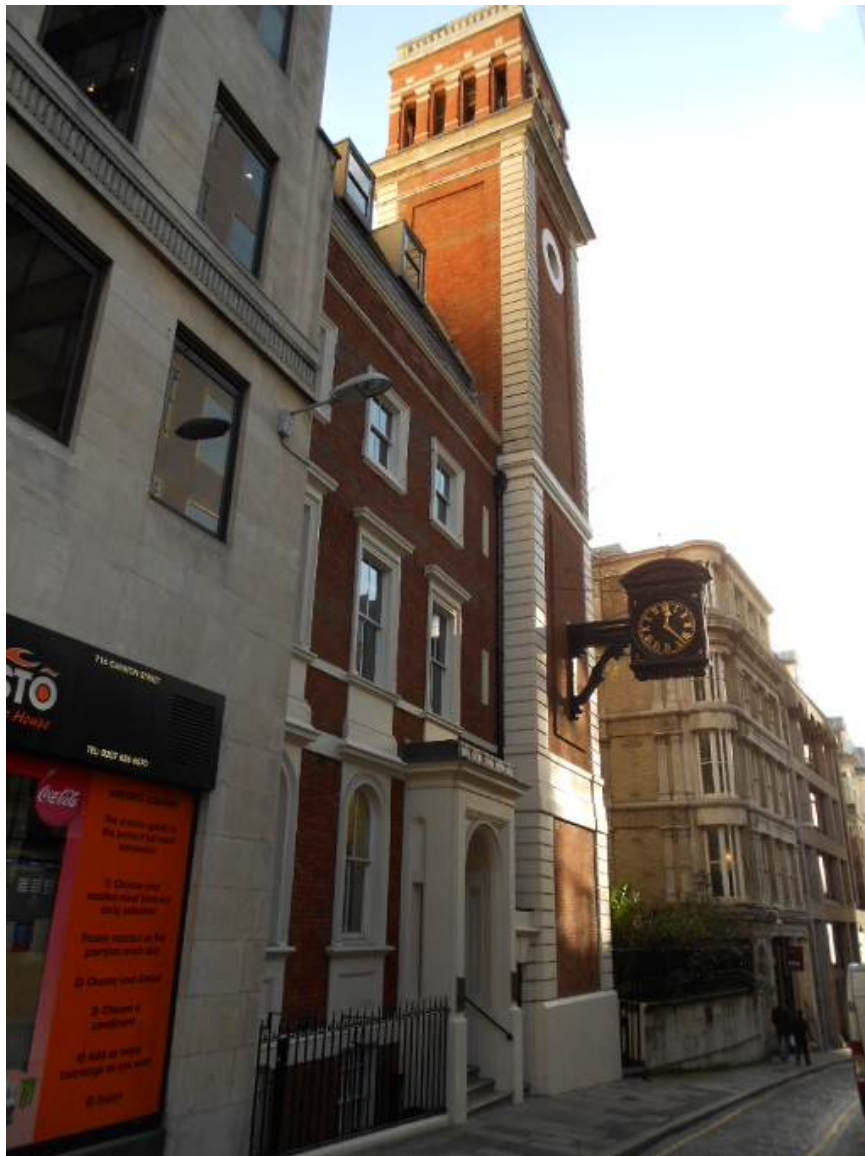
Photo 1: Main elevation to Martin Lane

- 4.1.3 The main façade on Martin Lane is characterised by three bays and three storeys in Flemish bond red brick with painted stucco dressings, and has a large bracketed clock above ground floor level with a segmental pediment facing the street. There are two attic storeys. The main entrance is through a projecting arched porch in stucco, flanked by round-headed windows with stucco architraves to the left, and a red brick bell tower with painted stucco quoins to the right. Photo 1 shows this elevation (a location plan for photographs is shown in Appendix 5).
