## **A10.2 – Building Damage Assessment Reports**

# Bank Station Capacity Upgrade Building Damage Assessment Report

This report summarises the results of a Stage 2 damage assessment for 27 Poultry/5 Princes Street (Building ref. A4).

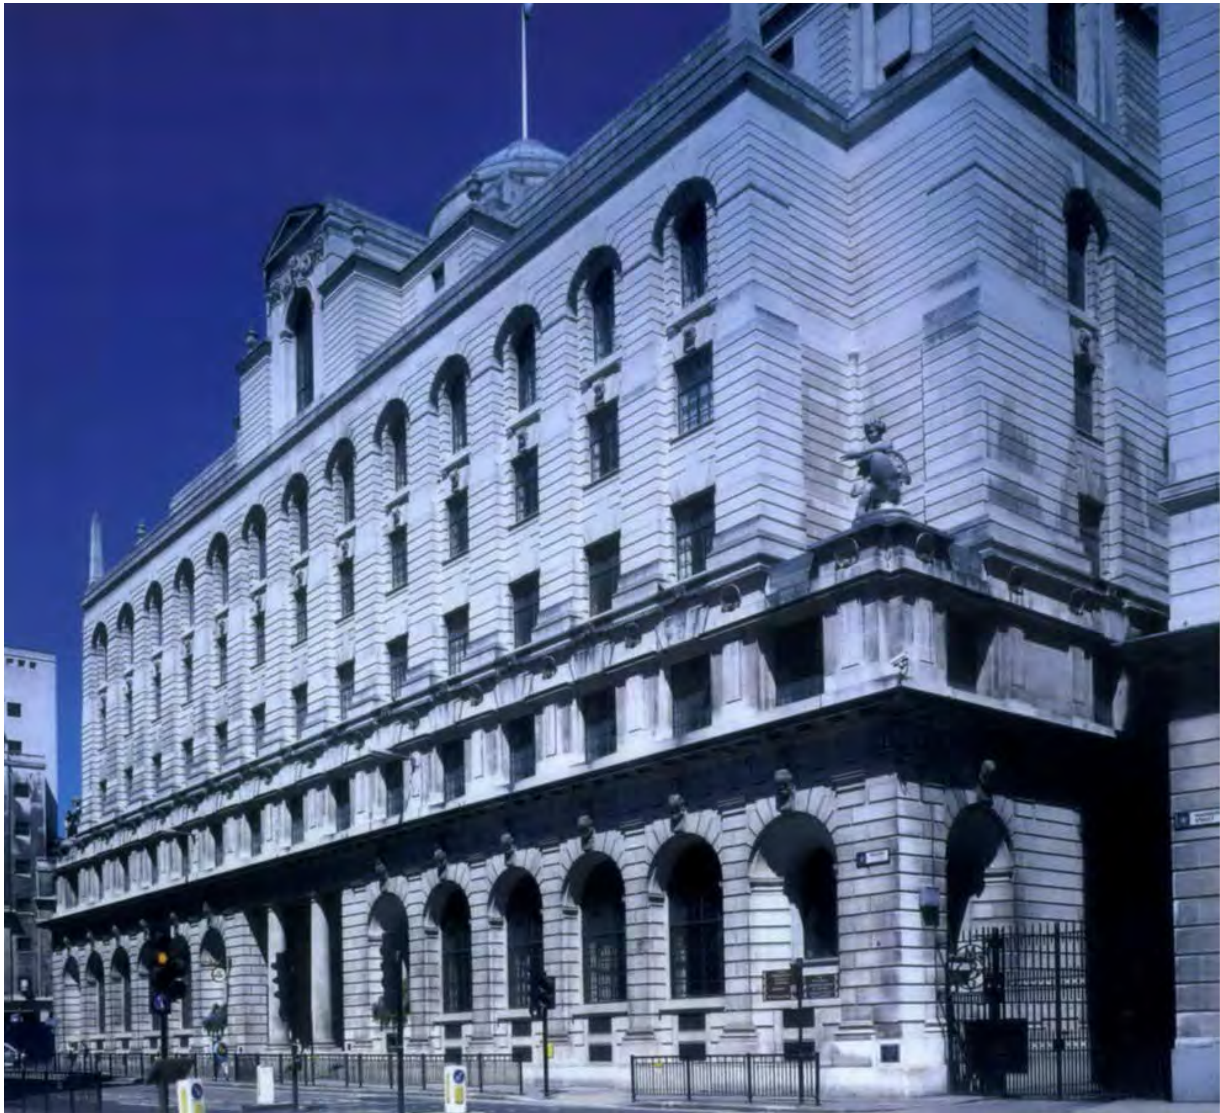
**Plate 1: General view**

The primary structural elements visible at the time of the site visit all appear to be in a good condition with little visible rusting or cracking.

The building exterior appears to be in good condition. Internally the building is largely stripped from first to third floor and generally seems in good condition with localized dampness to the upper floors and within the basement. The original features which have been retained are in relatively good condition, with no visible signs of cracks, damage or previous movement.

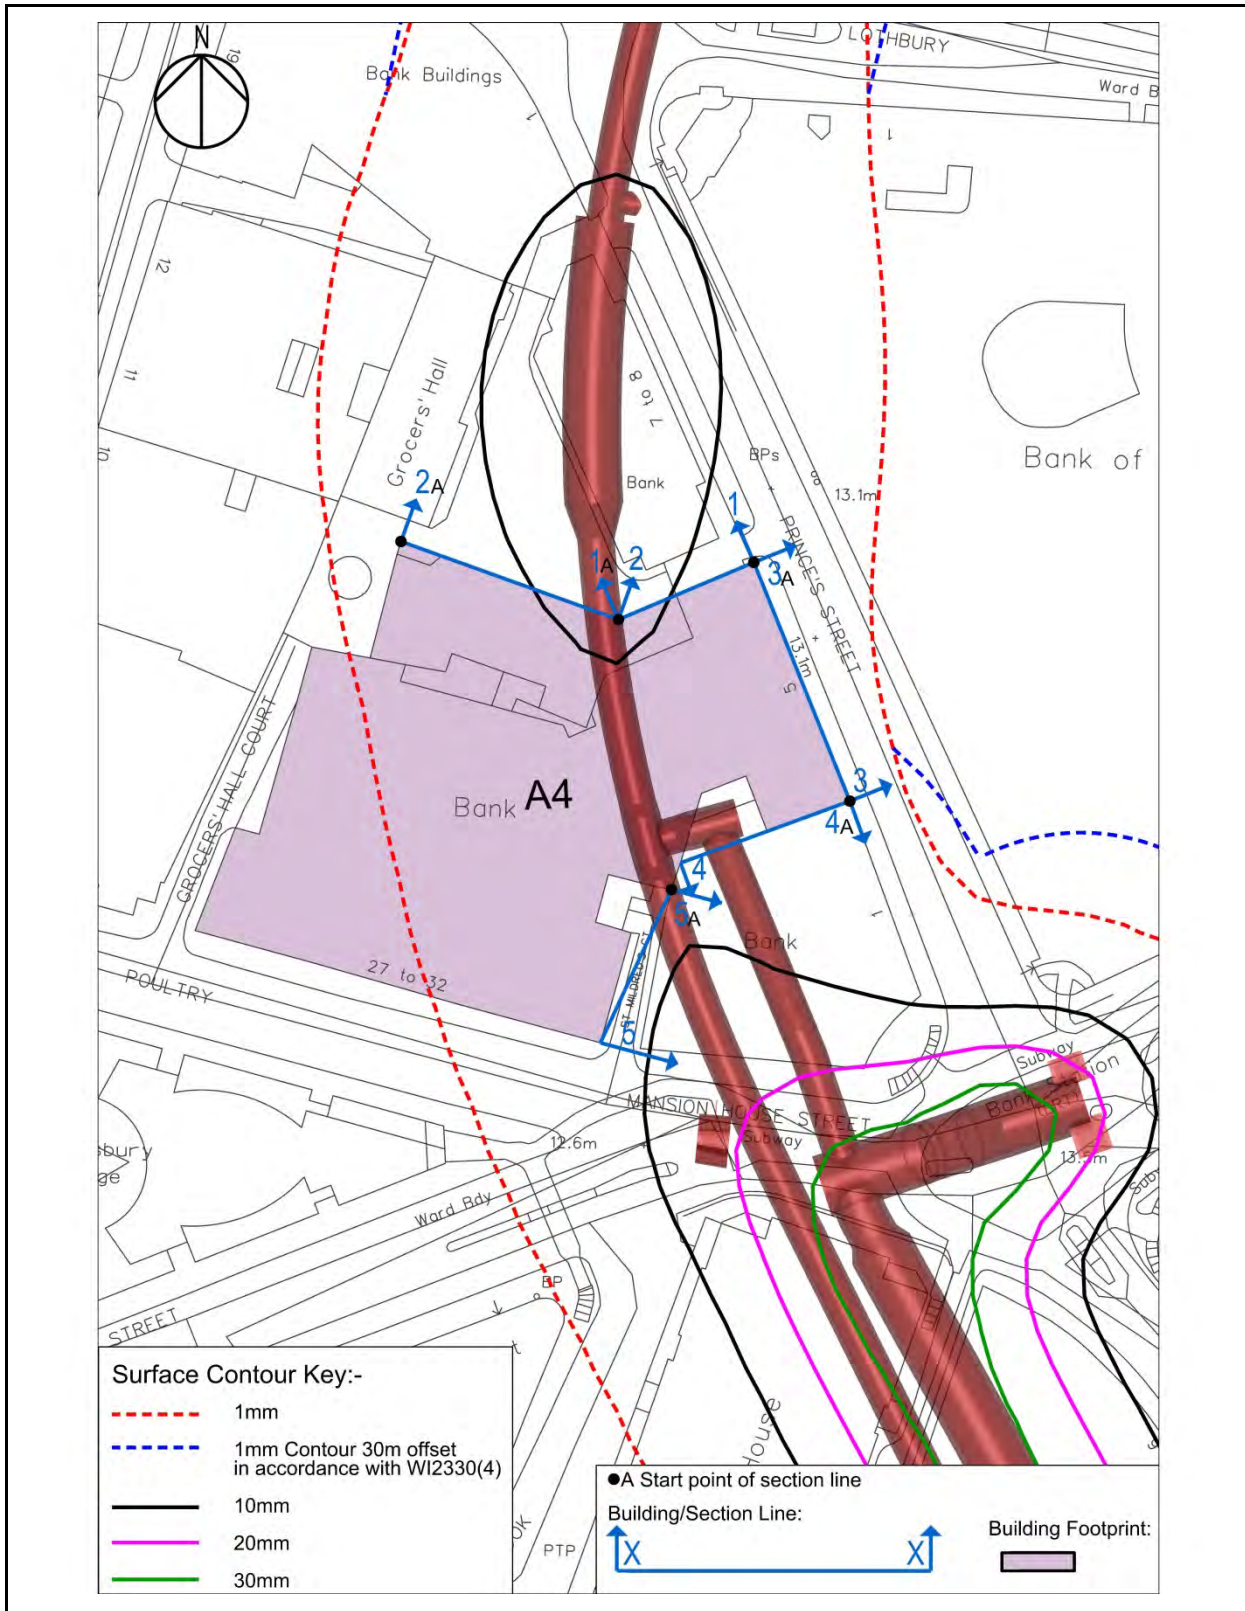
**Figure 3: Building location, sections analysed and Settlement Contours at stage of worst case for tensile strains**

Line No	Strains in section (Curvature)	Position from start (m)	Length (m)	Average* Horizontal Strain (%)	Maximum Tensile Strains (%)	Damage Category
4	Hogging	0	11.4	0.016	0.018	Negligible
4	Sagging	11.4	13.4	-0.030	0.011	Negligible

The Stage 2 engineering assessment has predicted that the maximum tensile strain falls within damage category 0. This corresponds to Negligible damage in accordance with Table 2.

The settlement of the building at foundation level at the end of Stage 2 is approximately 21mm, which does not increase in the subsequent stages.

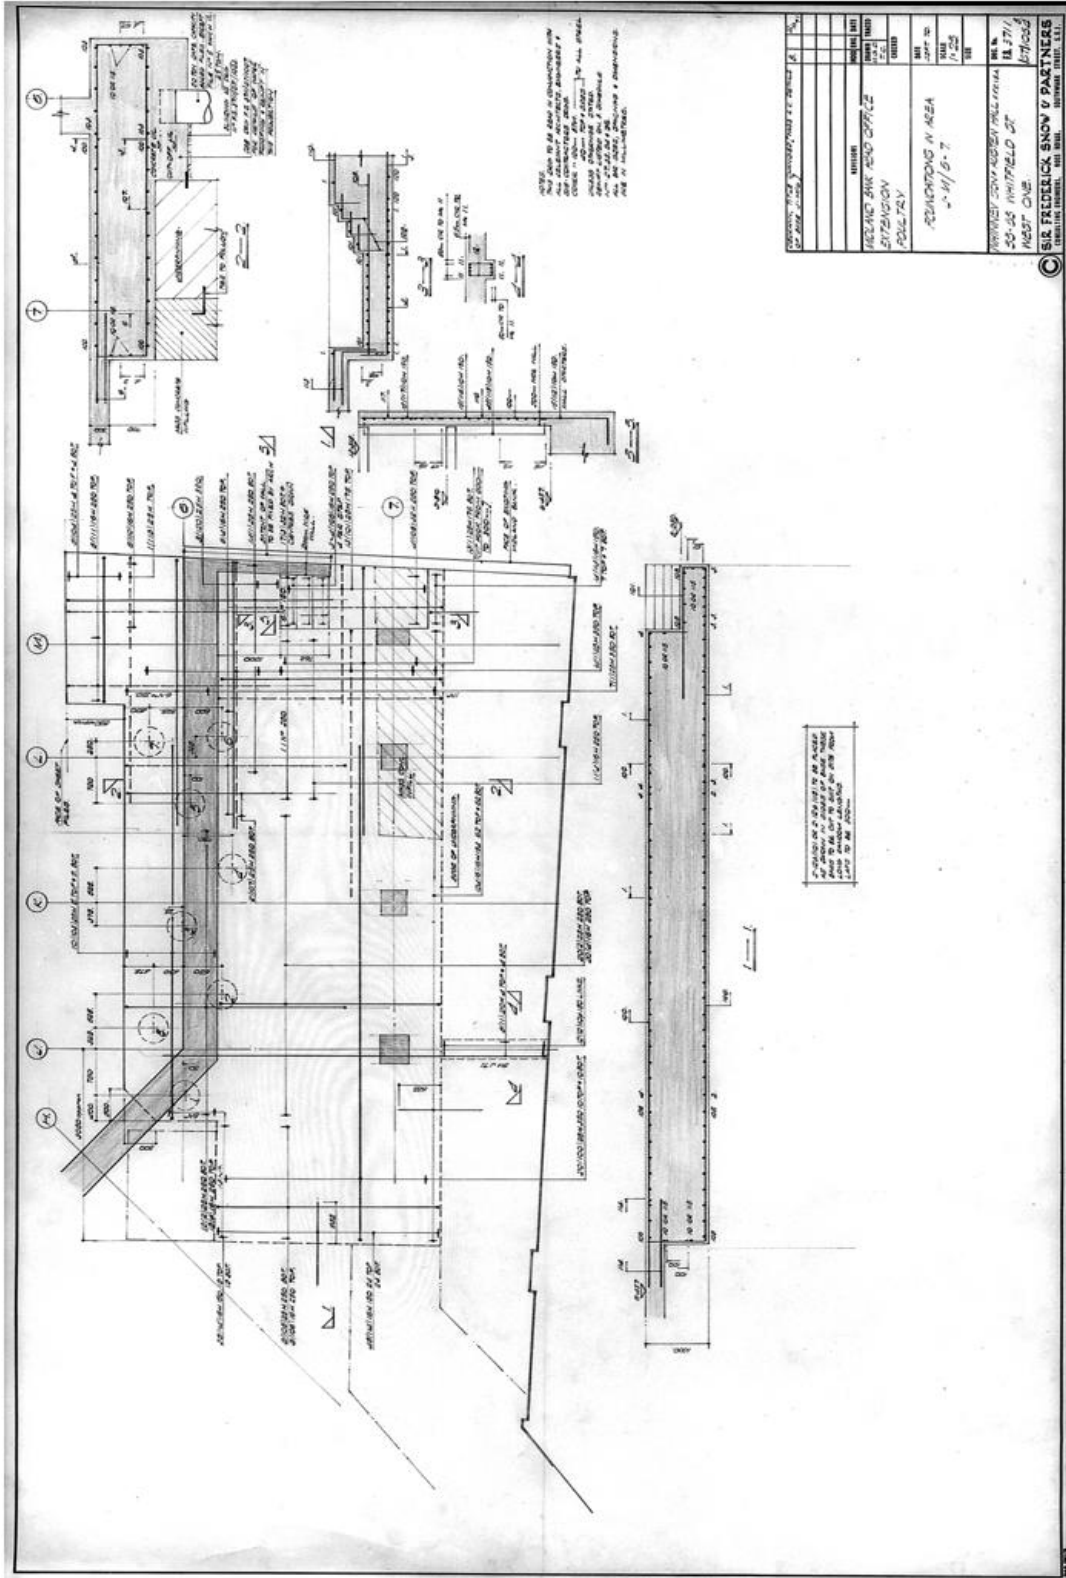
Figure 4: Plan of pile locations on northern boundary

The older building has three level basements. Over the majority of the building it is assumed that a 1.3m thick raft is below the basement level of 102.6mATD. The foundation level is assumed to be at 101.3mATD. The original structure is a steel frame. The later extension is a RC frame with two levels of basement. There is record of 8 number piles being installed along its northern façade.

An assessment of the load capacity of the pile versus depth shows that it is only a possibility that they extend to the tunnel level. It is proposed that should the piles be encountered they are trimmed to above the tunnel lining and structurally isolated from it. The change in performance of a friction pile of this length which has some shaft removed is very small. The damage assessment does not address the piles specifically since they influence a very small part of the whole building. There is a two basement level high reinforced concrete wall over them spanning across the tunnel line. It is therefore considered that the stiffness of the building will redistribute the loads and effects arising from the potential additional settlement of the piles.

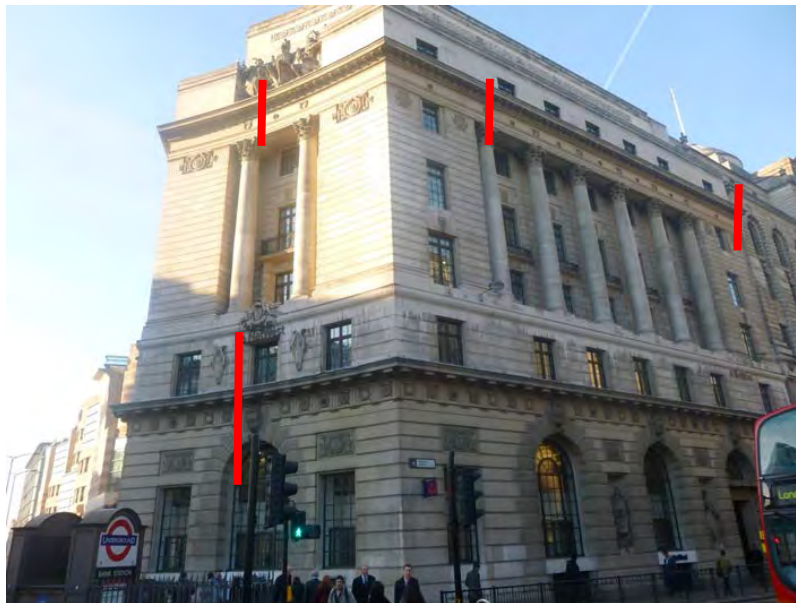
Plate 2: Stress Concentration in Elevations

The elevations to Princes Street and Mansion House Street include a large set back above second floor level extending to the underside of the cornice at sixth floor level. This set back will have the effect of concentrating all movement on these elevations to either end of the cornice, as indicated in the image below, where red lines indicate areas of stress concentration.

**Score: 2** - The inset elements of the façade will effectively act as large openings, leaving the narrow cornice to prop the two ends of the opening. This will lead to a stress concentration at each end of the setback, focusing all movement in these locations.

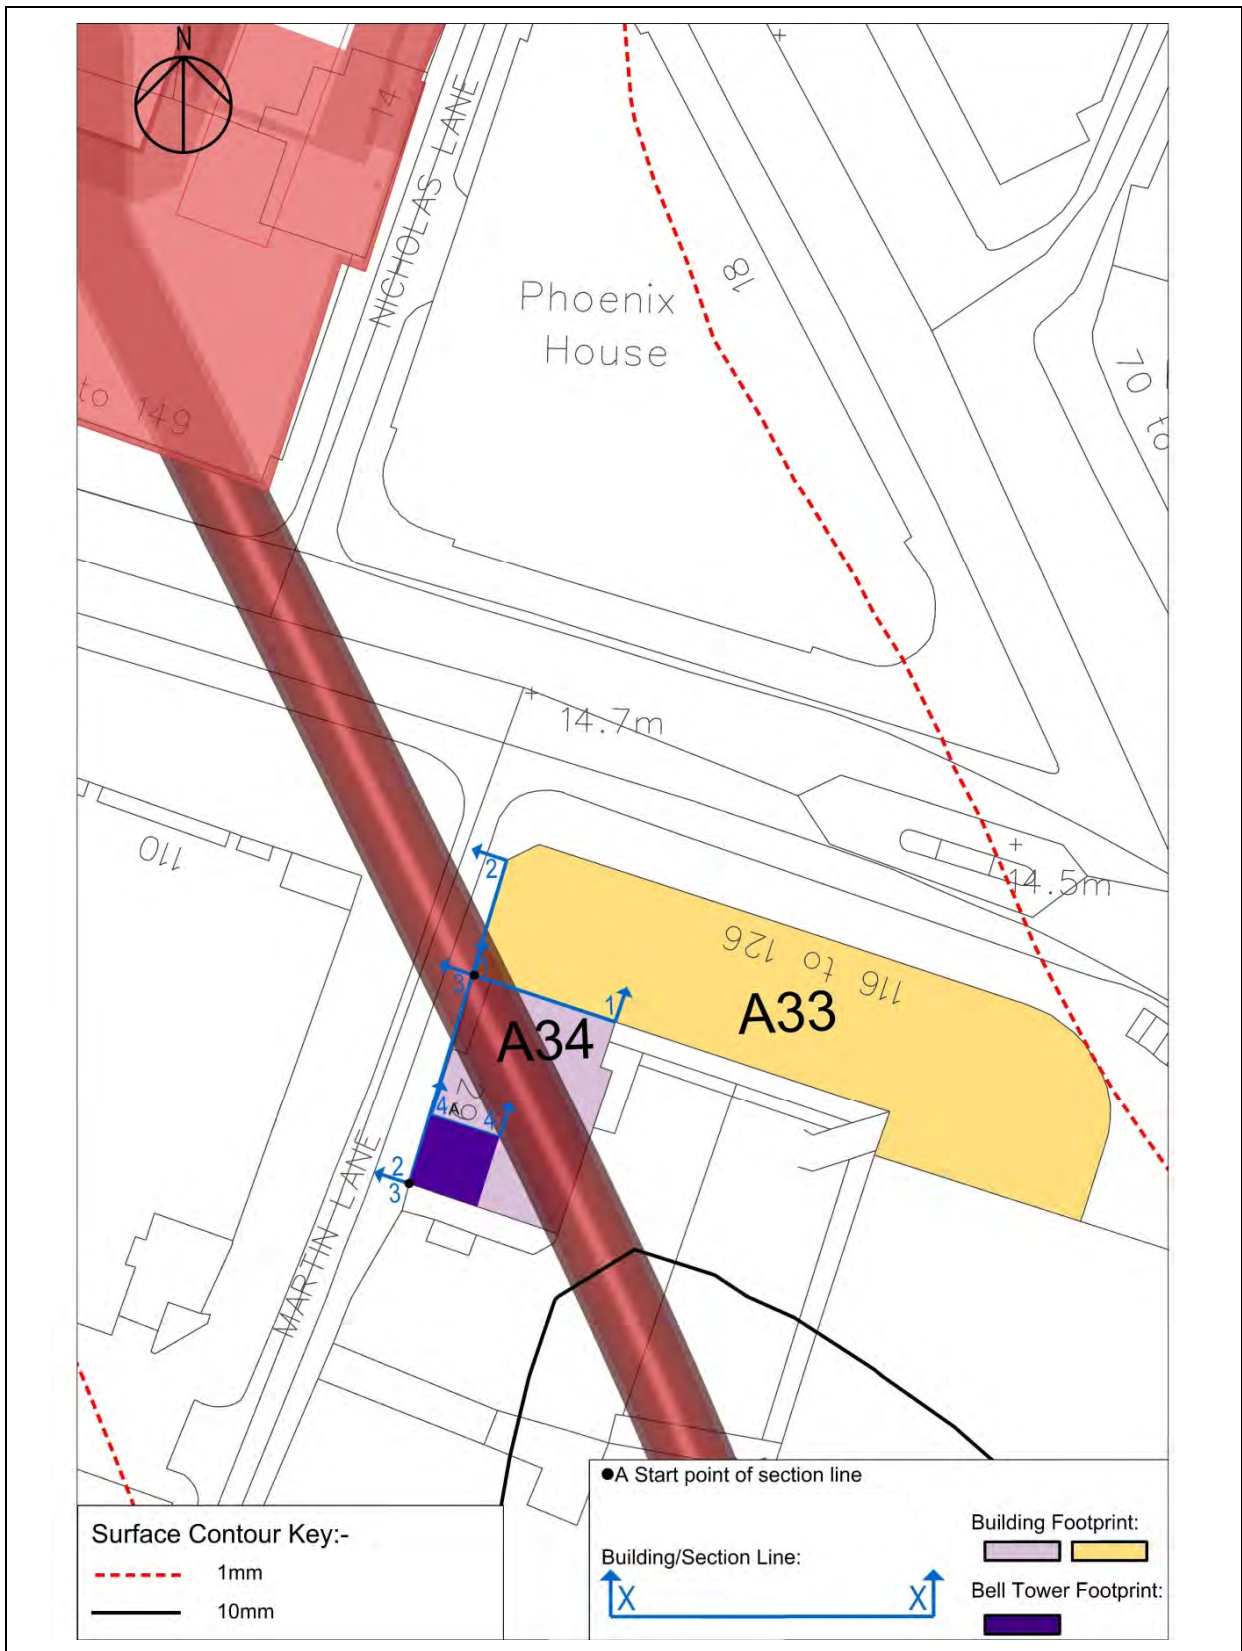
**Figure 3: Building location, sections analysed and Settlement Contours at stage of worst case for tensile strains**

The results of the assessment show that the intermediate construction Stage 1 is the critical stage for this building where (line 1) experiences the most onerous combined tensile strain. The orientation is shown in Figure 3. The vertical and horizontal Greenfield ground movements along the section of the building are shown in Figure 4. The relative position of the building and tunnels along section (line 1) is shown in Figure 8. The calculated strains are summarised in Table 8.

The Stage 2 engineering assessment has predicted that the maximum tensile strain for the building falls within damage category 0. This corresponds to negligible damage in accordance with Table 2.

The maximum settlement of the building at foundation level is 10mm which occurs at the construction stage 1, is fairly uniform across the site.

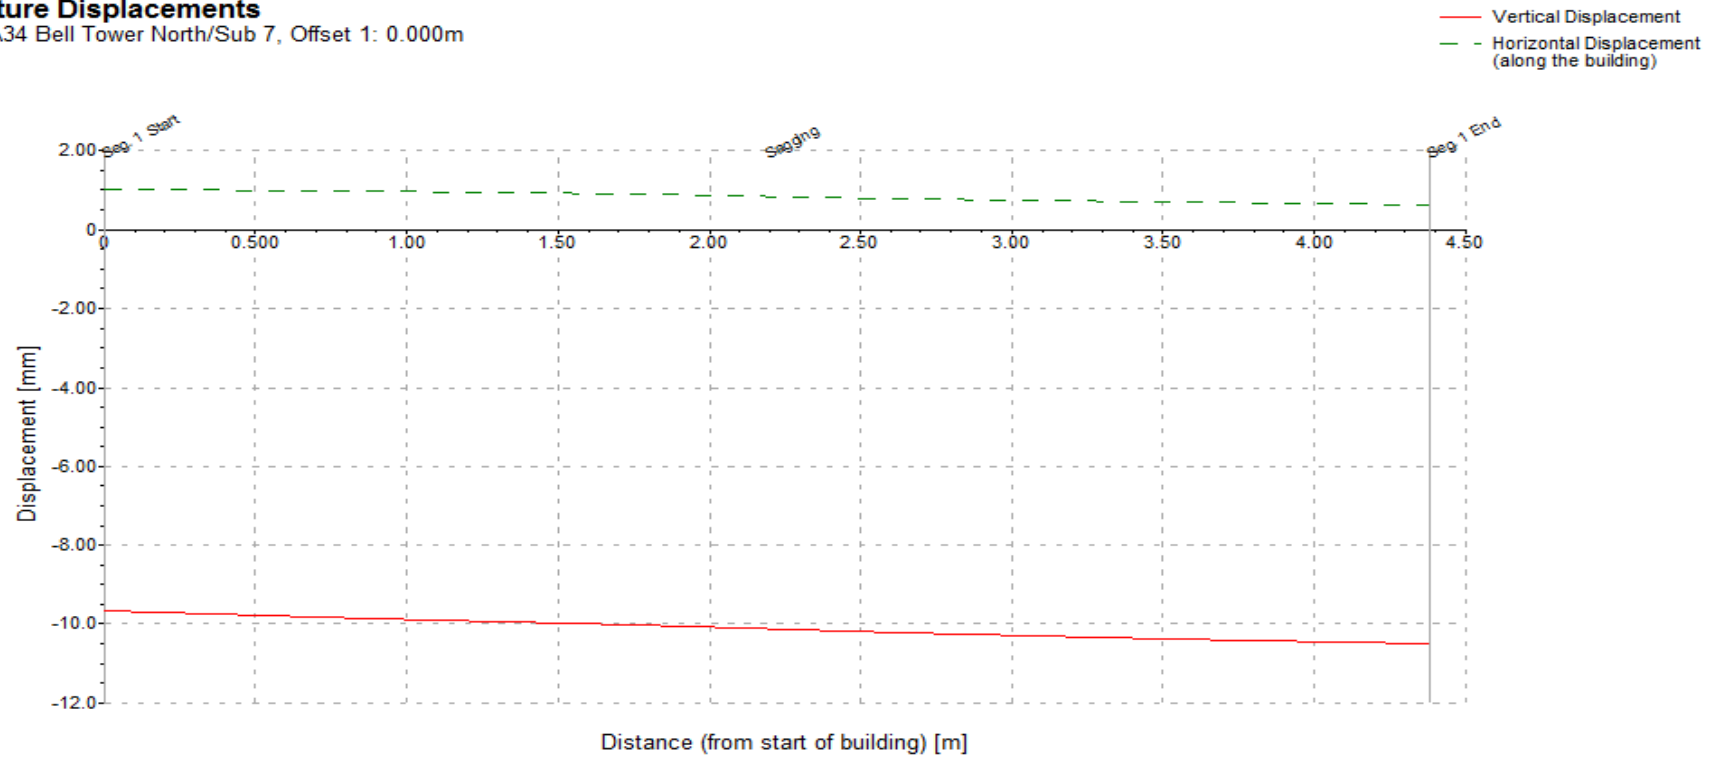
**Figure 7: Building displacement at founding level (Bell Tower) at stage 1 (line 4) of worst case for tensile strains**

A14 line 4 shows the movements for the north-west façade of the bell tower, Figure 7. Tensile strains are in the Negligible damage category.

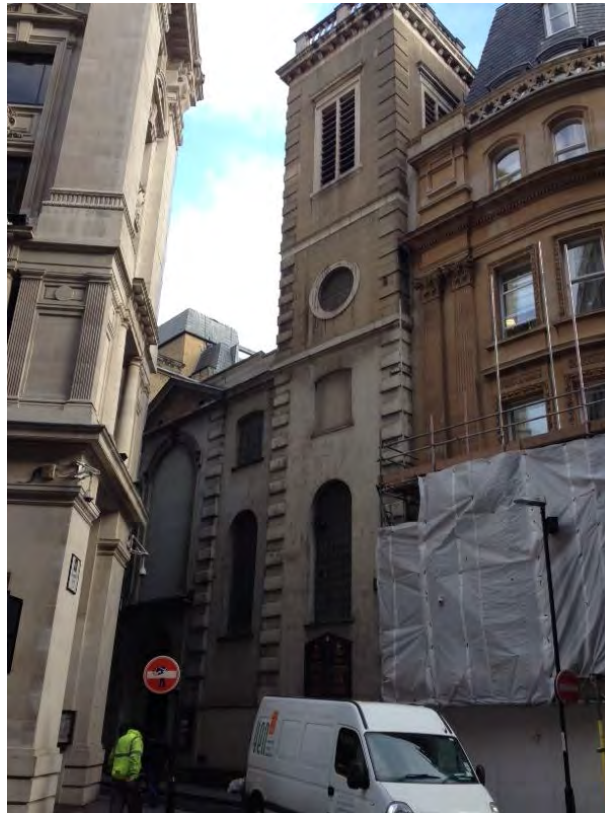
**Plate 1: General view**

SENSITIVITY OF THE STRUCTURE
<p>The external walls in both the church and the tower display some cracking, the main church building has a concentration of cracking to the North West elevation particularly in locations weakened by window and door locations. While the movement appears not particularly recent, additional movement could be aggravated in the event of further ground settlement and disturbance</p> <p>The foundations of the building are unknown but are likely to be spread brick corbels or simply formed directly onto a compacted soil base. Levels of the foundations are thought to be variable, and while the main body of the church and bell tower would probably have originally been consistent with one another, the church only appears to have a small basement to the rear. Construction of the adjoining building included the formation of a deep double basement, and although having an apparent shared wall, this would probably have initiated a form of underpinning to the south east wall of the church and possibly the return walls, locally extending these foundations to a much deeper level than the remaining church.</p> <p>The building was going through an internal refurbishment at the time of the site survey and it is possible that this internal work may have covered over other building defects. The roof to the nave has been replaced with steel trusses and new roof structure.</p>

<p><b>Score:1</b> – The interior finishes of the church are considered to be brittle and sensitive to small settlements, particularly the decorative plasterwork</p>
SENSITIVITY OF THE CONDITION
<p>The façades are in overall good condition despite showing fine vertical cracks crossing the side elevation in various areas, but a general lack of maintenance to exterior is noted. The interiors are in good condition, and the original features have been fully preserved and repaired.</p>
<p><b>Score: 0</b> the interiors are in good condition and are currently being improved; the minor condition issues to the façade would not be sensitive to the predicted settlement</p>

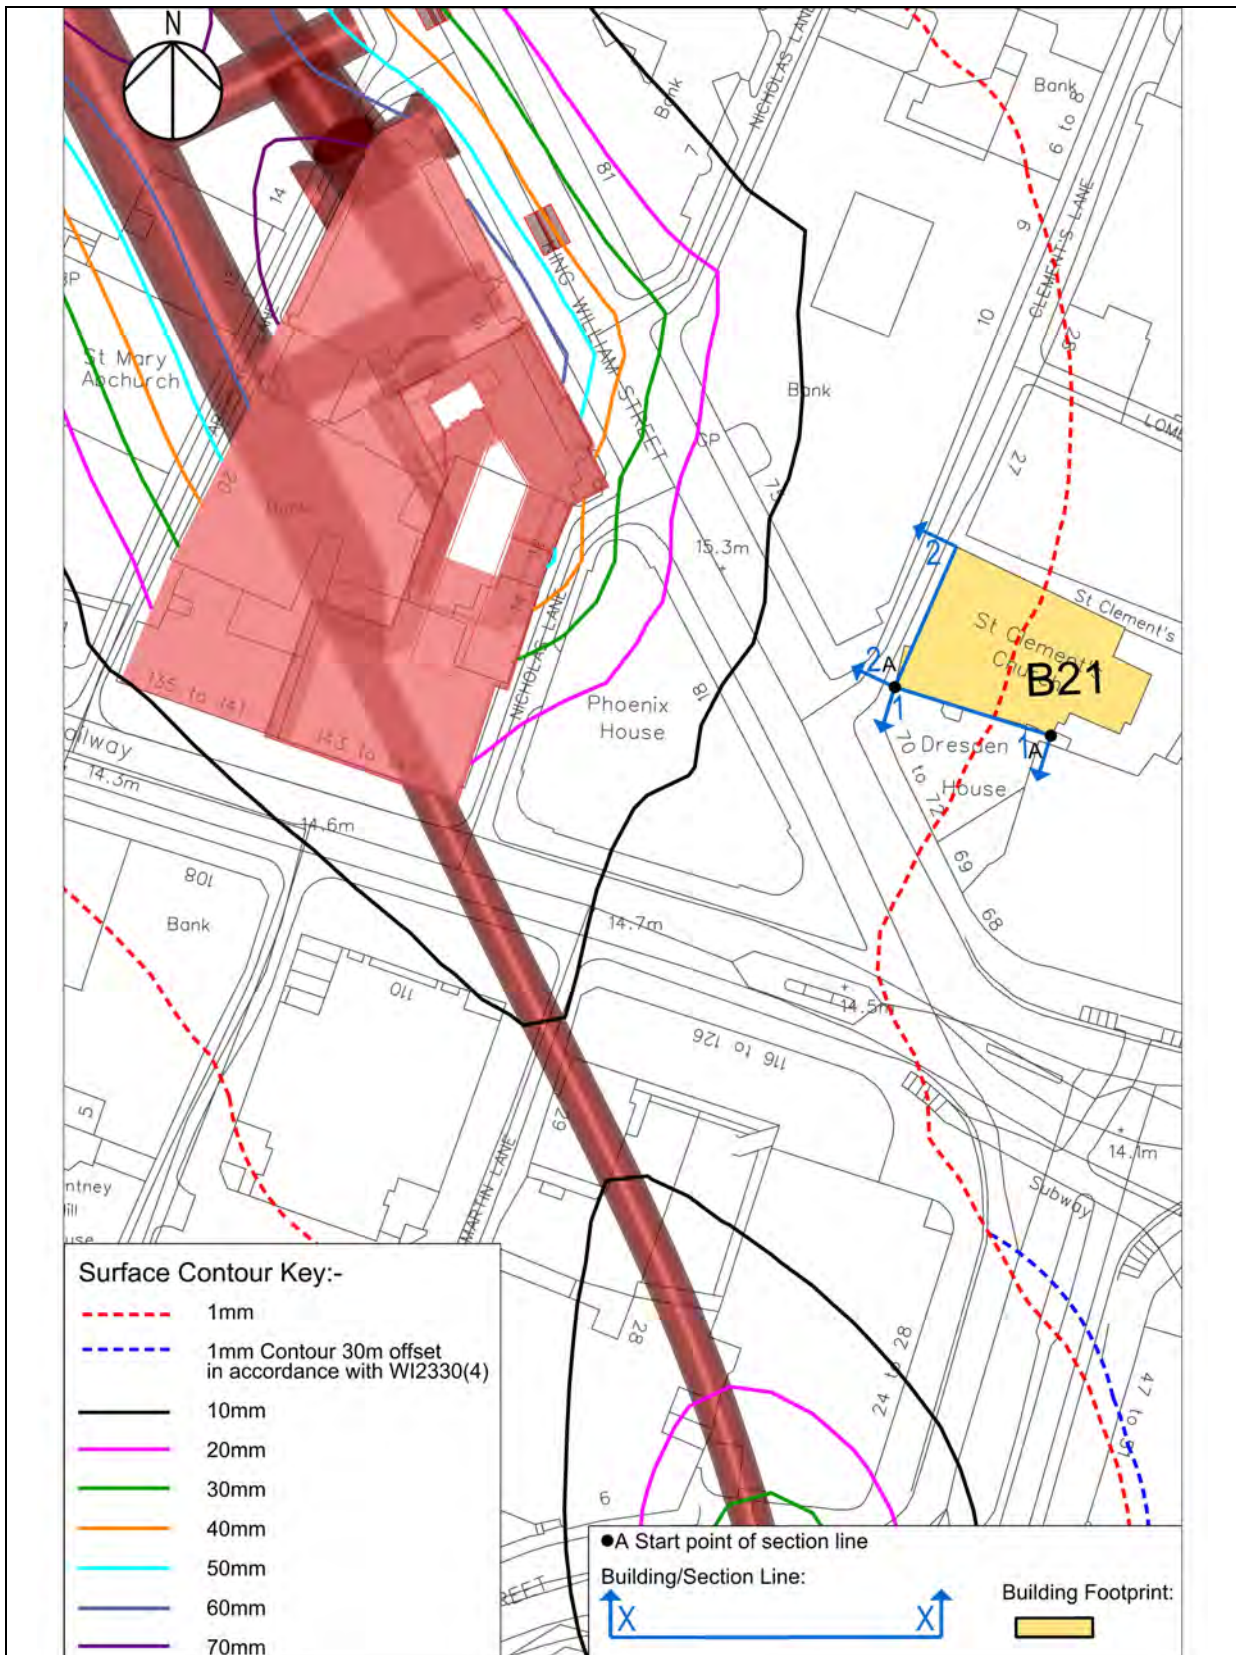
**Figure 3: Building location, sections analysed and Settlement Contours at end of construction.**

Strains in section (Curvature)	Position from start (m)	Length (m)	Average* Horizontal Strain (%)	Maximum Tensile Strains (%)	Damage Category
Sagging	18.8	1.0	<0.001	<0.001	Negligible

The Stage 2 engineering assessment has predicted that the maximum tensile strain falls within damage category 0. This corresponds to Negligible damage in accordance with Table 2.

The maximum settlement of the building at foundation level at construction stage 1 is less than 1mm.

It is recommended that the building does not require a Stage 3 assessment.
