Board

Date: 30 January 2018

Item: Tram Overturning at Sandilands, Croydon on 9 November 2016 – RAIB and TfL Investigations and Non-Operational Incident Responses Update

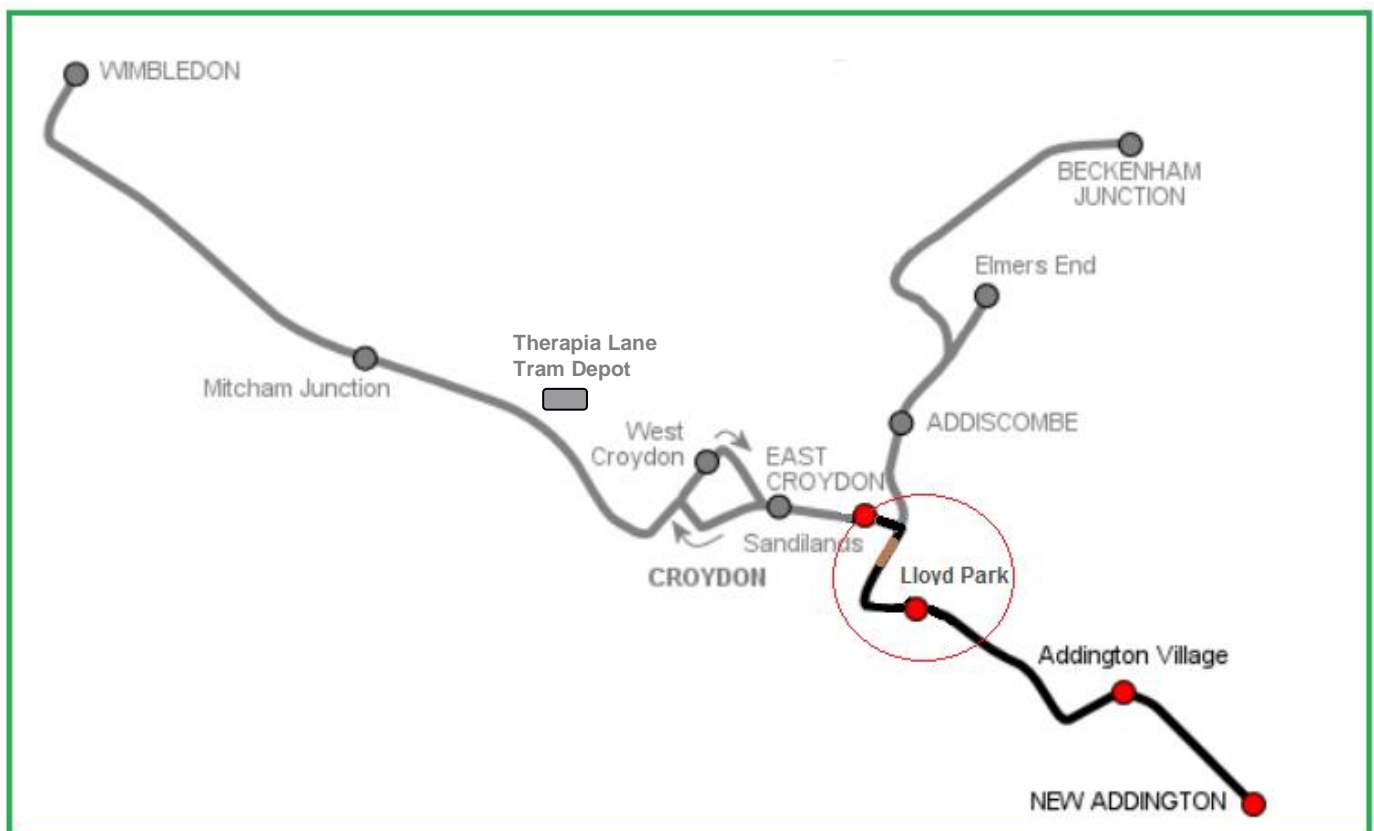
Figure 3 – LT Network highlighting Lloyd Park to Sandilands

The London Tram network is shown in Figure 3 with the critical Lloyd Park to Sandilands section highlighted. It includes a long largely straight section of the former Woodside and South Croydon Railway.

The tramway passes through three consecutive separate tunnels approaching the curve at Sandilands. At each end of the straight former railway sections there are small radius curves providing connections to the newer tramway alignments, both of which have 20km/h speed limits (see Figure 3).
