APPENDIX G – PERS ASSESSMENT

- G.1.1 This Pedestrian Environment Review System (PERS) audit has been submitted to support the Silvertown Tunnel Transport Assessment. It has been undertaken in order to establish the quality of the existing pedestrian environment within the vicinity of the proposed tunnel portals in the North Greenwich and Silvertown areas.

Silvertown Tunnel
Preliminary Transport Assessment

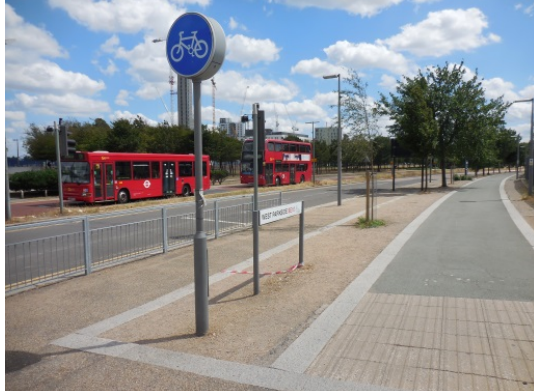
West Parkside cycle track (footway between it and main carriageway)	Uncontrolled mid-link cycle track and footway crossing of West Parkside

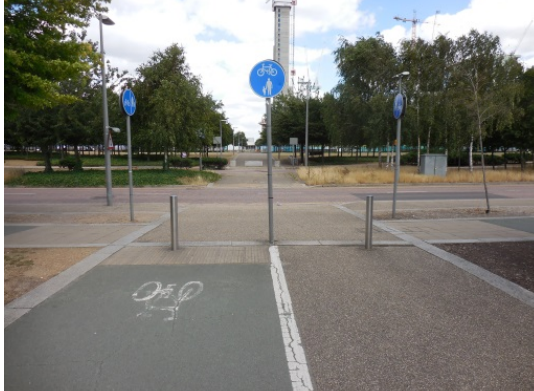
- There is a mid-link uncontrolled cycle crossing of the two West Parkside carriageways.
- There is a slightly complex junction with John Harrison Way. Cycling facilities cater for some movements. The junction is signal controlled with a long cycle time comprising four stages. The cycling facilities enable controlled or off-carriageway movements between John Harrison Way south-west and West Parkside north-west (with a cycle track following the bend) and between both arms of John Harrison Way (a Toucan style, straight-across crossing).

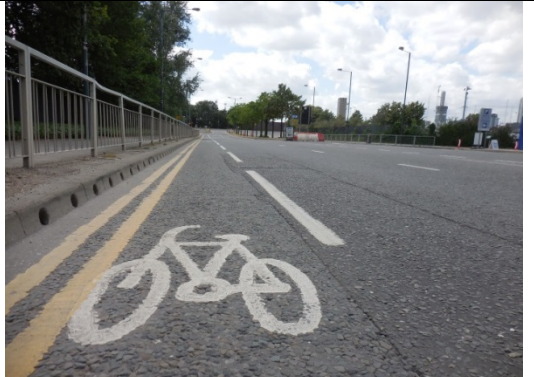
- A two lane dual carriageway in its western section before narrowing to a single carriageway (one lane in each direction) at the eastern end.
- In the dual carriageway section the only cycling facility is a west bound advisory cycle lane (approximately 1.5m in width).

Advisory cycle lane on Edmund Halley Way westbound	Edmund Halley Way dual carriageway section

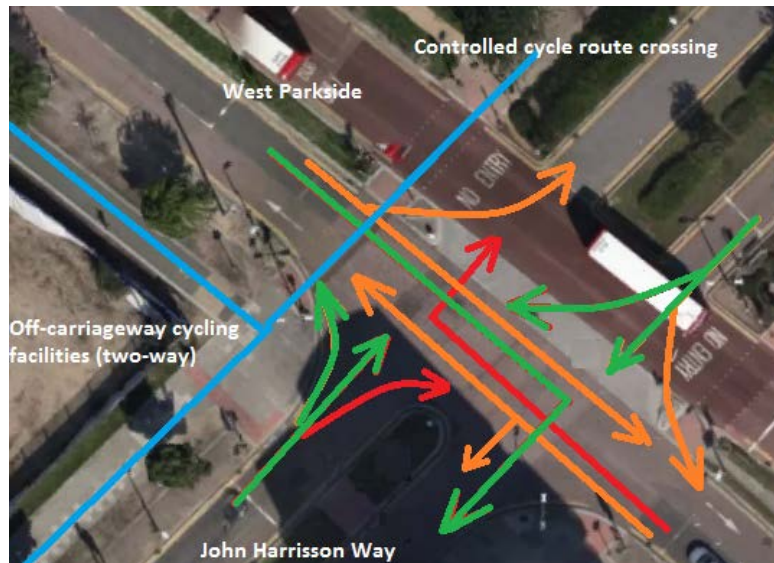
West Parkside and John Harrison Way

H.3.2 This junction has an unusual layout with two parallel two-way carriageways (one for buses, one for general traffic) on West Parkside, each with its own signal stage. There is a Toucan style crossing (which operates during an 'all-red' stage along with a pedestrian crossing). The green cycling movements either have their own controlled crossing (between the John Harrison Way arms) or can be made entirely off-carriageway (between John Harrison Way southwest and West Parkside northwest). The amber movements are on carriageway with no, or minimal, potential for conflict. The red movements are right turns which involve the need to cross a stream of traffic on the junction approach, and to pass an opposing movement as the right turn is made.

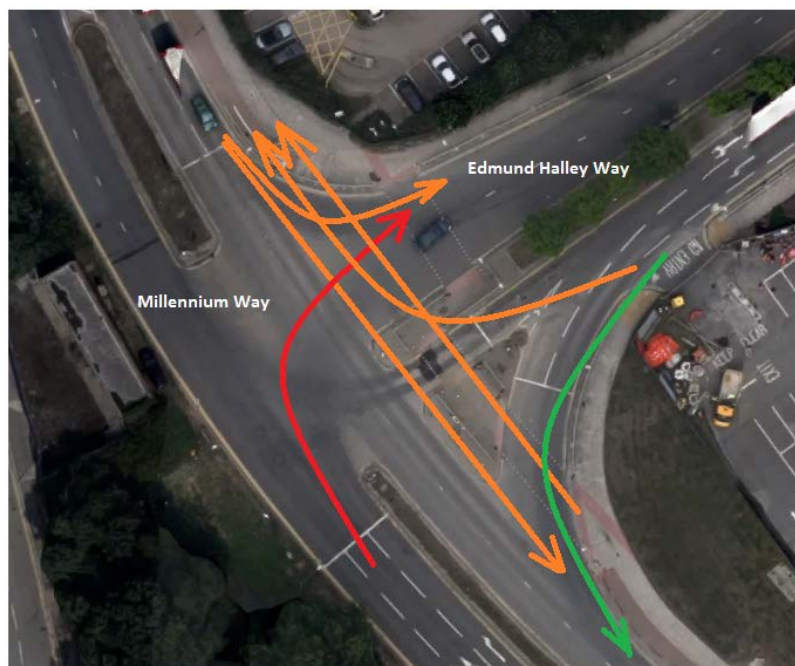
Millennium Way and Edmund Halley Way

H.3.3 This is a three-arm signalised junction with a controlled cycle crossing between the Millennium Way arms. The green movement is for the left turn from Edmund Halley Way as it can be made entirely within a cycling facility (cycle lane followed by cycle track). The amber movements include the left turn from Millennium Way on carriageway, and Toucan crossing (not a green as it is a staggered crossing and therefore takes a considerable amount of time – some cyclists were seen choosing to stay on carriageway). The red right-turn movement has no off-carriageway provision and is made as an opposing phase i.e. with the need to wait for a gap in the southbound traffic stream.

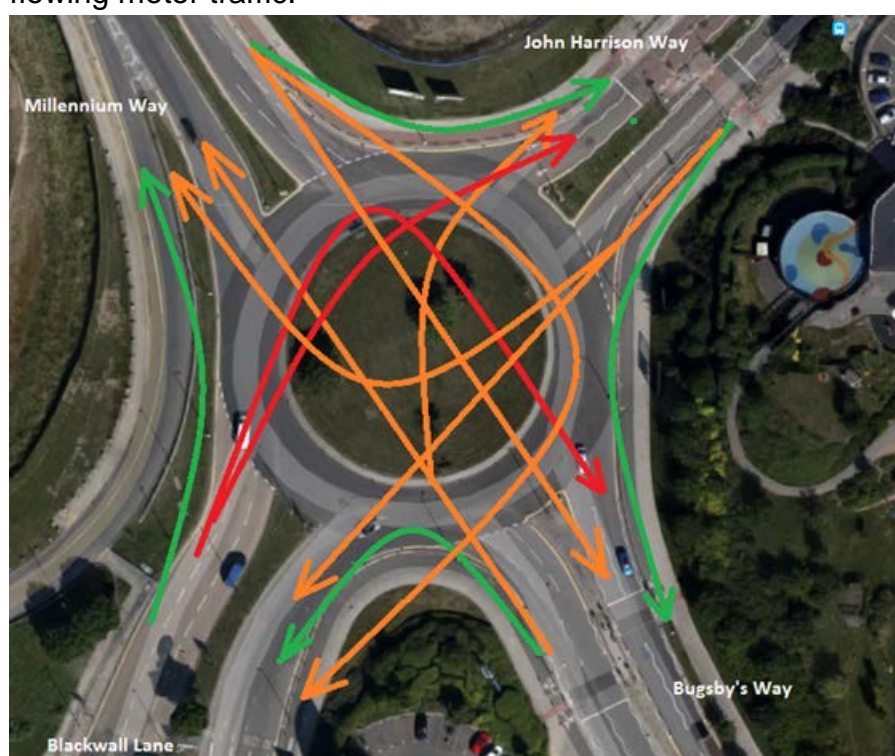
Millennium Way and John Harrison Way roundabout

H.4 This is a four arm, free flowing roundabout with offset, signal-controlled crossings on two arms. Only one crossing (John Harrison Way) has formal cycling provision but cyclists are also directed across the pedestrian crossing on Bugsby's Way. The green movements can be made off-carriageway and without delay at crossings. Amber movements require the use of the controlled crossings with considerable deviation from desire lines, and delay as they are both staggered two-stage crossings. The red movements have no off-carriageway provision, and are likely to feel particularly hazardous or intimidating as they would require cyclists to push across streams of free-flowing motor traffic.

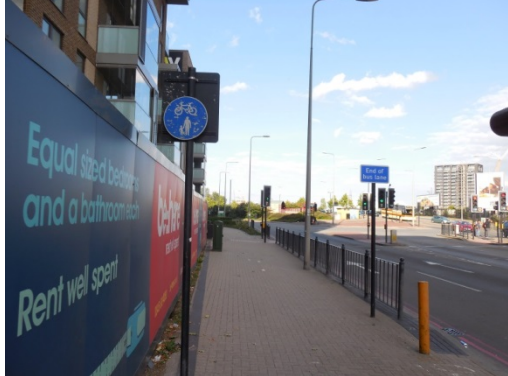
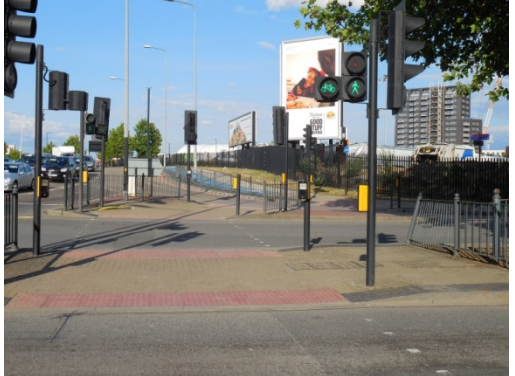
- There is a three-stage, staggered Toucan crossing of the western arm and of the southern arm (Leamouth Road).
- Cycling is permitted on the Leamouth Road western footway (which carries CS3) but not on the eastern footway.

Shared footway cycle track on the A13	Toucan crossing of Leamouth Road (looking towards CS3)

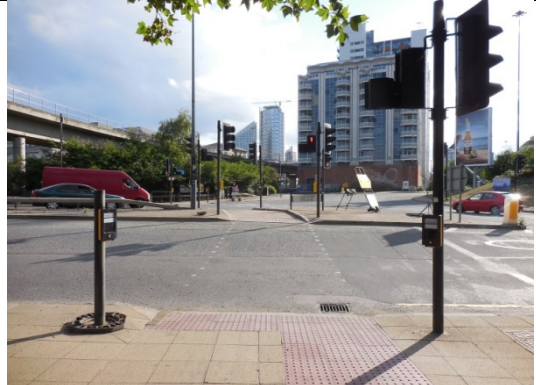
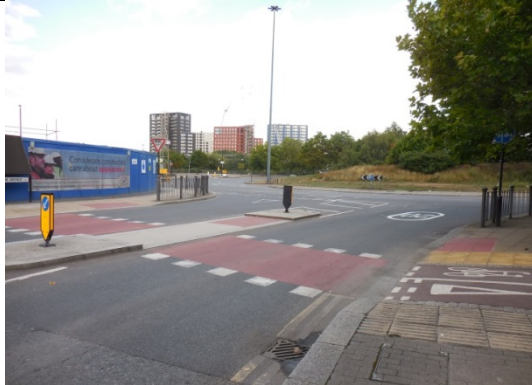
Staggered Toucan across Lower Lea Crossing arm	Uncontrolled crossing on a minor arm

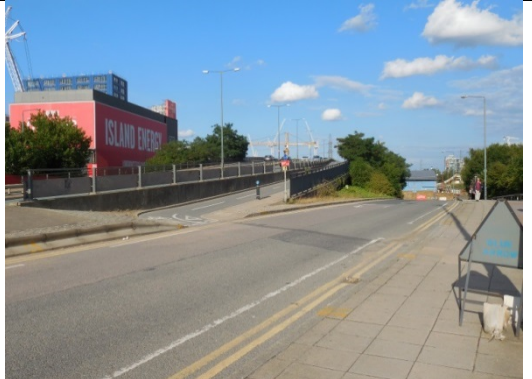
- This is a 900m section of dual carriageway over the River Lea connecting the A1011 with the A1261.
- There is a two-way cycle track on the southern side of the road, adjacent to the footway.
- It is reached at the western end via an uncontrolled crossing of the Orchard Place slip road. At the eastern end, it starts/ends on the A1011 roundabout by the Dock Street arm.

The cycle track across the bridge	Uncontrolled crossing at western end

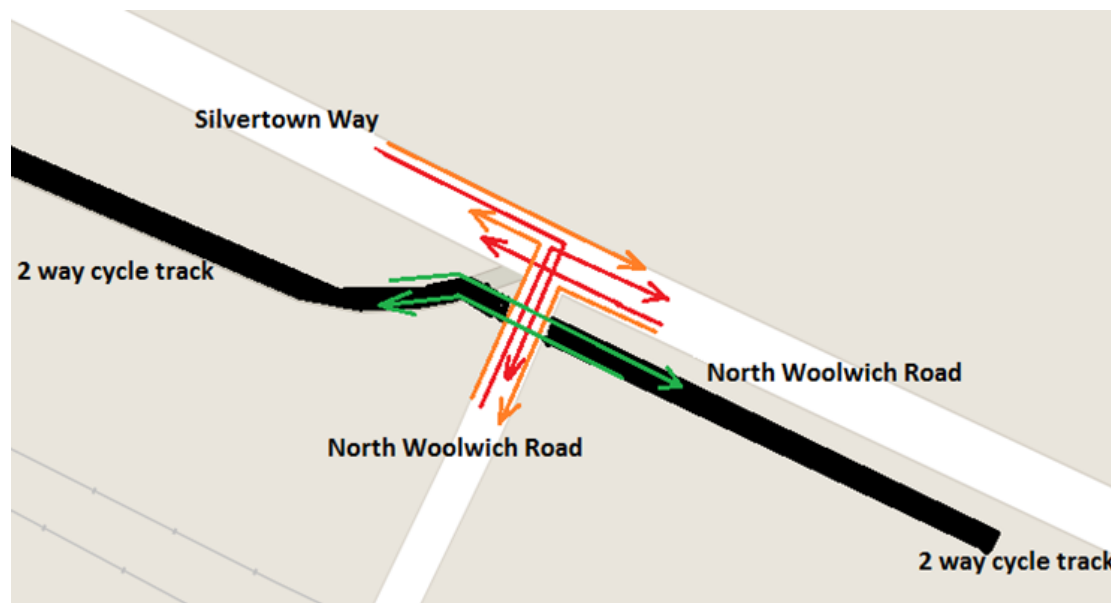
North Woolwich Road Silvertown Way junction

- H.6.1 The plan below shows a basic Junction Assessment for the junction of Silvertown Way and North Woolwich Road. This is currently a three arm, signal controlled junction which also has a two-way cycle track on either side. The cycle track runs parallel to North Woolwich Road on the eastern side of the junction but diverges from the main road (Silvertown Way) on the western side where it re-joins the minor arm of North Woolwich Road (a signed cycle route leading into Dock Road).

- H.6.2 The green arrow movements are for those made to and from the cycle track as this can be done via a separate stage at the Toucan crossing. The amber movements are made on carriageway and do not involve conflict with other streams of traffic. The red movements involve potential conflict with motor vehicles, as cyclists would either need to pull out across a stream of traffic to make the movement (right turns), or could have motor vehicles turn left in front of them (as they continue straight ahead).

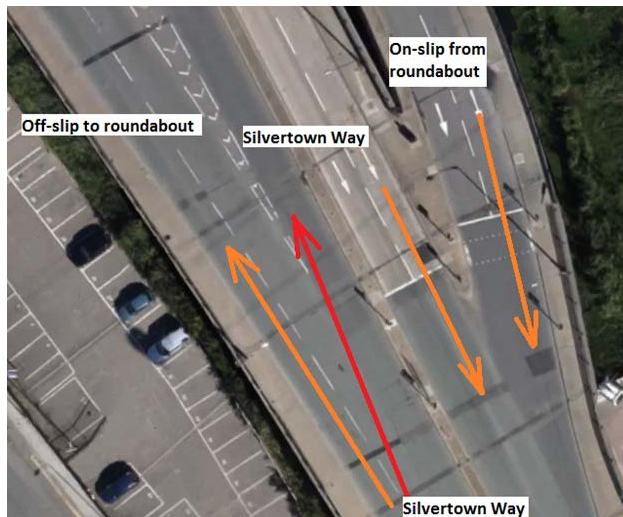
Silvertown Way junction with Tidal Basin Roundabout

- H.6.3 The plan below shows the junction of Silvertown Way and the slip roads from the Tidal Basin Roundabout. Realistic potential movements are limited to just two in each direction as anyone wishing to cycle between Silvertown Way northern arm and the Tidal Basin Roundabout could do this much more directly via Tidal Basin Road.

- H.6.4 The southbound movements are both labelled as amber. This is because they are on-carriageway with potentially fast moving and heavy traffic flows (preventing a green rating) but they are signal controlled, and there are no conflicting movements within each stage.

- H.6.5 The northbound movement towards the off-slip is rated as amber, as this does not involve any conflicting movements although it is in a (potentially) high speed, high flow environment. The most hazardous movement by far is northbound for cyclists remaining on Silvertown Way as they may have conflicting movements with fast moving, left-turning motor vehicles who are heading for the off-slip.

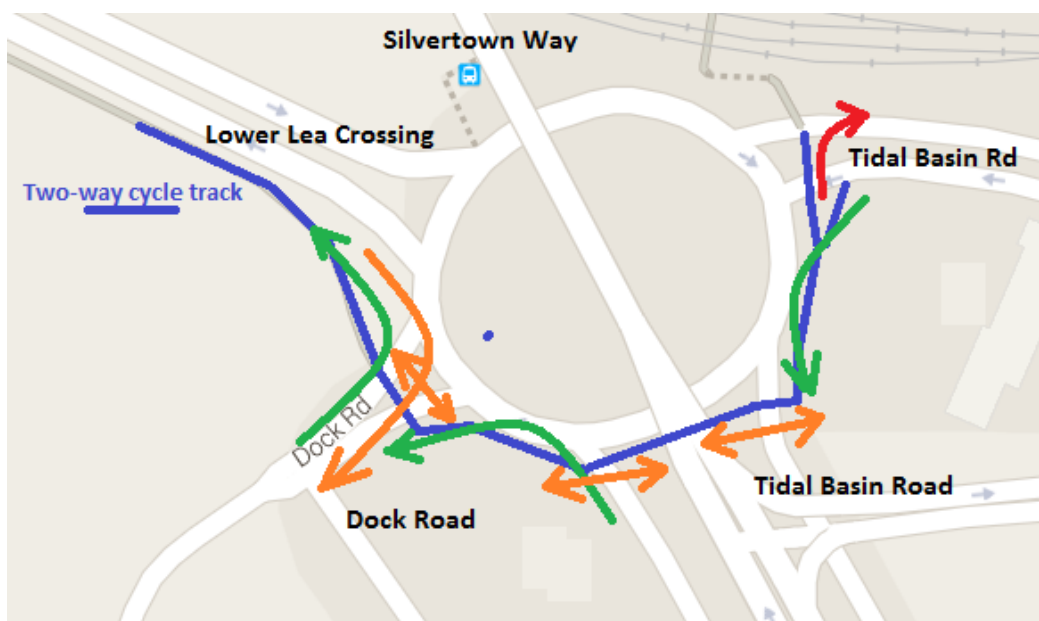
Tidal Basin Roundabout

H.6.6 The plan below shows the junction of Tidal Basin Road roundabout. Silvertown Way passes over the junction as a flyover. There is a two-way cycle track (shown in blue) which connects most of the arms with uncontrolled crossings. The movements are shown differently in this diagram as it is an unusual junction. Left turns which don't require crossing any traffic streams and can be made mainly off-carriageway are shown as green. Movements which involve uncontrolled crossings of arms (between cycle tracks) are shown as amber – they would need to be controlled for a green rating. The one red rating is given to a movement which goes directly onto a carriageway without any signal control.

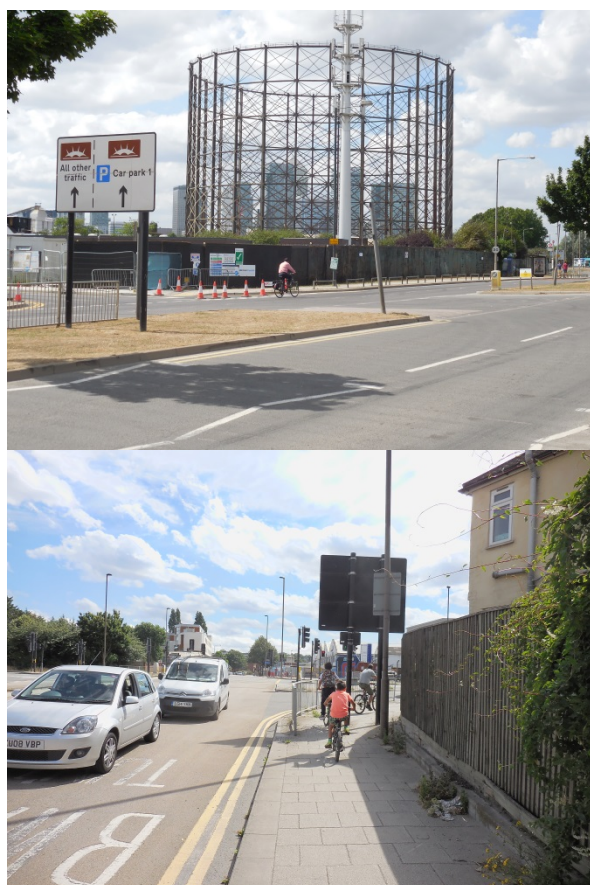
H.7.1 Two site visits were carried out during the study, and levels of cycling were observed during both. In the visit to North Greenwich, cycling activity was very light with approximately 12 to 15 cyclists seen throughout the four hour stay (in the inter-peak). About half were on carriageway where there was an option to use an off-carriageway. This is probably due to the relatively light motor-traffic flows on the carriageway and/or the quality and directness of the off-carriageway cycling provision. A cyclist was seen on the northbound carriageway of Millennium Way (below left) instead of using the footway cycle track. His crossing of Edmund Halley way would have been simpler and quicker on carriageway as the Toucan is staggered with three separate crossings. Conversely, the photograph, below right shows three people cycling on a footway which has no cycle route status.

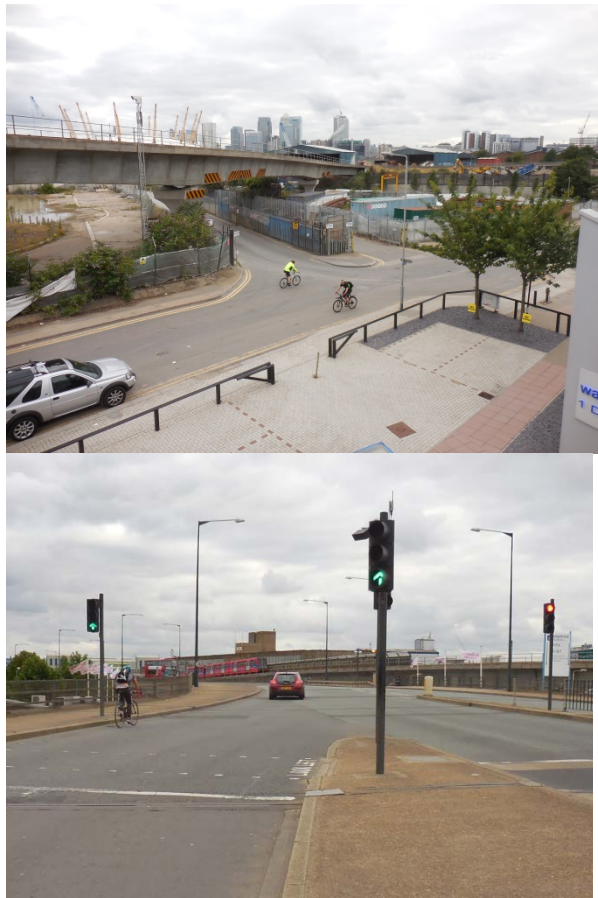
H.7.2 On the north side of the river, in Silvertown, levels of cycling were higher during the site visit. This will have been partly due to the fact that the site visit included the early part of the evening peak but also that the geography on this side of the river lends itself to radial cycle trips to and from central London (on the south side the meandering river acts as a barrier). The main area of cycling activity was Dock Road, and it was estimated that 60-100 cyclists were using this route per hour (below left).

H.7.3 It is easy to understand why as it is a much quieter road than the parallel Silvertown Way and stays at ground level (Silvertown Way is elevated along here). However, Silvertown way also attracted cycle trips including on the eastern section (above right) despite a lack of formal cycle route provision (which only extends eastwards as far as the junction with Tidal Basin Road).
