CLIENT: LONDON UNDERGROUND LIMITED

CONTRACT REF: TLL 7917

NORTHERN LINE EXTENSION

Kennington Park Passive Air Quality Monitoring – Six week report

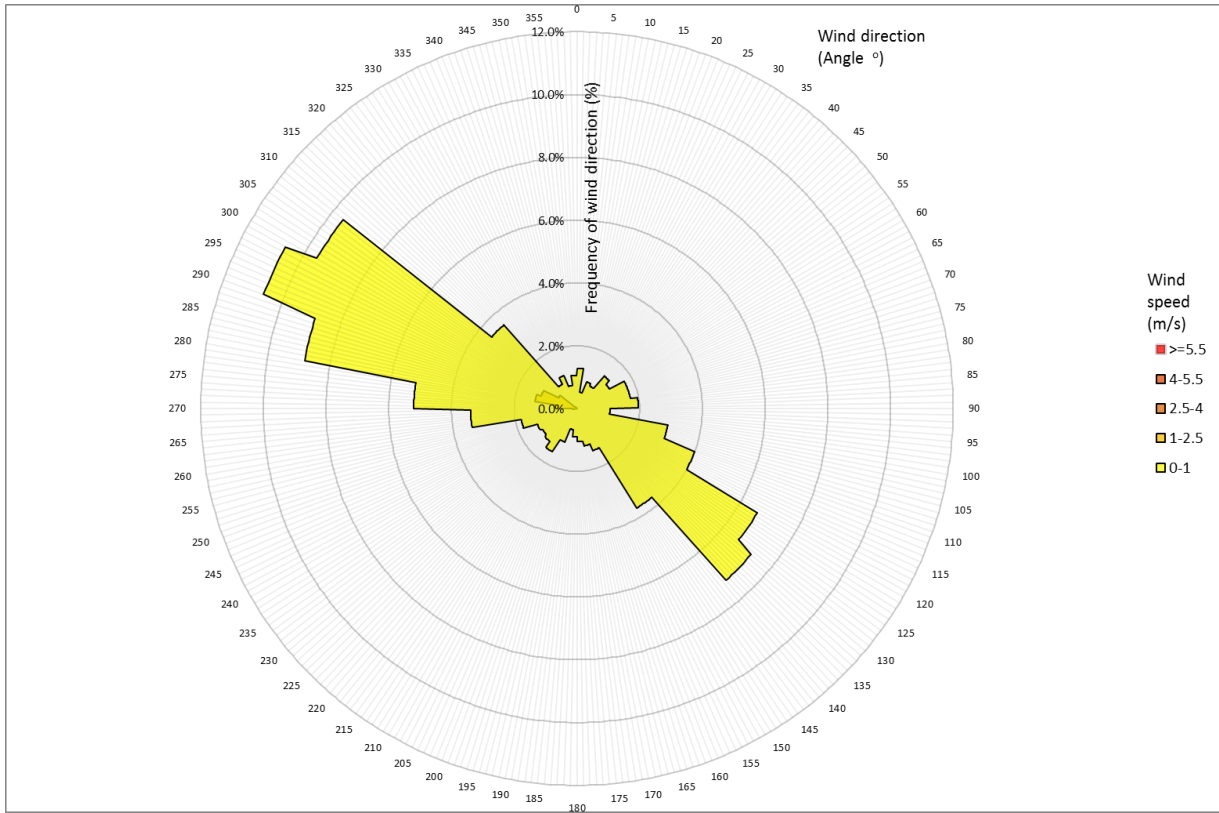
Figure 3. Wind rose from the Kennington Park sonic anemometer KP2W. Period 3.

Figures 1, 2 and 3 show the wind roses from the KP2W sonic anemometer during the relevant period. Data was downloaded via the Sigicom integrated monitoring system.

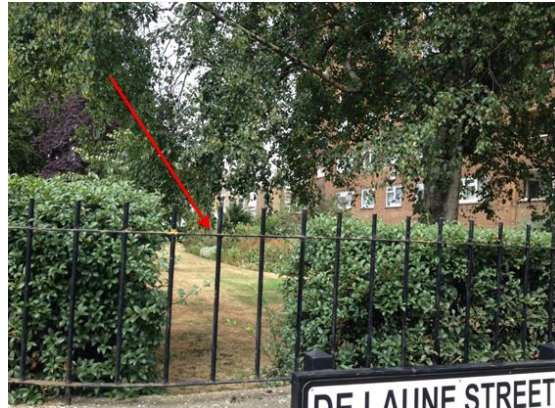
Figure 5 – Glass Slide 1

Glass Slide 1 – GS1

Location: street fence of Kennington Park House

Receptor: residents of Kennington Park House

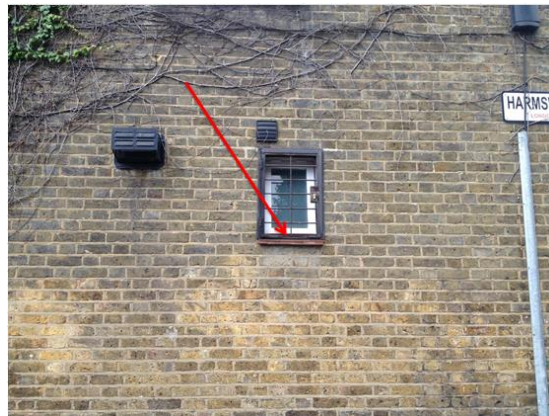
Figure 6 – Glass Slide 2

Glass Slide 2 – GS2

Location: back window of Bishop House Childrens Centre

Receptor: Bishop House Childrens Centre

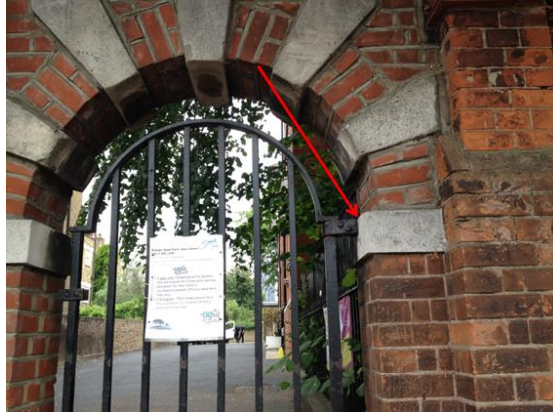
Figure 7 – Glass Slide 3

Glass Slide 3 – GS3

Location: front pedestrian door of Bishop House Childrens Centre

Receptor: Bishop House Childrens Centre

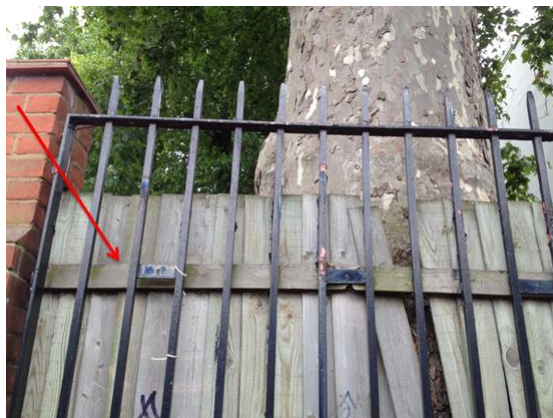
Figure 8 – Glass Slide 4

Glass Slide 4 – GS4

Location: side fence of Bishop House Childrens Centre

Receptor: Bishop House Childrens Centre

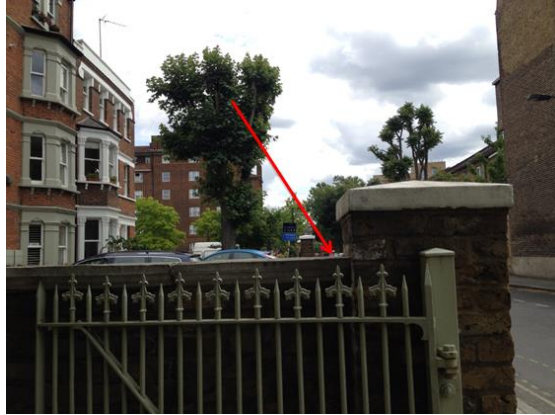
Figure 9 – Glass Slide 5

Glass Slide 5 – GS5

Location: wall in between 11 and 12 Kennington Park Place

Receptor: residents of Kennington Park Place (North NLE site)

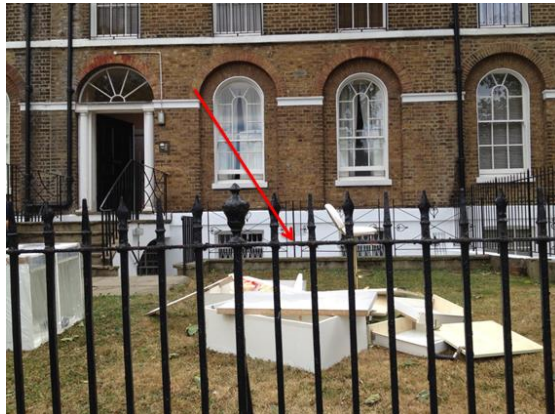
Figure 10 – Glass Slide 6

Glass Slide 6 – GS6

Location: front fence of 2C St Agnes Place

Receptor: residents of St Agnes Place
