CLIENT: LONDON UNDERGROUND LIMITED

CONTRACT REF: TLL 7917

NORTHERN LINE EXTENSION

**Kennington Park Passive Air Quality Monitoring – Four
weekly report**

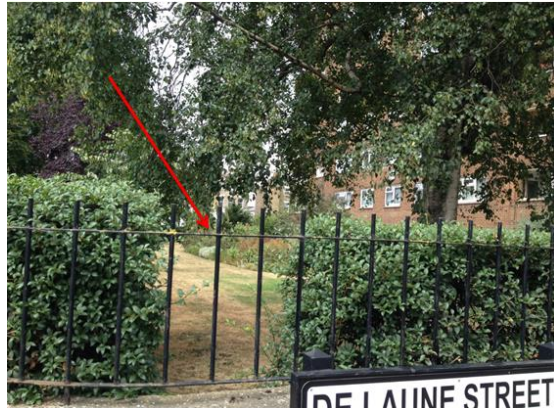
Figure 4 – Glass Slide 1

Glass Slide 1 – GS1

Location: street fence of Kennington Park House

Receptor: residents of Kennington Park House

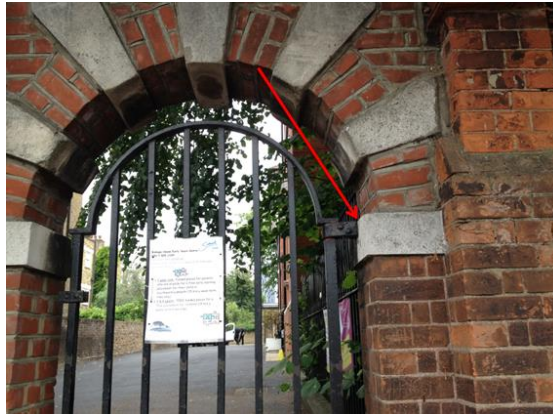
Figure 6 – Glass Slide 3

Glass Slide 3 – GS3

Location: front pedestrian door of Bishop House Childrens Centre

Receptor: Bishop House Childrens Centre
