CLIENT: LONDON UNDERGROUND LIMITED

CONTRACT REF: TLL 7917

NORTHERN LINE EXTENSION

**Nine Elms Passive Air Quality Monitoring – Four weekly
report**

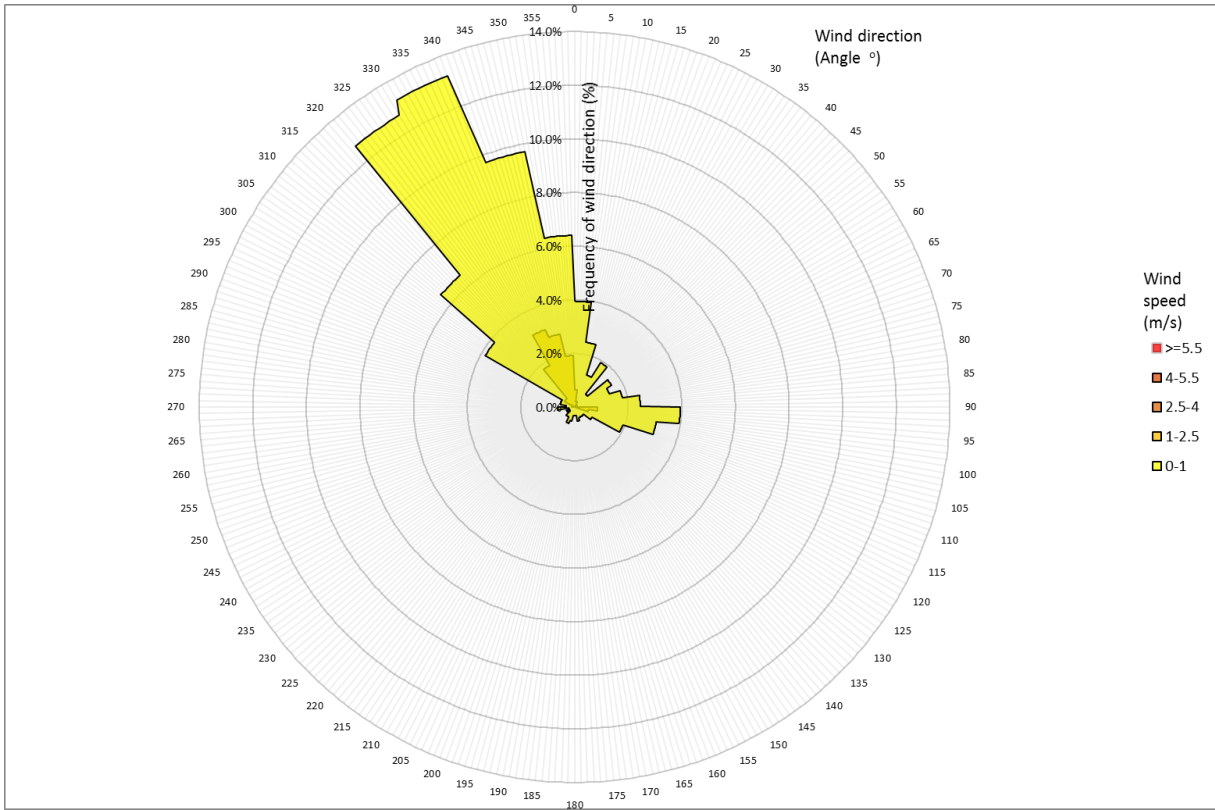
Figure 1. Wind rose from the Nine Elms sonic anemometer NE2_2094 W, period 1.

Figure 1 and 2 show the wind rose from the NE2_2094 W sonic anemometer during the relevant period. Data was downloaded via the Sigicom integrated monitoring system.

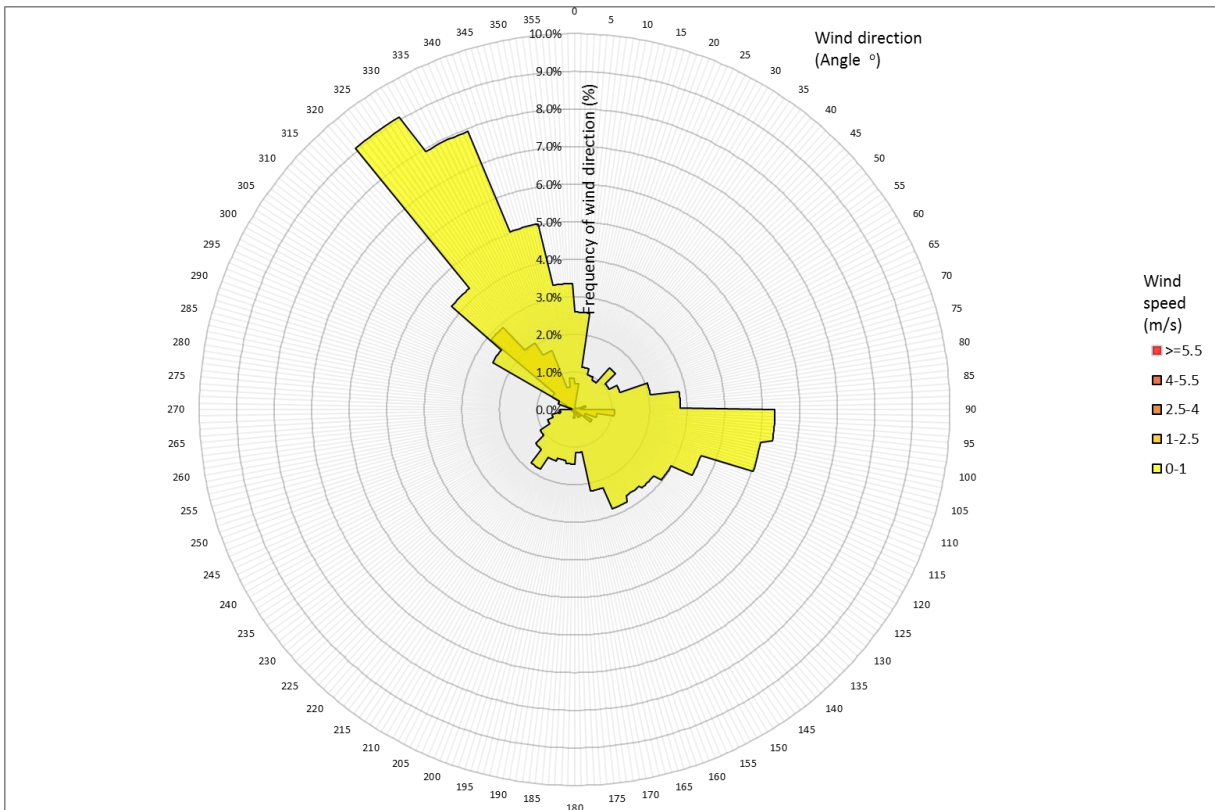
Figure 2. Wind rose from the Nine Elms sonic anemometer NE2_2094 W, period 2.

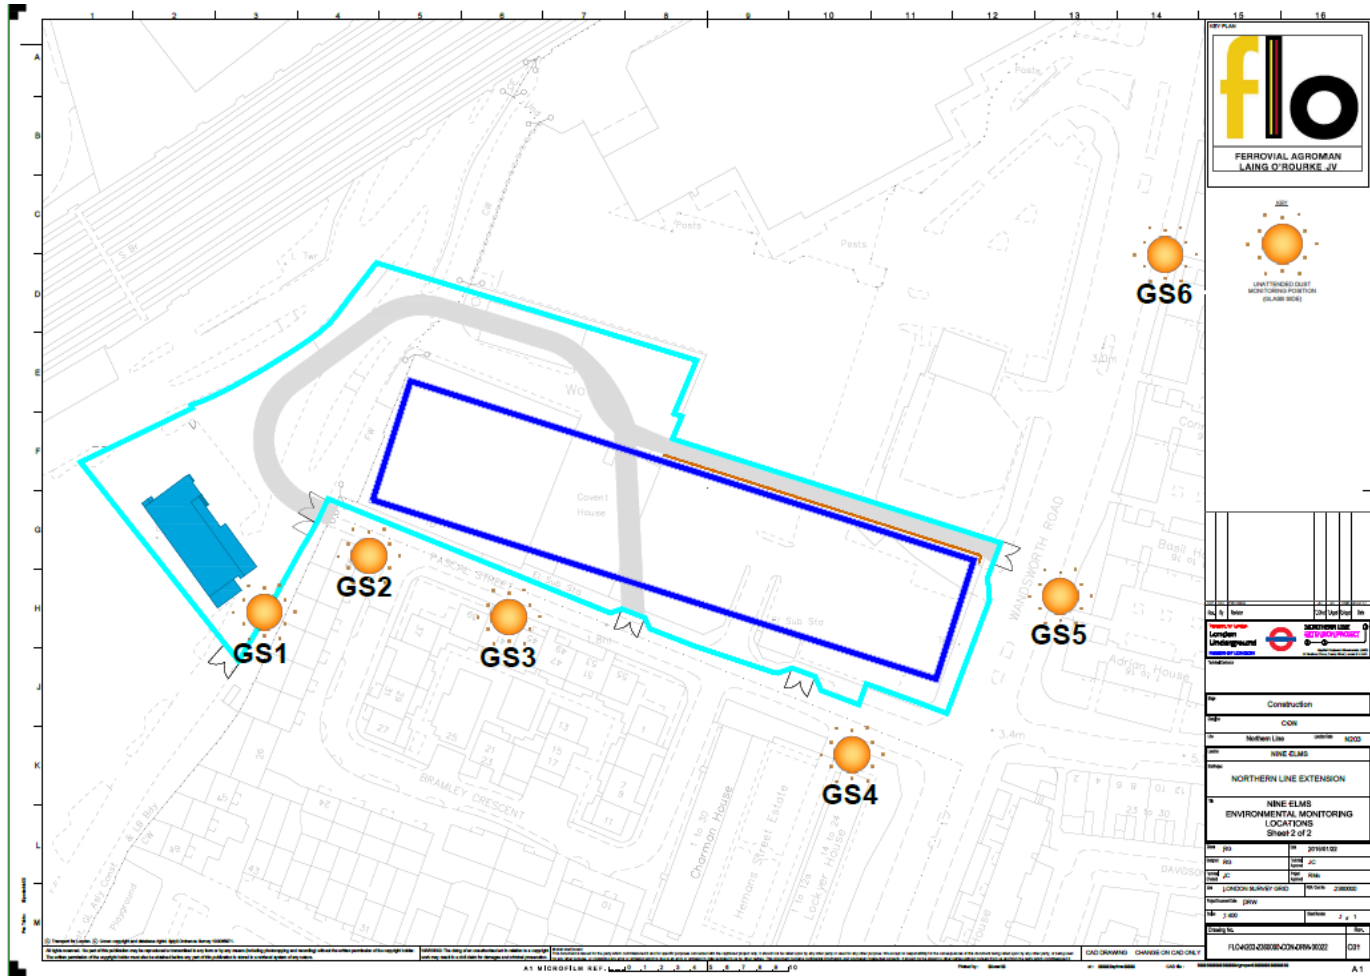
Figure 3 – Passive monitoring locations

The objective of this air quality monitoring assessment is to investigate the likelihood of dust soiling effects at sensitive receptor locations surrounding the Nine Elms site. The locations of the monitoring positions are shown in **Appendix I**.

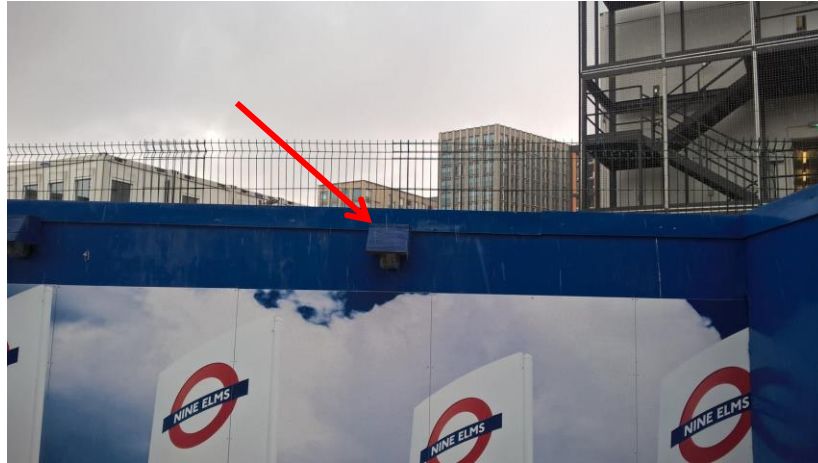
Figure 4 – Glass Slide 1b

Glass Slide 1b – GS1

Location: Post next to former Flower Market Junction Box

Receptor: Bramley Crescent West

The passive monitoring locations are shown in **Appendix II**. Due to inaccessibility to the Flower Market Junction Box, a new location was selected nearby for the placement of the dust slide. This is shown in **Appendix II** as glass slide 1b.

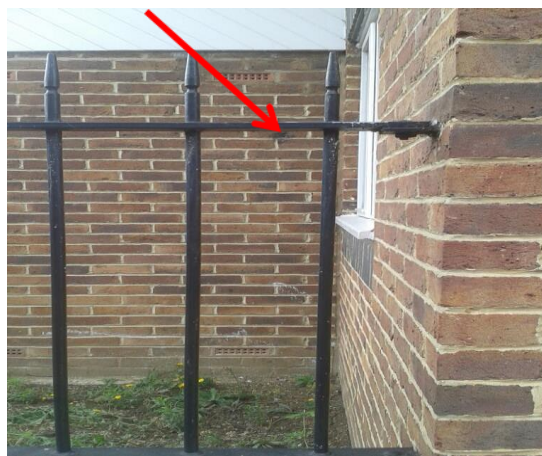
Figure 5 – Glass Slide 2

Glass Slide 2 – GS2

Location: side wall of No.38 Bramley Crescent

Receptor: residents of Bramley Crescent overlooking the Nine Elms main entrance gate

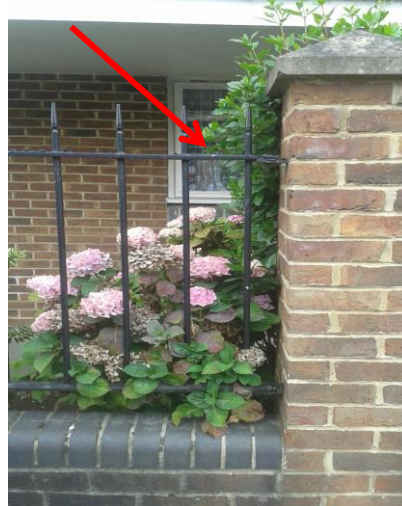
Figure 6 – Glass Slide 3

Glass Slide 3 – GS3

Location: No.55 Bramley Crescent

Receptor: residents of Bramley Crescent on Pascal Street opposite second gate

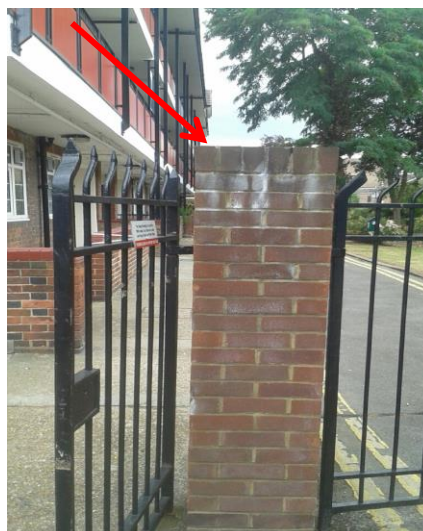
Figure 7 – Glass Slide 4

Glass Slide 4 – GS4

Location: Lockyer House

Receptor: residents along Pascal Street with Wandsworth Road

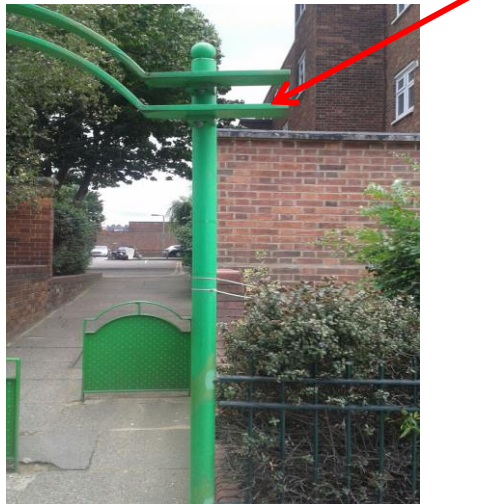
Figure 8 – Glass Slide 5

Glass Slide 5 – GS5

Location: top of gate at Basil House

Receptor: residents at Basil House

The guidance criterion of 25 SU per week (i.e. 50 SU per fortnight) set out by the Environment Agency was exceeded at measurement location GS5 during the first fortnightly period. The soiling units recorded suggests that there was a potential for nuisance at nearby receptors during this period. No other exceedences were recorded in the area surrounding the Nine Elms site. The soiling units recorded suggest that nuisance would have been unlikely at sensitive receptors during the monitoring period, with the exception of GS5 during the first fortnightly monitoring period.

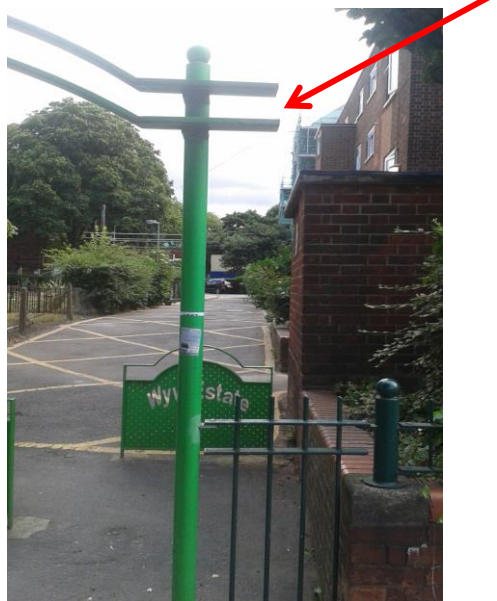
Figure 9 – Glass Slide 6

Glass Slide 6 – GS6

Location: top of gate at Edgar House

Receptor: residents at Edgar House
