CONTRACT REF: TLL 7917

NORTHERN LINE EXTENSION

MAIN WORKS CONTRACT

Nine Elms Passive Air Quality Monitoring – Monthly report

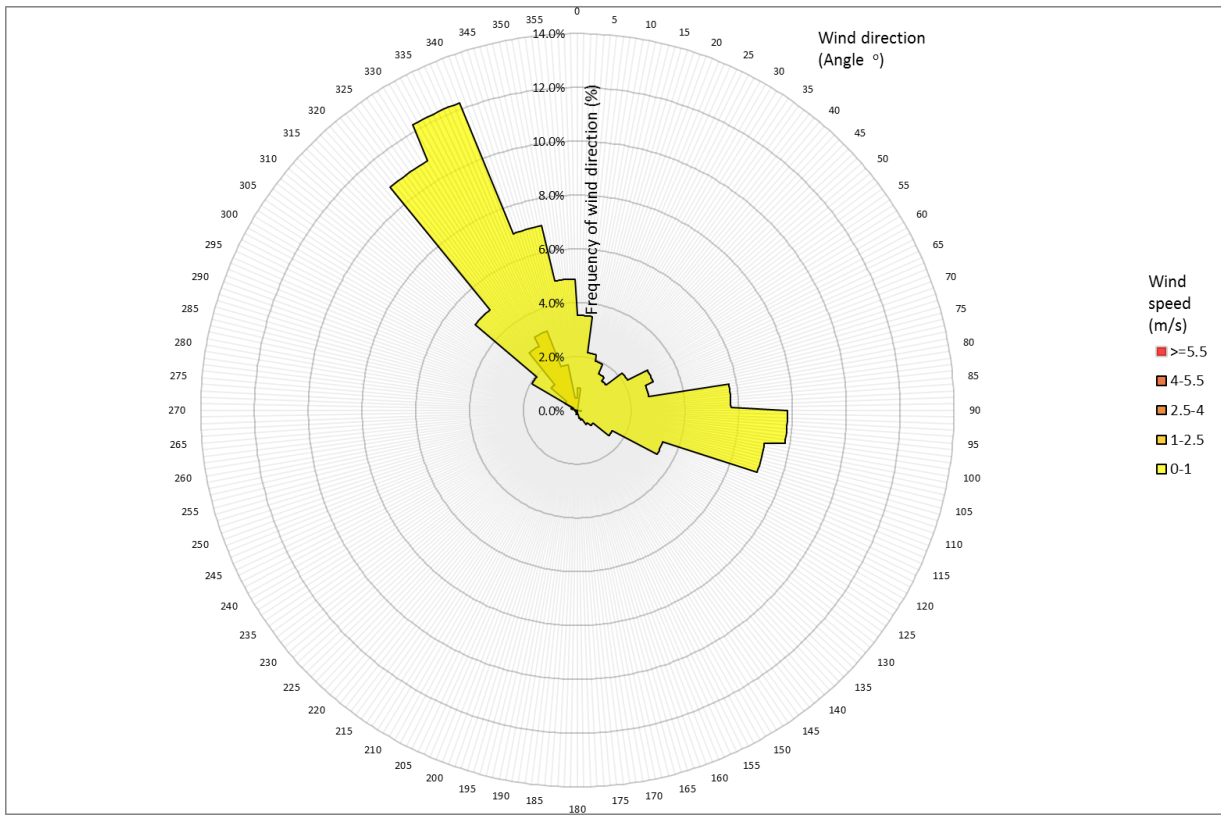
Figure 1. Wind rose from the Nine Elms sonic anemometer NE2_2094 W. Period 1.

Figure 1, and 2 show the wind roses from the NE2_2094 W sonic anemometer during the relevant period. Data was downloaded via the Sigicom integrated monitoring system.

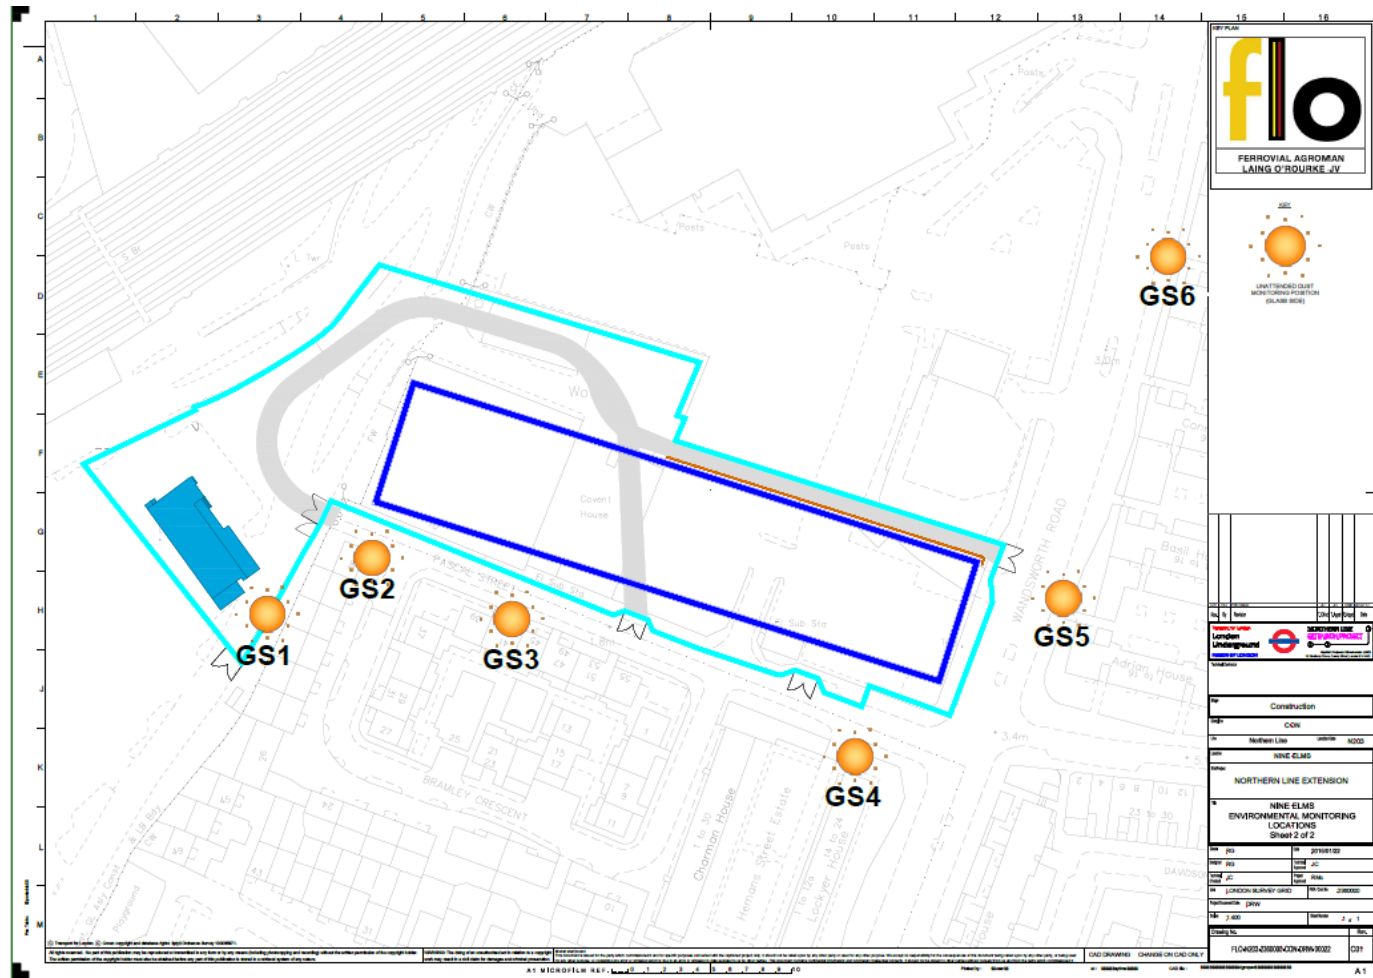
Figure 3 – Passive monitoring locations

The objective of this air quality monitoring assessment is to investigate the likelihood of dust soiling effects at sensitive receptor locations surrounding the Nine Elms site. The locations of the monitoring positions are shown in **Appendix I**.

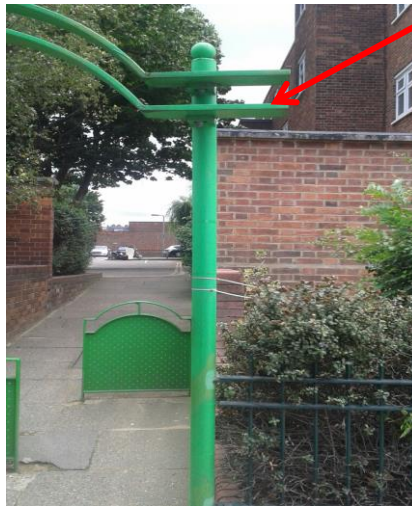
Figure 8 – Glass Slide 5

Glass Slide 5 – GS5

Location: top of gate at Basil House

Receptor: residents at Basil House

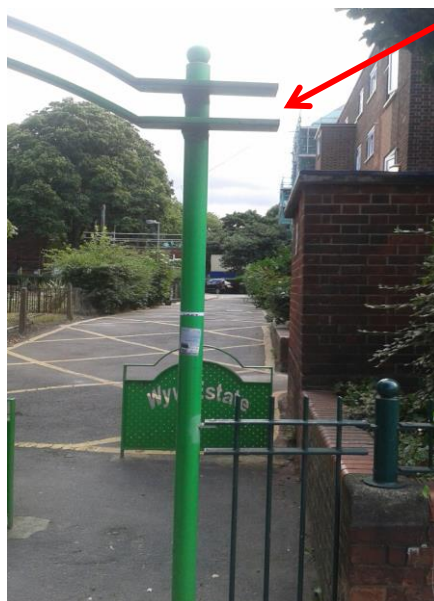
Figure 9 – Glass Slide 6

Glass Slide 6 – GS6

Location: top of gate at Edgar House

Receptor: residents at Edgar House
