**CLIENT: LONDON UNDERGROUND LIMITED**

**NORTHERN LINE EXTENSION**

## **Battersea Passive Air Quality Monitoring – Monthly report**

Prepared by	Checked by	Approved by	Date	Rev
Alexander Trotman	Richard Lane	Chris McCollin	05/12/2017	49.0

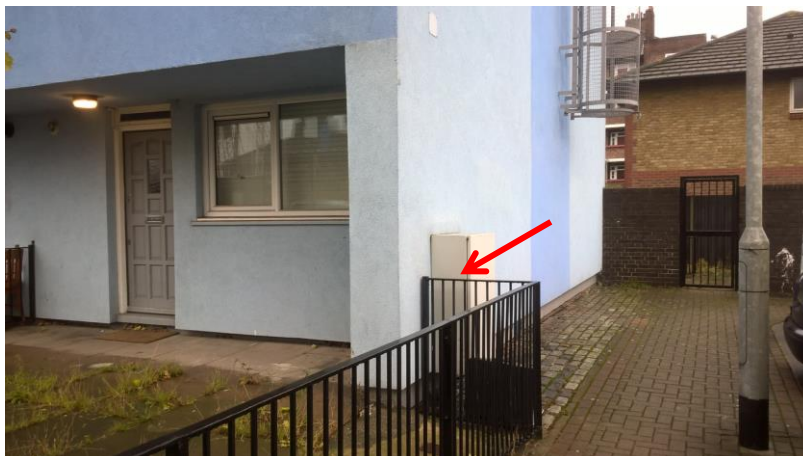
*Figure 5 – Glass Slide 2*

Glass Slide 2 – GS2

**Location:** Railing by Battersea Park Road, 113

**Receptor:** residents of Battersea Park Road

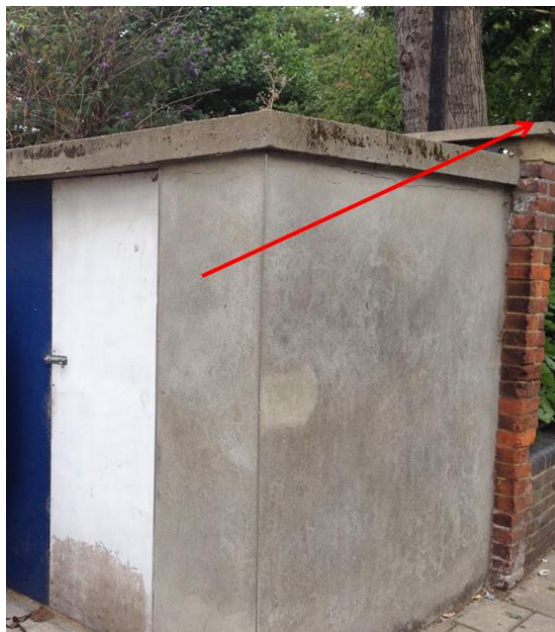
Figure 7 – Glass Slide 4

Glass Slide 4 – GS4

**Location:** wall on Thessaly Road

**Receptor:** residents along Thessaly Road

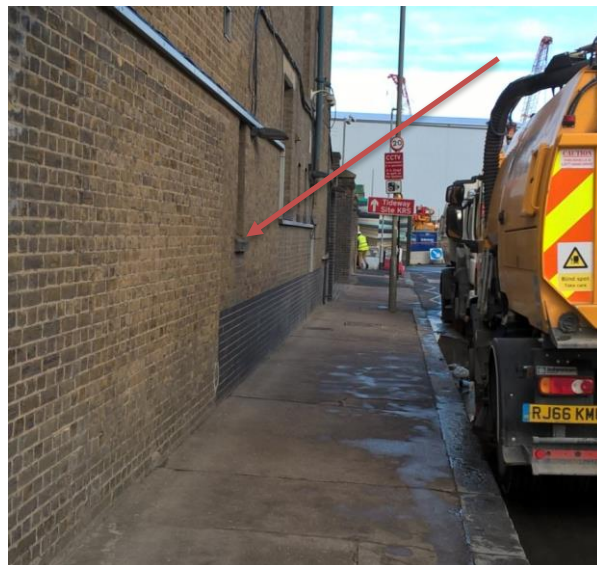
Figure 9 – Glass Slide 6

\*- side missing upon collection

Glass Slide 6 – GS6

**Location:** windowsill of warehouse on Kirtling Street

**Receptor:** commercial and residential receptors on Kirtling Street
