CLIENT: LONDON UNDERGROUND LIMITED

CONTRACT REF: TLL 7917

NORTHERN LINE EXTENSION

Nine Elms Passive Air Quality Monitoring – Monthly report

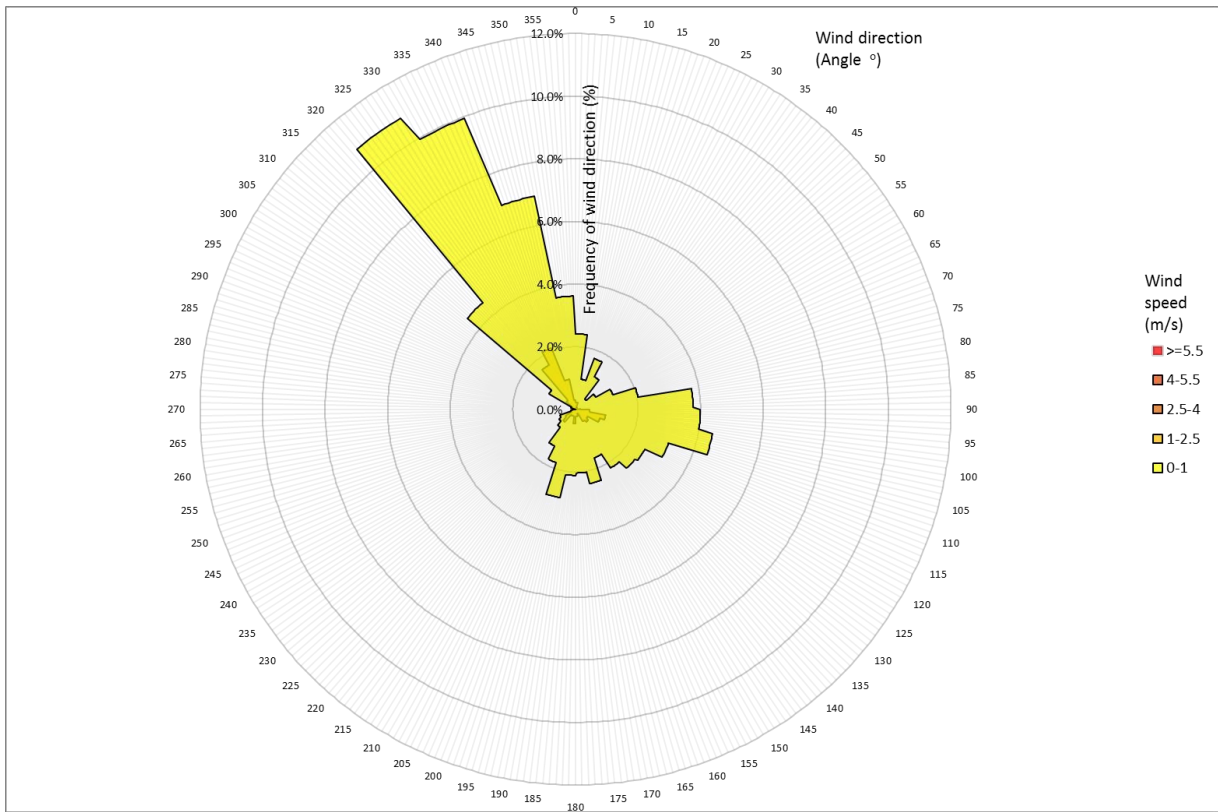
Figure 1. Wind rose from the Nine Elms sonic anemometer NE2_2094 W. Period 1.

Figure 1, and 2 show the wind roses from the NE2_2094 W sonic anemometer during the relevant period. Data was downloaded via the Sigicom integrated monitoring system.

SAMPLING PERIOD AVERAGE WEATHER CONDITONS		
Period	Rainfall / mm / day	Mean Daily Wind Speed / mph (ms ⁻¹)
01/09/2017 – 15/09/2017	0.66	1.4(0.6)
15/09/2017 – 02/10/2017	1.03	1.2(0.5)
