Northern Line Extension Main Works Contract

CONTRACT REF: TLL 7917

Nine Elms Passive Air Quality Monitoring – Six week report

FLO-N203-2360000-HSE-RPT-00007 Rev. 46.0

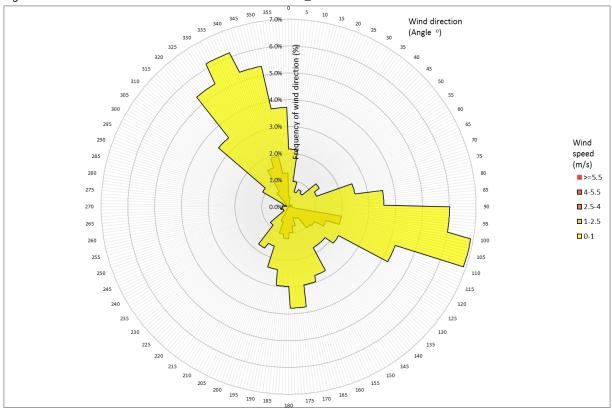
Figure 1. Wind rose from the Nine Elms sonic anemometer NE2_2094 W. Period 1.

Figure 1, 2 **and 3** show the wind roses from the NE2_2094 W sonic anemometer during the relevant period. Data was downloaded via the Sigicom integrated monitoring system.

Table 1 shows the mean wind speed measured by the sonic anemometer operating at the Nine Elms site (NE2_2094 W) and rainfall averages during the sampling period measured by the weather station operating at the Battersea site (BN2W).

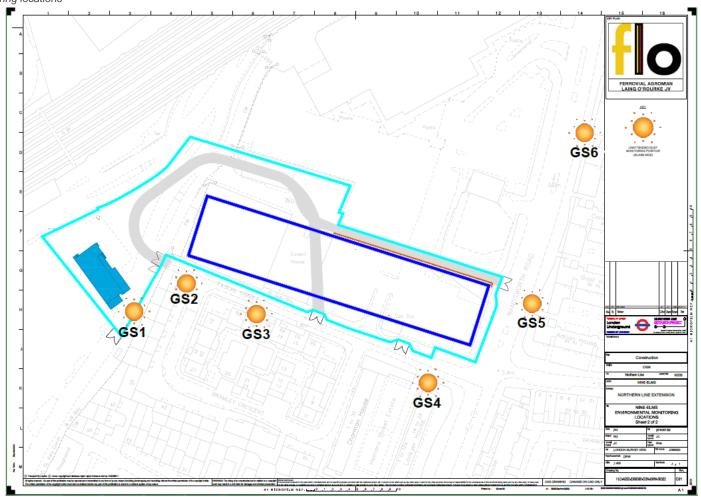
Figure 4 – Passive monitoring locations

The objective of this air quality monitoring assessment is to investigate the likelihood of dust soiling effects at sensitive receptor locations surrounding the Nine Elms site. The locations of the monitoring positions are shown in **Appendix I**.

- On top of blue hording next to former Flower Market Junction Box;
- Side of No.38 Bramley Crescent;
- No.55 Bramley Crescent;
- Lockyer House;
- · Basil House; and
- · Edgar House.

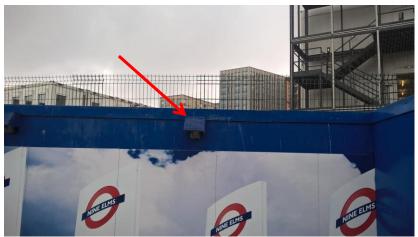
Figure 5 – Glass Slide 1b

The passive monitoring locations are shown in **Appendix II**. Due to inaccessibility to the Flower Market Junction Box, a new location was selected nearby for the placement of the dust slide. This is shown in **Appendix II** as glass slide 1b.

Glass Slide 1b - GS1

Location: Post next to former Flower Market Junction Box

Receptor: Bramley Crescent West

GLASS SLIDE RESULTS			
Slide Number	Fortnightly Soiling Unit (SU) Objective	Soiling Units (SU) measured during period 21/07/17 – 04/08/17	Nuisance (Y/N)
GS1b	<50	28.1	N
GS2	<50	6.8	N
GS3	<50	6.6	N
GS4	<50	13.9	N
GS5	<50	6.4	N
GS6	<50	30.6	N

GLASS SLIDE RESULTS			
Slide Number	Fortnightly Soiling Unit (SU) Objective	Soiling Units (SU) measured during period 04/08/17 – 18/08/17	Nuisance (Y/N)
GS1b	<50	6.7	N
GS2	<50	8.0	N
GS3	<50	3.3	N
GS4	<50	7.6	N
GS5	<50	15.4	N
GS6	<50	19.1	N

GLASS SLIDE RESULTS			
Slide Number	Fortnightly Soiling Unit (SU) Objective	Soiling Units (SU) measured during period 18/08/17 - 01/09/2017	Nuisance (Y/N)
GS1b	<50	16.7	N
GS2	<50	7.9	N
GS3	<50	-	N/A
GS4	<50	32.2	N
GS5	<50	17.9	N
GS6	<50	20.4	N
