**CONTRACT REF: TLL 7917**

**NORTHERN LINE EXTENSION**

## **Battersea Passive Air Quality Monitoring – Monthly report**

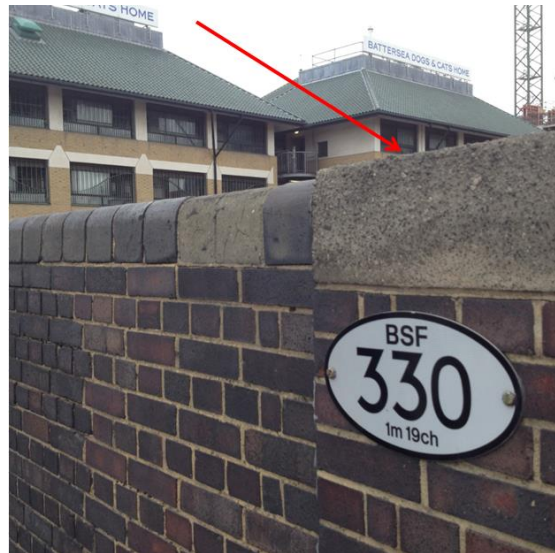
Figure 5 – Glass Slide 1

**Location:** side wall of Battersea Dogs & Cats Home

**Receptor:** Battersea Dogs & Cats Home

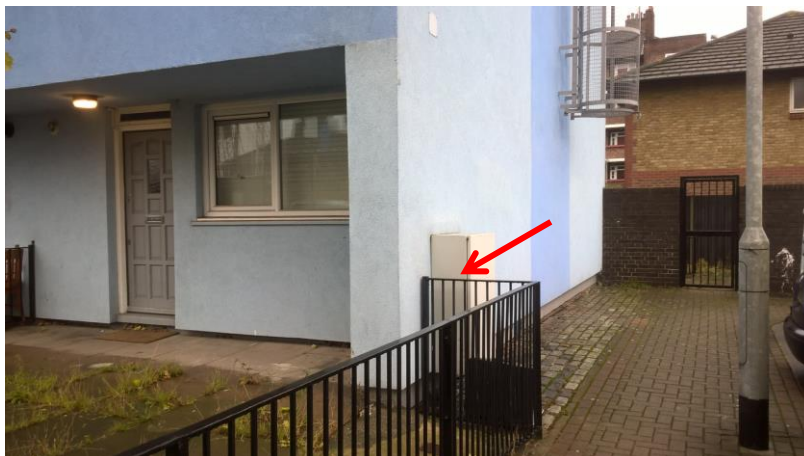
Figure 6 – Glass Slide 2

**Location:** Railing by Battersea Park Road, 113

**Receptor:** residents of Battersea Park Road

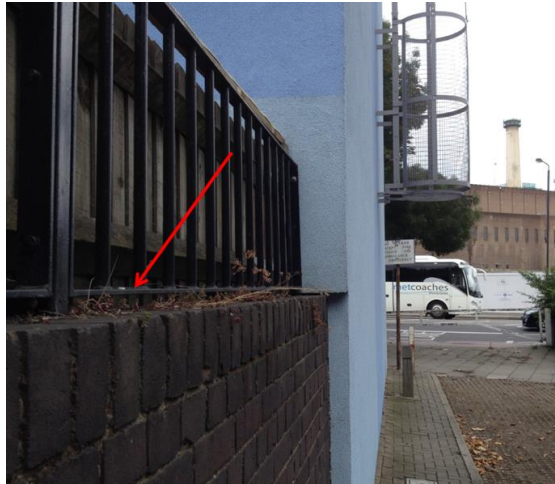
Figure 7 – Glass Slide 3

**Location:** rear wall of Savona Street

**Receptor:** residents of Savona Estate

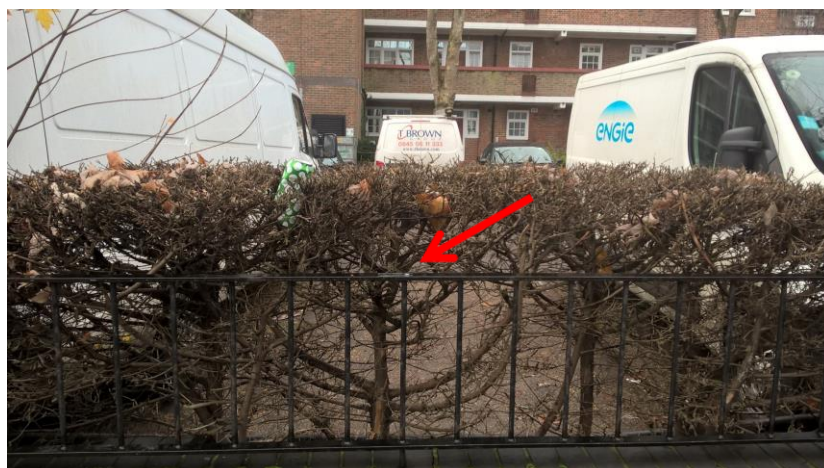
Figure 8 – Glass Slide 4

**Location:** wall on Thessaly Road

**Receptor:** residents along Thessaly Road

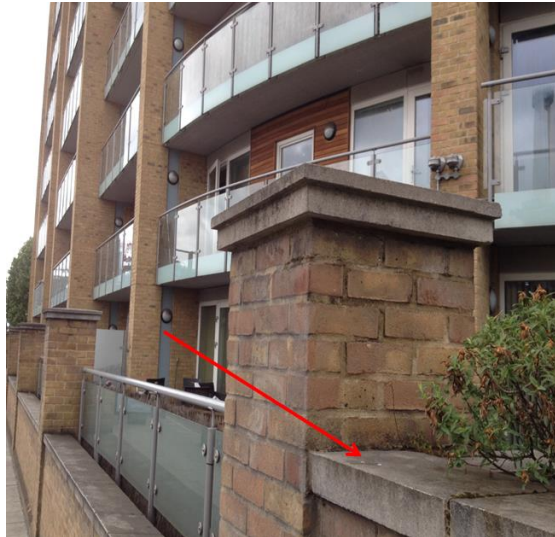
Figure 9 – Glass Slide 5

**Location:** wall opposite Viridian Apartments

**Receptor:** residents at Viridian Apartments

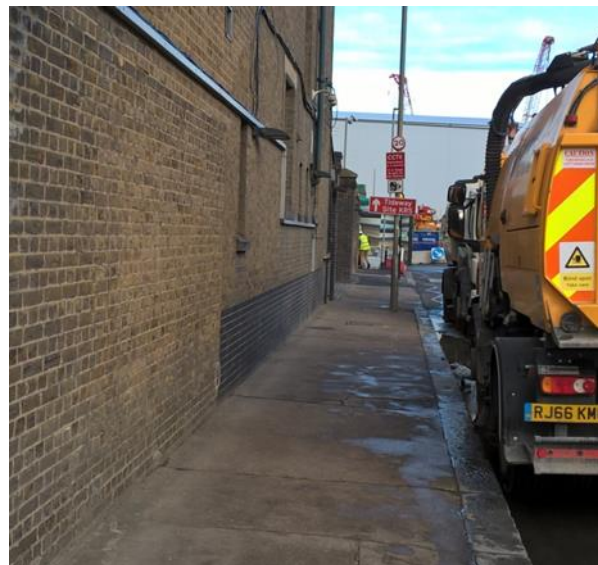
Figure 10 – Glass Slide 6

The guidance criterion of 25 SU per week (i.e. 50 SU per fortnight) set out by the Environment Agency was only exceeded at GS6 during the second of the fortnightly monitoring periods in the surroundings of the Battersea site. The soiling units recorded at GS6 show that it was slightly over the nuisance threshold. The soiling units recorded at the other locations, however, suggest that dust nuisance would have been unlikely at sensitive receptors during the monitoring period.

**Location:** top of post on Kirtling Street

**Receptor:** commercial and residential receptors on Kirtling Street
