SILVERTOWN TUNNEL

**Preliminary Environmental Information
Report: Appendix 16.D**

**River Wall
Structural
Condition Survey**

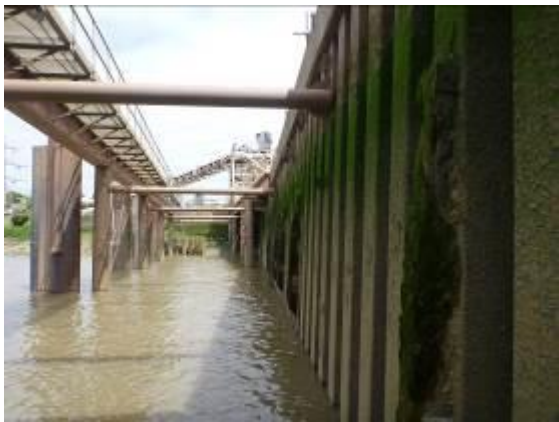
Figure 1 - Steel sheet pile wall with large diameter fender piles and rails for spoil transfer system

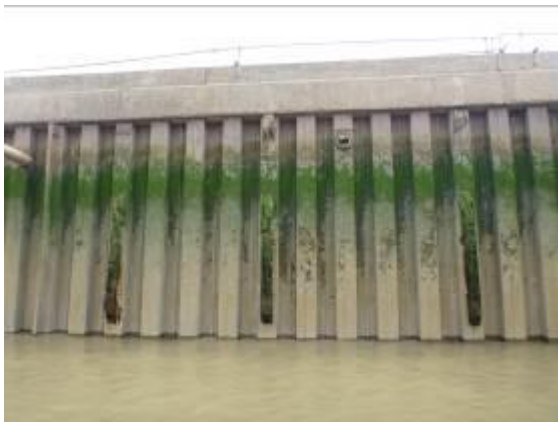
Figure 2 - Steel sheet pile wall with concrete capping beam and parapet

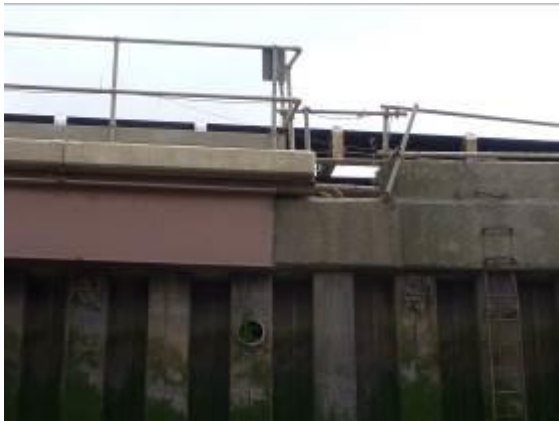
Figure 3 - Intersection between steel sheet pile capping beam and spoil transfer structure

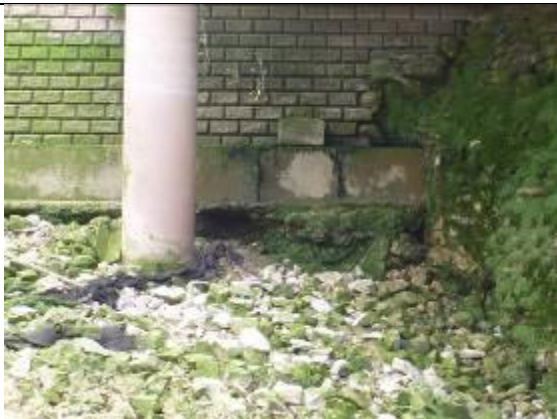
Figure 6 - Blockwork wall frontage with localised erosion at toe of wall

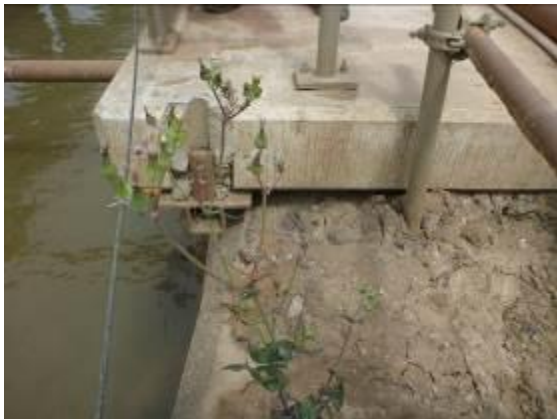
Figure 8 - Temporary structure covering ground at upstream extent of the frontage

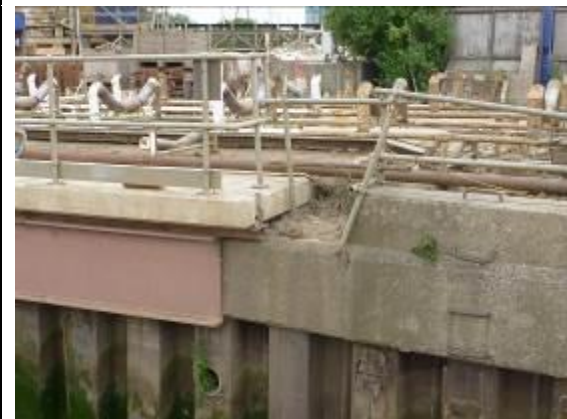
<p>Structural Condition</p>	<p>Concrete bag work appears to be in good condition with no signs of missing or damaged bags. However, a close inspection was not possible [Figure 5].</p> <p>Sheet pile cut off has been installed at approximately 10m chainage for approx 10m; it has likely been installed to either retain the toe of the rock armour revetment and concrete bag work section or to protect the structures from impact damage. Alternate piles are “left high”[Figure 7]. The cut-off is in good condition with only minor superficial corrosion and no sign of vessel impact.</p> <p>The blockwork wall is generally in good condition and appears stable along the majority of the frontage. Some erosion and scour of the toe is evident at the eastern extent where it meets the bag work [Figure 6].</p> <p>The alignment of the steel sheet piling appeared to be good with no indication of leaning. The piles themselves appeared to be in good condition with limited levels of corrosion. There are no visible waling bolts or anchor bolts in the steel sheet pile section.</p> <p>There are 2 flap valves which are missing from the sheet pile section. One has a large void behind which might indicate loss of fill material [Figure 4].</p> <p>A topside survey could not be carried out on the upstream extent of the steel sheet piling and concrete bagwork sections due to the presence of a temporary structure covering the ground over this asset [Figure 8 and Figure 9].</p> <p>No settlement behind the wall was observed along the sections which could be accessed.</p>

Figure 9 - Intersection between temporary structure and existing river wall

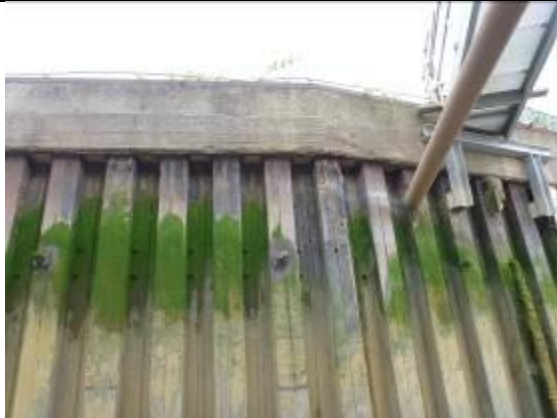
Figure 15 - Steel sheet pile with steel brace and concrete parapet

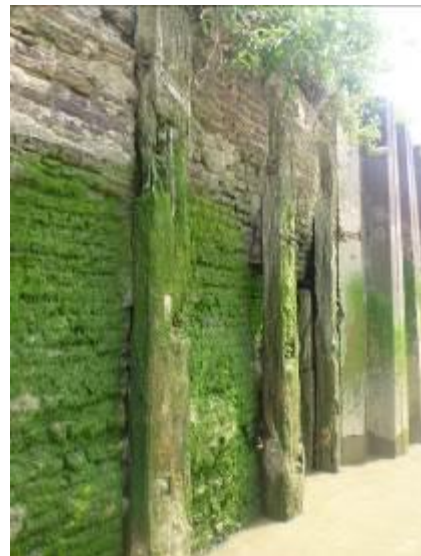
Figure 32 – View of algal growth and remains of timber fenders at downstream extent of asset

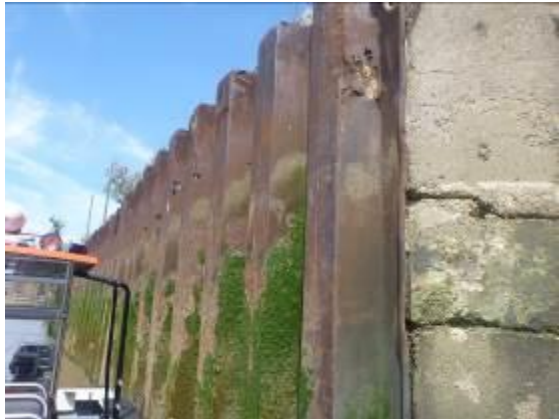
Figure 35 – View of steel sheet pile wall and concrete interface

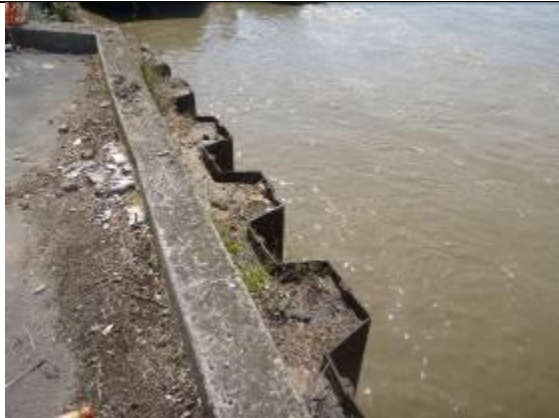
Figure 37 - Concrete backfill behind sheet piles and concrete parapet

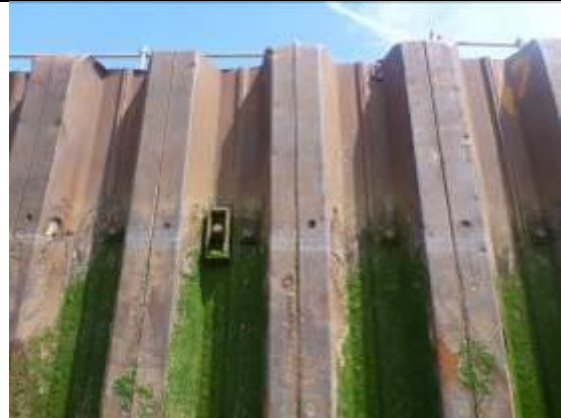
Figure 41 - Waling and anchor bolts

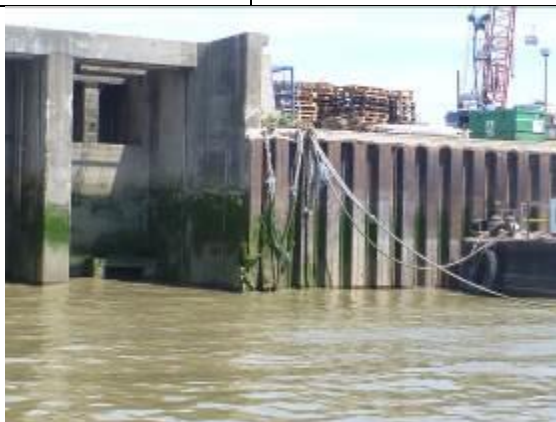
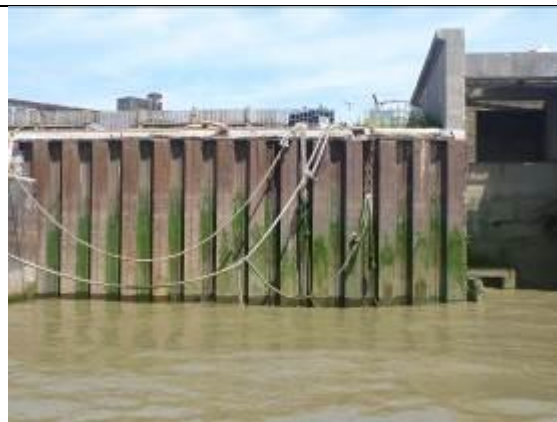
Figure 49 - Steel sheet pile wall and concrete Thames Water outfall

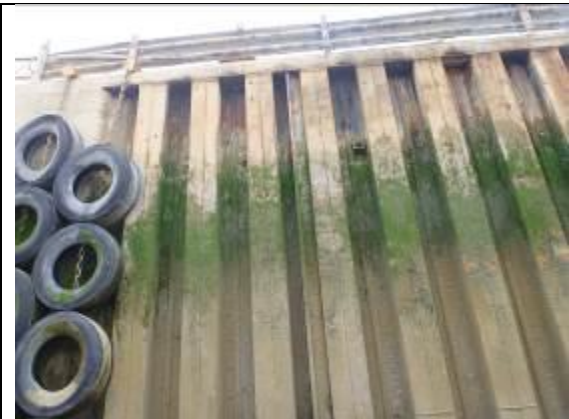
Figure 52 - Steel sheet pile wall with waling, anchor bolts and concrete coping

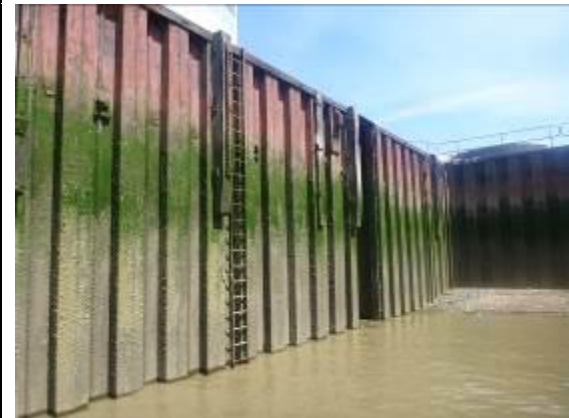
Figure 71 - Steel sheet pile walls with waling and anchor bolts

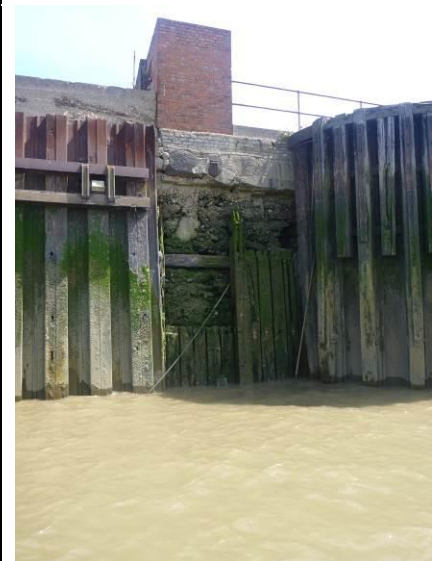
Figure 73 - Timber wall section at upstream extent of asset

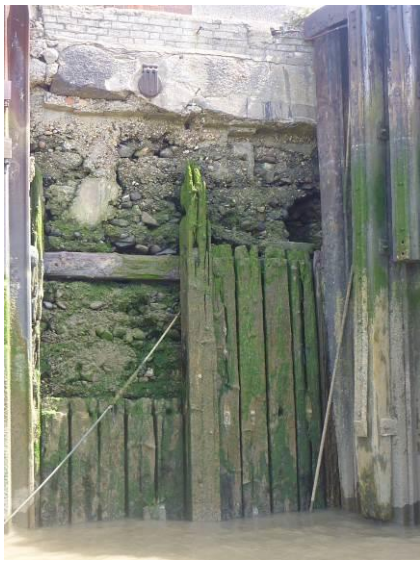
Figure 74 - Timber wall with concrete fill behind

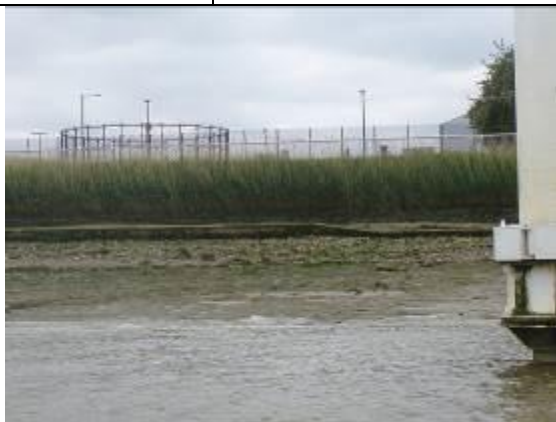
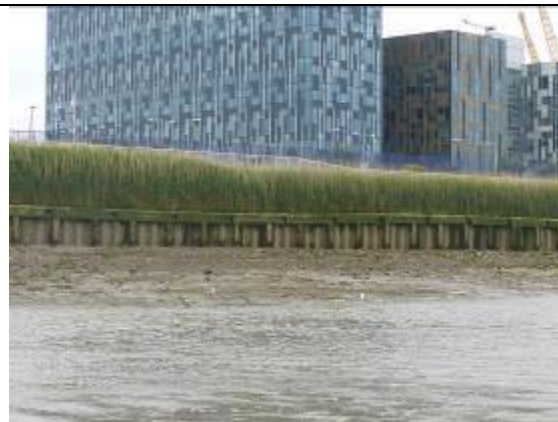
Figure 76 - Concrete wall is obstructed by reeds but gabion baskets at the toe are visible

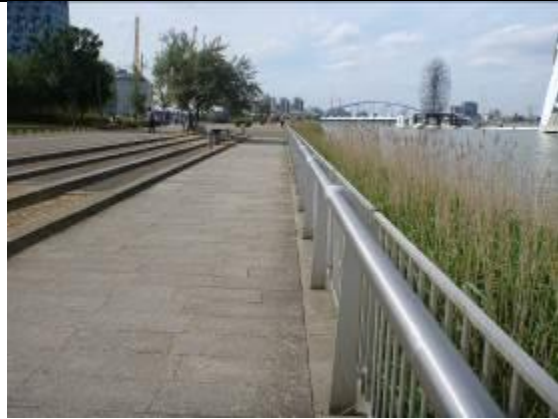
Figure 77 - Section of the river wall with sheet piled toe

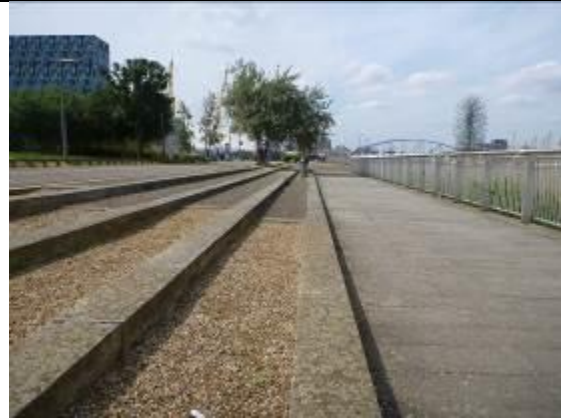
Wall Construction	<p>The flood defence is of multi-tiered construction. The riverside toe of the defence is a mixture of gabion baskets and steel sheet piling, which support a vegetated inter-tidal terrace. Behind the terrace is a cantilevered L-shaped concrete wall, which supports a 3m wide Thames Path. Behind the path there are 4 No (120mm high, 1000mm wide) paved steps up to the flood defence level.</p> <p>The above construction details are verified in the available as-built drawings.</p>
Structural Condition	<p>The concrete wall appears to be in good condition, although, visibility of the frontage from the riverside was impaired due to vegetation cover [Figure 76].</p> <p>The crest level of gabion baskets appeared to undulate although the baskets themselves appeared to be in reasonably good condition with no signs of tears or loss of ballast [Figure 76].</p> <p>The finish level of the sheet piling likewise appeared to undulate although the condition of the capping beam would seem to indicate that these undulations have existed since construction. The condition of the piles could not be viewed due to tidal and foreshore conditions. The alignment of the piles appeared to be generally good [Figure 77].</p> <p>The paving and handrails along the path and crest are in good condition [Figure 78 and Figure 79].</p>

Figure 78 - Lower Thames Path directly behind the frontage
